**UT to Little Coharie Creek (Roseboro Site)
Stream Restoration Project
Sampson County
North Carolina**

**CU: 030030006
DENR Contract No. 004578
EEP Project No. 314**

**Monitoring Year 5 of 5
Data Collection: May through November 2013
Submission Date: November 27, 2013**

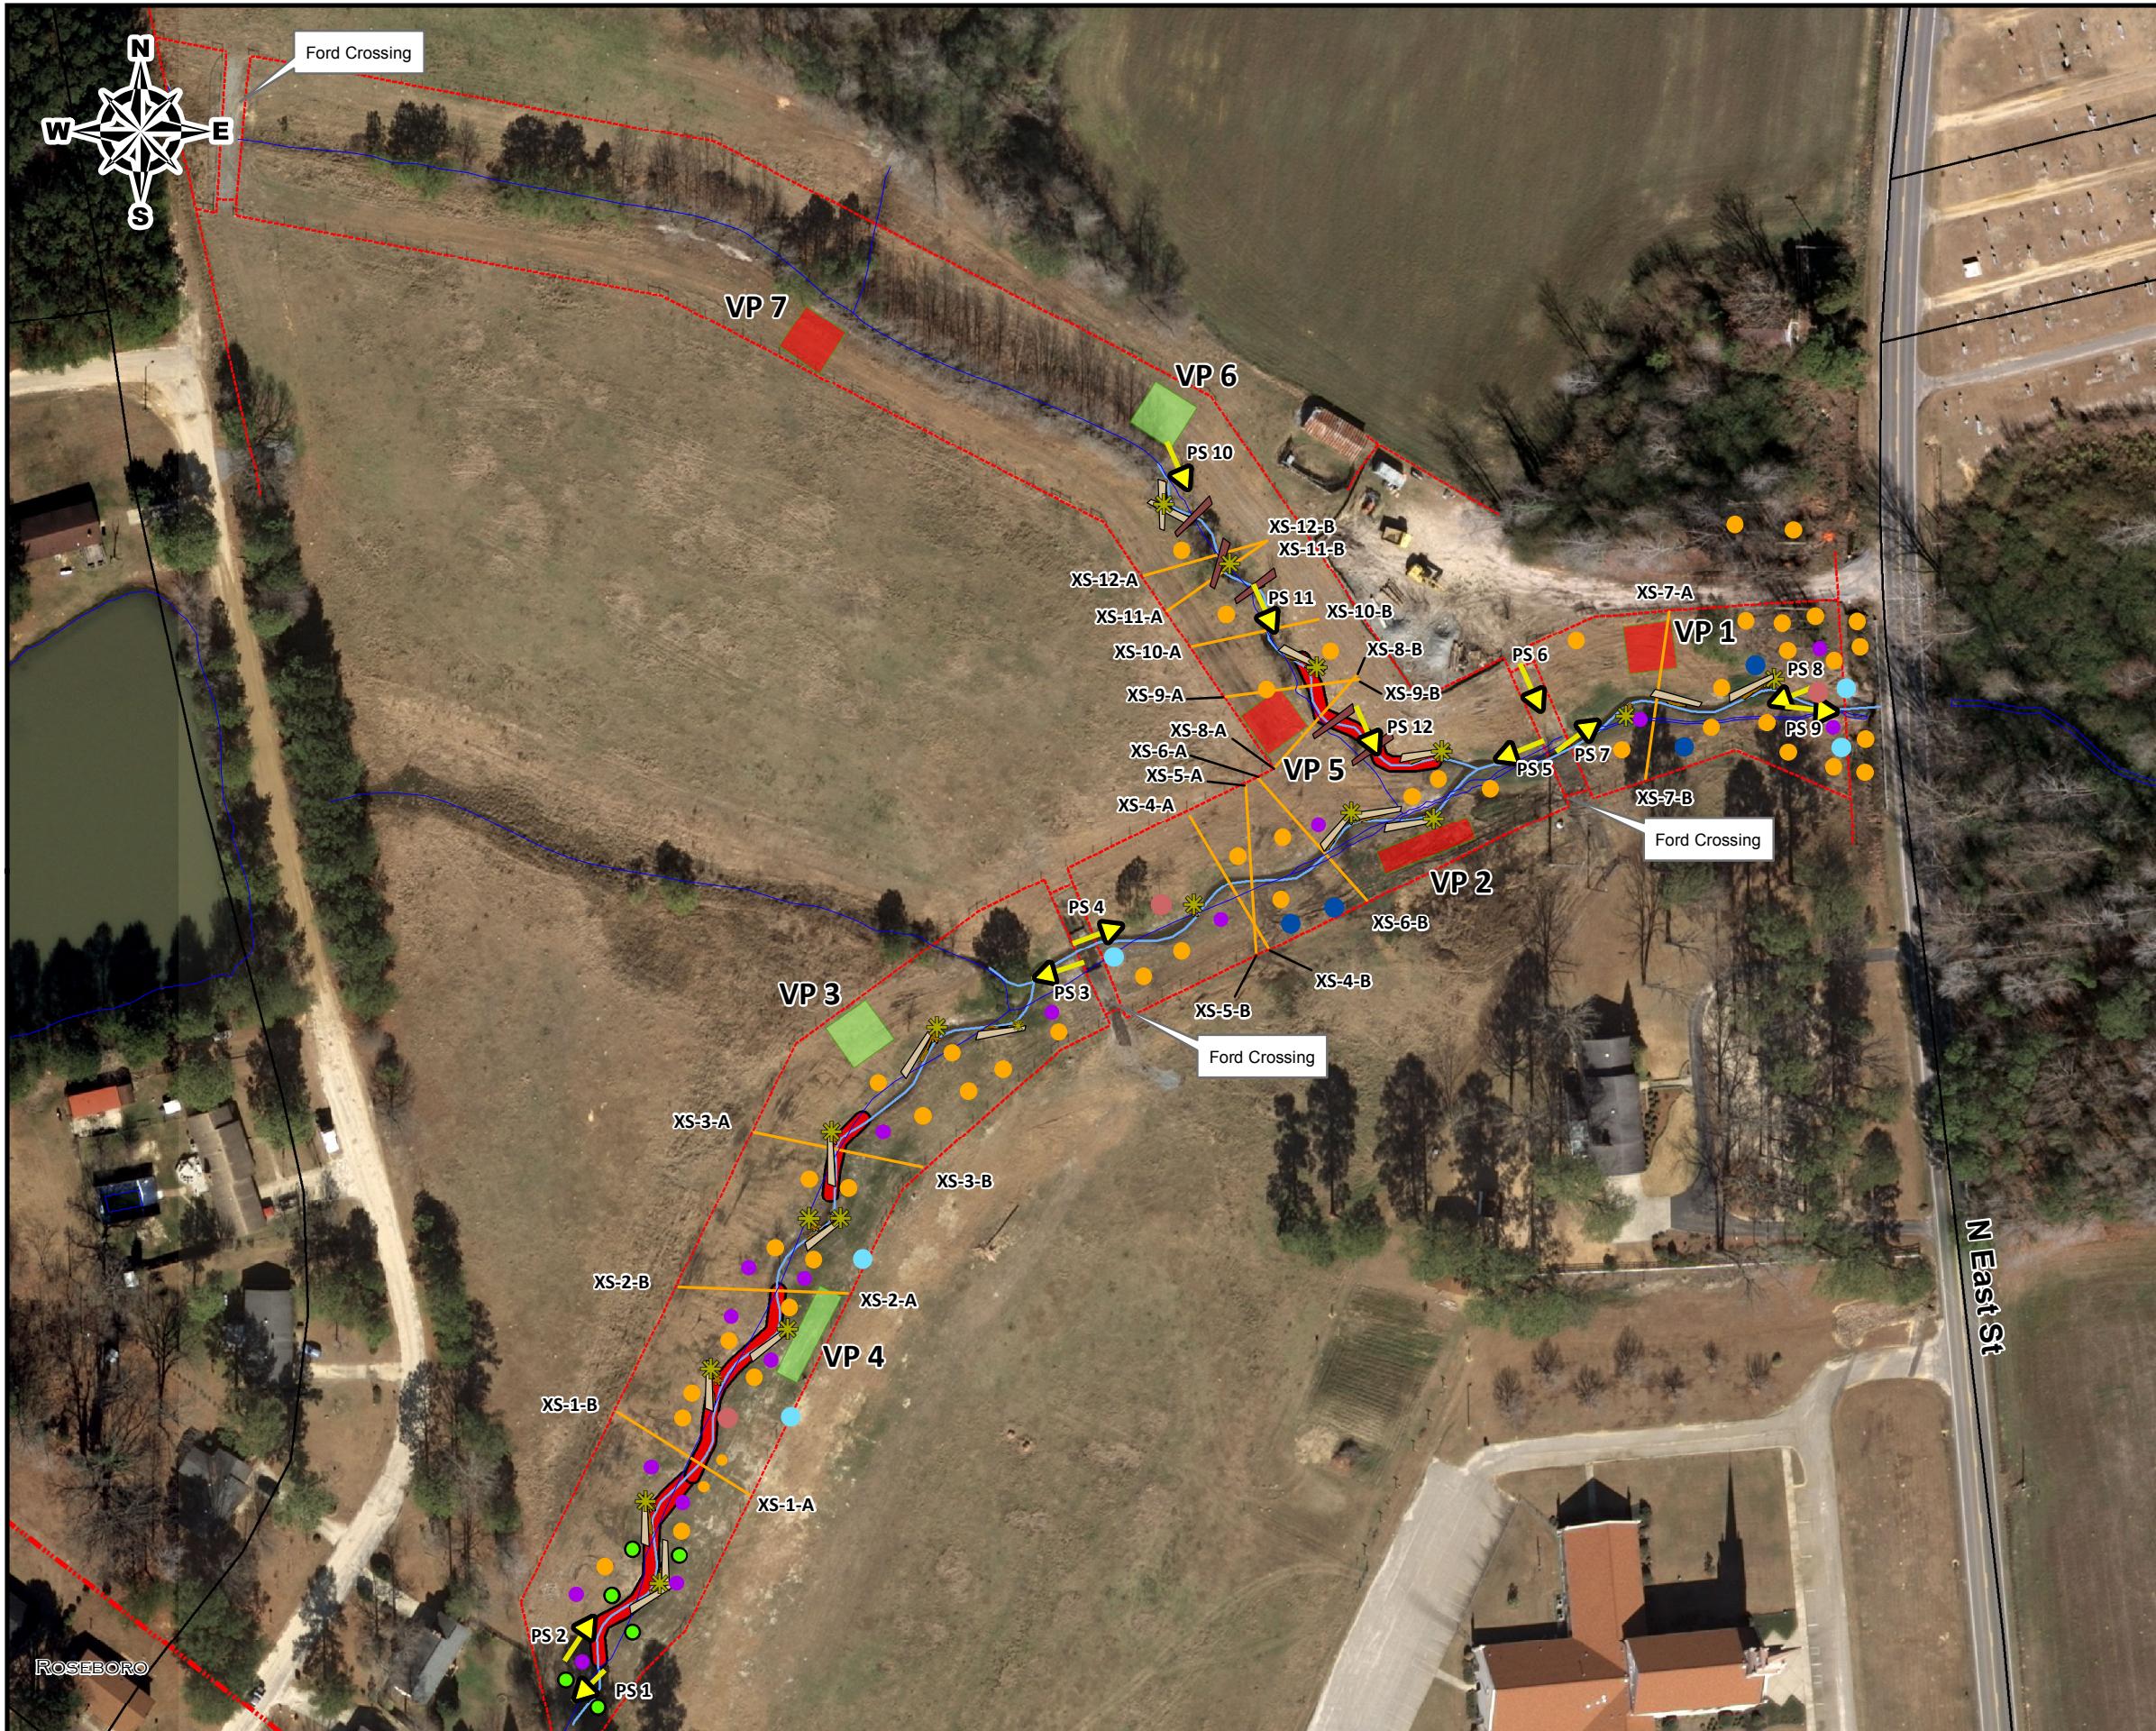
**2013
Current Conditions Plan View**

Stream Problem Areas UT to Little Coharie Stream Restoration Project - EEP No. 314			
Feature Issue	Station Number	Suspected Cause	Photo Number
Aggradation	Main 10+00 to 300+00	Sediment influx from upstream and offsite	Cross Section 1 - 3
Aggradation	Northern 11+40 to 12+15	Trapped Sediment/Low Flow	Figure 2

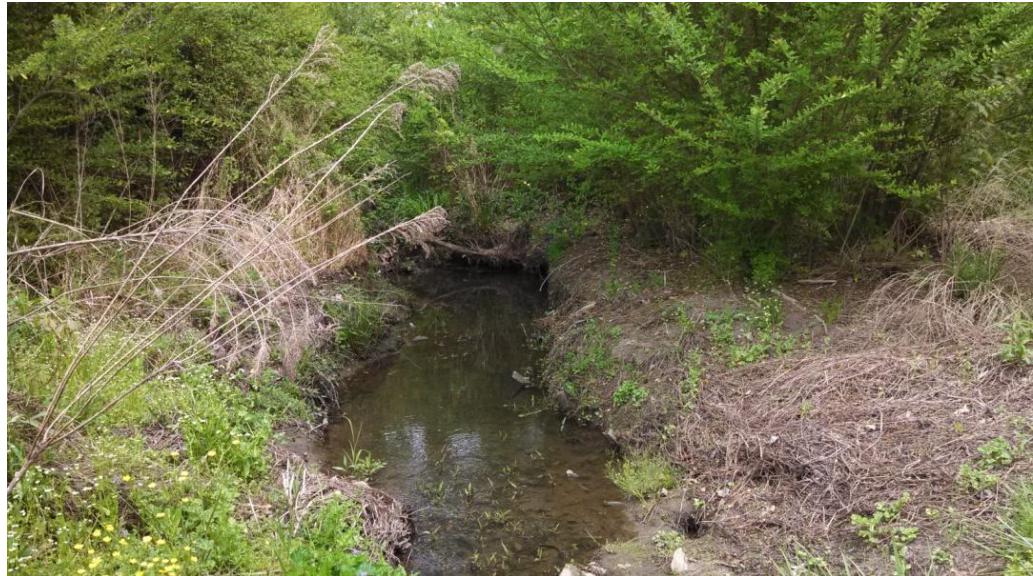
7 - Main Reach Station 10+50 – Looking Downstream

Date of Data Collection	Date of Occurrence	Method	Photo #
April 18, 2013	April 2013	Photographed onsite (Wrack Line)	Stream Photo 3
November 1, 2012	October 2012	Photographed onsite (Wrack Line)	Stream Photo 7
October 22, 2011	September 2011	Photographed onsite (Wrack Line)	Stream Photo 13 of the 2011 MY3 Monitoring Report
November 13, 2010	September 2010	Photographed onsite (Wrack Line)	Stream Photo 6 of the 2010 MY2 Monitoring Report
October 29, 2009	September 2009*	Wrack line observed onsite	Photographic evidence is not available for this occurrence. 2009 MY1

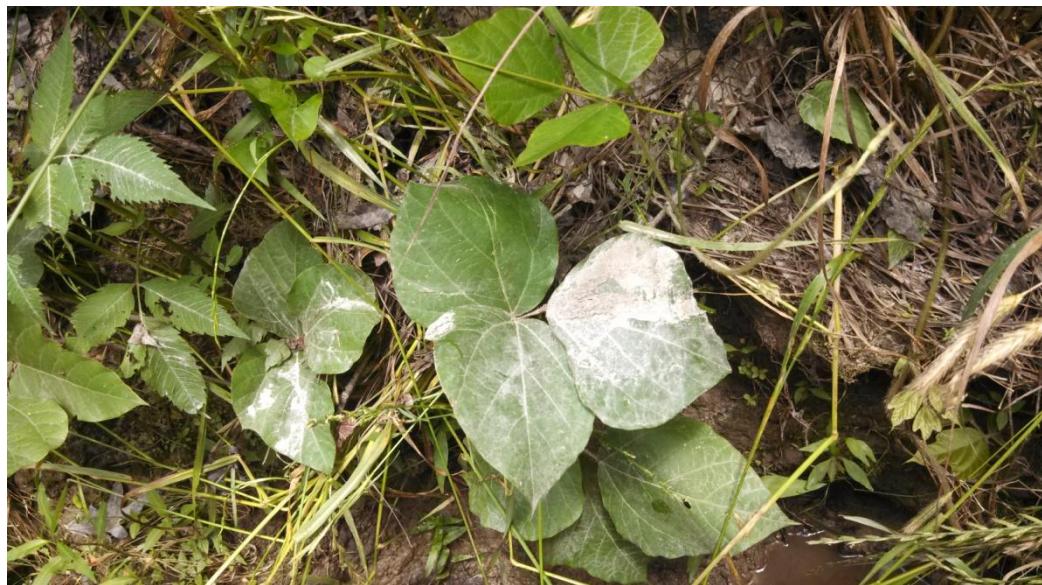
Vegetation Problem Areas UT to Little Coharie Stream Restoration Project - EEP No. 314			
Feature Category	Station Number	Suspected Cause	Photo Number
Cattail	Throughout	Low Flow Conditions	Figure 2
Invasive Vegetation	Various, Refer to Figure 2 for Location	Offsite seed source	VPA1

VPA1 – Kudzu Encroachment (Figure 2)

Seven (7) permanent vegetation plots were established and used in annual vegetation monitoring. Vegetation plots VP3, VP4, and VP6 exceed the minimum success requirements. Vegetation monitoring plots VP1, VP2, VP5, and VP7 fall below the minimum success requirements. By visual observation, a majority of the site is diverse and numerous of planted stems species. For 2013, MY5, the vegetation monitoring identified stem counts below the minimum success criteria for MY5 resulting in an average density of 240 planted stems per acre for the entire site. The vegetative success criteria based on the US Army Corps of Engineers Stream Mitigation Guidelines (USACE, 2003) will require the survival of 260 planted woody stems per acre at the end of the year 5 monitoring period. UT to Little Coharie Creek utilizes a CVS Level 2 protocol for vegetation data collection. This protocol does include volunteer stems during data collection. For vegetation success criteria, only the planted stems are used to determine stems per acre. Vegetation plot locations are identified in Appendix C. Invasive vegetation species Chinese privet (*Ligustrum sinense*), Japanese honeysuckle (*Lonicera japonica*), mimosa (*Mimosa sp.*), kudzu (*Pueraria lobata*), and Asiatic daylily (*Commelina communis*) have been identified onsite and the location of each are depicted in Figure 2. Multiflora rose (*Rosa multiflora*) and fescue (*Festuca sp.*) have also been identified onsite. Supplemental planting for UT to Little Coharie will be completed in December 2013 and during early 2014, the site will be treated for invasive vegetation.
