FINAL
YEAR 3 (2016) MONITORING REPORT
UT TO MARTIN'S CREEK (CONTRERAS) MITIGATION PROJECT
Cherokee County, North Carolina
DMS Project No. 92766 (Contract No. 005717)
USACE Action ID No. 2010-00961/DWR Project No. 2010-00448
SCO No. 08-07249-01

Data Collection – March-November 2016

December 2016

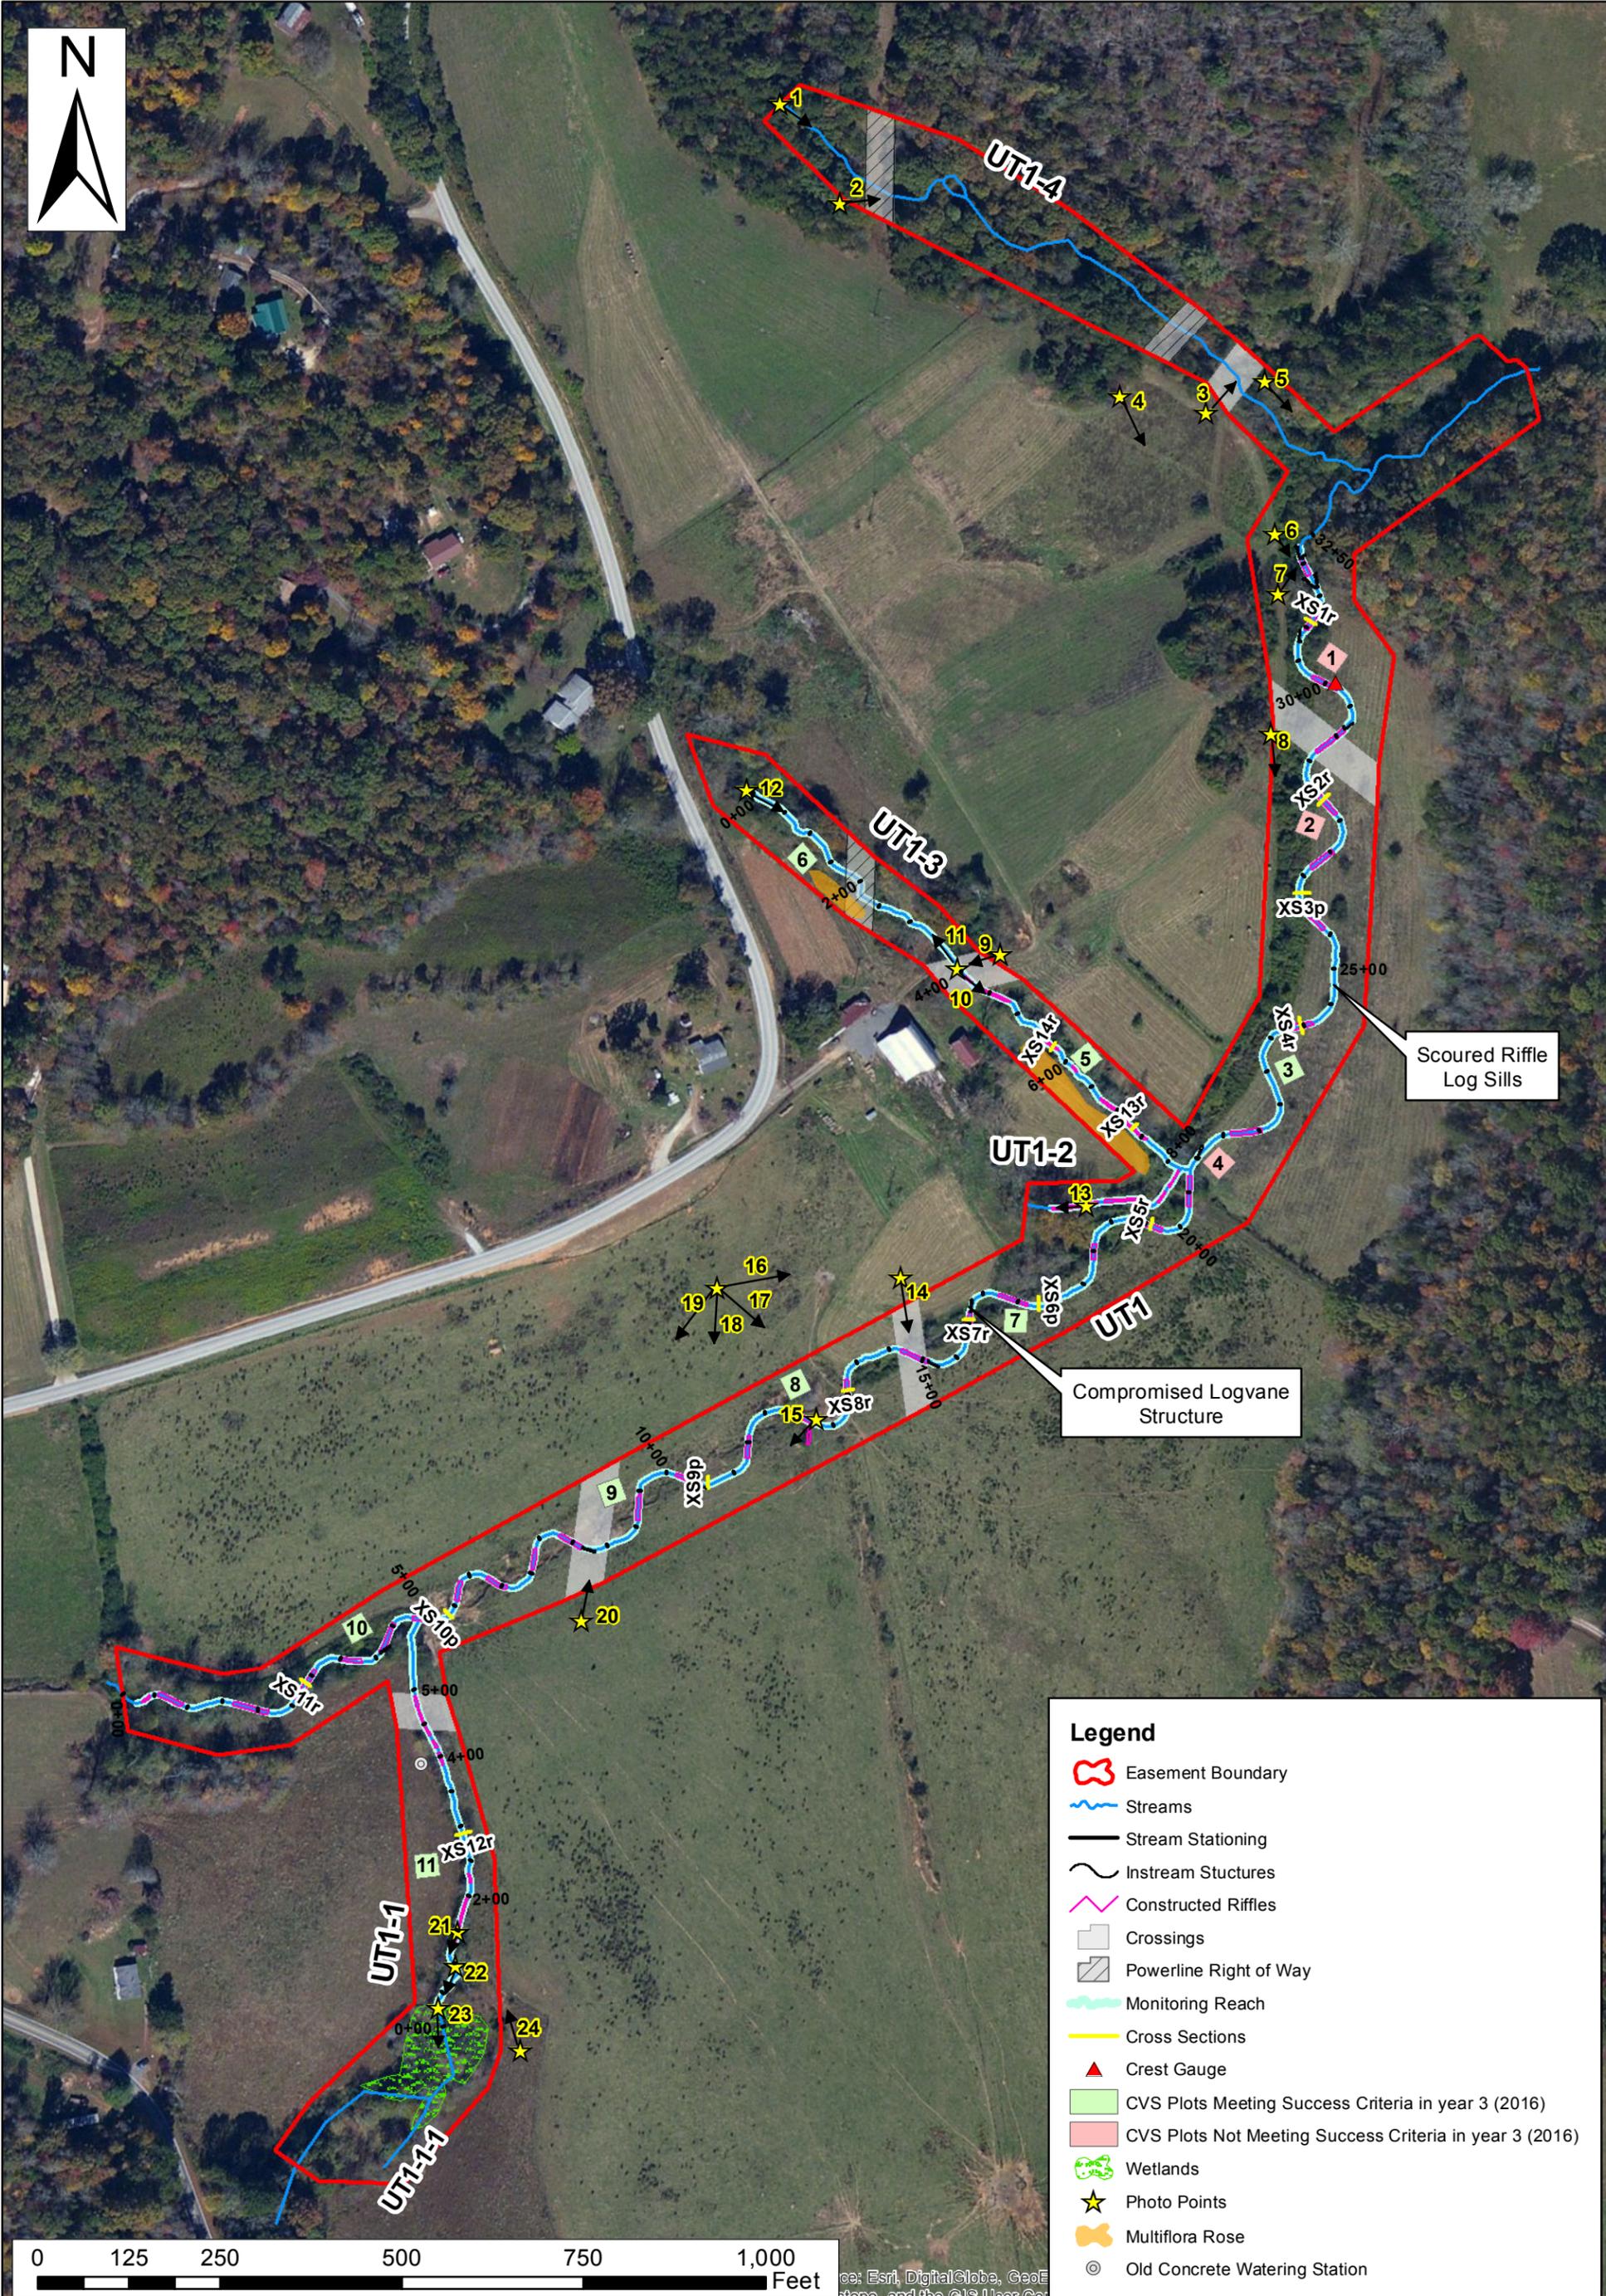
Figure 2. Current Conditions Plan View (CCPV)

Two areas of concern were noted along UT-1. One area consists of a section of log sills constructed within a riffle near station 25+00. The riffle bed material surrounding the log structures has scoured resulting in pools through this section of stream. The log sills continue to maintain grade but could potentially become undermined during heavy storm flows. An additional area of concern includes a log vane structure along the right bank of UT-1 with a failed footer. This structure is located immediately downstream of cross-section 7. The structure has continued to maintain grade along the upstream riffle thus far, but it is unstable and is likely to fail. These areas of concern will be closely monitored during the remainder of the monitoring period. Stream areas of concern are depicted on Figure 2 and quantified in Table 5A (Appendix B).

Scoured Riffle Log Sills

Compromised Logvane Structure
