YEAR 2 MONITORING REPORT

UT TO NEUSE RIVER (BIG DITCH) STREAM RESTORATION SITE

Wayne County, North Carolina

DMS Project No.: 92682

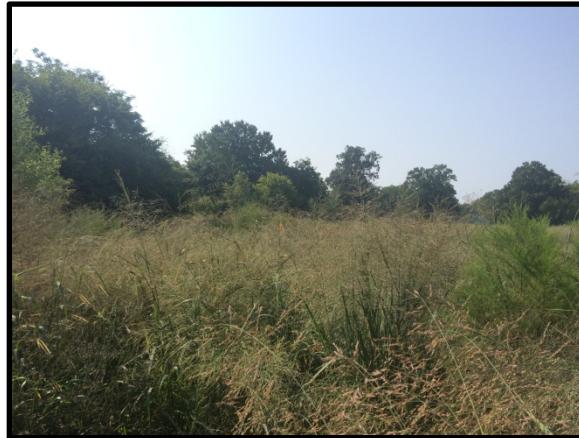
3.1 Vegetation Plot 2

(*Alnus serrulata*), white fringe tree (*Chionanthus virginicus*), winter berry (*Ilex verticillata*), and sweetbay magnolia (*Magnolia virginiana*). After the second growing season, planted stems appeared stressed throughout the site. Seven of the nine vegetation plots (Plot 1, 2, 3, 5, 6, 7, and 9) did not meet the success criteria of at least 320 stems per acre. It was noted in Year 1 Monitoring that overall planted stem vigor was low and the site was prone to losing many of the planted stems. Plots in the upper half of the site are being outcompeted by broomsedge. Additionally, many of the plots are subject to frequent overbank flow which has eroded the soil and washed away many of the planted trees. When taking into account natural recruits only Plots 2, 7, and 9 fail to meet success criteria of at least 320 stems per acre.

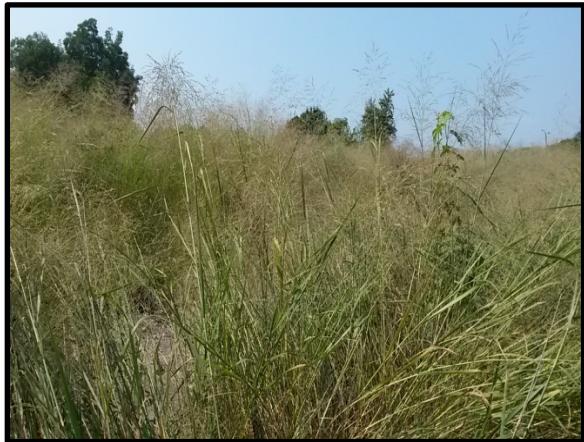
3.8 Vegetation Plot 9

The bare area in and surrounding Plot 9 is decreasing in size, however, frequent overbank flows are still causing exposed roots, loss of planted trees and stunted growth. Additional seeding or planting is recommended to stabilize the soil in this area and prevent further erosion.

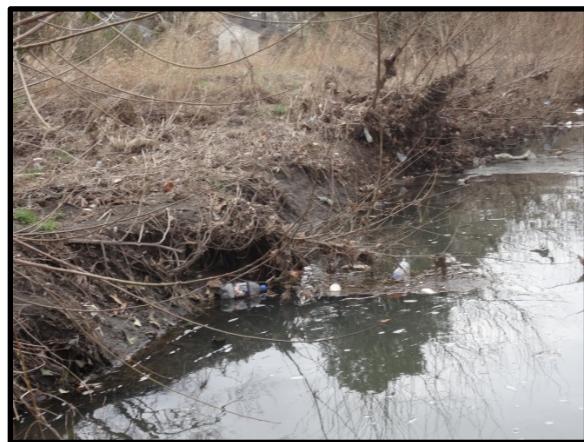
3.9 Minor Erosion Station 12+00

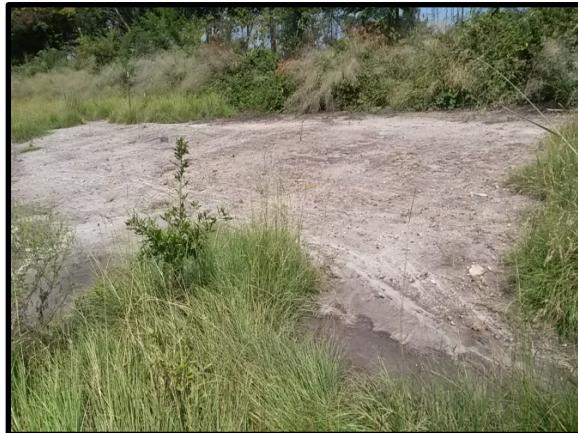
3.10 Thin Grass Station 29+00

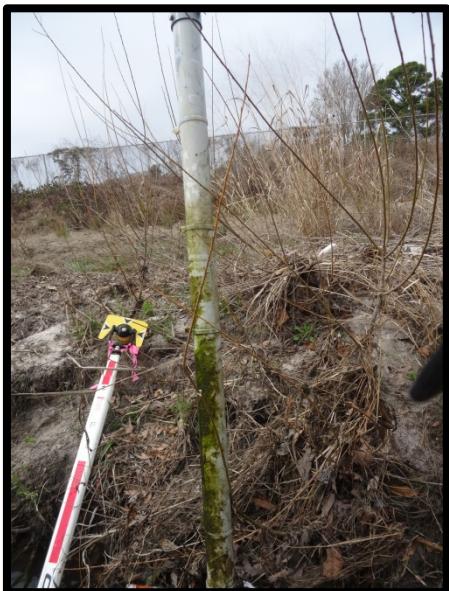
Figure 6.3 Crest Gauge 3/13/2015

The site has experienced at least four bankfull flows through the first two years of monitoring. The crest gauge installed on-site was inspected on April 28, 2014, August 20, 2014, March 13, 2015 (found in need of repair), and September 4, 2015. The crest gauge indicated that a bankfull event occurred at least twice during both years (Table 13). Additional overbank evidence includes debris and detritus lines, vegetation bent in the downstream direction, and exposed roots within the floodplain and on the terrace slopes.
