## **Unnamed Tributary to Pembroke Creek Wetland and Stream Restoration**

Chowan County, North Carolina, EEP Project #283

Year 1 of 5 Monitoring Report

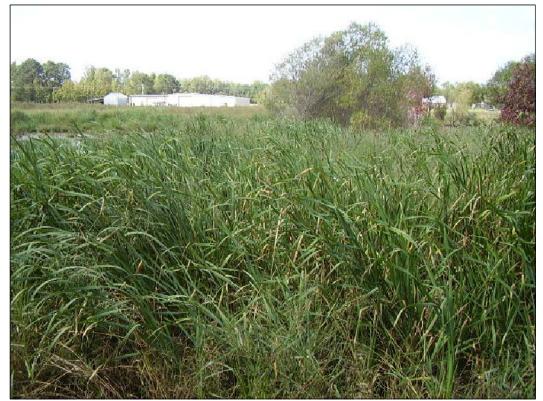
Invasive species from station 21+00 to 25+00 includes: cattail (*Typha latifolia*), Japanese honeysuckle (*Lonicera japonica*), Japanese stilt grass (*Microstegium vimineum*), Chinese privet (*Ligustrum sinense*), and parrotfeather (*Myriophyllum aquaticum*). These invasive species were previously noted in the Final Mitigation Plan and primarily isolated within the remaining drainage ditches. Continued monitoring is recommended to check for any significant encroachment of these invasive species. It is also recommended that a plan of action be developed to control cattail (*Typha latifolia*) encroachment.

Invasive species from station 21+00 to 25+00 includes: cattail (*Typha latifolia*), Japanese honeysuckle (*Lonicera japonica*), Japanese stilt grass (*Microstegium vimineum*), Chinese

privet (*Ligustrum sinense*), and parrotfeather (*Myriophyllum aquaticum*). These invasive species were previously noted in the Final Mitigation Plan and primarily isolated within the remaining drainage ditches. Continued monitoring is recommended to check for any significant encroachment of these invasive species. It is also recommended that a plan of action be developed to control cattail (*Typha latifolia*) encroachment.

Problem Area I - Cattail (Typha latifolia) Encroachment. Stationing from 2I+00 to 25+00.

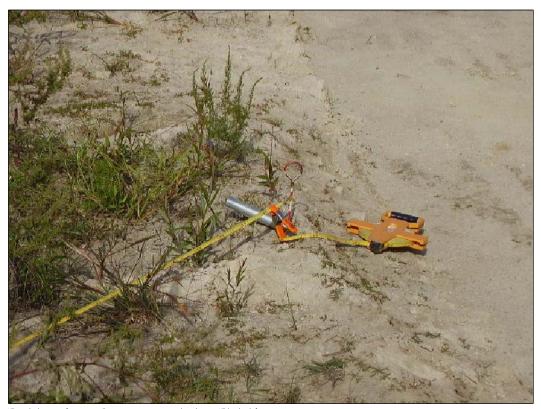
Problem Area 2 - Damaged Veg Plot 16

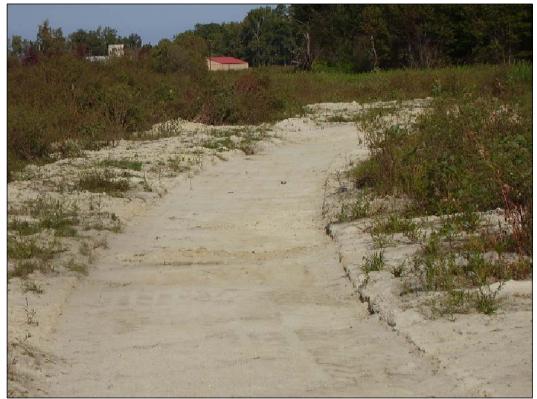
Problem Area 3 - Damaged Veg Plots 13 and 14

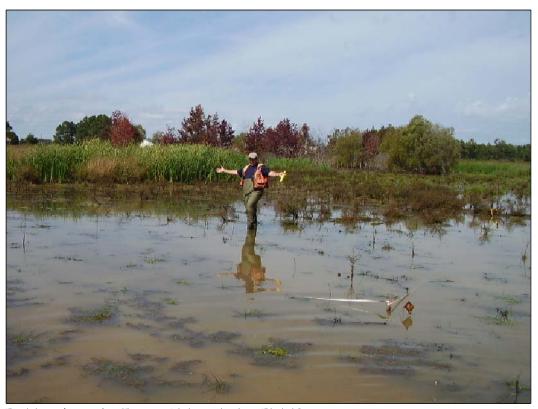
Problem Area 4 - Excess Water at Veg Plot 12

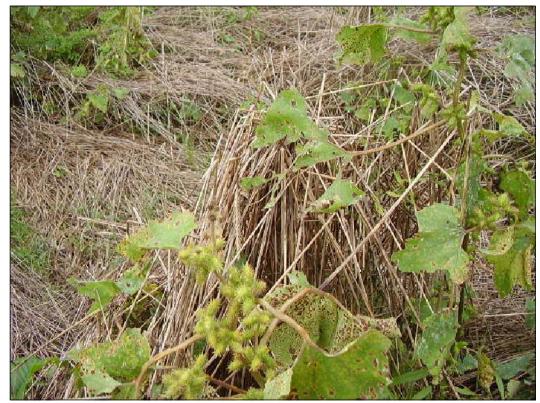
Invasive species and competitive species which were formerly associated with past agricultural production are likely causes of survival decline to planted woody species. In many cases, herbaceous species from seed sources in the soil surmounted the bare root seedling. Damage concerns after planting also existed from the complete or partial removal

Problem Area 5 - Competitive species dominating planted woody stem species
