Randolph County, North Carolina

2011 Year 4 Monitoring Report - Final EEP Project Number: 403 USGS HUC 03030003020010 EcoEngineering Project Number: EEP-08030

UT TO SANDY CREEK

CONSOLIDATED CURRENT CONDITIONS PLAN VIEW - YEAR FOUR MONITORING

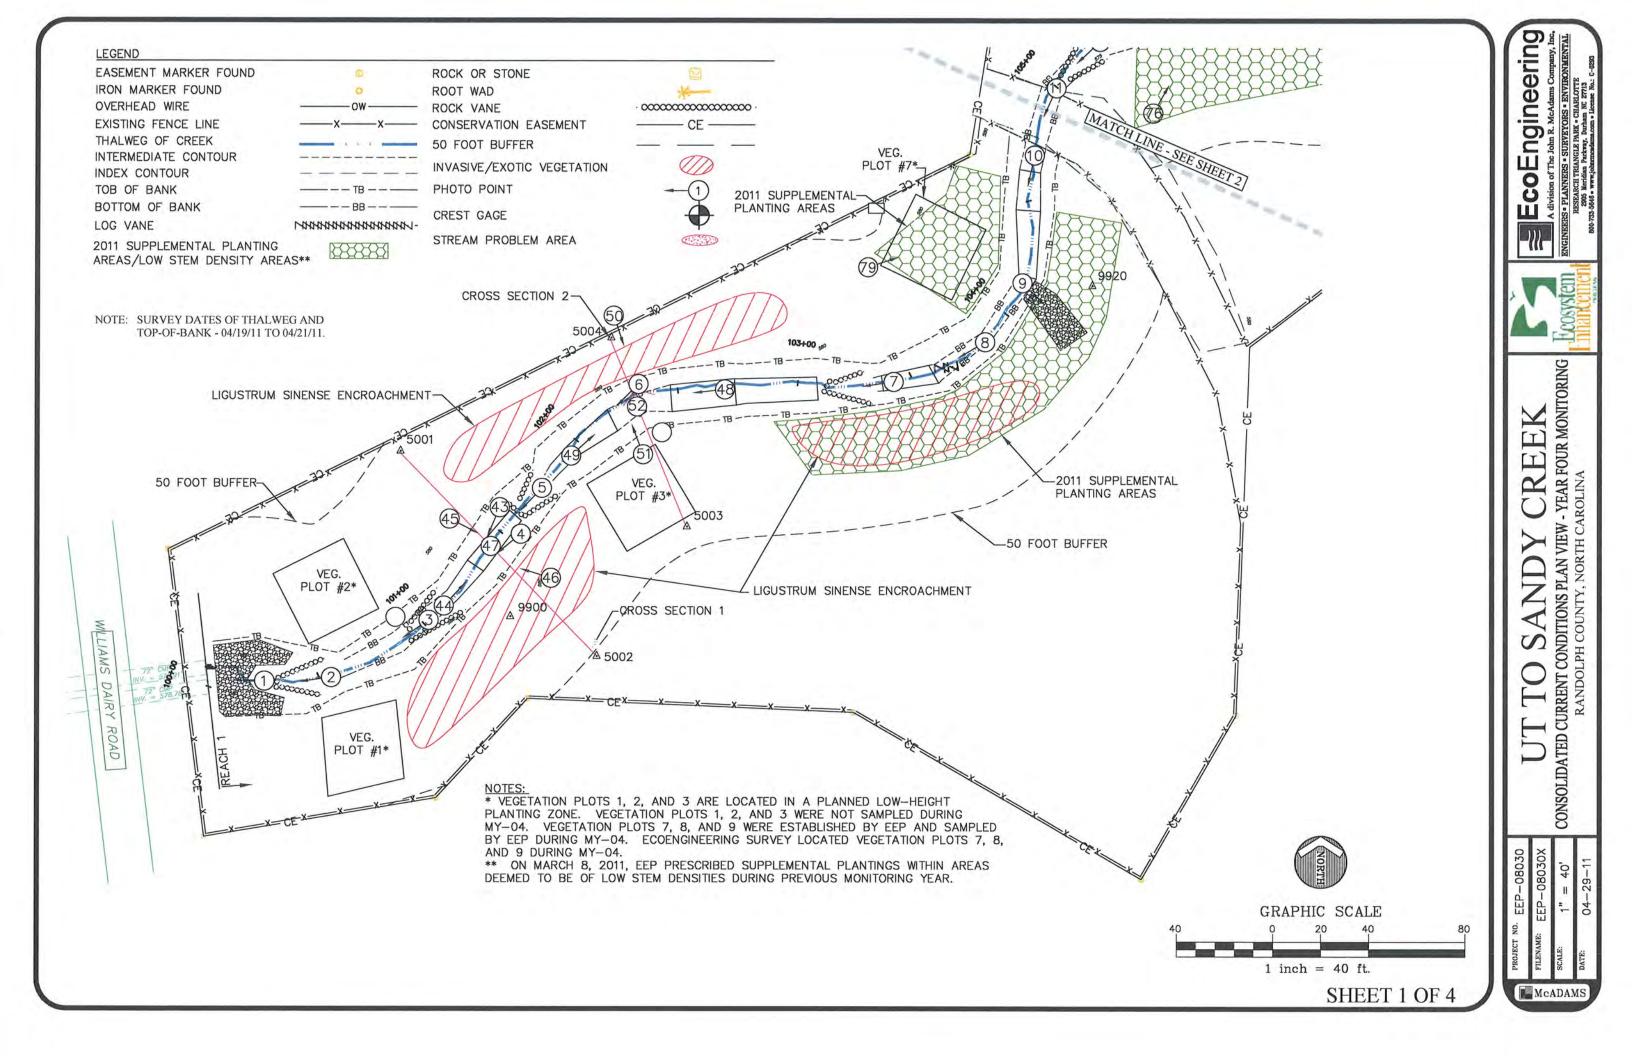
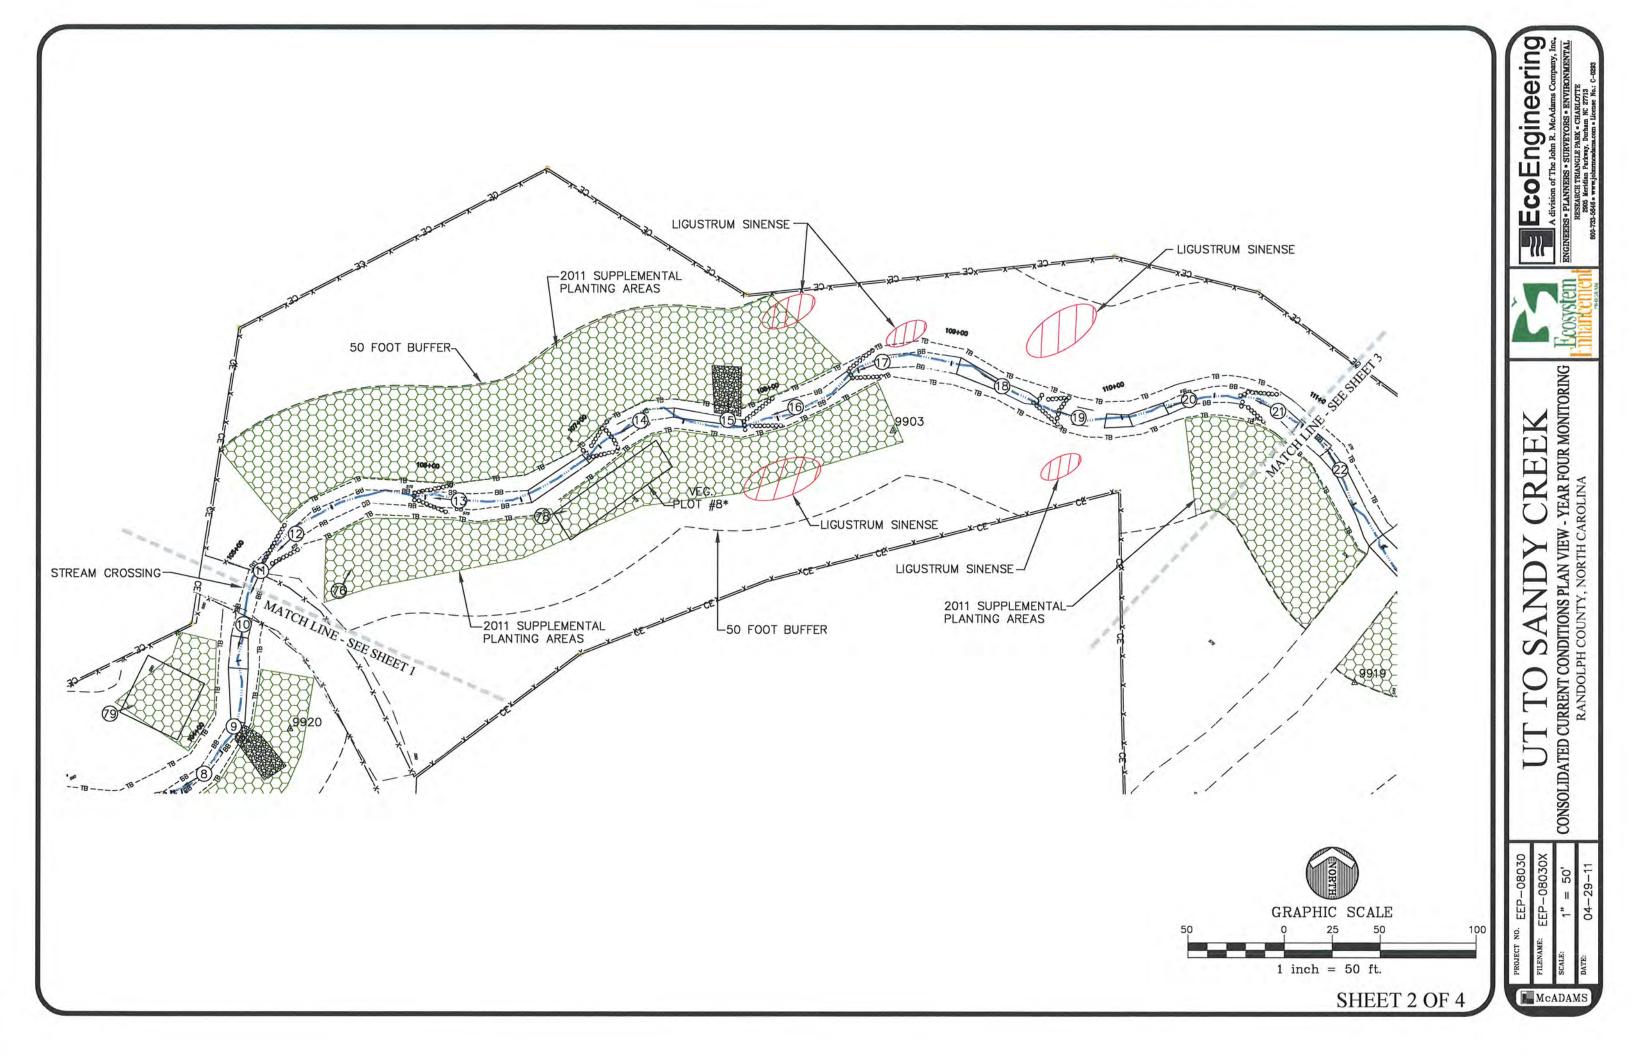
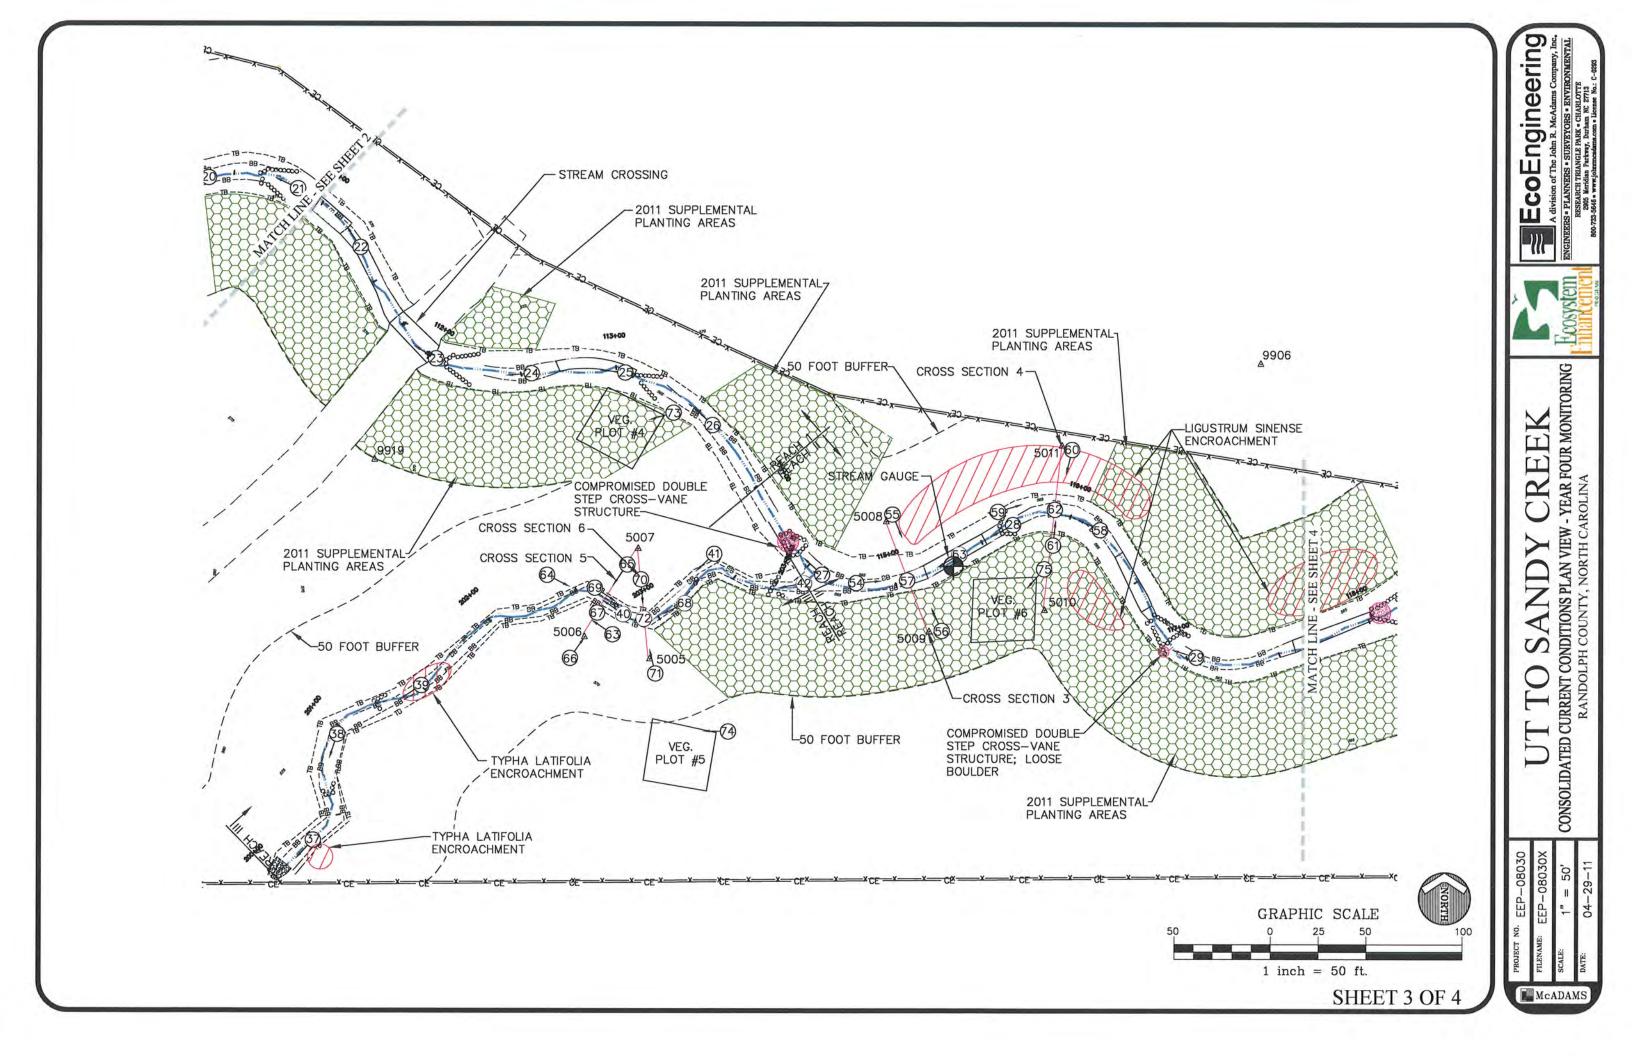
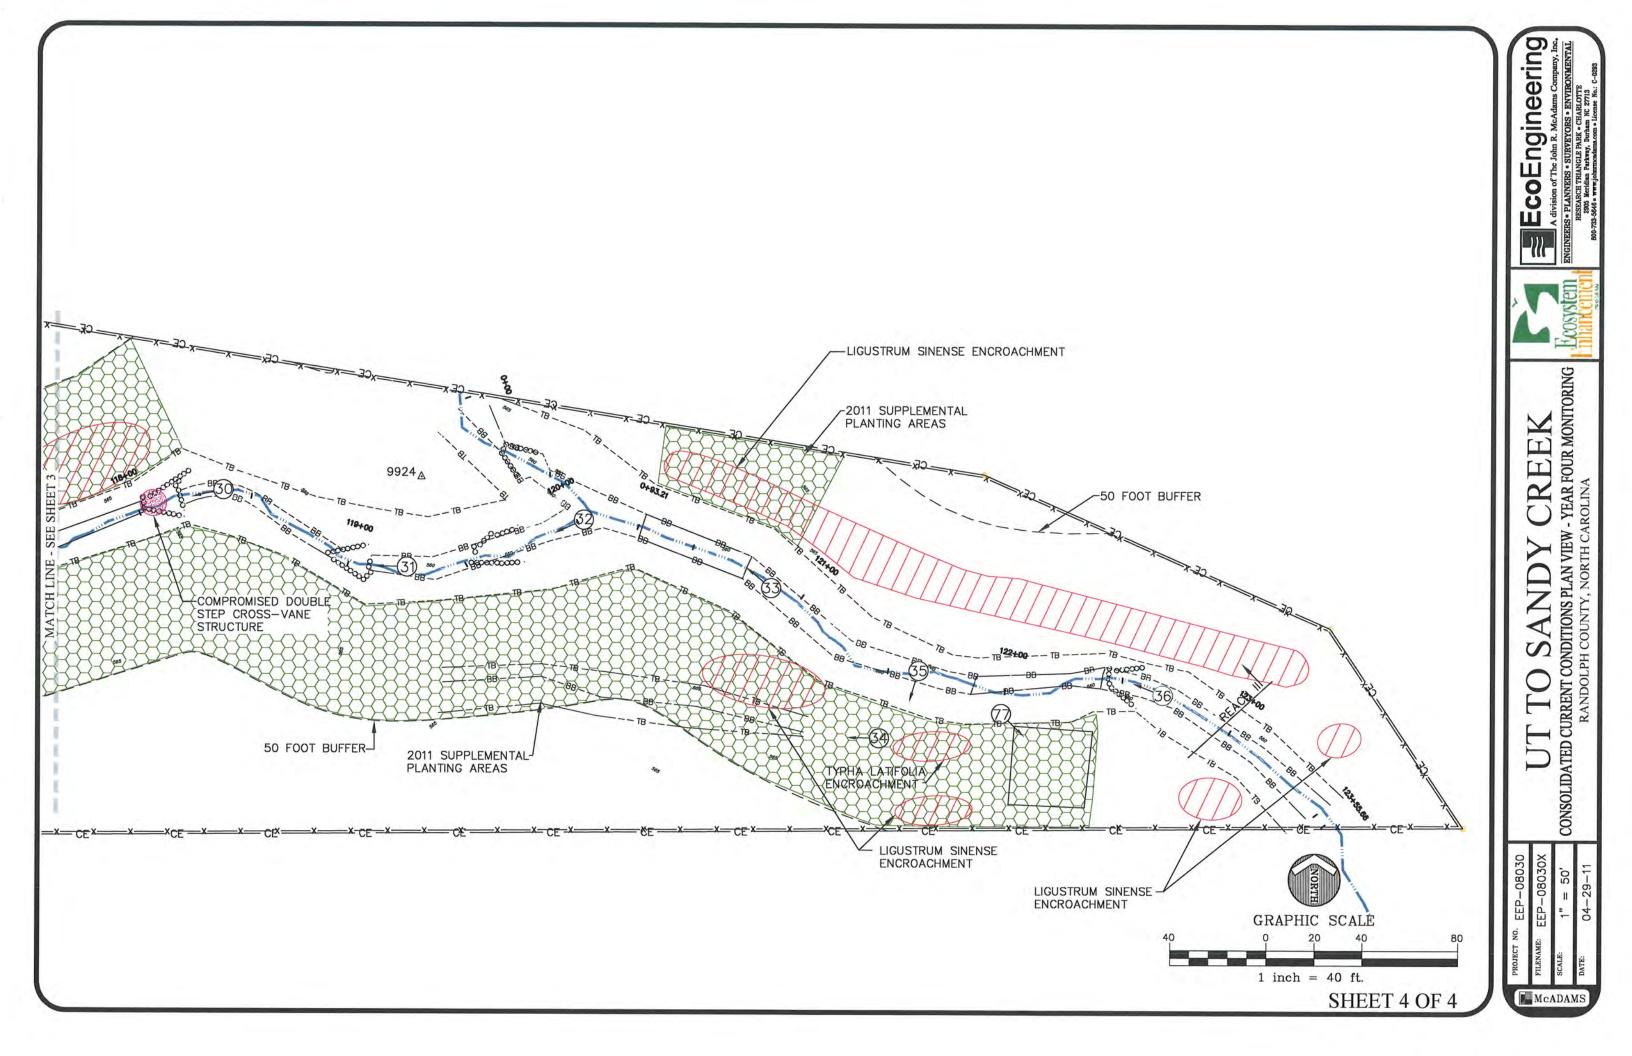
are sixteen areas in which exotic/invasive species were observed totaling approximately 0.47 acres in size and are approximately 4.61% of the easement acreage. The extent of exotic/invasive species is depicted in the Consolidated Current Condition Plan View **Appendix A**.

The primary concern at UT to Sandy Creek is the sporadic flow conditions observed in the channel in past monitoring years although flow was observed during the 2011 Monitoring Year 4 field investigation. The stream was dry during previous site visits during the month of August. Flowing water in the stream channel has been observed approximately half of the time the site has been monitored. To document bankfull events a crest gage is located approximately 50 feet upstream of cross-section 4 and is depicted in the Consolidated Current Condition Plan View **Appendix A**. Evidence of a bankfull event was observed this monitoring year.

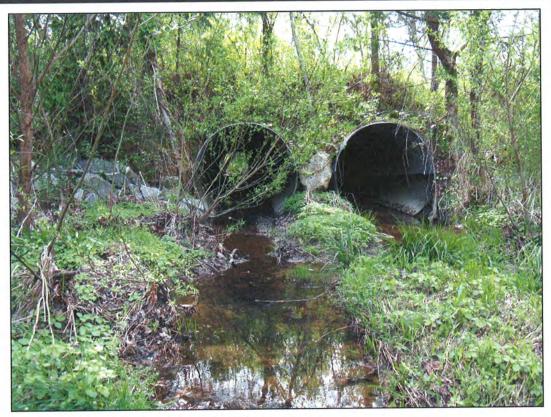
PHOTOGRAPH I: RIP-RAP. HEAD OF UT-I.

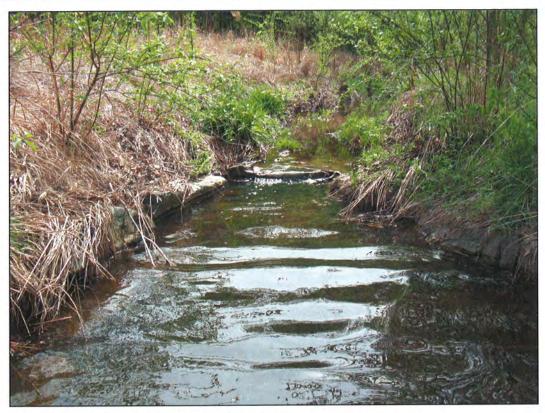
PHOTOGRAPH 3: CROSS VANE. STA: 100+73.

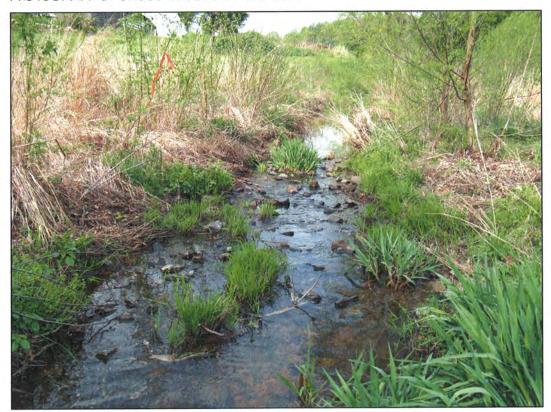
PHOTOGRAPH 4: CONSTRUCTED RIFFLE. STA: 101+09.

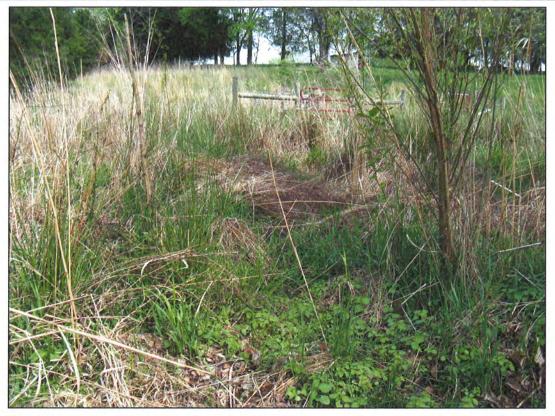
PHOTOGRAPH 9: RIP-RAP FOR WETLAND AREA.

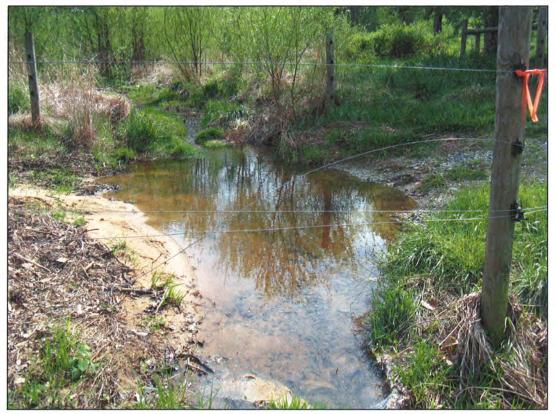
PHOTOGRAPH II: CROSSING. STA: 104+23.

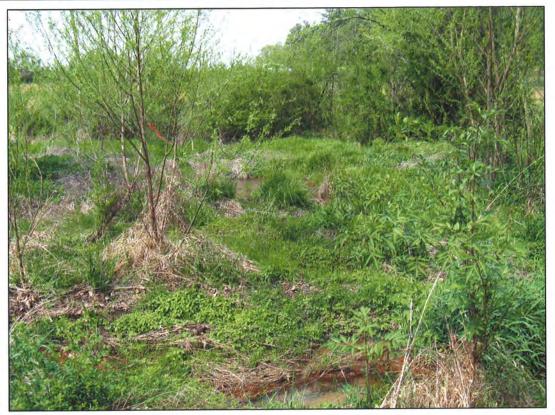
PHOTOGRAPH 15: RIP-RAP.

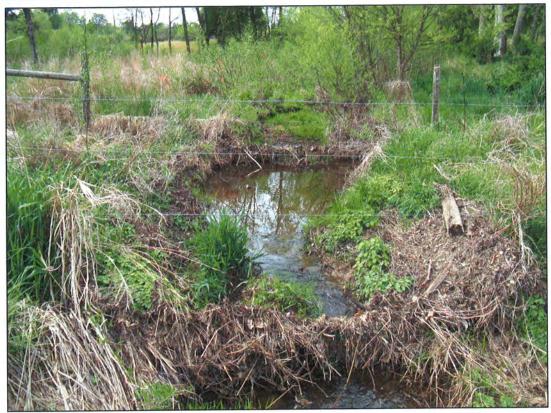
PHOTOGRAPH 23: CROSSING. STA: III+32.

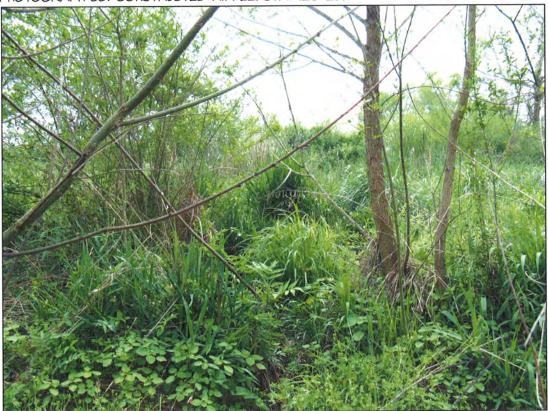
PHOTOGRAPH 34: RIP-RAP. WETLAND DRAINAGE.

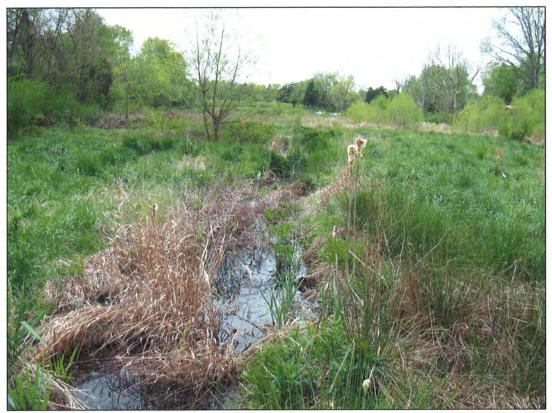
PHOTOGRAPH 35: RIP-RAP. WELTAND DRAINAGE.

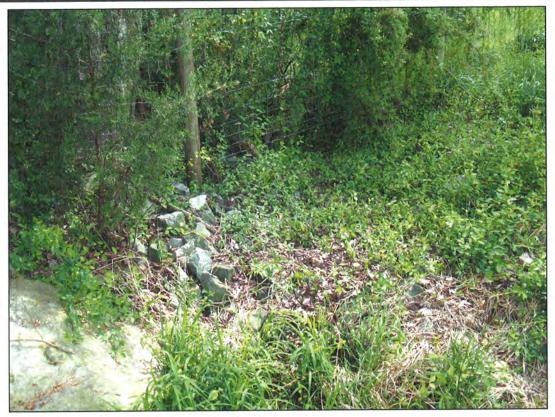
PHOTOGRAPH 37: RIP-RAP, HEAD OF UT-2.

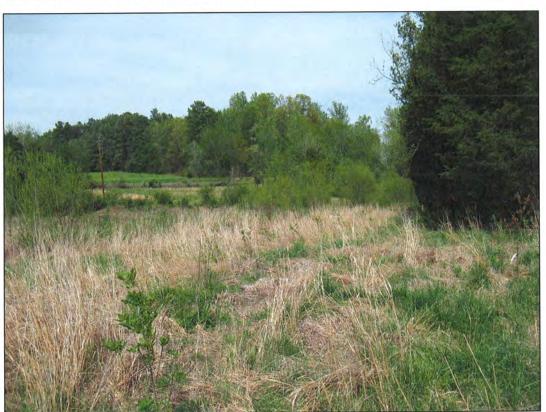
PHOTOGRAPH 76: VIEW OF FLOODPLAIN LOOKING DOWNSTREAM.
