Valley Fields Farm Stream Restoration Project

Monitoring Report: Year 04

Davidson County, North Carolina
Upper Yadkin River Basin
Cataloging Unit 030401030
EEP Project ID #407

December 2014

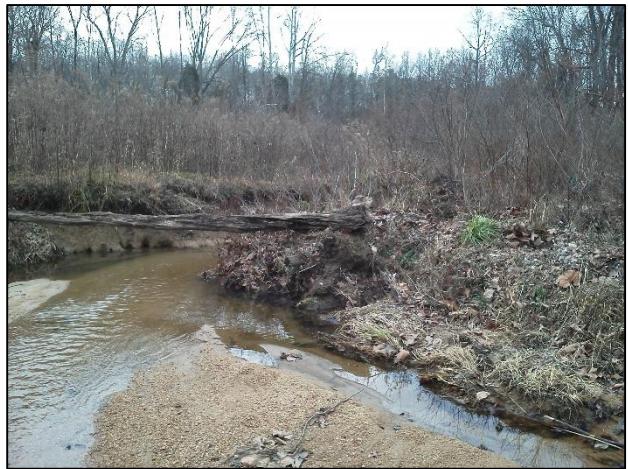
Bank erosion (Station 55+00) – 12/18/2014

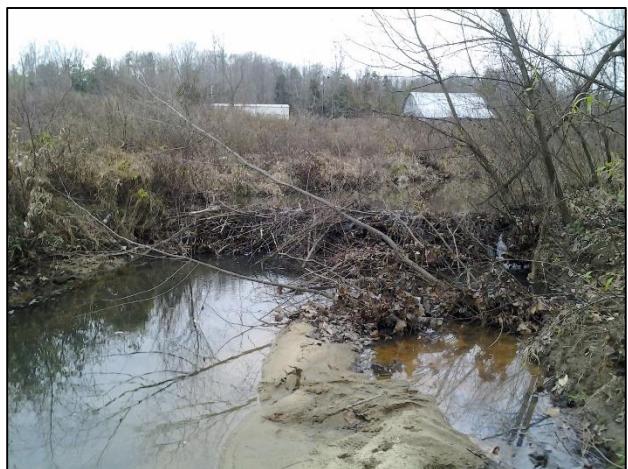
Bank erosion (Station 95+75) – 12/18/2014

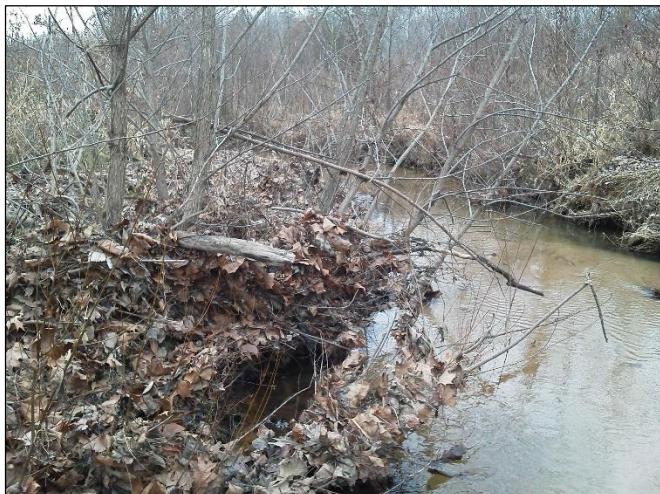
Photo 1. Wracklines along Reach A

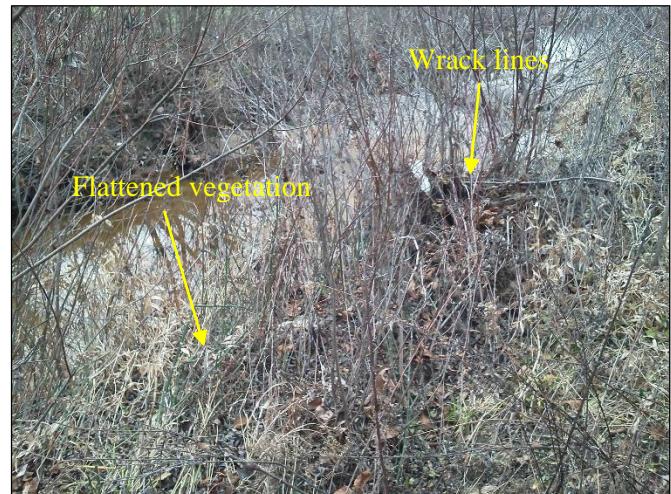
Photo 2. Wracklines and flattened vegetation along Reach B

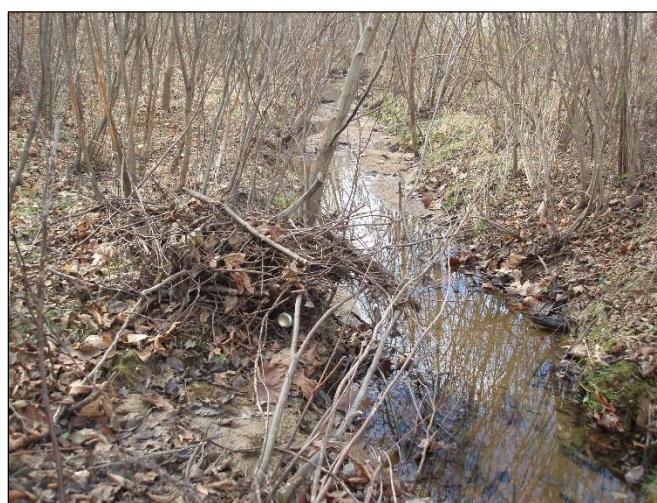
Photo 3. Wracklines along Reach C
