MONITORING YEAR 7 ANNUAL/CLOSEOUT REPORT

VILE CREEK MITIGATION SITE

Alleghany County, NC
DEQ Contract No. 5999
DMS Project No. 96582

Data Collection Period: April – October
2023 Submission Date: December 21, 2023

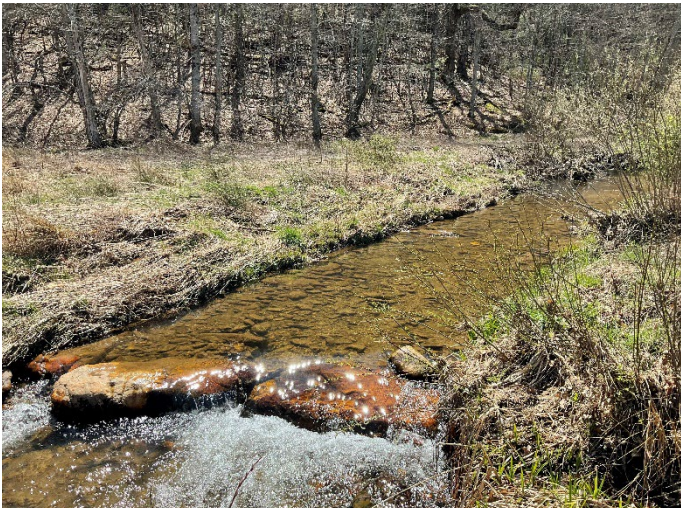
Vile Creek R2: STA 118+50 - 118+80 - Right Bank Repair 04-03-2023

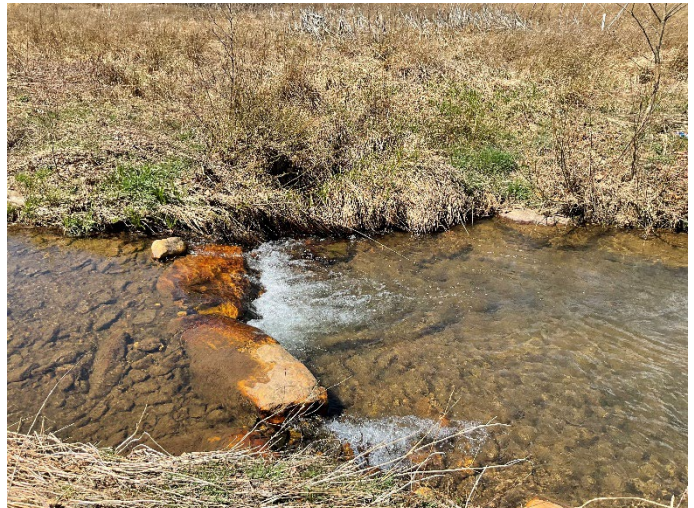
Vile Creek R2: STA 118+80 – J-Hook Repair 04-03-2023

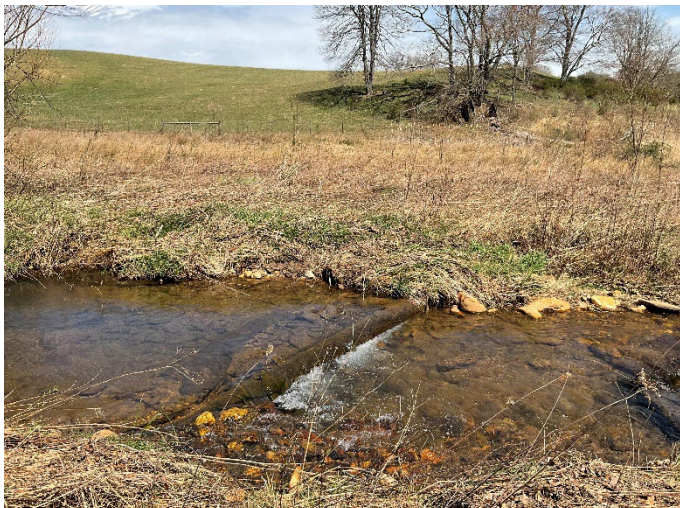
Vile Creek R2: STA 119+50 - 119+70 - Bank Repair 04-03-2023

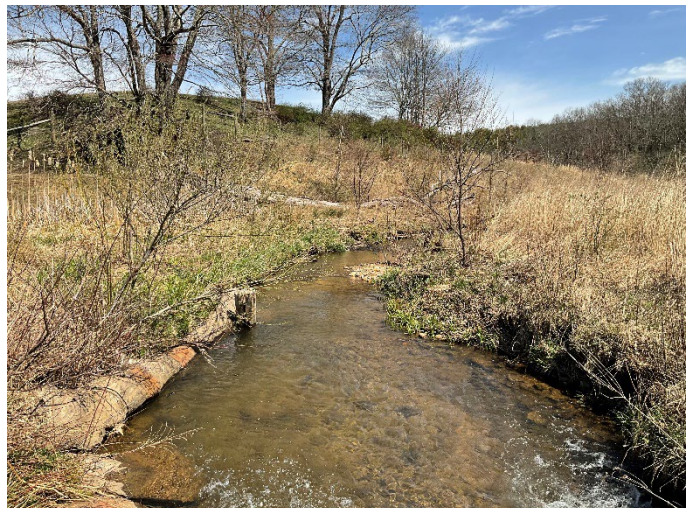
Vile Creek R2: STA 121+00 - 121+25 - Right Bank Repair 04-03-2023

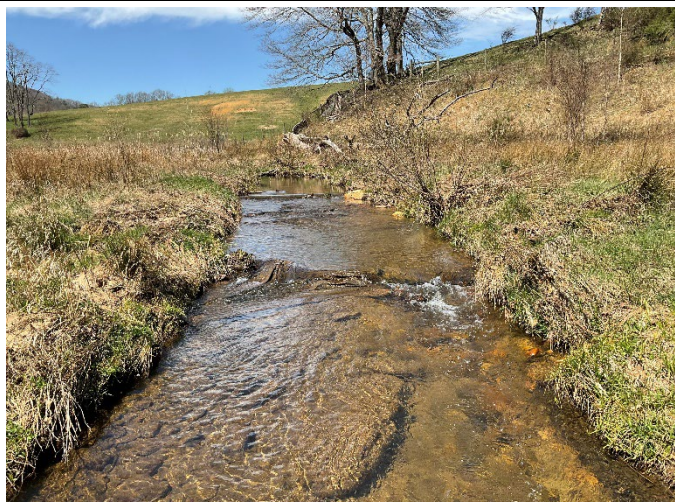
Vile Creek R2: STA 122+20 - 123+00 – Stream Repair
04-03-2023

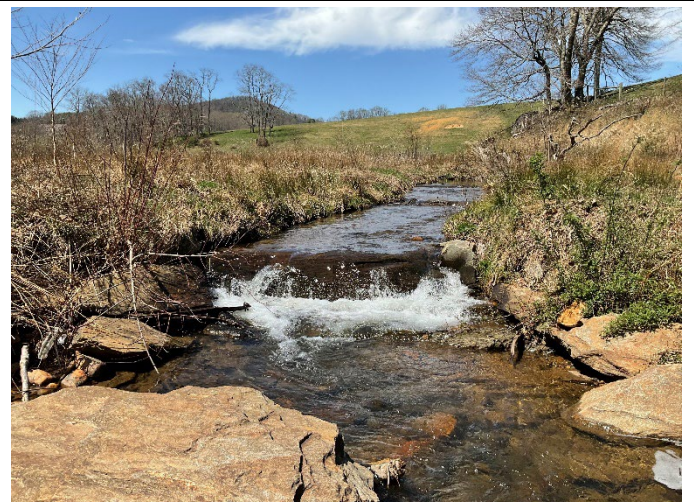
Vile Creek R2: STA 123+00 – Rock Sill Repair 04-03-2023

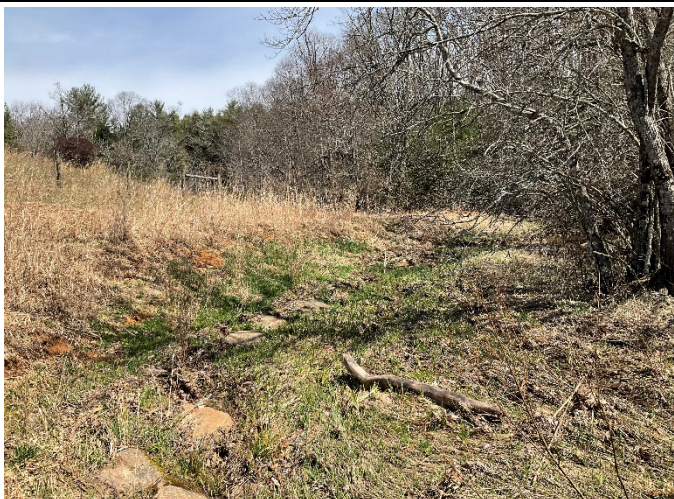
Vile Creek R3: STA 125+00 - 125+60 - Secondary Channel Repair
04-03-2023

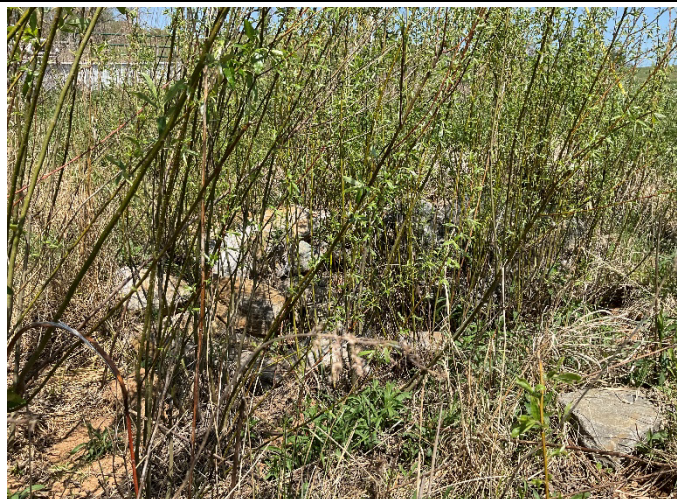
UT2 BMP – Headcut Repair 04-20-2023

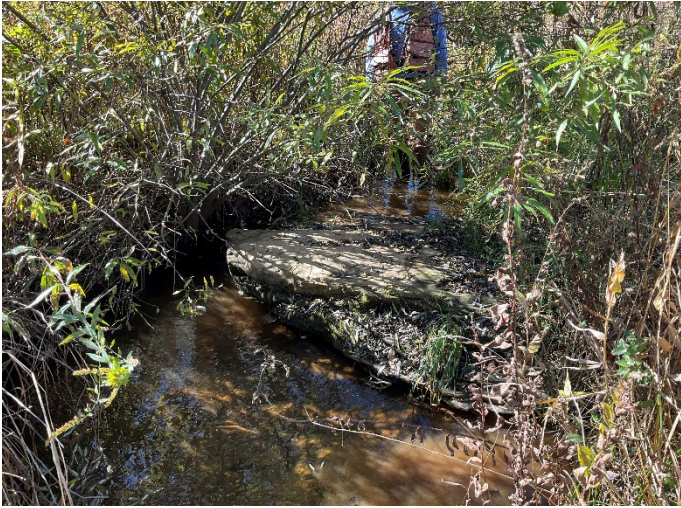
There is no associated bank erosion, and the condition has not worsened since MY6. The structure at station 207+50 on UT1 was repaired in December 2023 using existing materials to plug the piping and redirect flow over the structure as intended. All noted areas of concern are isolated and have no negative impact on overall stream function or stability. This information has been added to section 1.2.5 of the MY7 report.

Photo 1: UT1 R1 STA 207+50 – Piping Structure 10-23-2023
