MONITORING YEAR 1 ANNUAL REPORT

VILE CREEK MITIGATION SITE

Alleghany County, NC
DEQ Contract No. 5999
DMS Project No. 96582

Data Collection Period: May - October 2017
Draft Submission Date: November 30, 2017
Final Submission Date: December 20, 2017

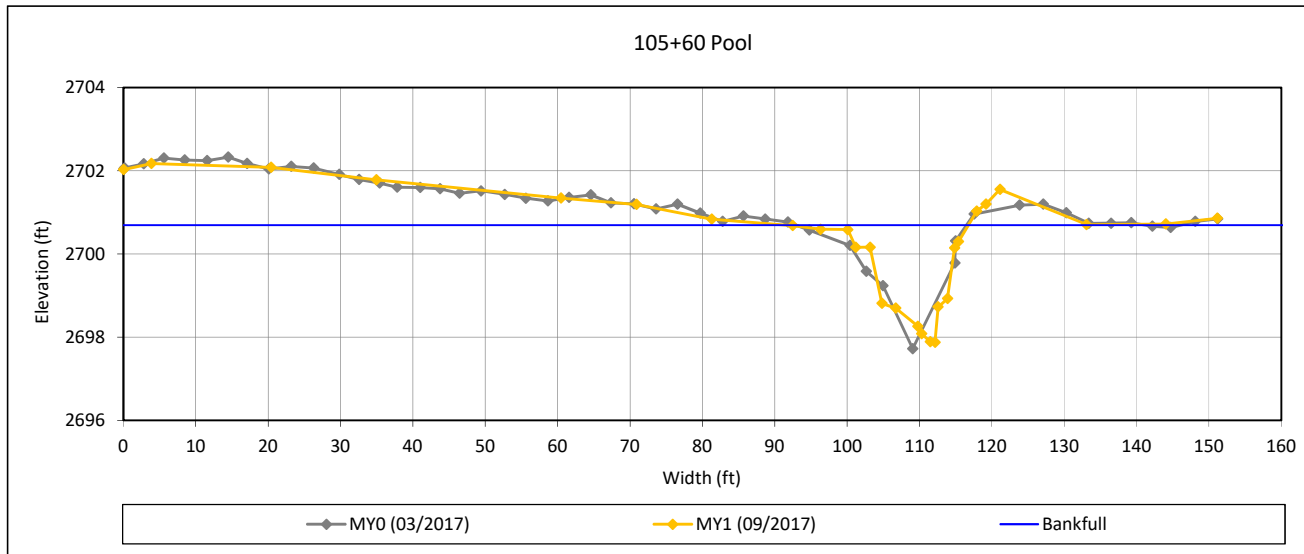
Cross-section 1 - Vile Creek Reach 1

25.8	x-section area (ft.sq.)
24.6	width (ft)
1.1	mean depth (ft)
2.8	max depth (ft)
26.4	wetted perimeter (ft)
1.0	hydraulic radius (ft)
23.4	width-depth ratio

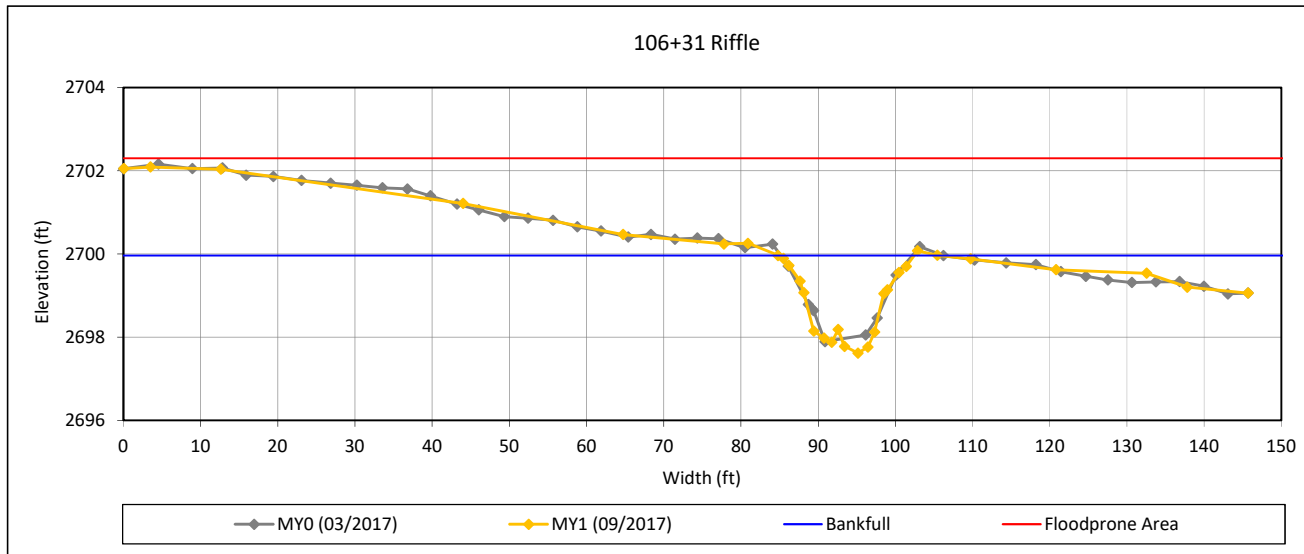
Cross-section 2 - Vile Creek Reach 1

22.7	x-section area (ft.sq.)
17.6	width (ft)
1.3	mean depth (ft)
2.3	max depth (ft)
18.7	wetted perimeter (ft)
1.2	hydraulic radius (ft)
13.7	width-depth ratio
200.0	W flood prone area (ft)
11.4	entrenchment ratio
1.1	low bank height ratio

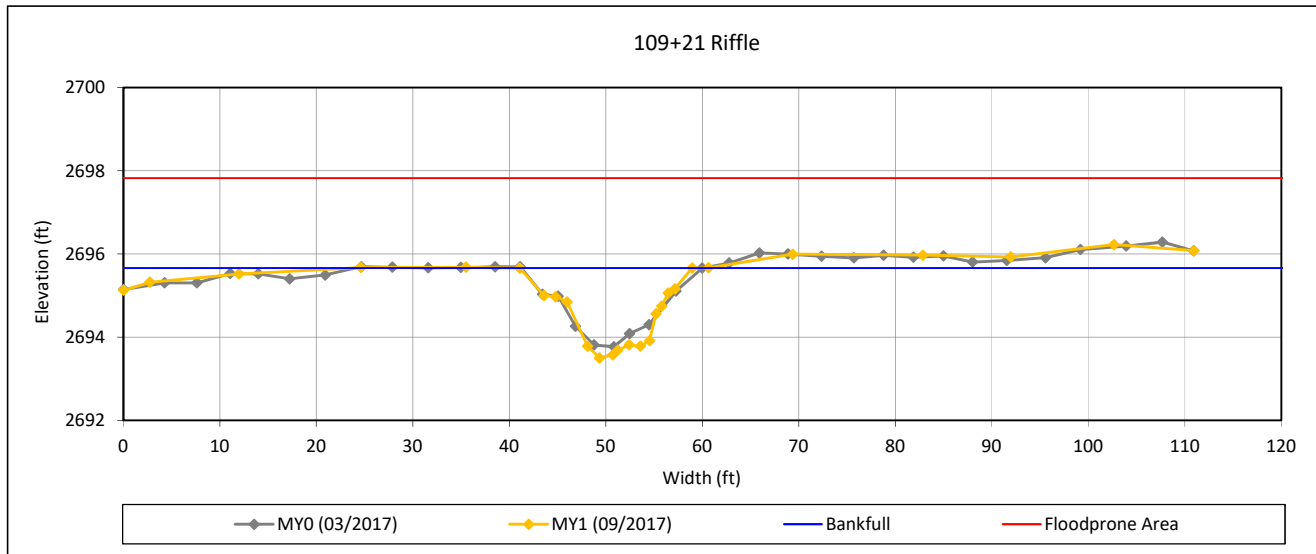
Cross-section 3 - Vile Creek Reach 1

20.9	x-section area (ft.sq.)
17.9	width (ft)
1.2	mean depth (ft)
2.2	max depth (ft)
18.7	wetted perimeter (ft)
1.1	hydraulic radius (ft)
15.3	width-depth ratio
200.0	W flood prone area (ft)
11.2	entrenchment ratio
1.0	low bank height ratio

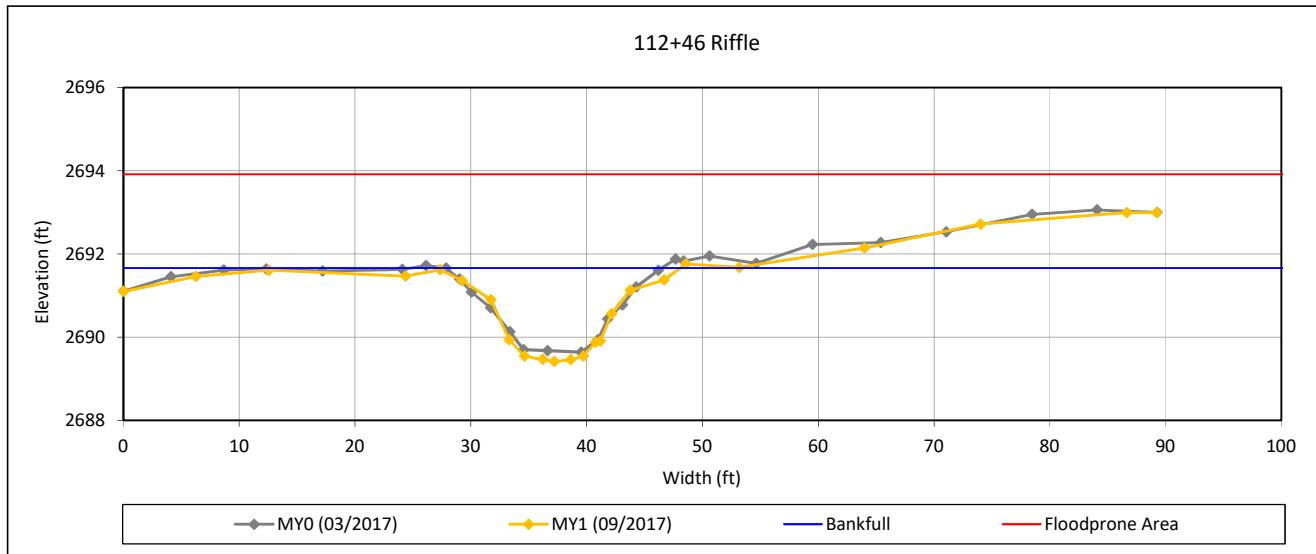
Cross-section 4 - Vile Creek Reach 2

23.1	x-section area (ft.sq.)
19.4	width (ft)
1.2	mean depth (ft)
2.3	max depth (ft)
20.2	wetted perimeter (ft)
1.1	hydraulic radius (ft)
16.3	width-depth ratio
188.0	W flood prone area (ft)
9.7	entrenchment ratio
1.0	low bank height ratio

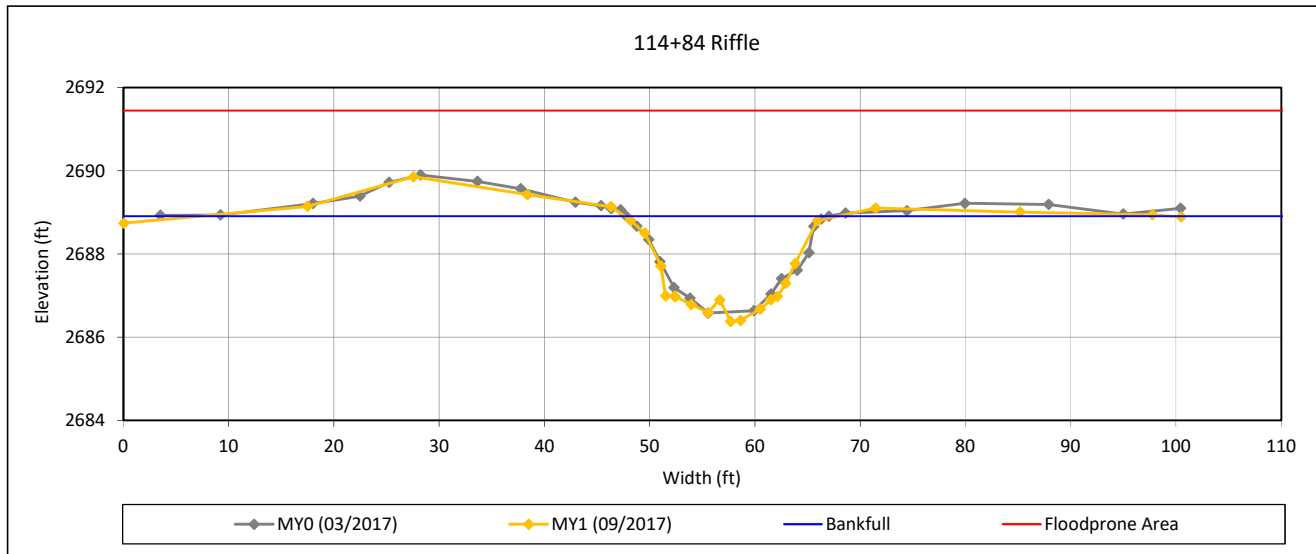
Cross-section 5 - Vile Creek Reach 2

29.7	x-section area (ft.sq.)
19.8	width (ft)
1.5	mean depth (ft)
2.5	max depth (ft)
21.1	wetted perimeter (ft)
1.4	hydraulic radius (ft)
13.2	width-depth ratio
156.0	W flood prone area (ft)
7.9	entrenchment ratio
1.0	low bank height ratio

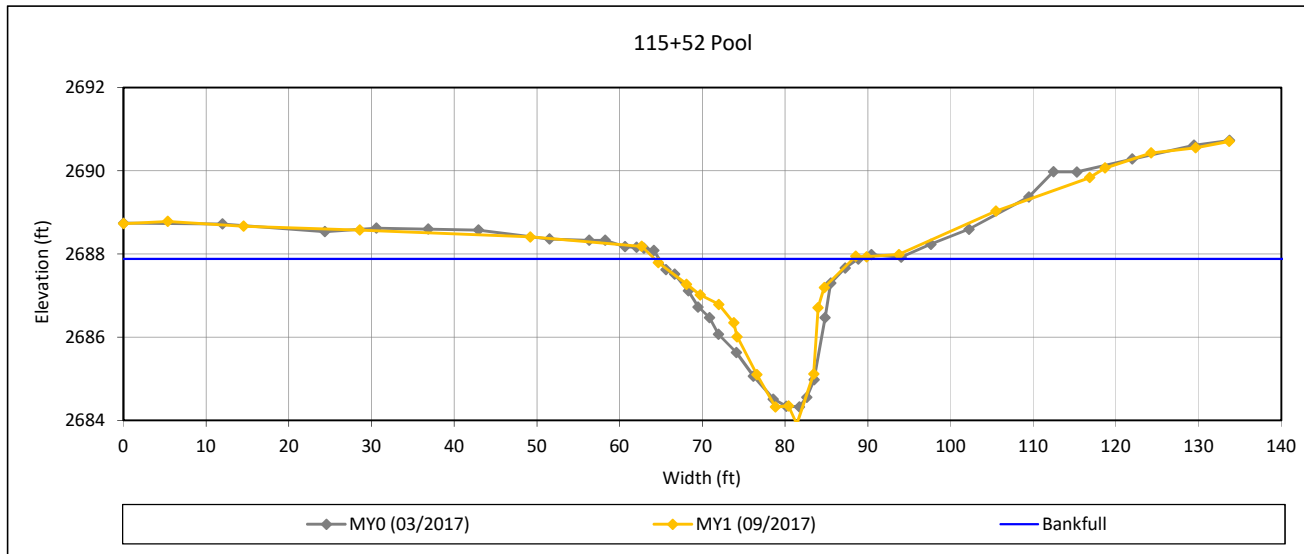
Cross-section 6 - Vile Creek Reach 2

39.6	x-section area (ft.sq.)
24.0	width (ft)
1.6	mean depth (ft)
4.0	max depth (ft)
26.4	wetted perimeter (ft)
1.5	hydraulic radius (ft)
14.6	width-depth ratio

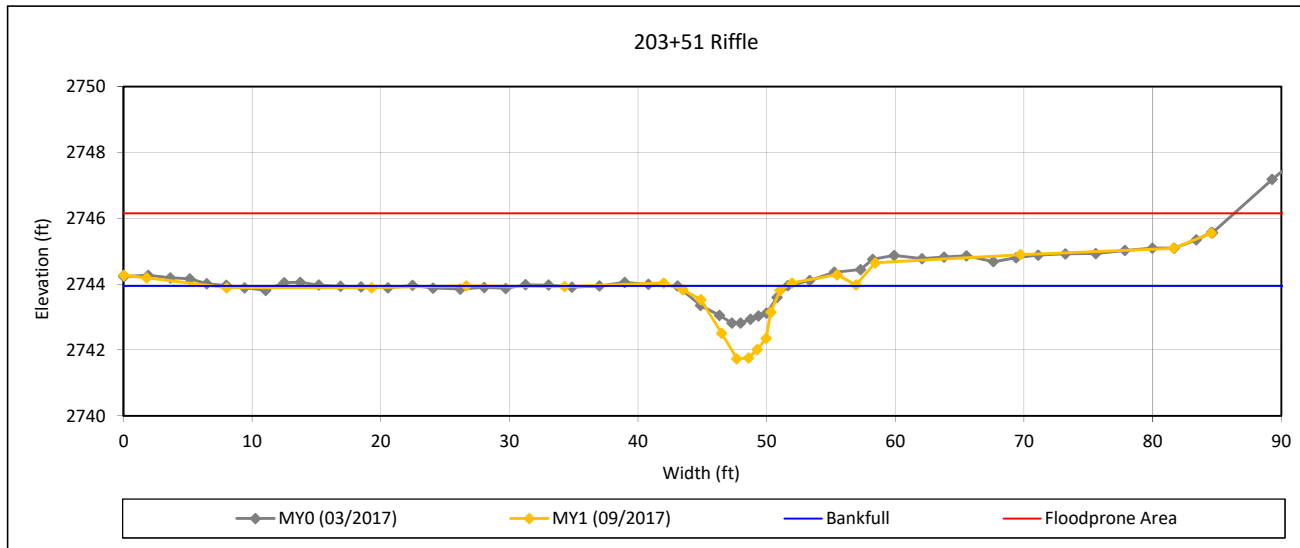
Cross-section 7 - UT1 Reach 1

9.4	x-section area (ft.sq.)
8.1	width (ft)
1.2	mean depth (ft)
2.2	max depth (ft)
9.6	wetted perimeter (ft)
1.0	hydraulic radius (ft)
7.0	width-depth ratio
63.0	W flood prone area (ft)
7.8	entrenchment ratio
1.0	low bank height ratio

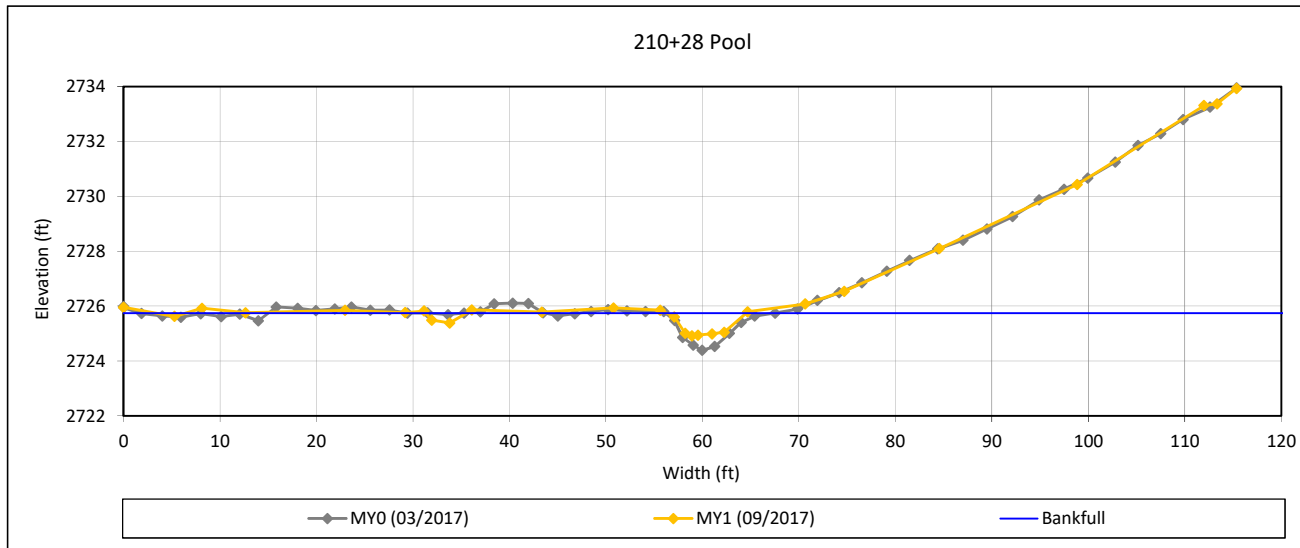
Cross-section 8 - UT1 Reach 1

4.4	x-section area (ft.sq.)
8.2	width (ft)
0.5	mean depth (ft)
0.8	max depth (ft)
8.5	wetted perimeter (ft)
0.5	hydraulic radius (ft)
15.3	width-depth ratio

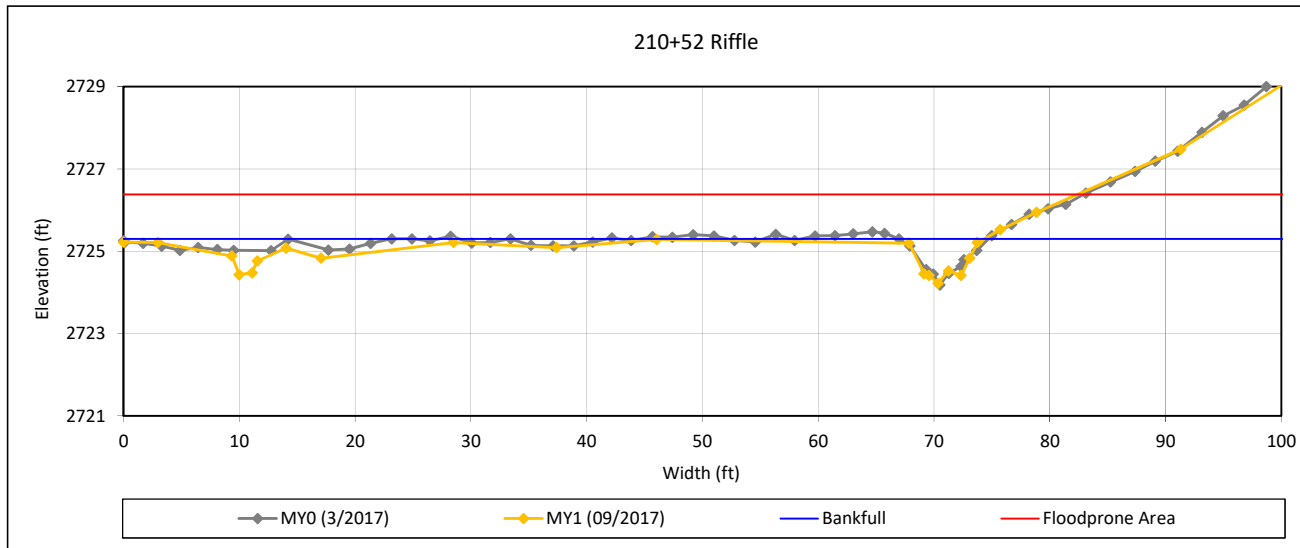
Cross-section 9 - UT1 Reach 1

4.2	x-section area (ft.sq.)
6.5	width (ft)
0.7	mean depth (ft)
1.1	max depth (ft)
7.0	wetted perimeter (ft)
0.6	hydraulic radius (ft)
9.9	width-depth ratio
82.4	W flood prone area (ft)
12.7	entrenchment ratio
1.0	low bank height ratio

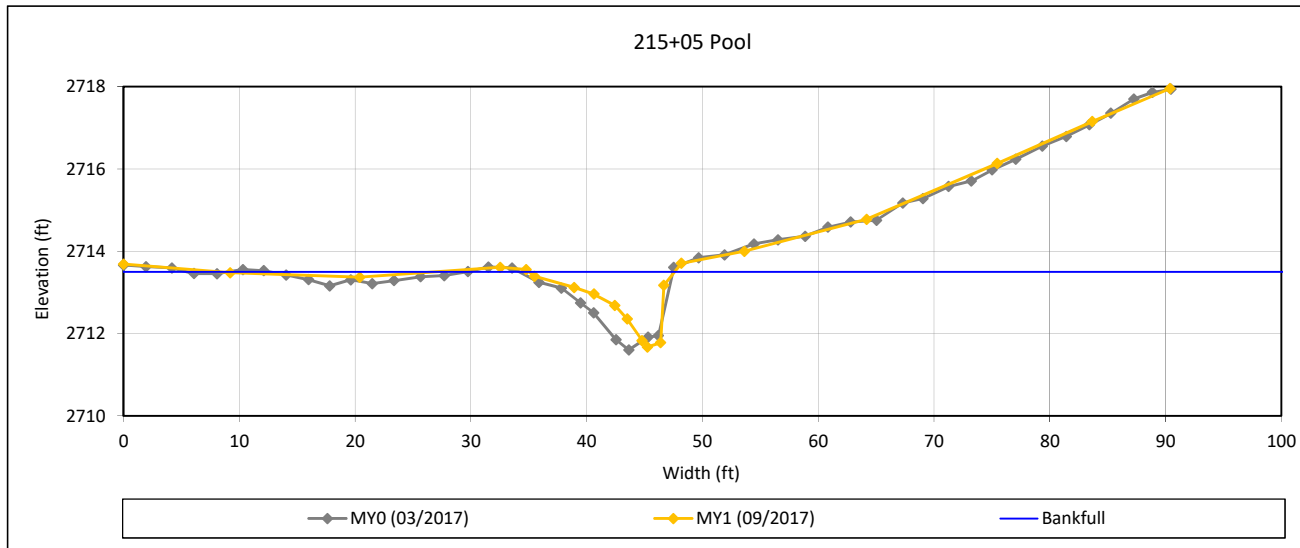
Cross-section 10 - UT1 Reach 2

9.0	x-section area (ft.sq.)
12.6	width (ft)
0.7	mean depth (ft)
1.8	max depth (ft)
14.0	wetted perimeter (ft)
0.6	hydraulic radius (ft)
17.6	width-depth ratio

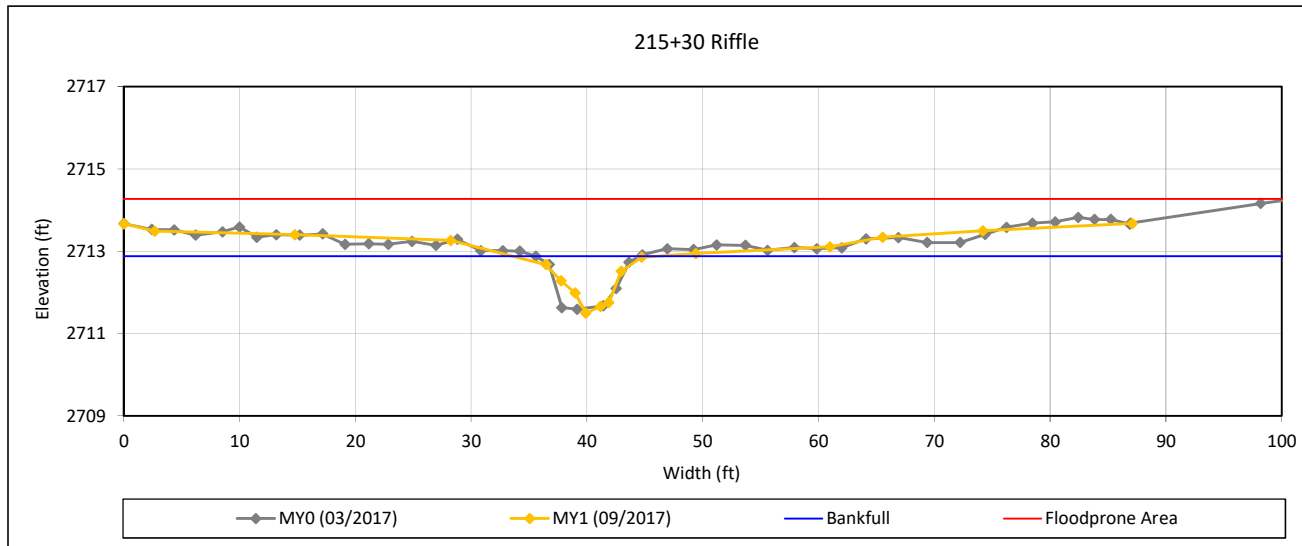
Cross-section 11 - UT1 Reach 2

6.5	x-section area (ft.sq.)
12.6	width (ft)
0.5	mean depth (ft)
1.4	max depth (ft)
13.1	wetted perimeter (ft)
0.5	hydraulic radius (ft)
24.5	width-depth ratio
96.0	W flood prone area (ft)
7.6	entrenchment ratio
1.0	low bank height ratio
