Dale Tract Year Five Monitoring Report

Brunswick County, NC

Prepared by: Land Management Group, Inc. Wilmington, NC

January 2006

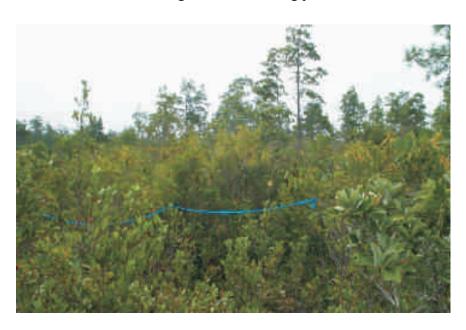
Vegetation monitoring plot.

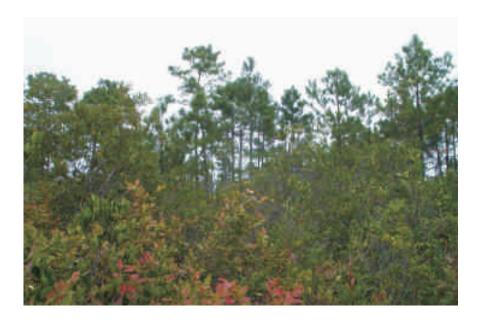
As in previous years, other vegetation observed at Dale included titi (Cyrilla racemiflora), sweet pepperbush (Clethra alnifolia), fetterbush (Lyonia lucida), gallberry (Ilex glabra), and bracken fern (Pteridium aquilinum), which were mainly found in the shrub and herbaceous layers (Appendix B). The filled ditches were vegetated with herbaceous species such as broomsedge, (Andropogon glomeratus), soft rush (Juncus effusus), and goldenrod (Solidago spp). Some woody species like fetterbush and sweet pepperbush have filled in the old ditch lines. Exact counts of these species were not conducted since they did not factor into the vegetation criterion.

▼ View of typical vegetation within the Dale tract.

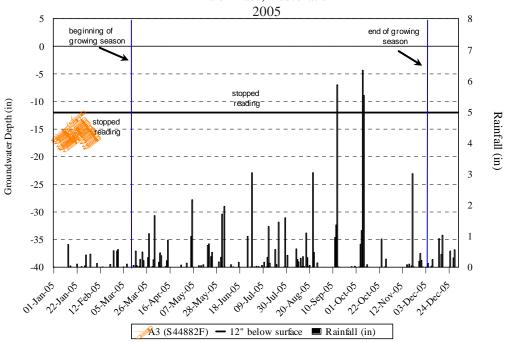
Figure 3. Hydrology Monitoring, Gauge A3
Dale Tract; Restoration

Eleven of the twelve gauges at the Dale Tract met the 12.5% hydrology criterion for 2005, which is a water table within 12" of the soil surface for 12.5% of the growing season (33 days). Most of the gauges greatly exceeded this minimum. The one gauge that did not achieve this criterion (A3) stopped functioning during the growing season. As shown in Appendix A, most of the gauges documented wetland hydrology during late spring or fall. The reference gauges (R1 and R2) located within the Eagle Brunswick tract reflected the same patterns as the gauges located at Dale, and documented wetland hydrology for 76 and 47 days, respectively (Table 2).

Hydrology data from 2005 revealed that eleven of the twelve monitoring gauges throughout the restored and enhanced areas of the Dale tract met the 12.5% wetland hydrology criterion established in the mitigation plan. Most of the gauges greatly exceeded this minimum. The one gauge that did not achieve this criterion (A3) stopped functioning during the growing season.
