## FINAL MONITORING REPORT 2020 (Year 2)

#### HERON STREAM AND WETLAND MITIGATION SITE

Alamance County, North Carolina

DMS Project ID No. 100014 Full Delivery Contract No. 7192 USACE Action ID No. SAW-2017-01471 DWR No. 17-0290 RFP No. 16-006990

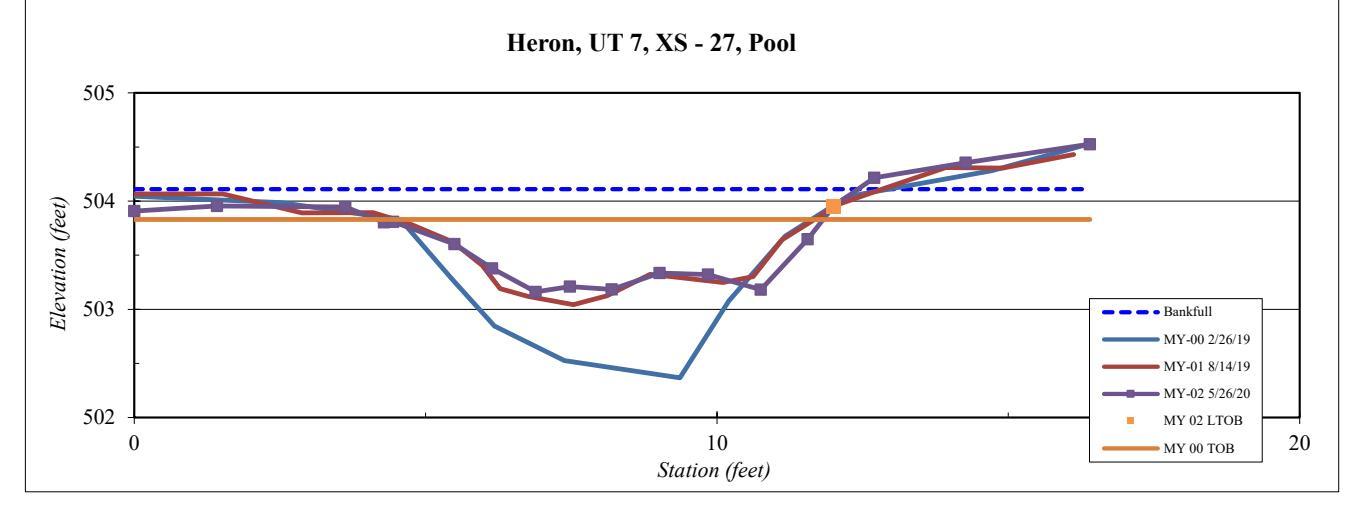
Note: Sediment deposition in pool appears natural and is not expected to lead to instability.
