MY3 FINAL MONITORING REPORT Odell's House Buffer Mitigation Project Monitoring Year 3 Calendar Year of Data Collection: 2023

NCDEQ DMS Project Identification #100041 NCDEQ DMS Contract # 7420 Neuse River Basin (CU 03020201) DWR Project # 2018-0200 USACE Action ID Number: SAW-2018-00431 Johnston County, NC Data Collection Period: March and September 2023 Submission Date: December 2023

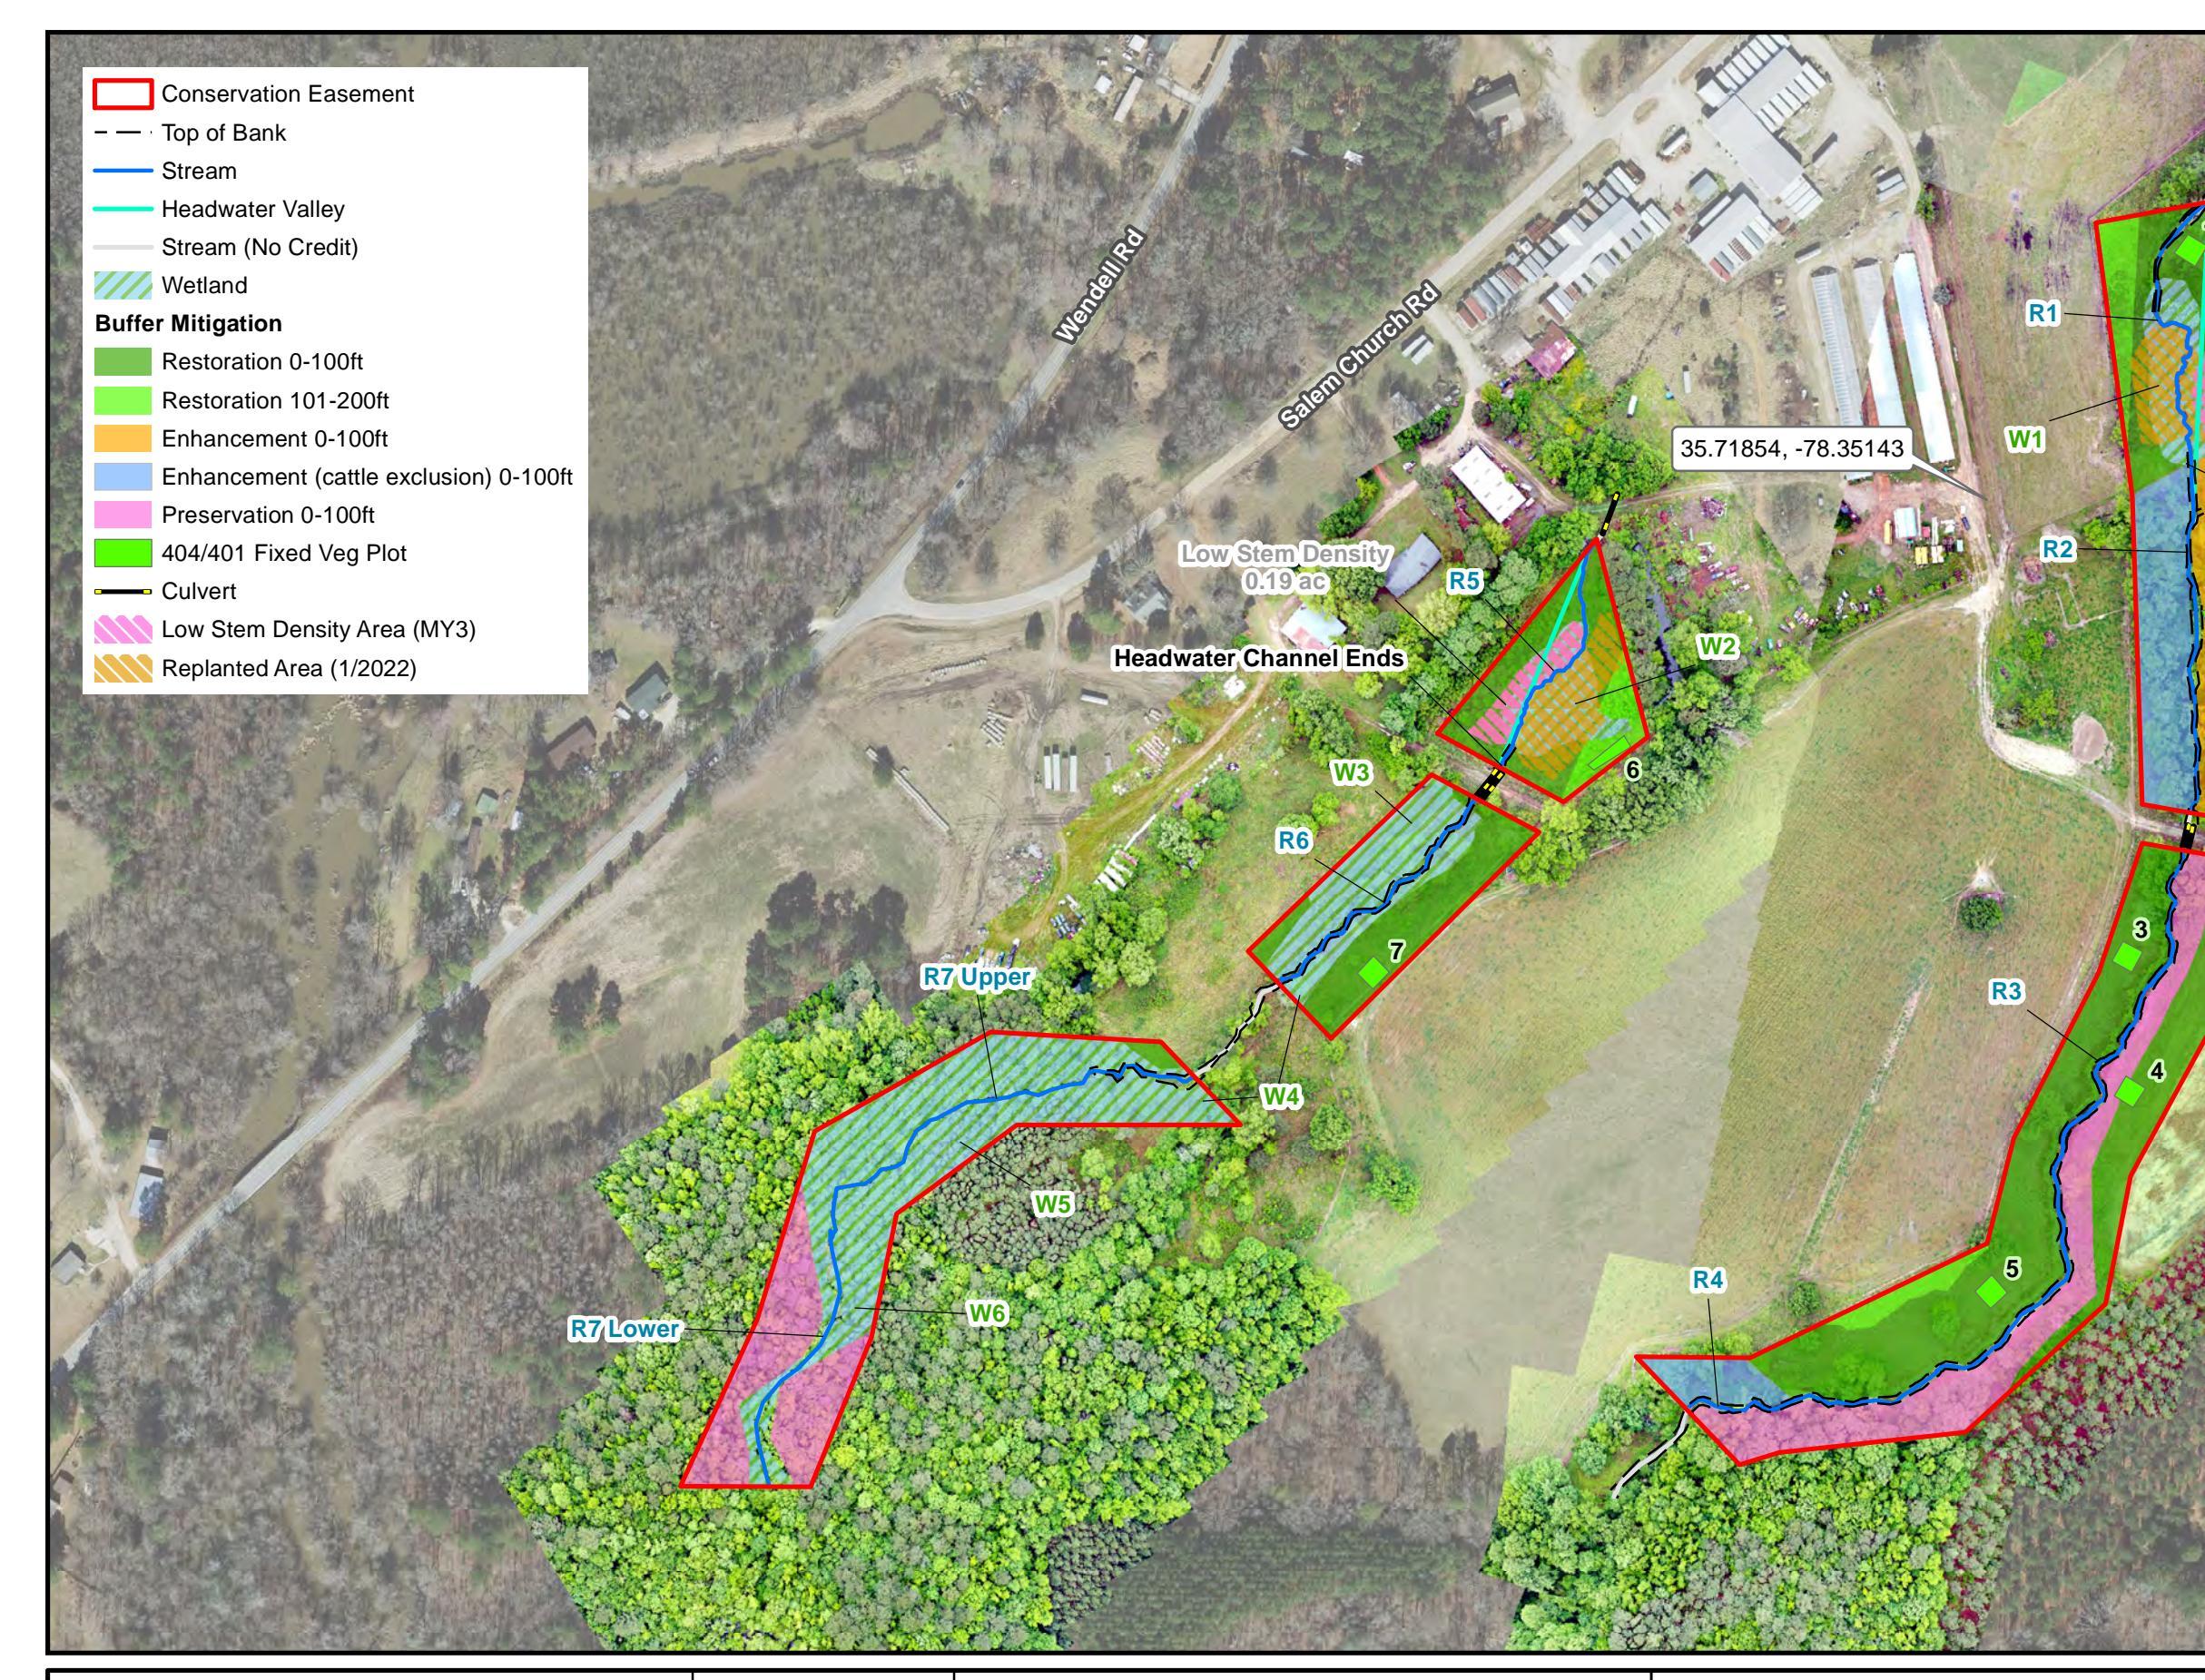
FIGURE 2**a**

Visual assessment of vegetation outside of the monitoring plots indicates that the herbaceous vegetation is becoming well established throughout the project. One area of encroachment was noted in MY1 along R3 left bank slope (~0.12 acres). An active farm field along the easement led to farm equipment encroachment. Prior to MY2, additional t-posts, string, and flagging was added to the easement. No trees were damaged from the encroachment, only herbaceous vegetation. No further encroachment in this area was noted in MY3.

Two areas of low stem density were observed in MY1. Low stem densities in these areas (~1.07 acres) are due to low planting densities at as-built, mortality due to high hydrology, and dense herbaceous vegetation. Extremely soft and wet soil conditions during construction and planting made areas of W1 and W2 unsafe for the contractor to plant bare roots. During MY2, both wetlands (W01 & W02) were replanted with wet tolerant species from the approved mitigation plan on January 6<sup>th</sup>, 2022 (see Table 3 below). Based on this year's data, the low-stem density area was reduced to the left floodplain of R1 within W1 (0.14 acres) and the right floodplain of R5 (0.19 acres) for a total of 0.33 acres. WLS is not proposing any supplemental planting.

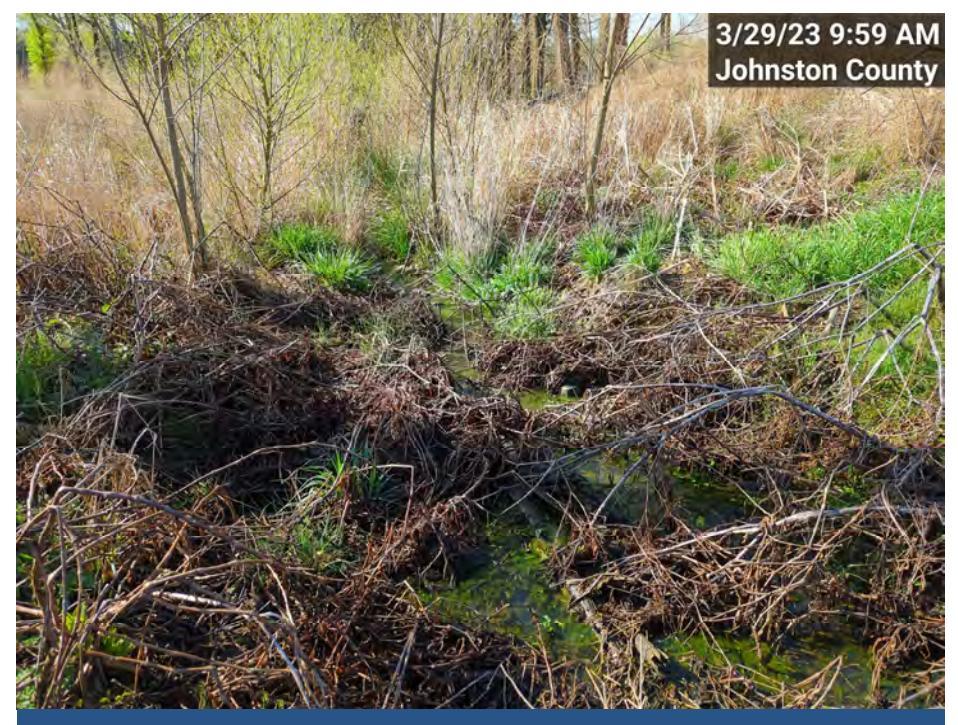
R1 Looking Downstream at FG-3 04/27/2023 (MY-03)

During MY2 site visits, it was noted that stream flow through the lower portion of R1 from station 12+50 – 14+60 (based off the as-built surveyed stream) was flowing subsurface during drier portions of the year. WLS installed a flow gauge within this area (FG-3) prior to MY2. During MY3, FG-3 did not record any consecutive days of flow greater than 1 day. FG-1, located above the old pond bed, recorded 163 consecutive days of flow. WLS noted flow resurfacing at station 14+60 which is located at a rock riffle at the old pond dam. Flow is visible below this point within the channel from R2 down to the exit of the project area on R4. Poor soil conditions at the time of construction did not allow for sufficient excavation of pond silt and structure placement. This has caused the subsurface flow conditions that are affecting stream flow and wetland hydrology within W1.

WLS understands these credits are at risk within the old pond bed portion of R1, all of W1, and the associated headwater Buffer credits. Stream function and buffer function above the affected reach of R1 remains functional and creditable. Stream flow is present and documented with FG-1 until station 12+50. R1 stream credit is calculated based off headwater valley length, and the associated at-risk credits are calculated within the valley crediting parameters.

WLS is not proposing any remedial action on R1 in the old pond bed. WLS will continue to monitor the area for stream flow, wetland hydrology, and vegetation.
