DWR 2020 Survey Report – Lake Orange, SCS #1, #2 and #3

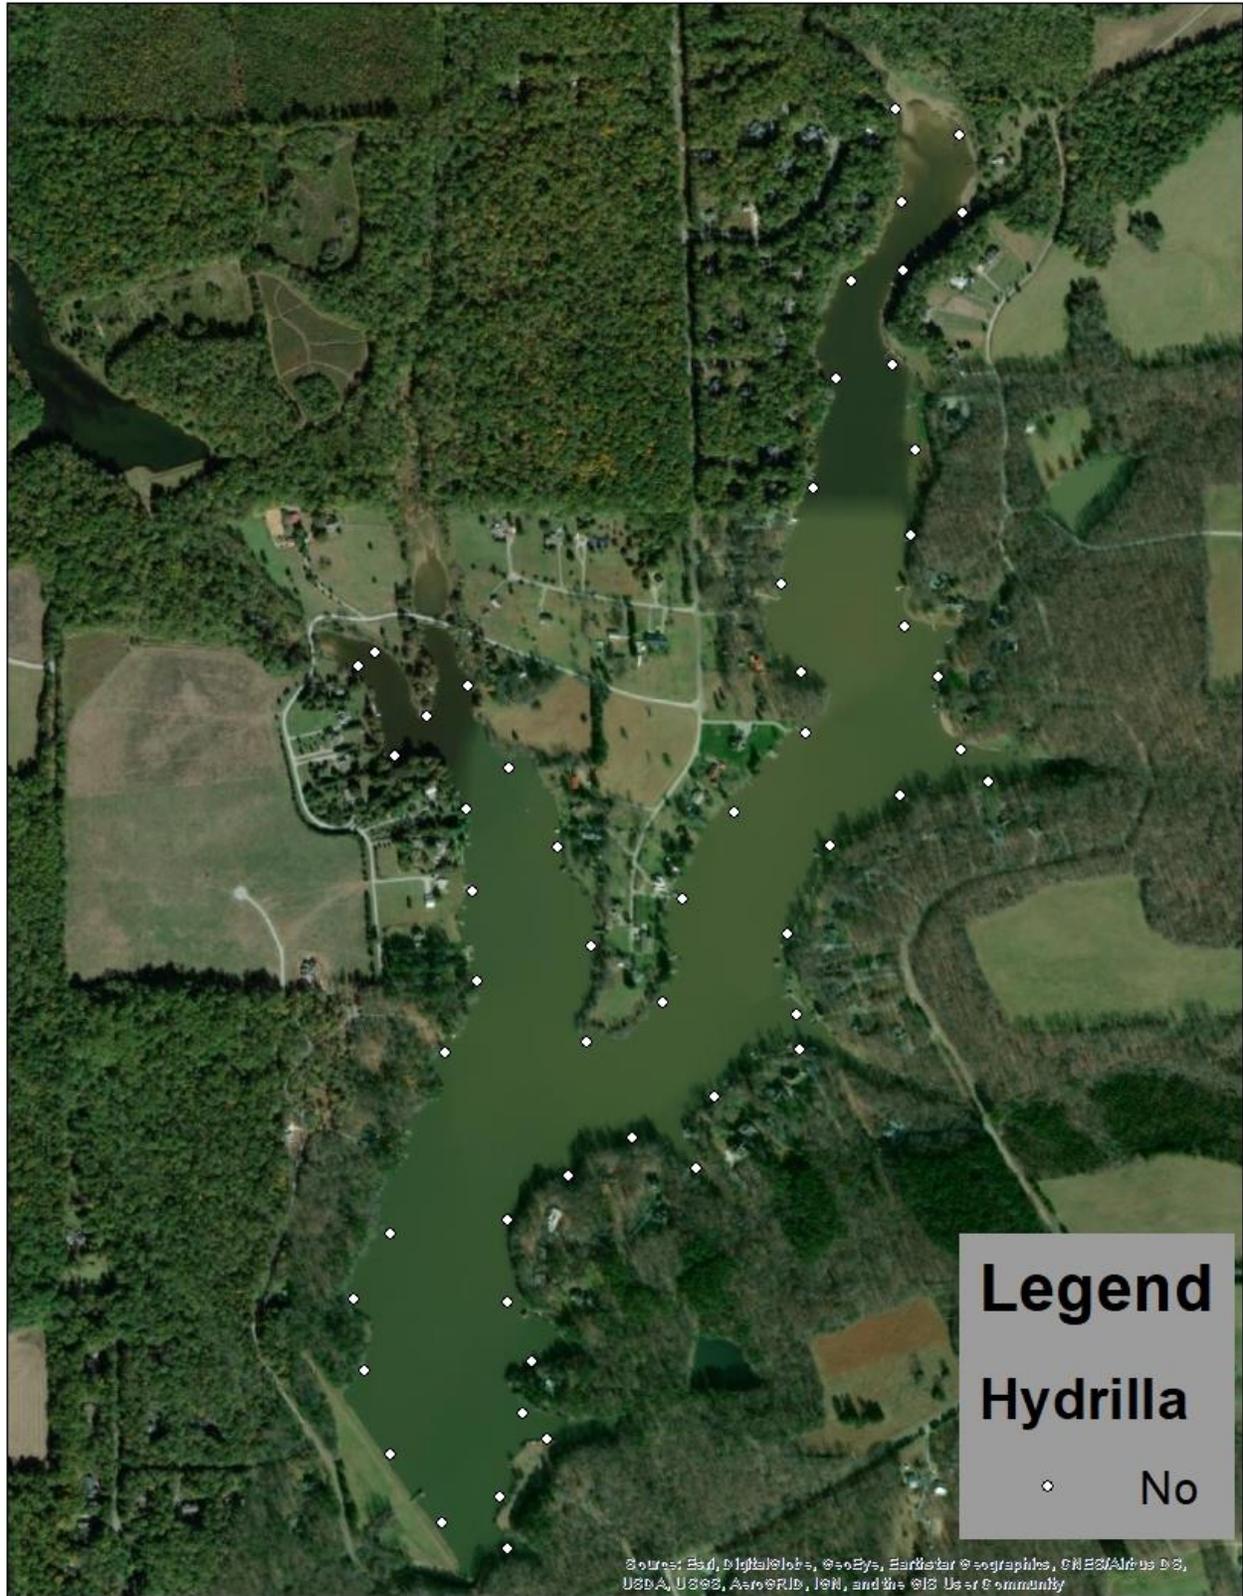
A total of 55 points were sampled during the 2020 survey. There was no Hydrilla found at any of the points (Figure 2). This is a decrease from the 2019 survey which found Hydrilla at 2 points, or 4%, of the 55 points sampled. There was very little other submerged vegetation found during the survey. Southern Naiad, *Najas guadalupensis*, was found at 3, or 5%, of the points sampled (Figure 3). The macroalgae Chara, *Chara spp.*, was found at 1, or 2%, of the points sampled (Figure 4).

Figure 2. Map showing presence/absence of Hydrilla at Lake Orange.

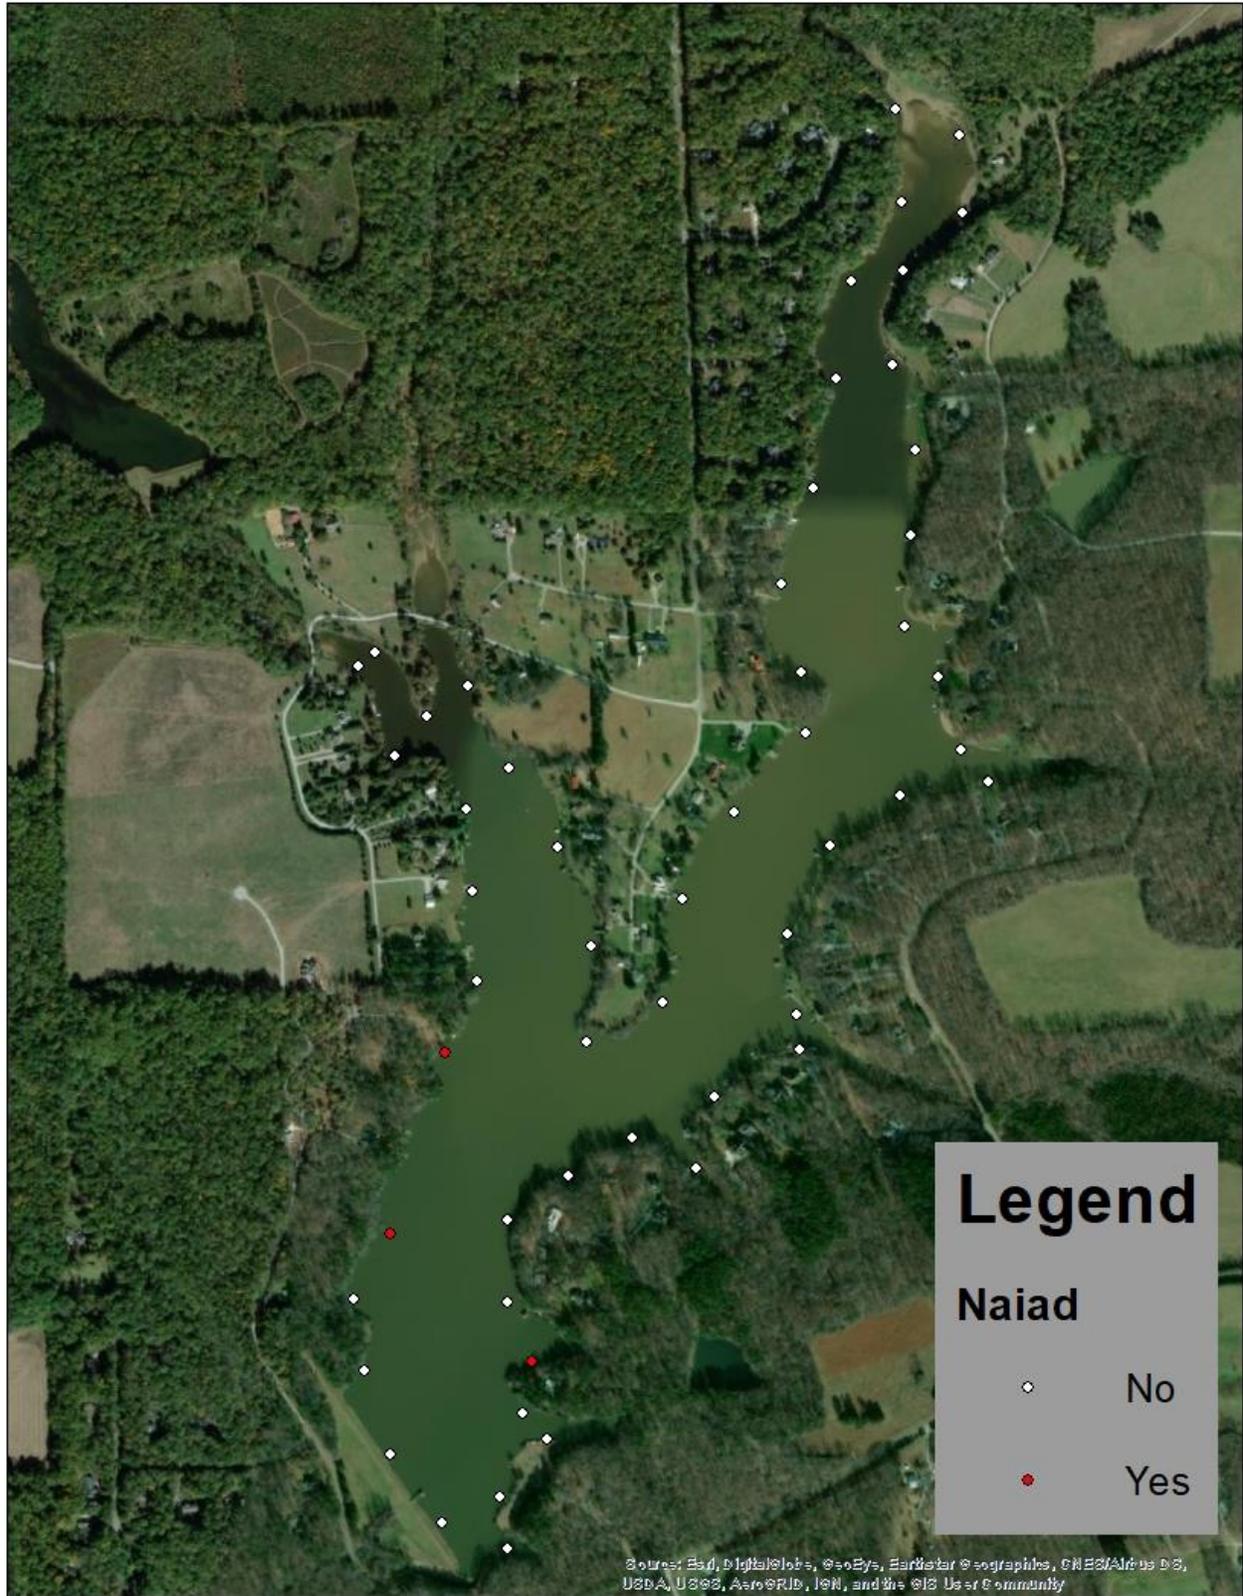
Figure 3. Map showing presence/absence of Southern Naiad at Lake Orange.

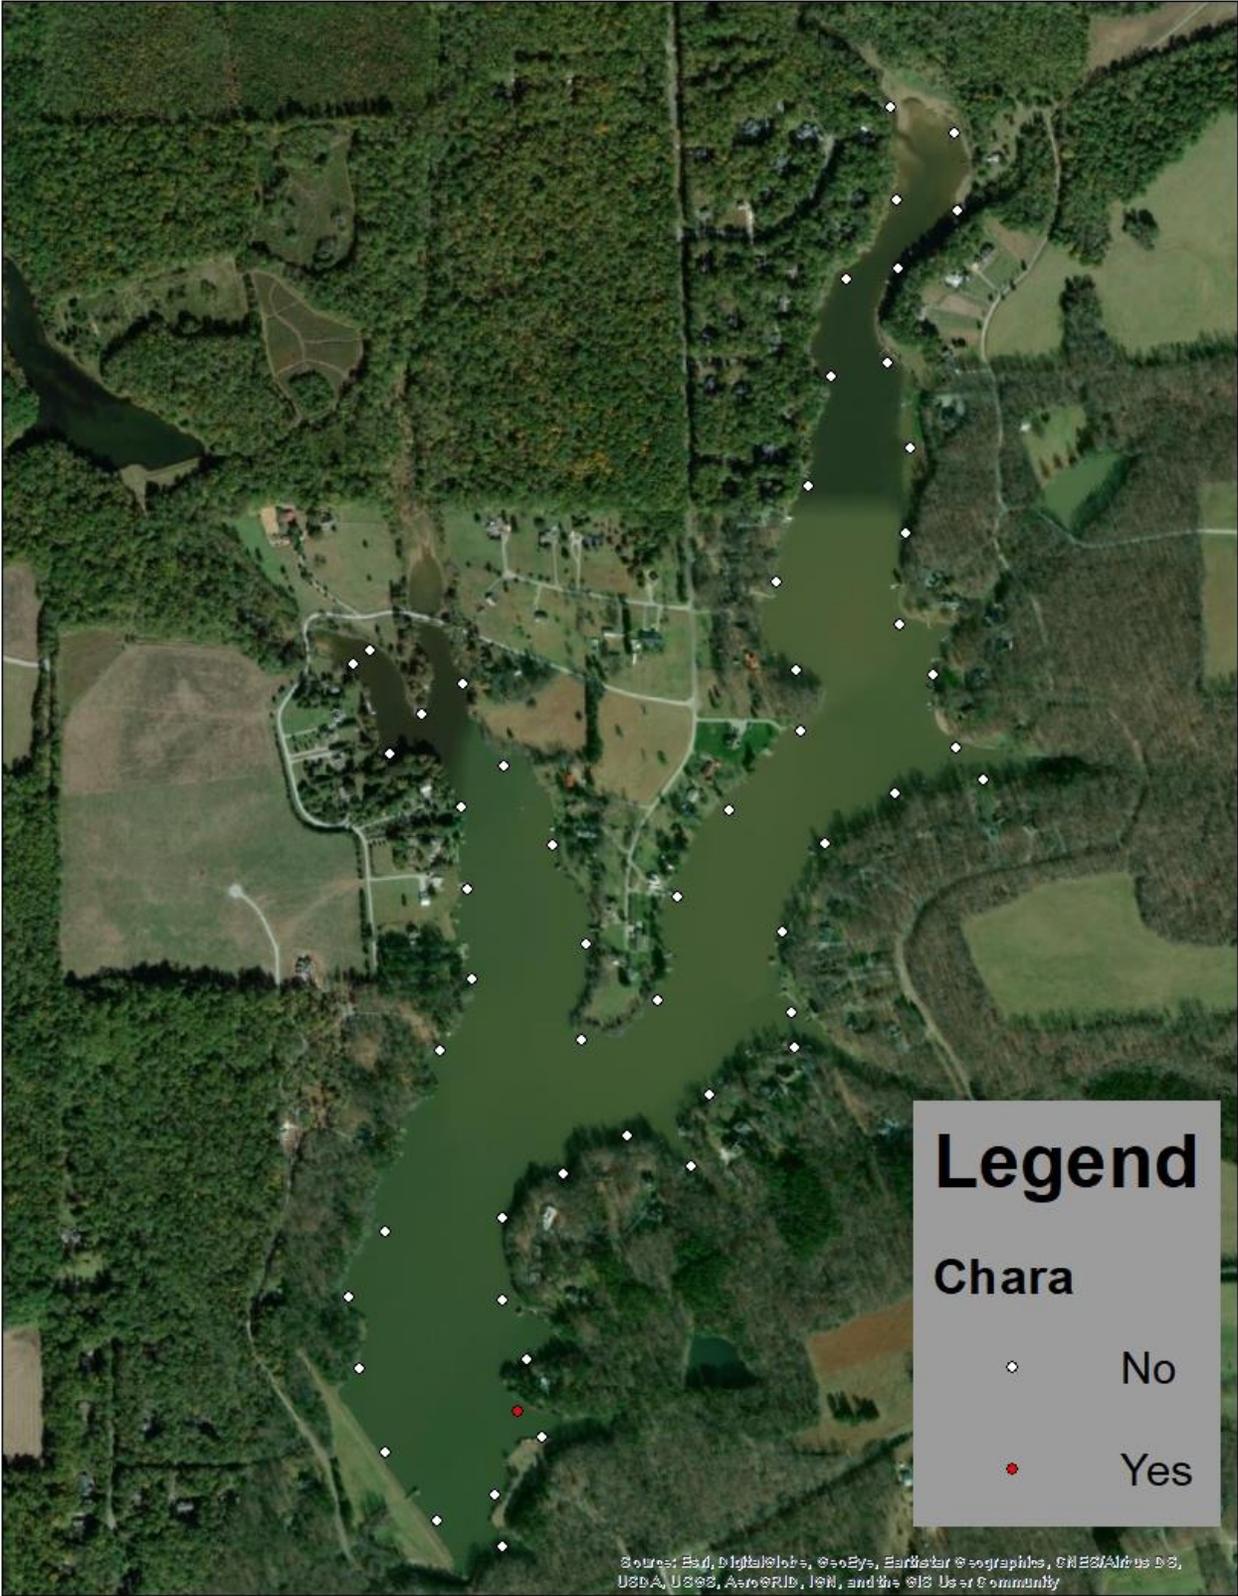
Figure 4. Map showing presence/absence of the macroalgae Chara at Lake Orange.

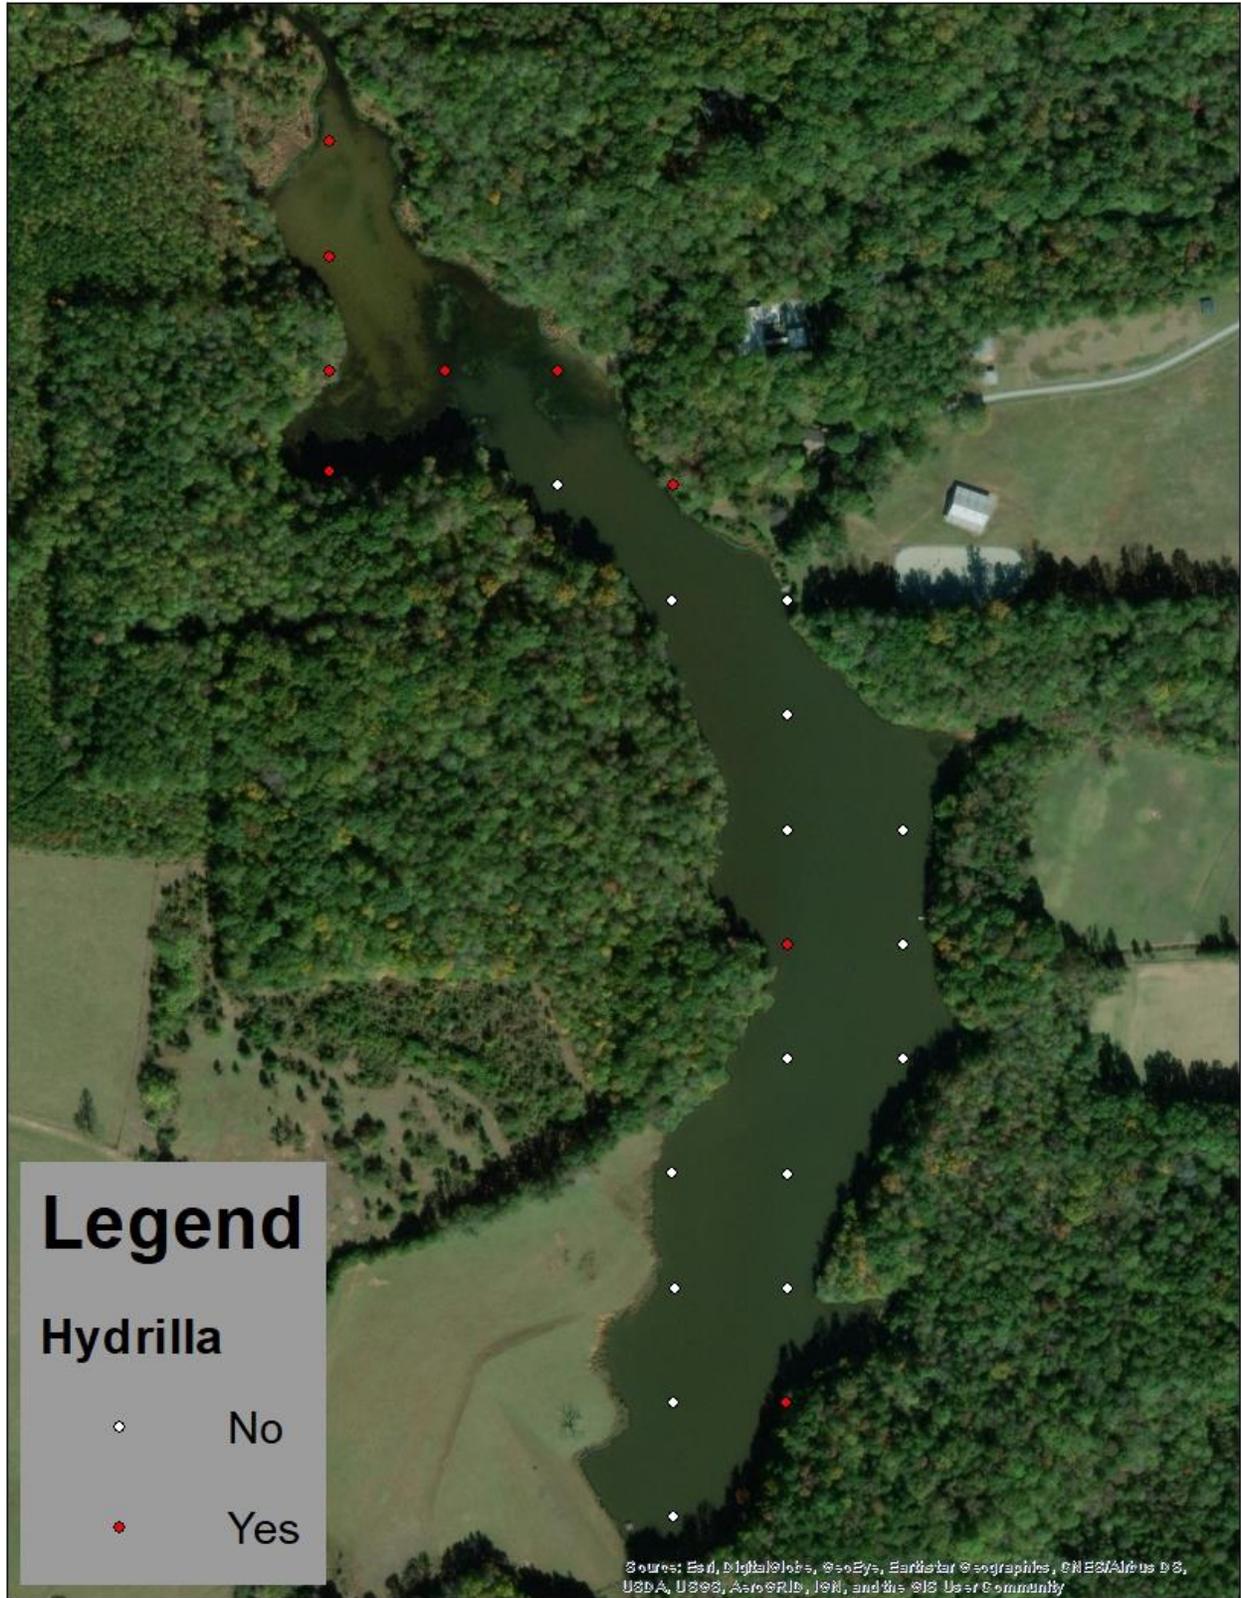
A total of 24 points were sampled during the 2020 survey. Hydrilla was found at 9, or 38%, of the sampled points (Figure 5). This was a decrease from the 2019 survey which identified Hydrilla growing at 15, or 63%, of the sampled points. The estimated Hydrilla coverage in 2020 is 5.5 acres (Figure 6). This was a slight increase from the 2019 survey which estimated Hydrilla coverage at 4.5 acres.

Figure 5. Map showing presence/absence of Hydrilla at Compton's Pond.

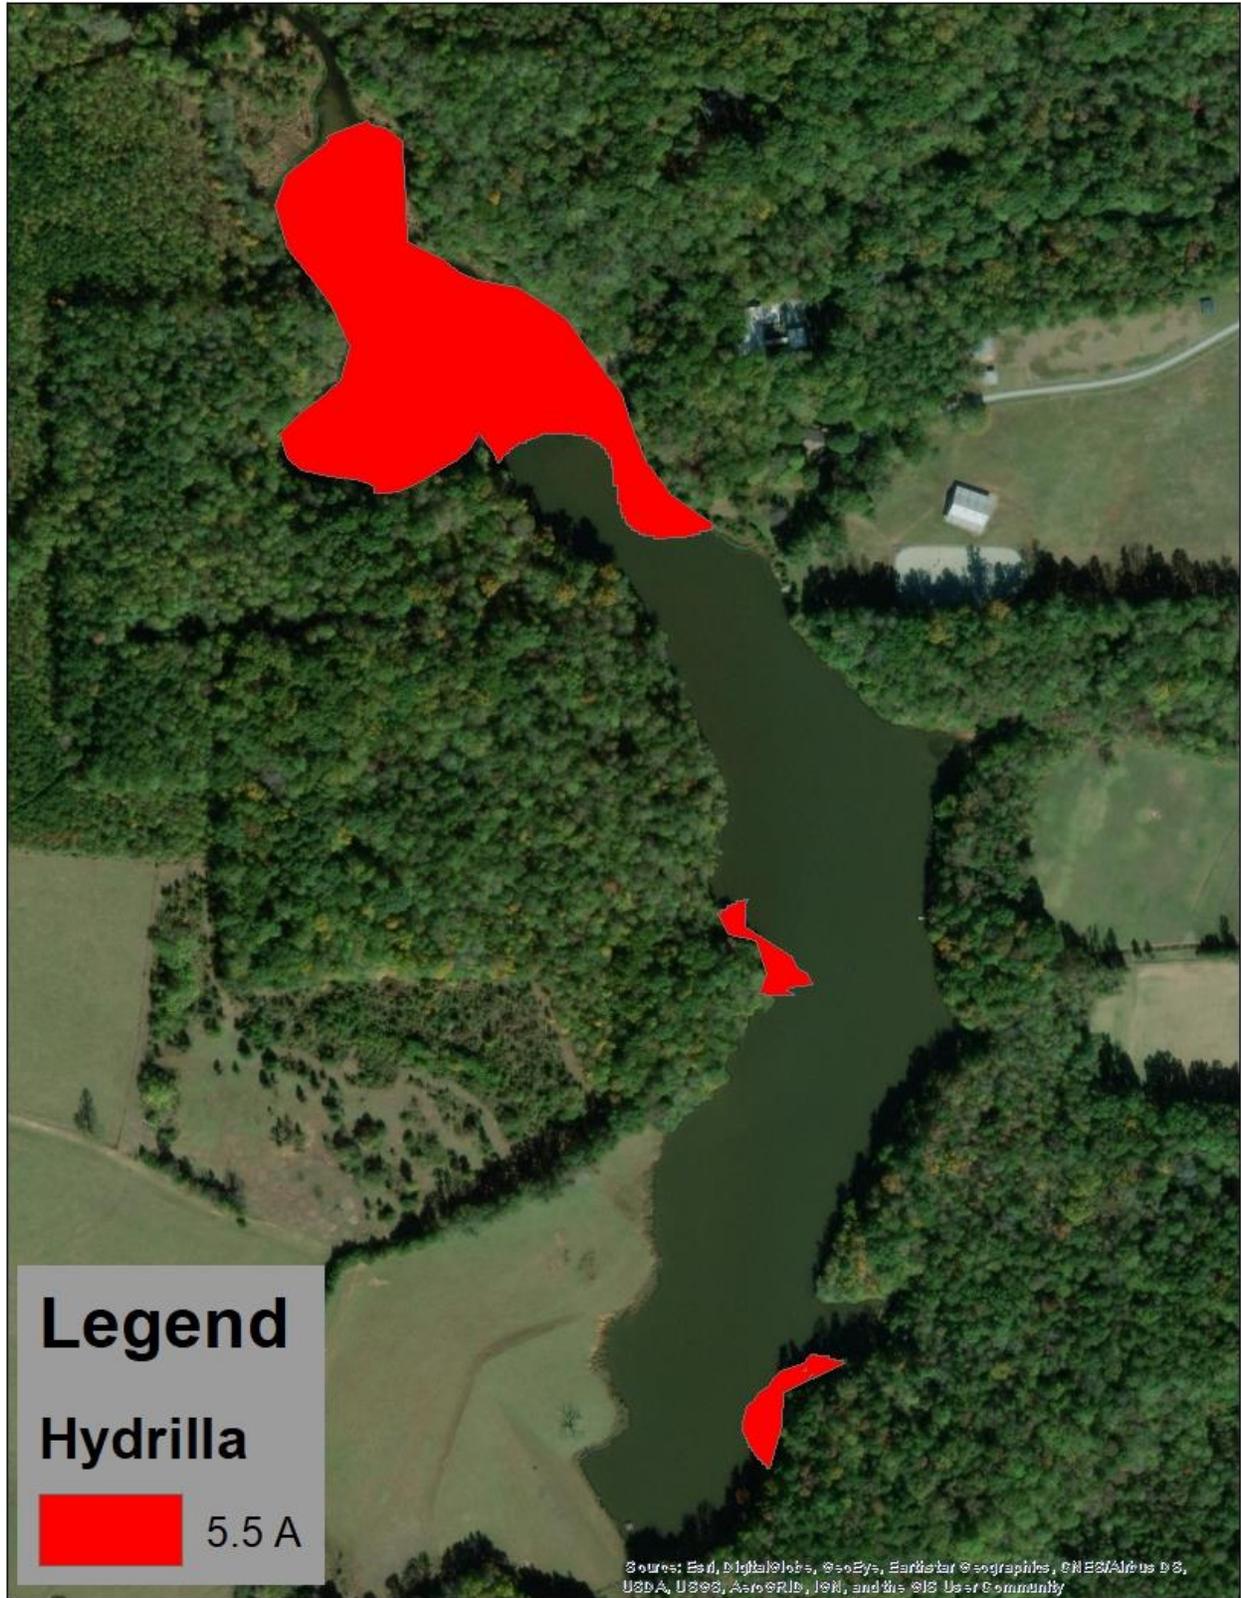
Figure 6. Map showing Hydrilla coverage at Compton's Pond.
