Middle Fork New River Restoration Prioritization Plan

Watauga County, North Carolina

August 31, 2018

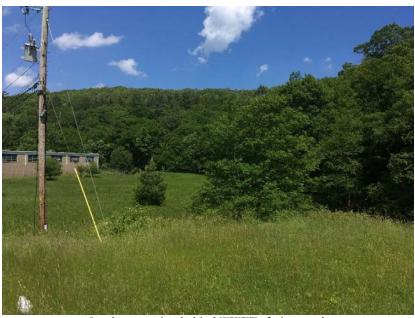
Southern portion behind WWTP, facing north

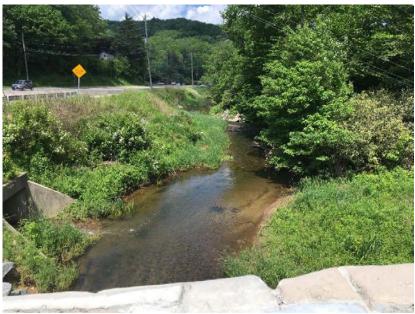
North-central portion at Chestnut Ridge Bridge, facing north

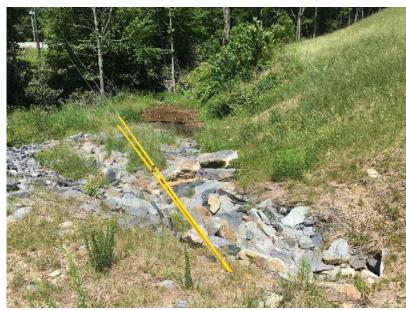
Stormwater feature on the northern portion for future enhancement, facing northeast

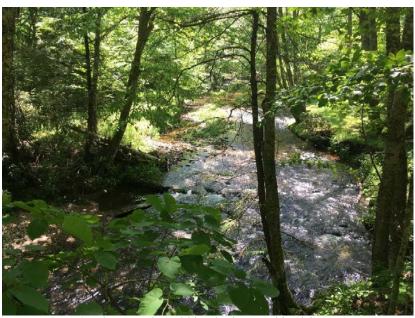
Southern portion within Firethorn residential area

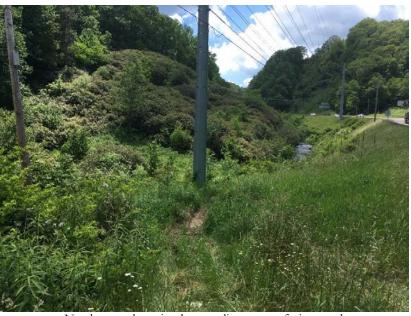
North-central portion by recycling center, facing south

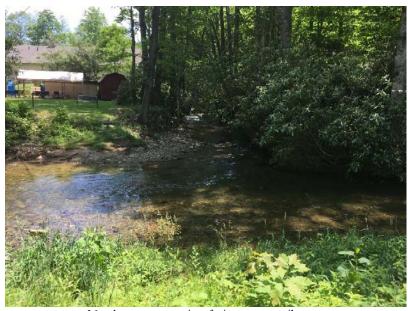
Northernmost portion facing east to tributary

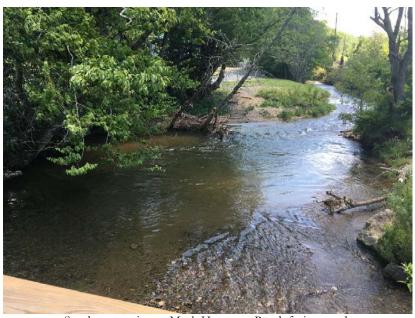
Southern portion at Mack Hampton Road, facing south

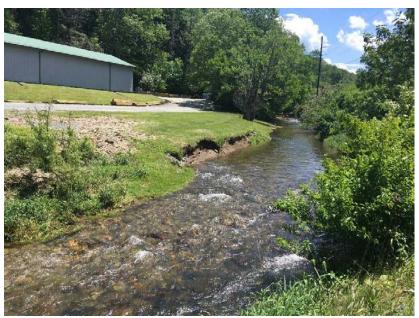
Central portion, facing south

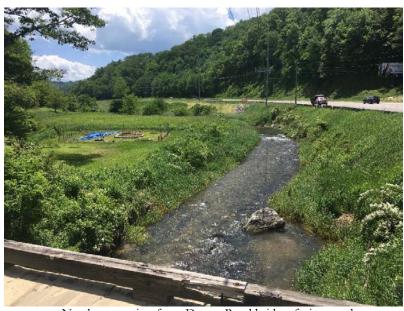
Northern portion from Dexter Road bridge, facing south

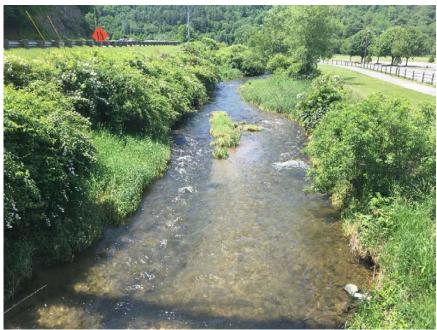
4a: Northern portion from Tweetsie Railroad entrance, facing south

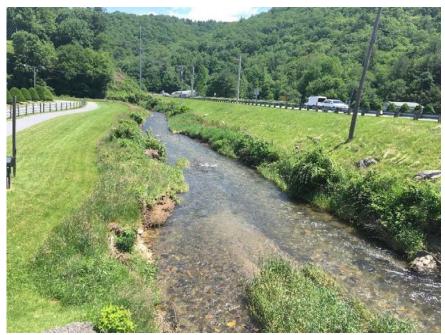
4b: Southern portion from Tweetsie Railroad entrance, facing north

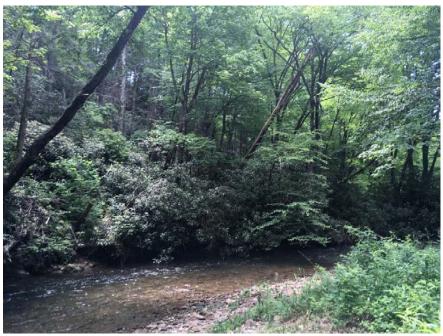
4b: South-central portion behind "red bus," facing east towards Reference Reach 2

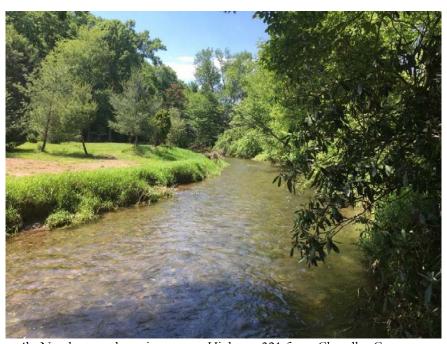
4b: North-central portion across Highway 321 from Chandler Concrete, facing south

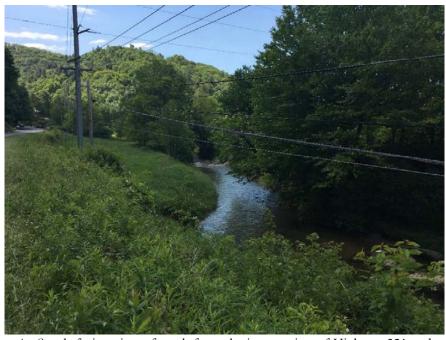
4c: South-facing view of reach from the intersection of Highway 321 and Mine Branch Road

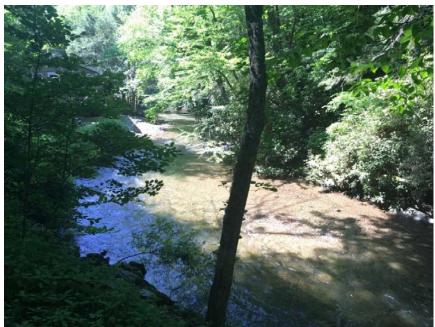
South portion from Rippling Water Road, facing south

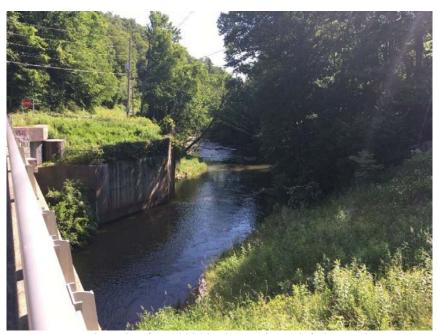
North portion from Old Blowing Rock Road, facing north

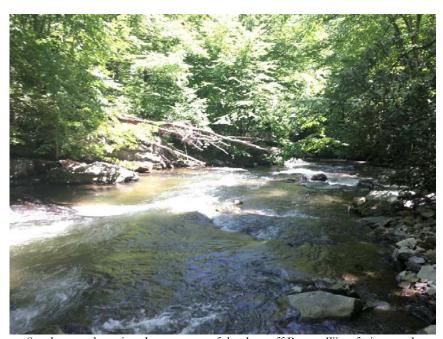
South-central portion downstream of the dam off Paynes Way, facing north (within Reference Reach 3)

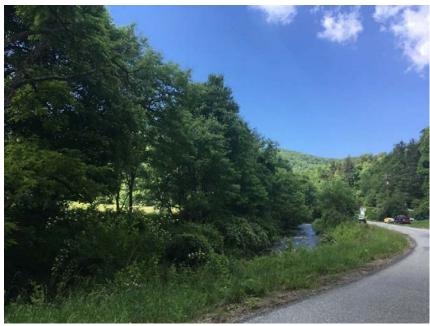
North-central portion from near the intersection of Jordan V. Cook Road and Edna Road, facing southwest

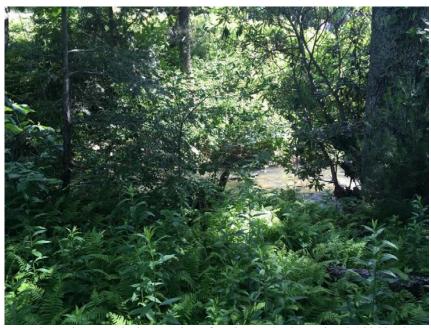
North portion near the intersection of Jordan V. Cook Road and Old Blowing Rock Road, facing northeast (standing on east side of river)

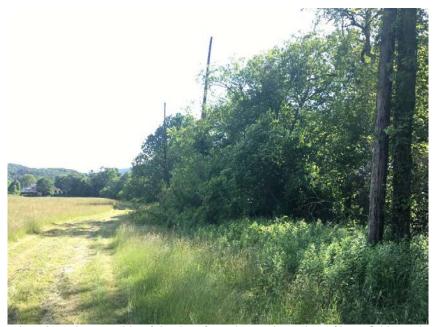
View along the west side of the river from the south portion of large field (south of the hospital), facing north

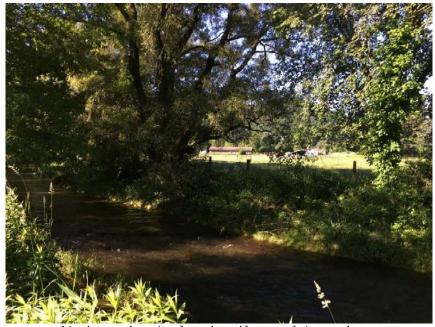
North-central portion from the golf course, facing southwest

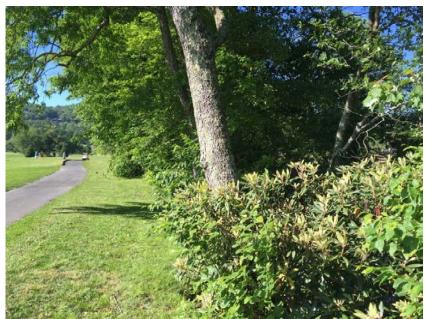
North-central portion from the golf course, facing south (standing on the east side of the river)

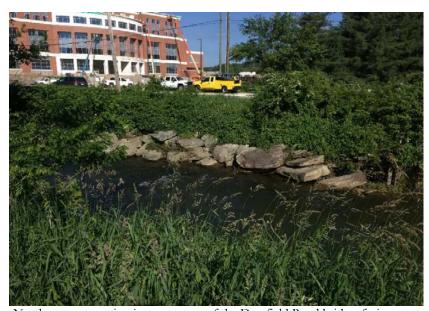
Northernmost portion just upstream of the Deerfield Road bridge, facing west
