**Briles Site**  
**Randolph County, North Carolina**  
*Stream Restoration Plan*

**Contract No. EW-02040S**  
**State Project No. 020591001**

**December 2005**

Prepared by: KCI Associates of North Carolina, P.A.

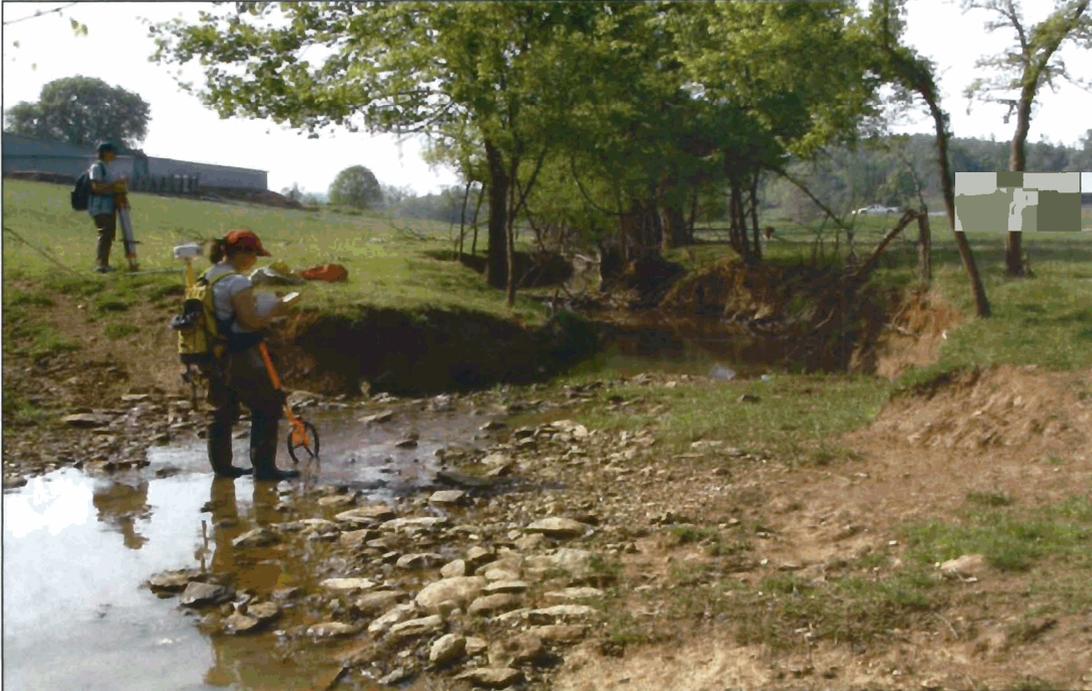
**Photograph 3 – View of a low water crossing at Station 10+46. The crossing is used by livestock and to pass farm machinery. This crossing acts as a grade control, preventing bed degradation in this area.**

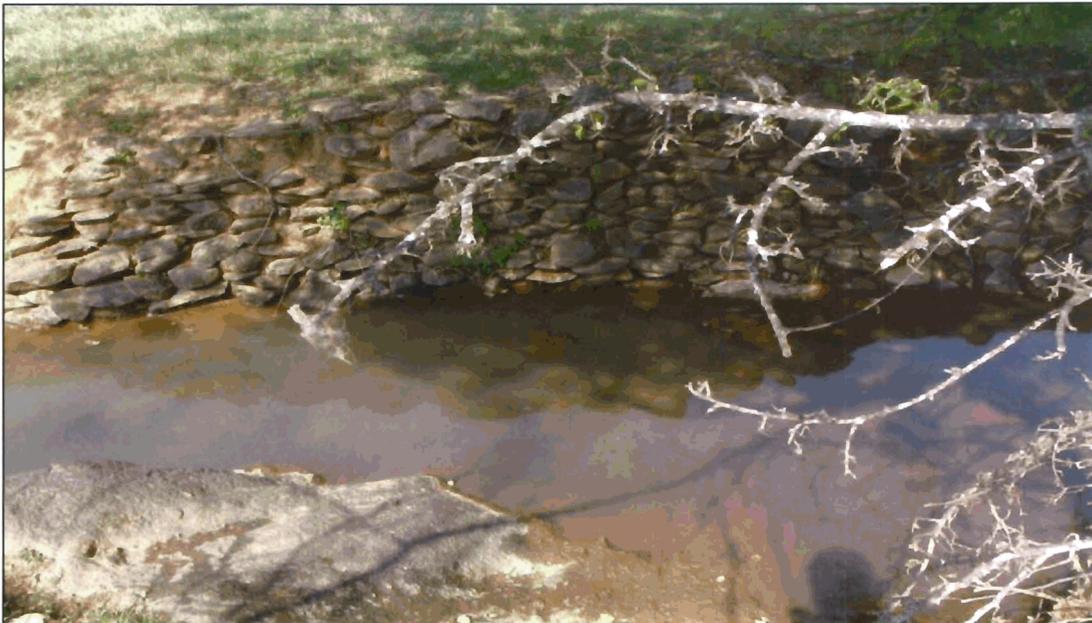
**Photograph 6 – Several sections of an imbricated stonewall exist from Stations 11+58 to 11+76, 11+72 to 11+80, and 11+92 to 12+10. Also, note the bedrock outcrop in the foreground.**

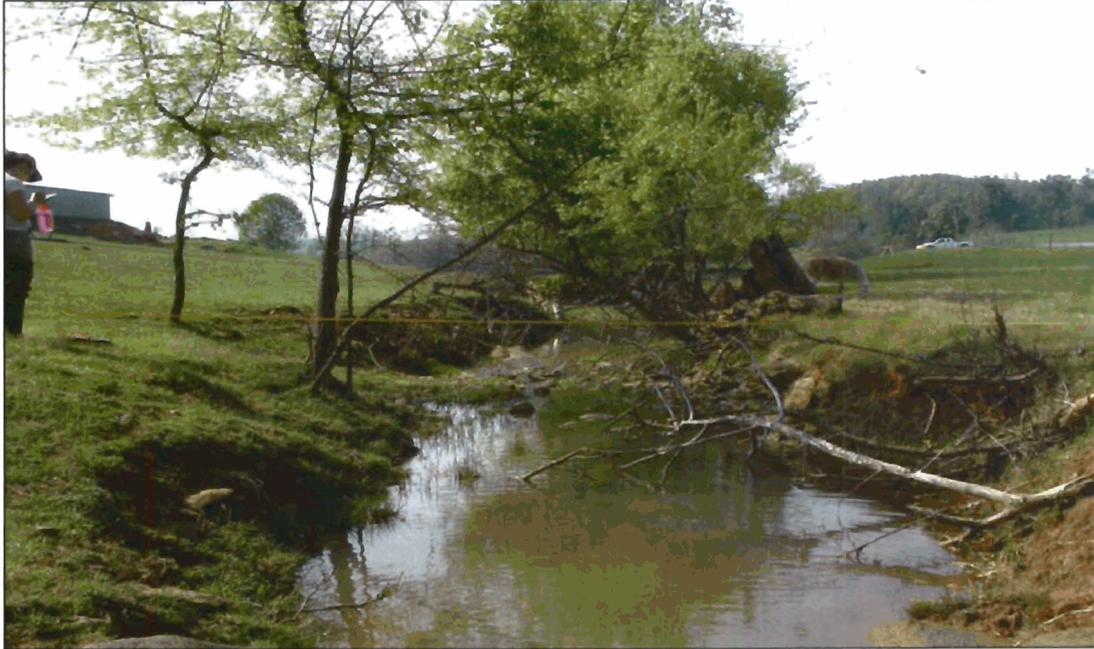
Photograph 7 – View looking downstream at Cross-section 1 (Station 11+92). Note the active bank erosion and lack of riparian buffer on both banks.

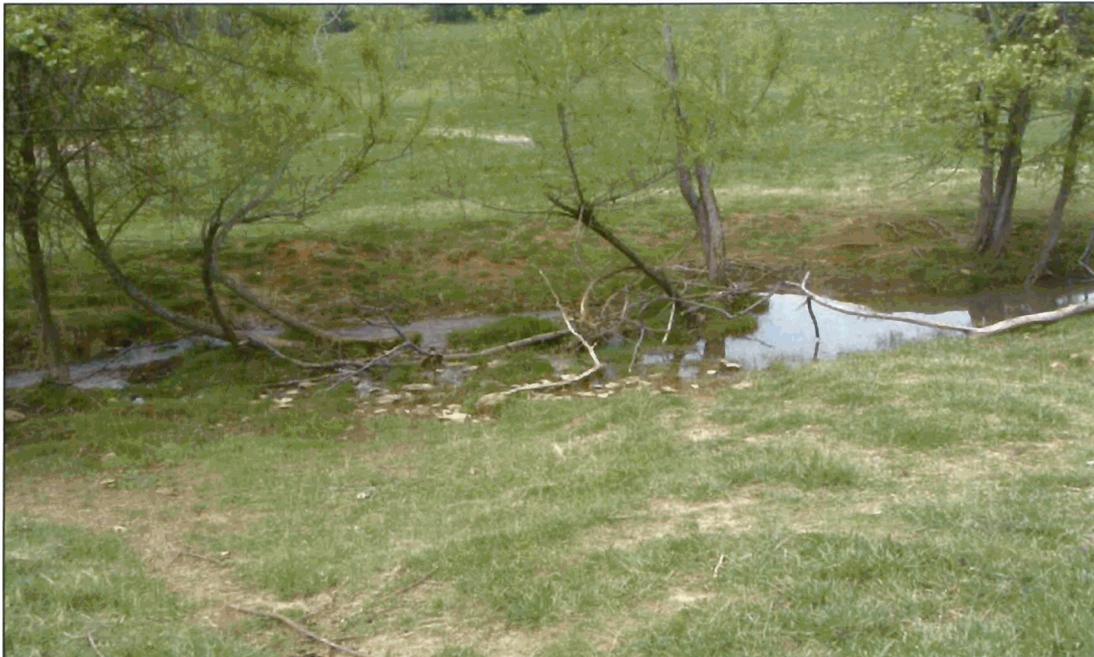
Photograph 8 – Short over-widened section near Station 12+60. Note the mid-channel depositional feature with trees. This section has been used as a low water crossing by livestock and farm machinery.

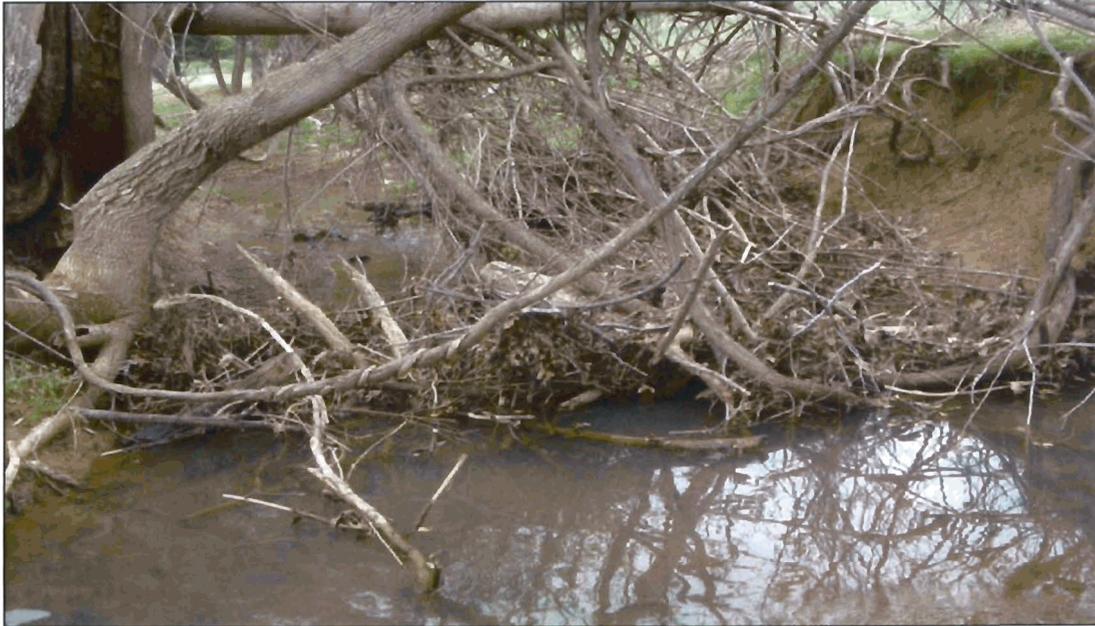
Photograph 9 – Upstream view of a debris jam located at Station 13+05.

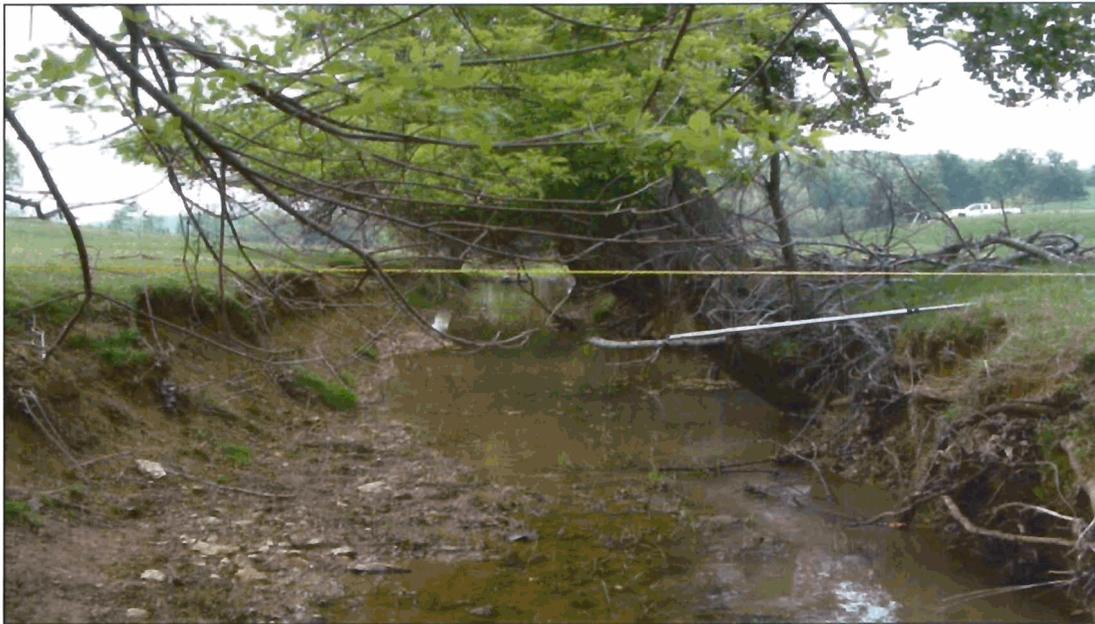
Photograph 10 – Downstream view of Cross-section 2 (Station 13+41). Note the eroding banks and absence of riparian buffer.

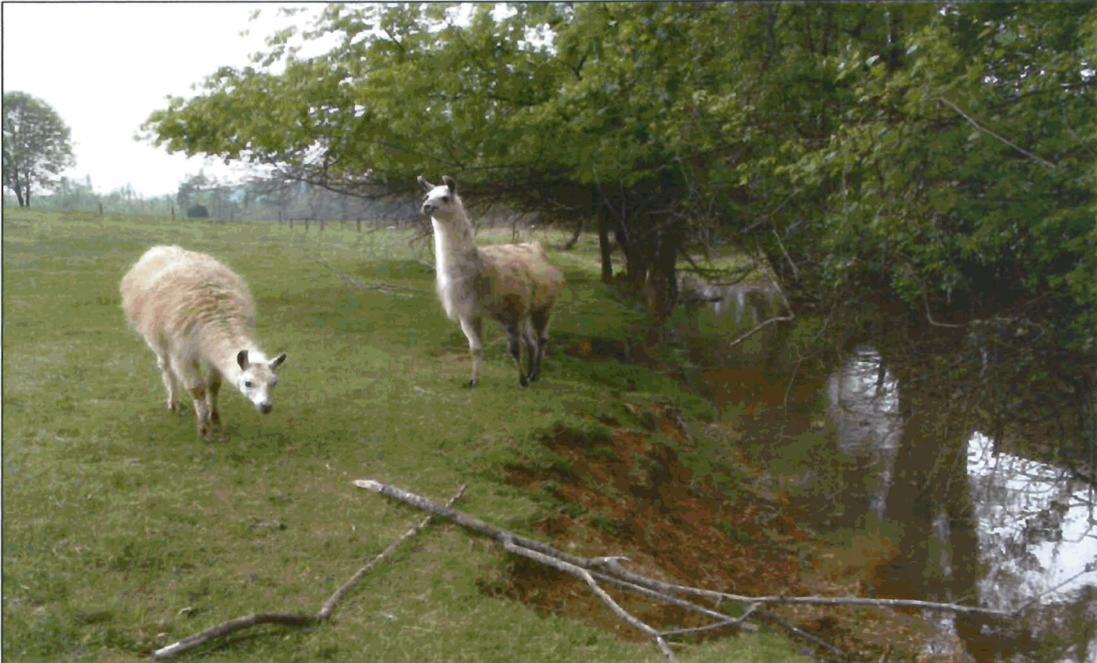
Photograph 11 –Livestock grazing adjacent to the left stream bank. Note the absence of a riparian buffer in this reach.

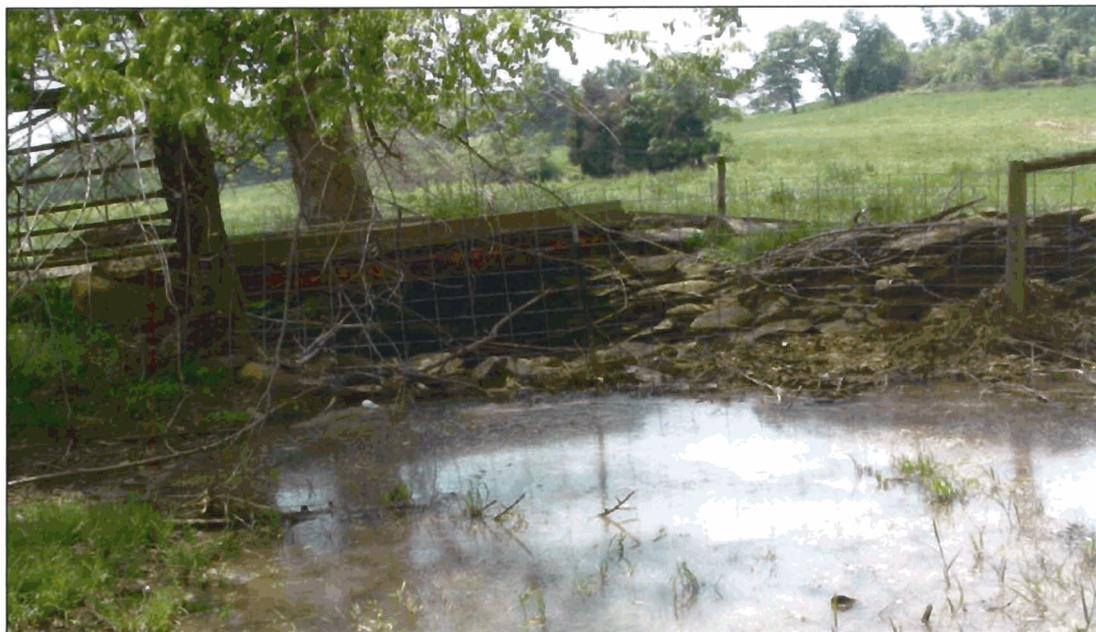
**Photograph 15** – View of a fence crossing the stream and a 10'x 3.5' opening under a concrete/steel bridge at Station 16+89. Note the debris blockage restricting flow through this reach.

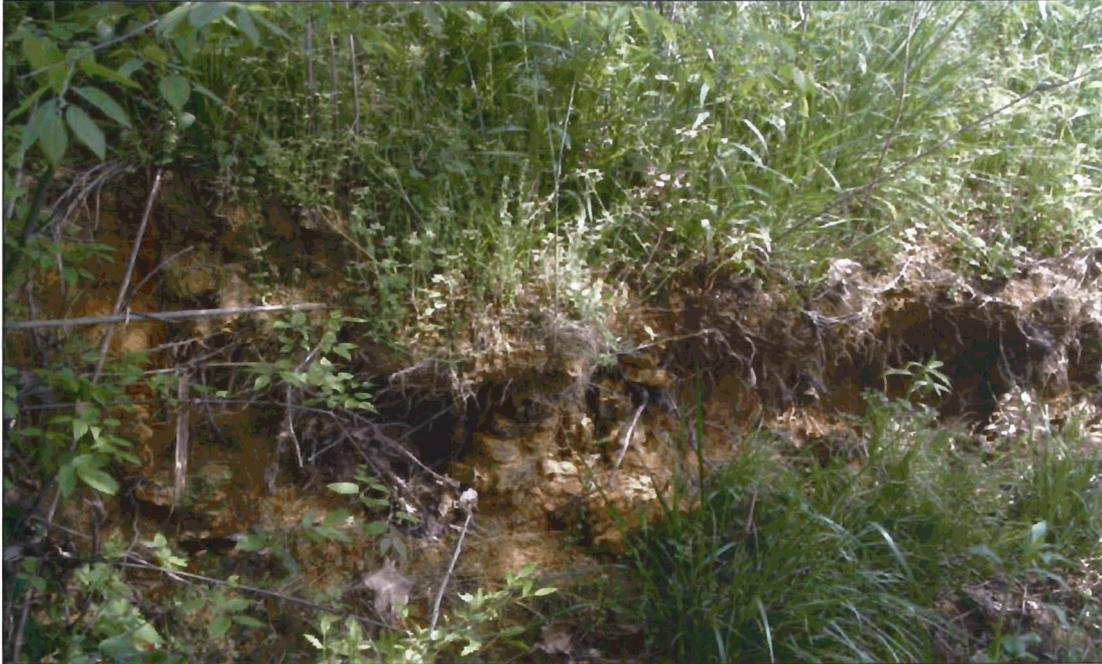
Photograph 17 – View of a gravel lens exposed in the bank in the vicinity of Cross-section 4.

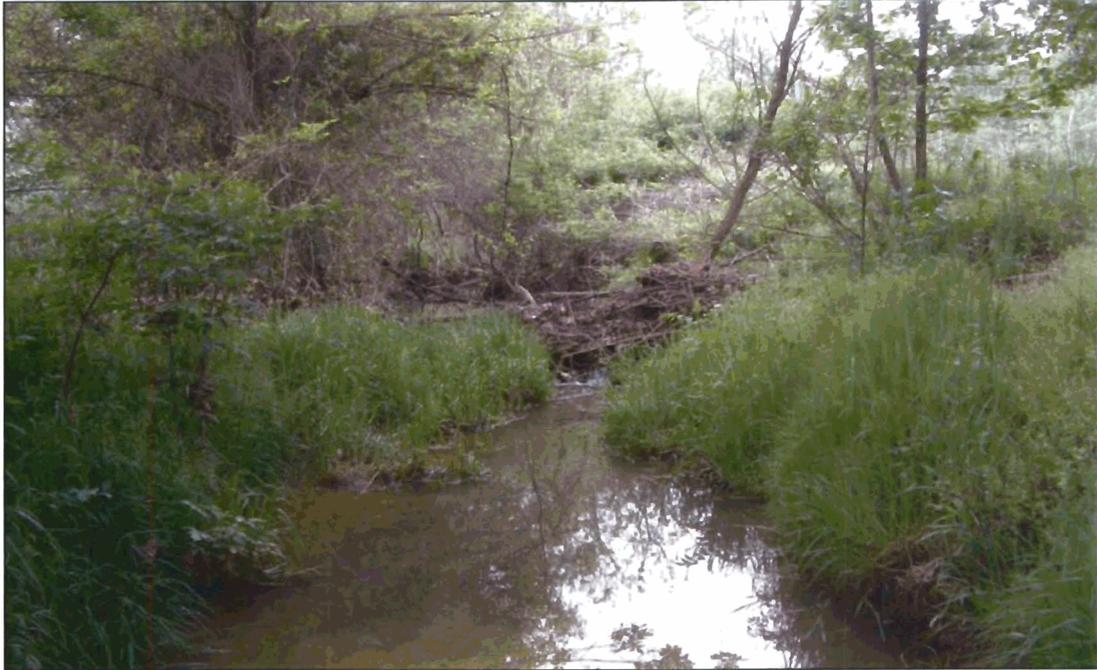
Photograph 23 – Multiple debris jams are located at Stations 24+27 and 25+46, in the lower portion of UTJC1.

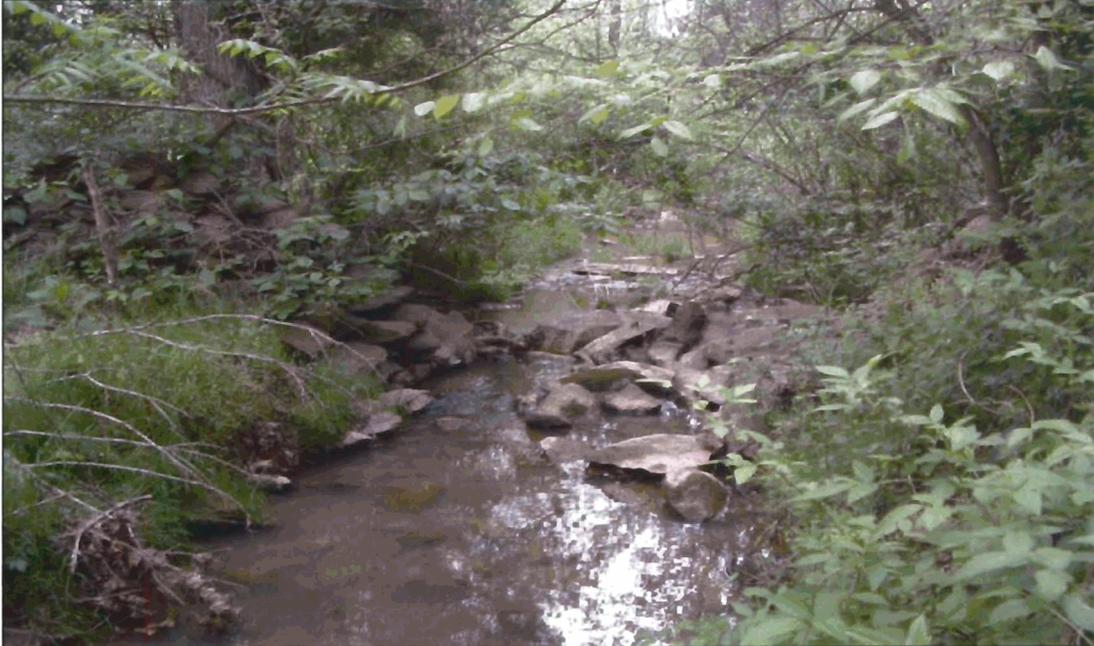
Photograph 25 – View of the remnants of an old stone-walled dam. Bedrock outcrops in the streambed are prevalent both up and downstream of this location. This area is the downstream extent of the Briles Site project reach.

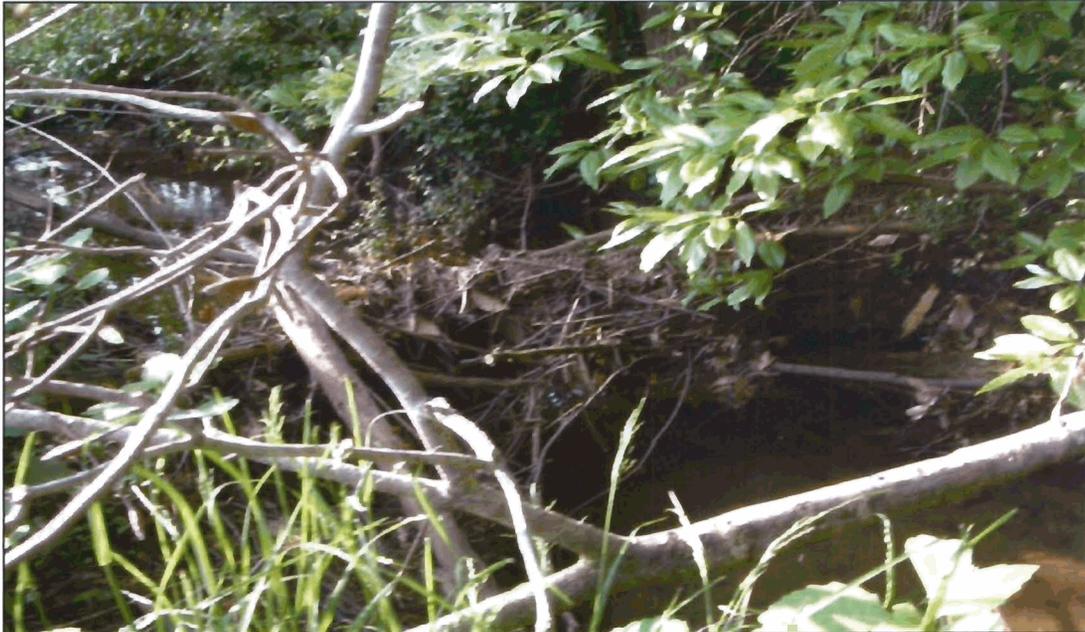
Photograph 3 – Several small debris jams exist in the upper portion of UTJC2. The debris jam in the photo is located at Station 51+00.

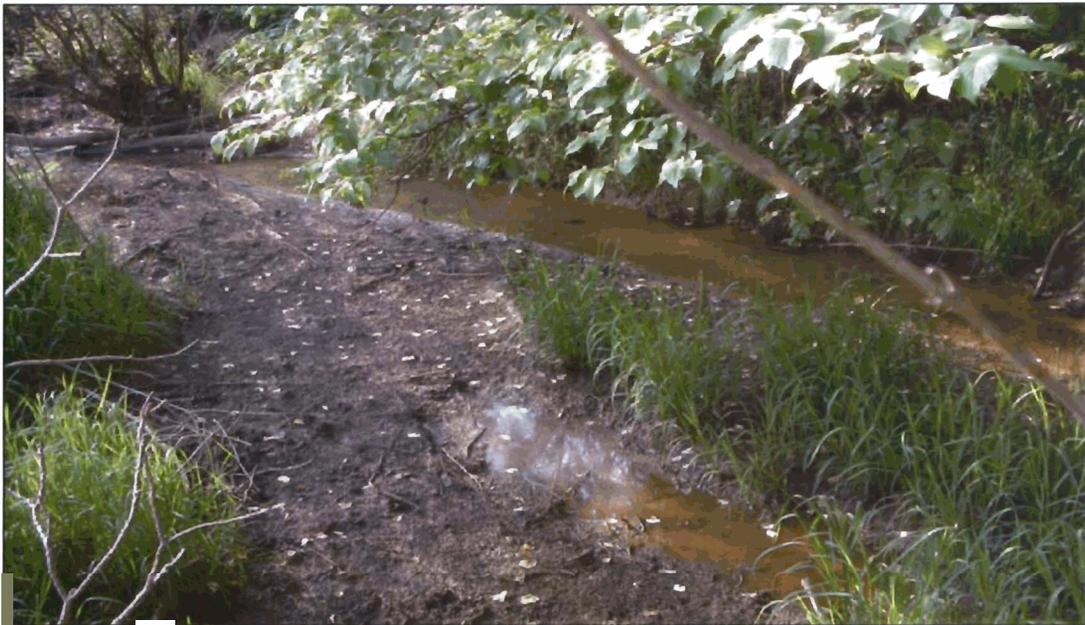
Photograph 4 – A lateral bar has formed along the toe of the left bank of UTJC2, at Station 51+75.

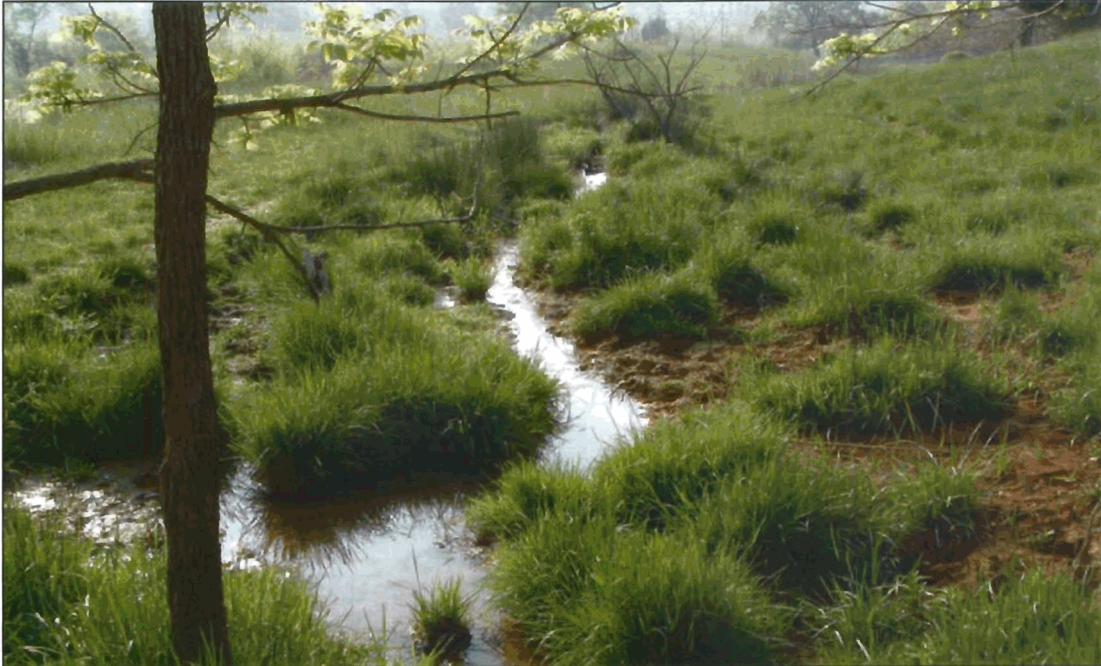
Photograph 9 – Downstream view from the culvert at Station 52+31. Note the stream flows through a well developed juncus/carex community. Disturbance from livestock access is evident in this photograph.

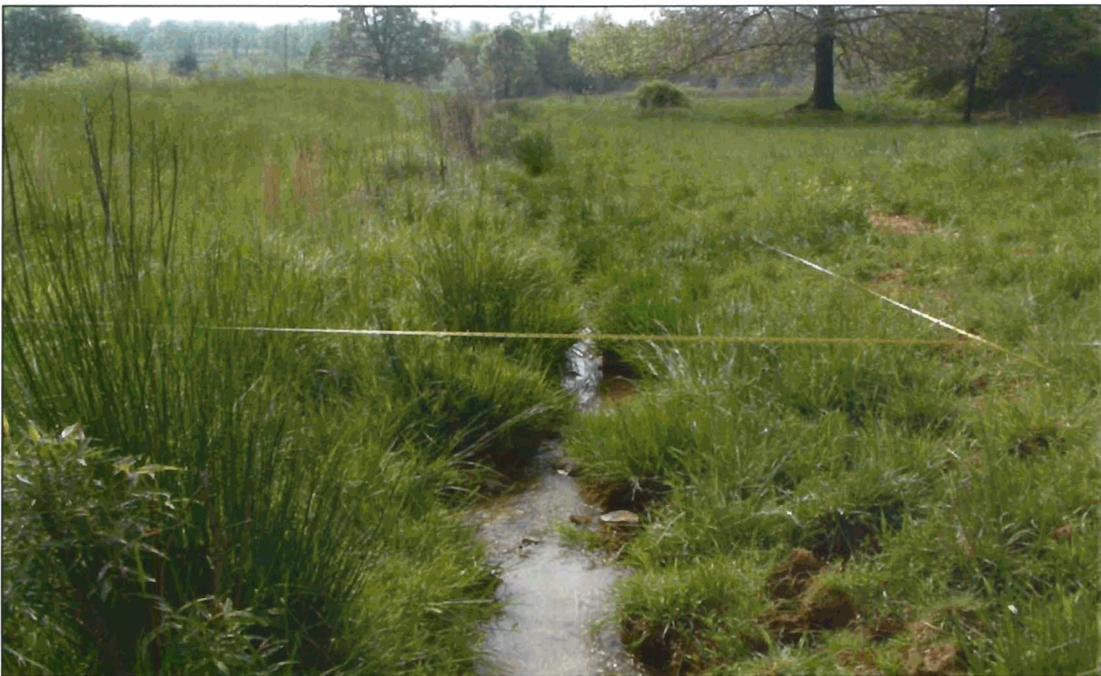
Photograph 10 – Downstream view of Cross-section 1 at Station 53+55. Note that the left bank is elevated due to spoil from the excavation of the adjacent pond.

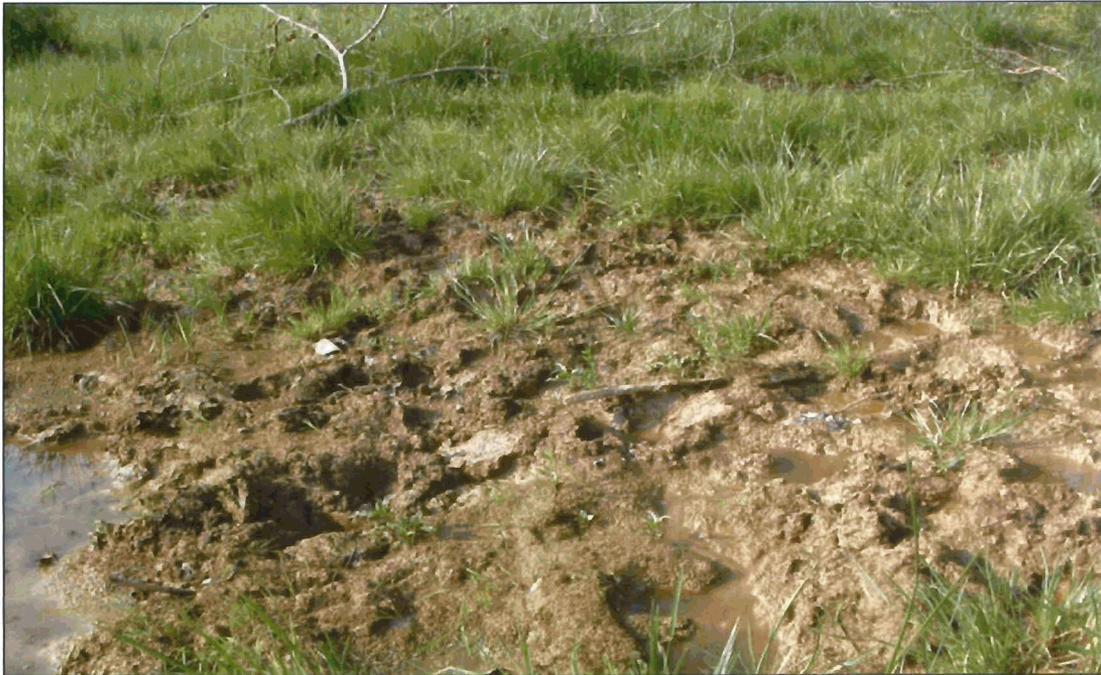
Photograph 13 – View of the right stream bank located opposite the outlet of the pond overflow pipe. Note the evidence of livestock impacts, absence of vegetation, and standing water present.
