South Fork Hoppers Creek - Melton Farm Stream Restoration Project Year 5 Monitoring Report

McDowell County, North Carolina

NCDMS Project Number – 92251

<u>Site Assessment Report – Monitoring Year 5</u>

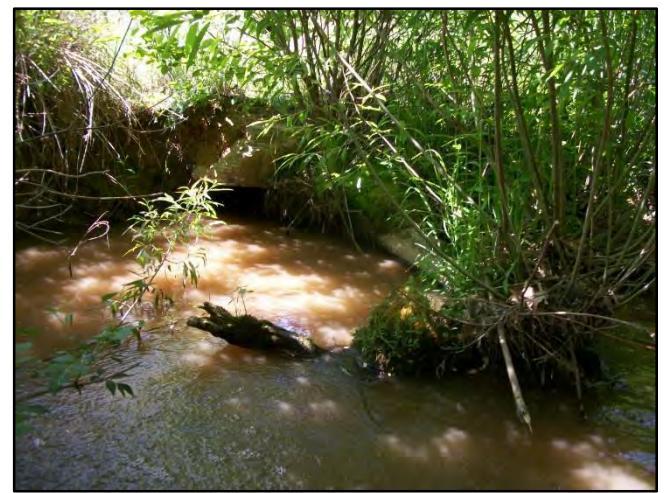
SPA2-1 and SPA5-3 are located just downstream of a log sill on SFHC Reach 1 at Station 16+25. These SPAs are characterized by erosion, undercut bank, and structure failure. The invert along the upstream log sill is directing velocity vectors into the bank which has caused erosion to occur around the back of the root wad and the invert/left bank tie-in of the downstream log sill; therefore, resulting in structure failure. The root wad has slumped into the channel and the log sill had separated from the bank and is under water. Native herbaceous and woody vegetation are present and providing some stability to the bank. This area will be assessed again during the Year 5 Monitoring period to document its state of stability.

SPA2-1 – Bank scour along left bank has led to erosion around root wads and log sill causing structure failure (5/16/16)

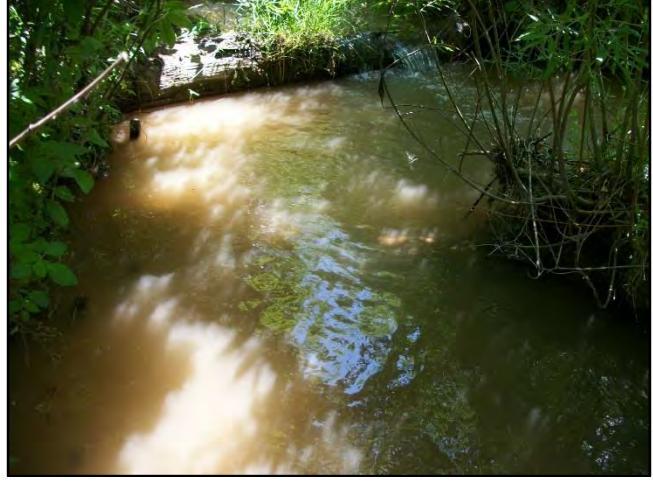
SPA 5-3 – Log sill has slipped out of place and is under water due to bank scour of SPA2-1 (5/16/16)

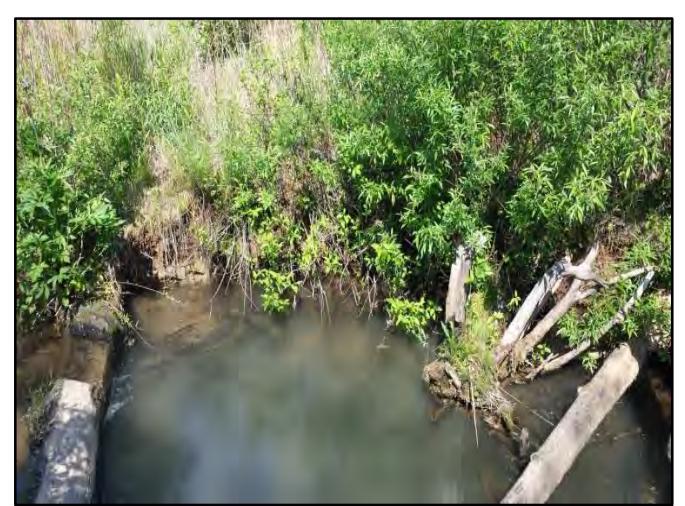
SPA4-1 and SPA 5-5 are located on the left bank just downstream of a log sill on SFHC Reach 2 at Station 20+20. These SPAs are characterized by erosion, undercut bank, and structure failure. The invert along the upstream log sill is directing velocity vectors into the bank causing erosion to occur around the back of the root wad and around the downstream of log sill invert/left bank tie-in. The root wad and the sill's header log are still tied-in to the bank; however, it appears that the sill's header and footer have separated. Currently the header log is suspended across the channel above the surface water elevation. Native herbaceous and woody vegetation are present and aiding in the stability of the bank. This area will be assessed again during the Year 5 Monitoring period to document its state of stability.

SPA4-1 Undercutting bank along left bank has led to root wad failure

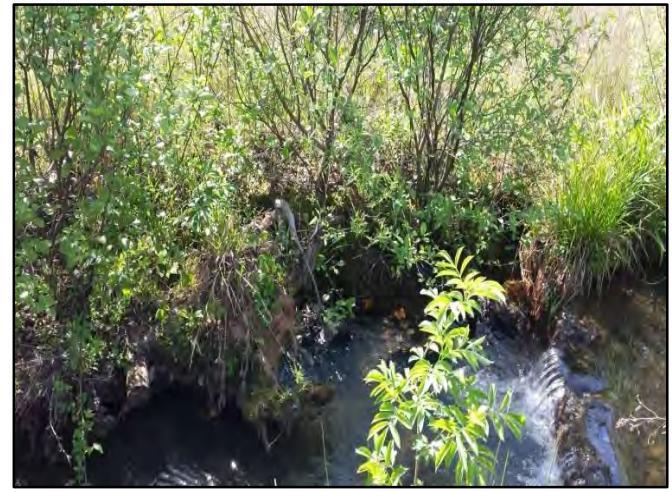
SPA4-2 consists of both bank erosion and undercut bank and is located along the right bank downstream of a log sill on SFHC Reach 2 (Station 20+75). This SPA is likely caused by the invert of the log sill directing the channel flow into the right bank just downstream of sill's tie-in. The area of erosion is located immediately upstream of the root wad and may eventually compromise the integrity of the structure. However, the root wad is still providing some bank protection, at this time. Native herbaceous and woody vegetation are present and are providing some stability to the bank. This area will be assessed again during the Year 5 Monitoring period to document its state stability.

SPA4-2 – Root wad failure along right bank due to undercutting along bank

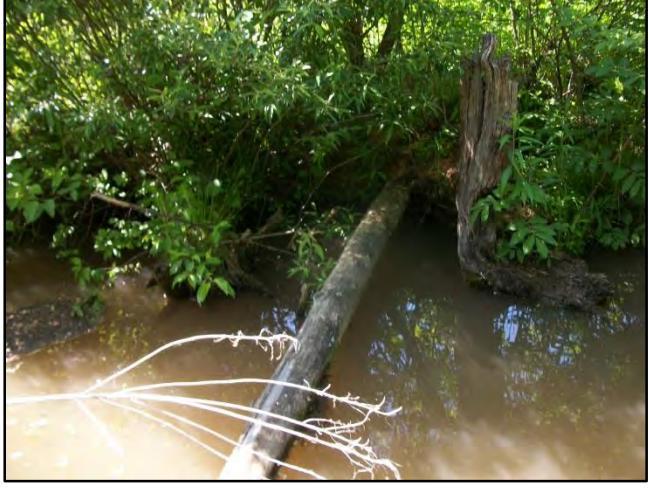
SPA5-5 – Log sill has been compromised due to bank scour on left bank from SPA 4-2 (5/16/16)

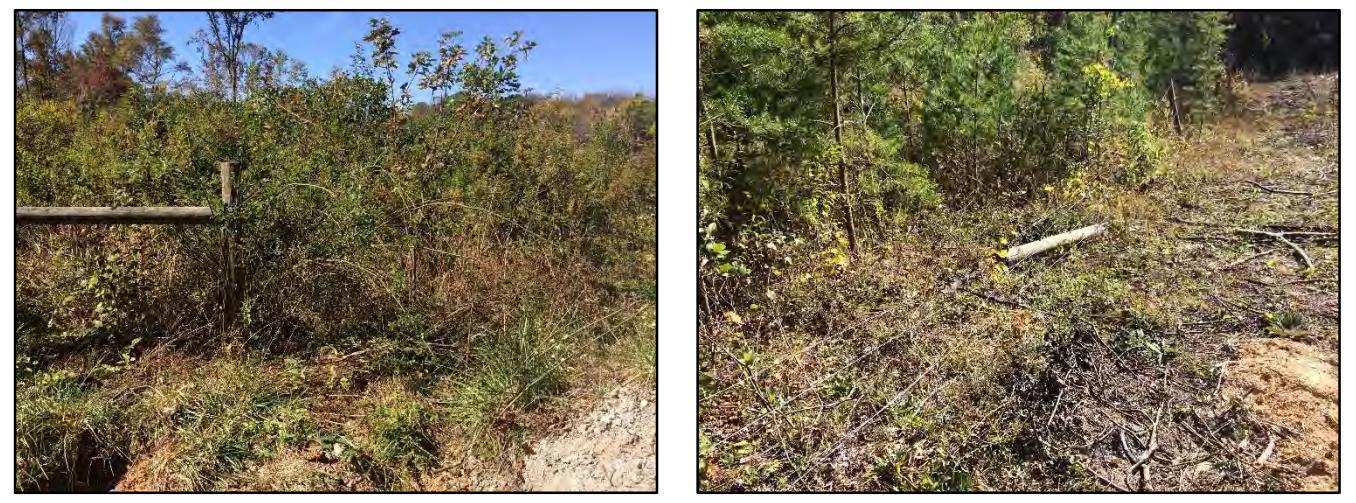
Fence line down from logging activity located outside but adjacent to easement

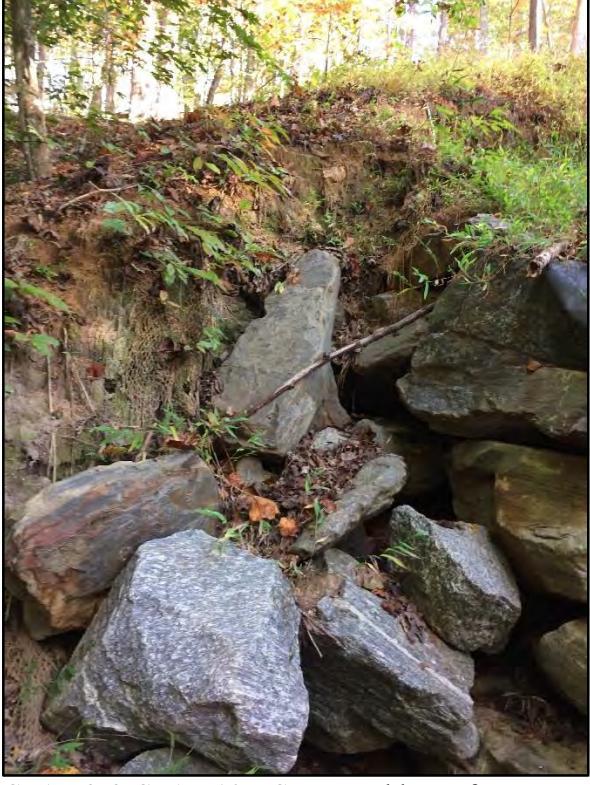
SPA5-9 & SPA5-10 – Scour and loss of structure integrity on boulder tie-in on fourth boulder sill of ephemeral drainage channel (10/19/16)

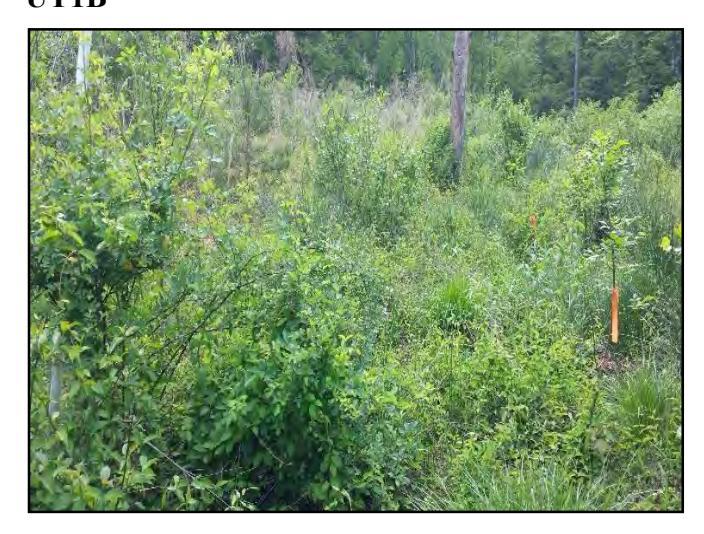
VPA2-4 – Multi-flora rose and Japanese honeysuckle
