Carteret-Craven Electrical Cooperative Wetland Restoration Morehead City, Onslow County, North Carolina

2003 Annual Monitoring Report

March 2004

Carteret-Craven Electrical Cooperative (CCEC) Wetlands Restoration Site (Jumping Run Creek) Fall 2003 Monitoring Summary

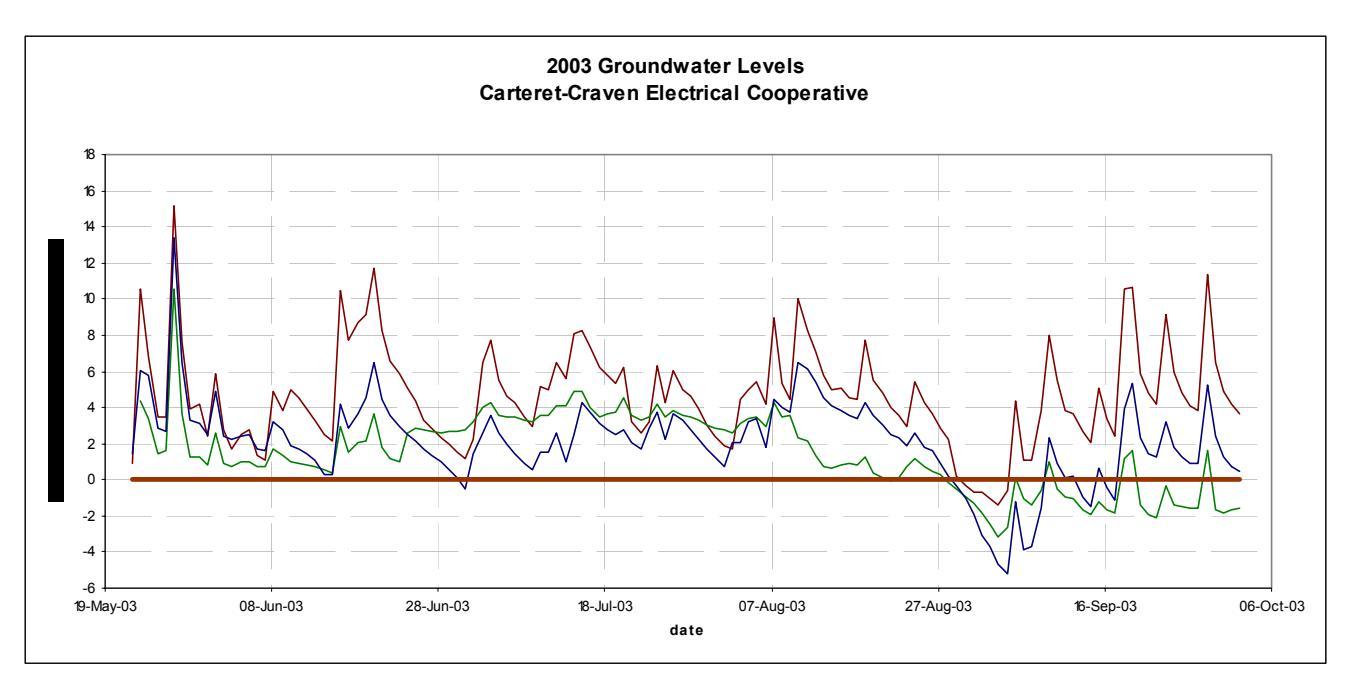
Figure 3. 2003 Groundwater Levels

Three ground water gages were set up at the site for the purposes of hydrologic monitoring after the project construction was completed. No revisions to the current hydrologic monitoring plan were proposed for this site. The data from each of the devices was downloaded during the monitoring visit. Analysis and overlay of the data showed that saturation levels well exceeded the mitigation requirements. Water levels in each area were recorded above the ground surface for much of the growing season and the water level never dipped past 12 inches below the surface (Figure 2).

Although water levels appear to be sufficient in the wetland, observations indicate that some short-circuiting of the wetland is occurring due to a ditch along the edge of the West Cell. Filling of this ditch or the installation of targeted channel plugs would probably improve hydrologic cycling and the water quality benefits of the wetland. The continued level of surface inundation may also be causing stress and contributing to the poor health and propogation of the trees. This type of hydroperiod, which is more similar to a constructed wetland than a natural one, may be more suitable for herbaceous wetland plants. If maximizing water quality benefits is a primary goal of the project, it may be recommended to compliment the Western Cell with a herbaceous planting. Regrading of the ditch area and installation of some higher microtopographic areas could also have a benefit. Higher areas could be replanted with desirable trees.

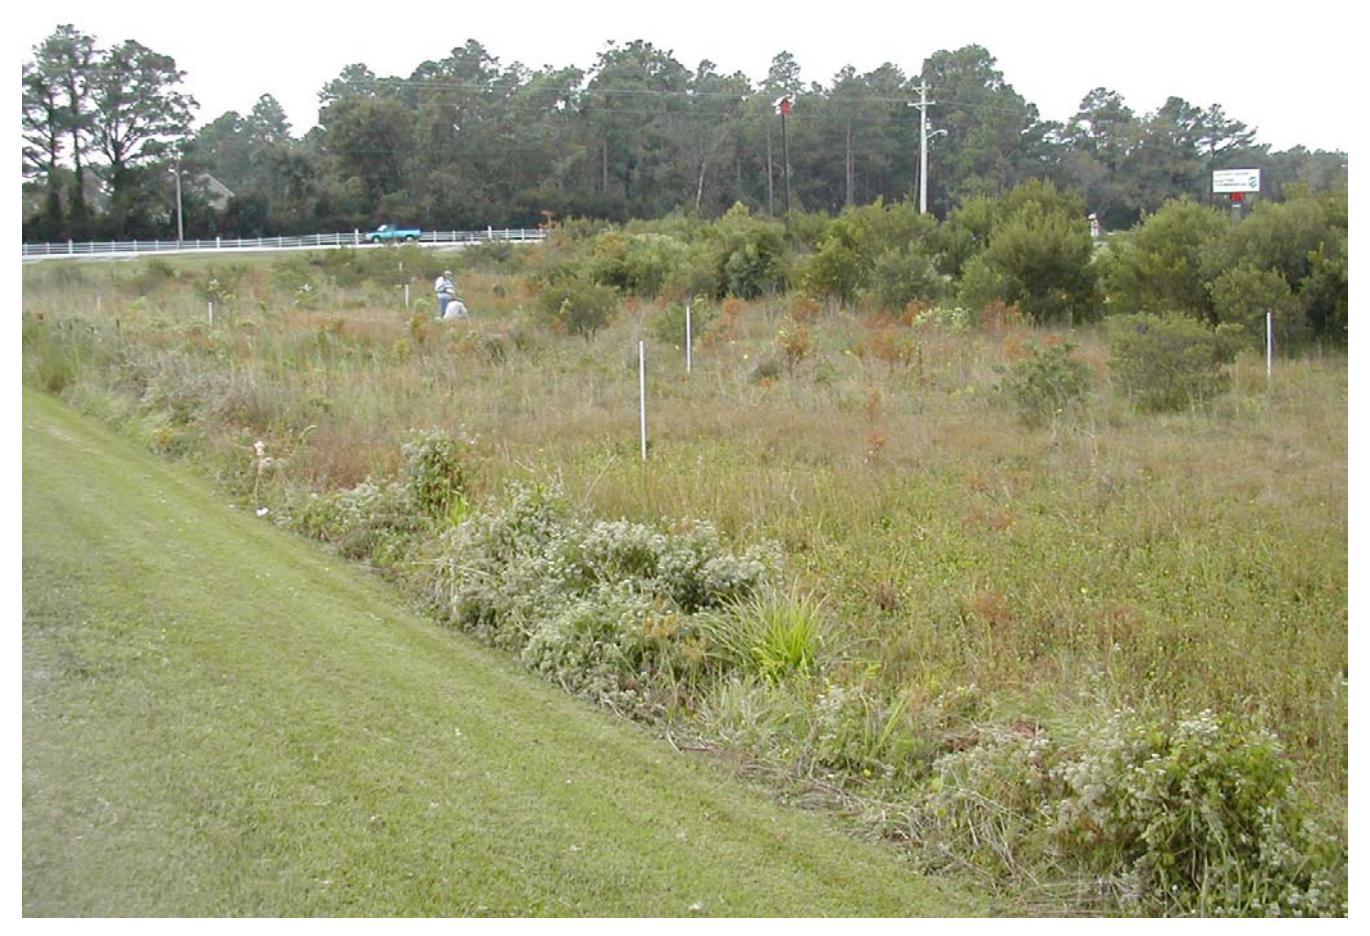
```
Photo 1. East Cell
```

Vegetation throughout the East Cell appeared healthy and consisted of a combination of both planted trees and shrubs and volunteer shrubs and herbaceous plants. The herbaceous plants were widely diverse and thick throughout. A variety of algae was found in areas of standing water. Microtopography was heterogeneous in most areas.

Invasive plant species on the site included *Mikania scandens* (climbing hempweed) and *Typha* spp. (cattails). Although not exotic, these plants were present in the wetland. The climbing hempweed covered nearly every shrub and tree. This vine appeared to strangle smaller shrubs and cause irregular growth in the trees. Cattails were located in an isolated area along an outfall area near the road.

The east cell is currently meeting the requirements of vegetative success at this site. Recommendations for this site are to monitor the invasive plants over time and maintain them if needed. Overall, this portion of the site has a healthy, diverse vegetative population.

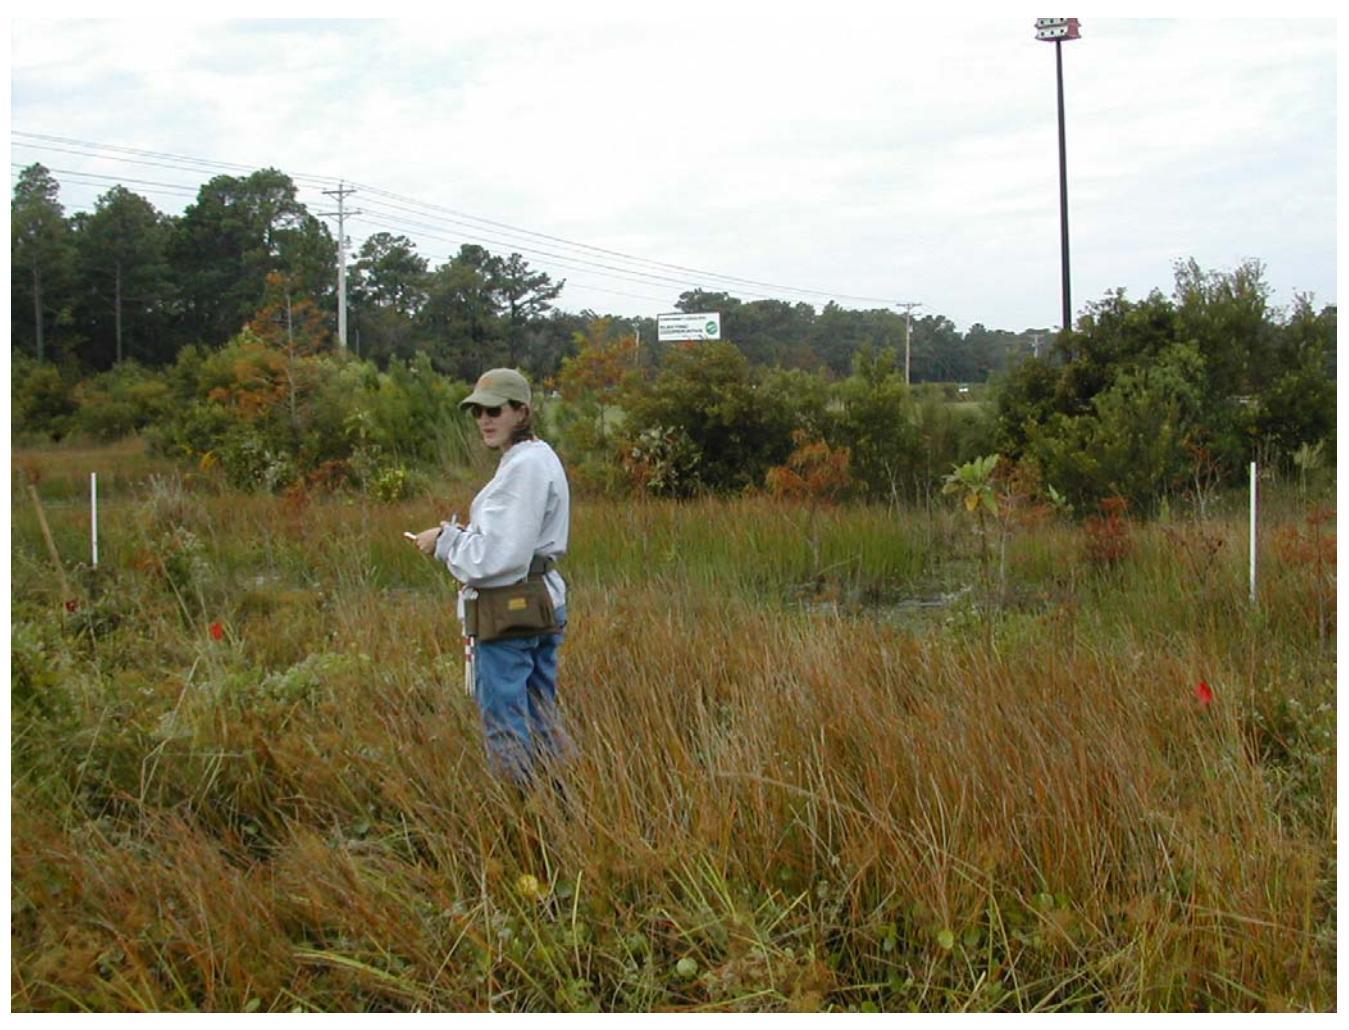
Photo 2. East Cell Vegetation Plot

Two random plots were assigned to this cell. Herbaceous vegetation consisted of a variety of emergent and terrestrial plants. *Hydrocotyle* spp. (Pennywort) and *Diodia virginiana* were dominant emergents. Rushes and sedges were common, but nowhere dominant. Few shrubs existed and those that were noted were small species of *Myrica cerifera* (wax myrtle), *Rosa palustris* (swamp rose) and *Cephalanthus occidentalis* (button bush).

Planted trees were prevalent on this site. *Taxodium distichum* (bald cypress) and *Nyssa aquatica* (water tupelo) were the dominate trees. Planted trees were largely healthy and appeared vigorous. *Pinus serotina* (pond pine) was present, although unhealthy in appearance. Some tree mortality was noticed. Extrapolation from two plots in the East Cell resulted in an average of 940 trees per acre for this area. This number appears to be from planted trees only with little to no naturally regenerated trees noted.

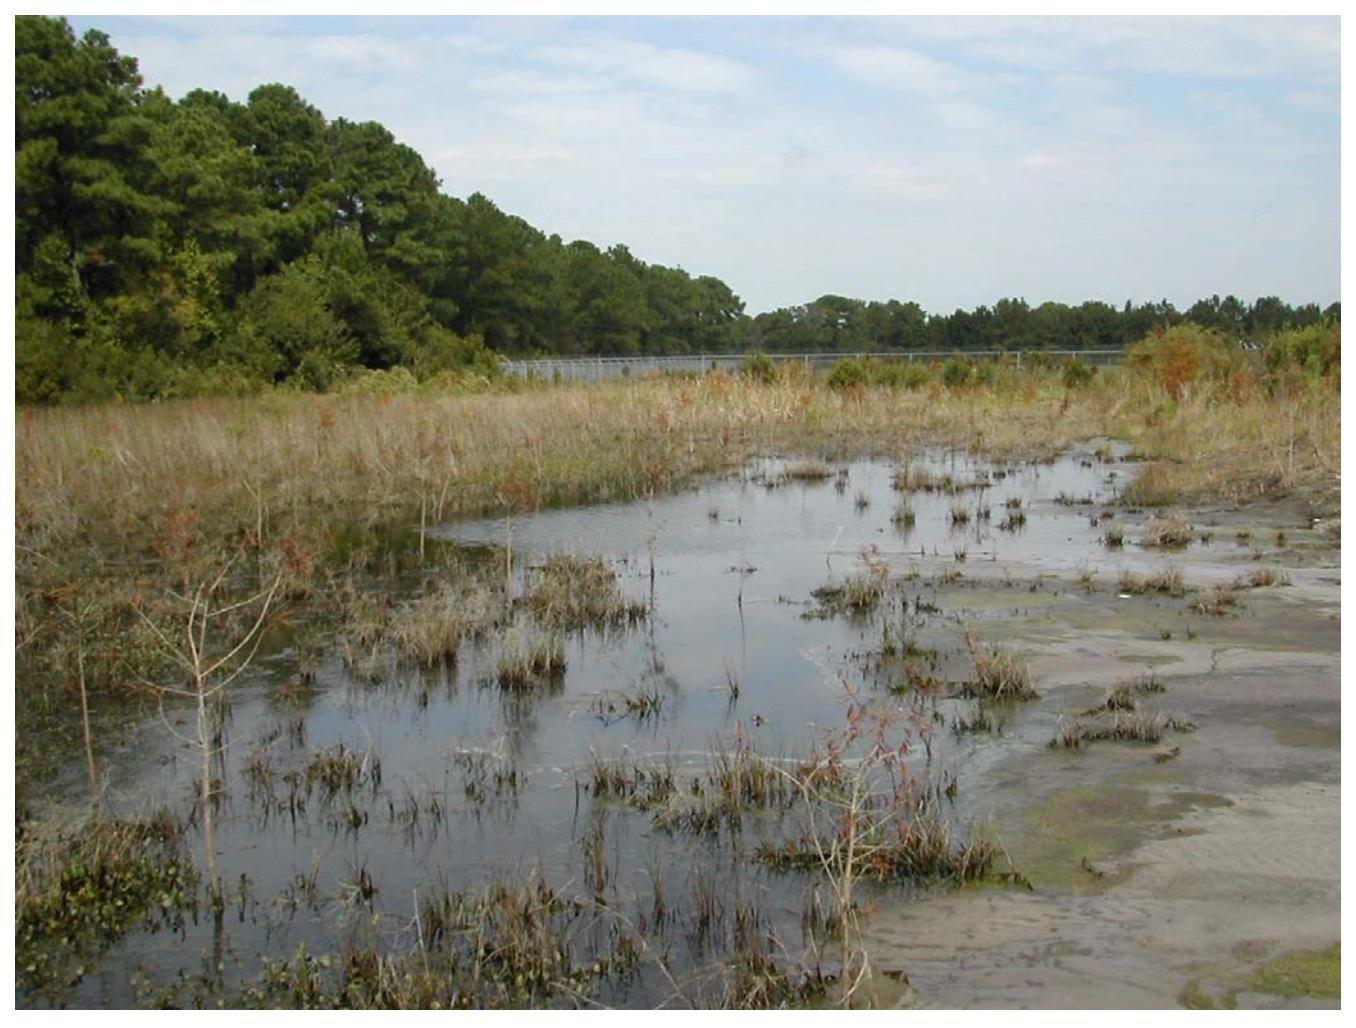
Photo 3. West Cell - above weir

appeared to be less vegetated than the area below the weir. A variety of algae was found in areas of standing water. Both plot locations graded from drier areas to wetter (standing water) areas.

Herbaceous vegetation consisted of a variety of emergent and terrestrial plants. *Hydrocotyle* spp. and *Diodia virginiana* were dominant emergents in the area below the weir. The plot above the weir was very sparse in herbaceous vegetation and compared to the East Cell, diversity of herbs was low in the West Cell. Only small species of wax myrtle represented the shrub layer. These appeared to be volunteers from a nearby hedgerow. A few unidentifiable dead shrubs were noted. In both areas, the shrub and herb layer was more abundant in the drier areas than the wetter areas.

Planted trees on this site included predominantly bald cypress and water tupelo with a few *Chamaecyparis thyoides* (Atlantic white-cedar) and *Nyssa biflora* (Swamp tupelo) scattered around. The overall health of these trees was poor, particularly those in the standing water areas and those in the location above the weir. The area below the weir was abundant in *Pinus* spp. volunteers, which were healthy and vigorous. Extrapolation from two plots in the West Cell resulted in an average of 420 planted trees per acre for this area. Planted trees and volunteer trees resulted in an extrapolated average of 1260 trees per acre.

Currently, this portion of site is meeting the mitigation success criteria. However, there is some concern about the continued survival of desired species in this cell. Recommendations for this site are to monitor the invasive plants over time and maintain them if needed. Secondly, a soil fertility test is recommended. The substrate appeared to be quite sandy, and given the poor health of the planted trees, may be lacking in nutrients. The site would probably benefit from the addition of more planted trees.
