Carteret-Craven Electrical Cooperative Wetland Restoration Morehead City, Onslow County, North Carolina

Year 4 of 5 Annual Monitoring Report 2005

December 2005

Carteret-Craven Electrical Cooperative (CCEC) Wetlands Restoration Site (Jumping Run Creek) Fall 2005 Monitoring Summary

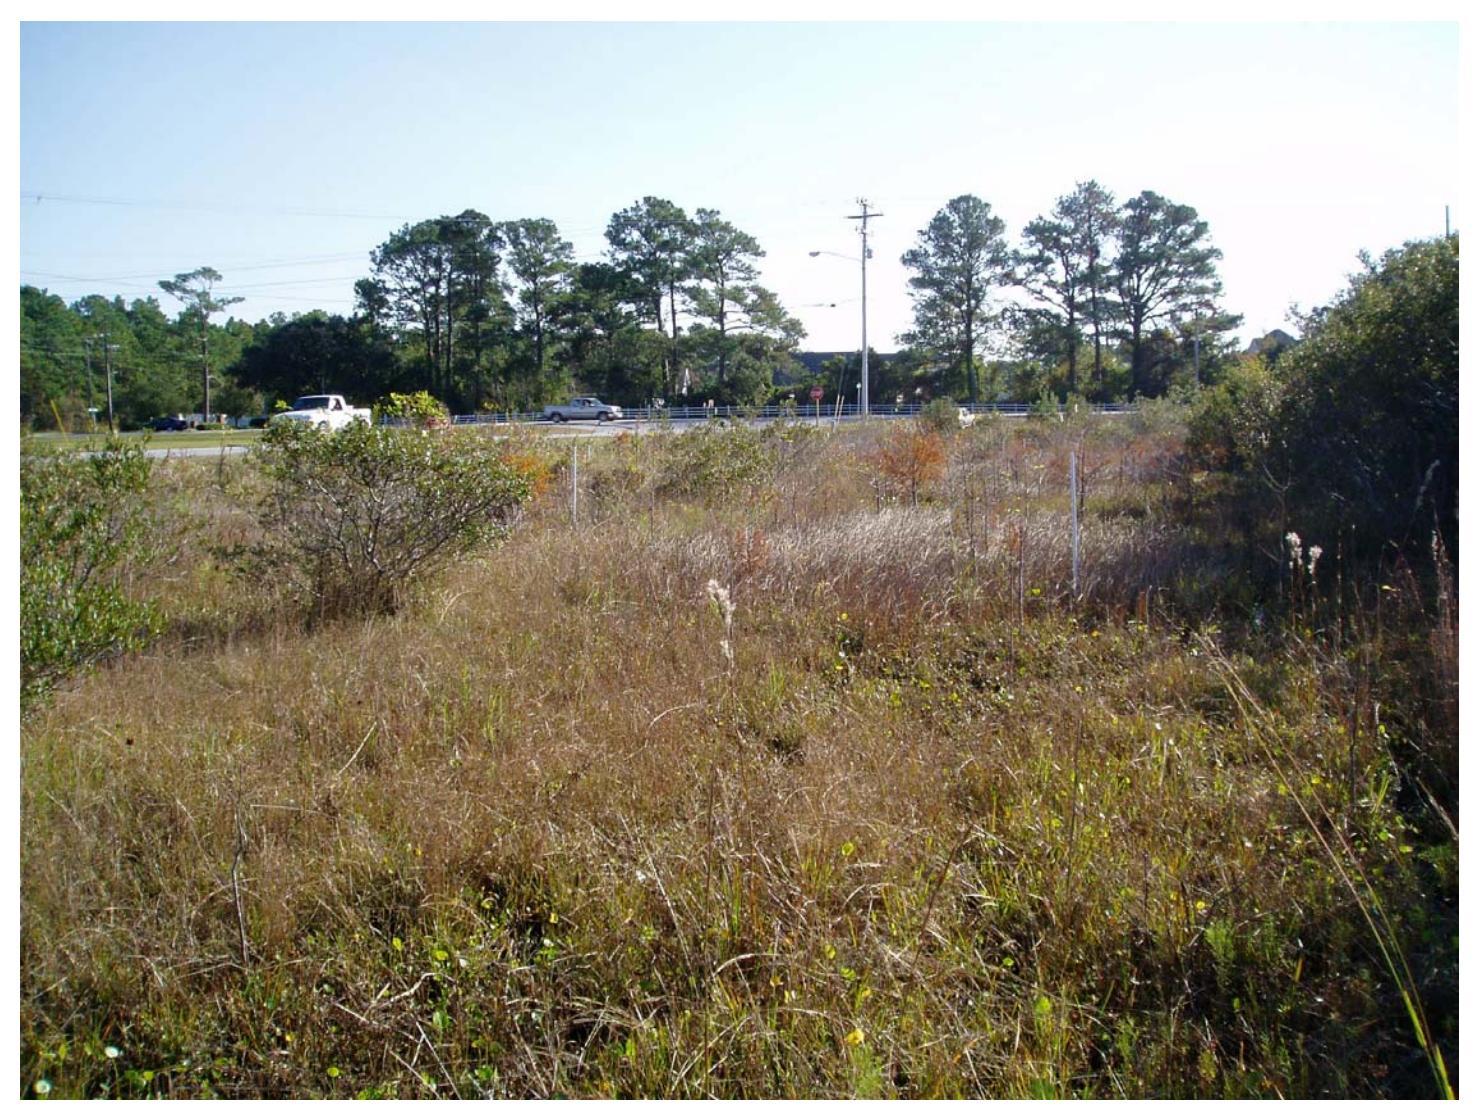
Invasive plant species on the site included *Mikania scandens* (climbing hempweed) and *Typha* spp. (cattails). Although not exotic, these plants can reduce diversity and growth of other plants. The climbing hempweed covered nearly every shrub and tree in this cell. This vine appeared to strangle smaller shrubs and cause irregular growth in the trees. Cattails appeared to be spreading into the east cell. An isolated patch was observed in 2004, along an outfall area near the road, which now seems to be expanding. The climbing hempweed does not seem to be currently prohibiting growth of trees so far and cattails are not endangering tree populations.

Photo 1. East Cell and Plot

The east cell is currently meeting the requirements of vegetative success at this site. Recommendations for this site are to monitor the invasive plants over time and treat or remove them if needed. Overall, this portion of the site has a healthy, diverse vegetative population.

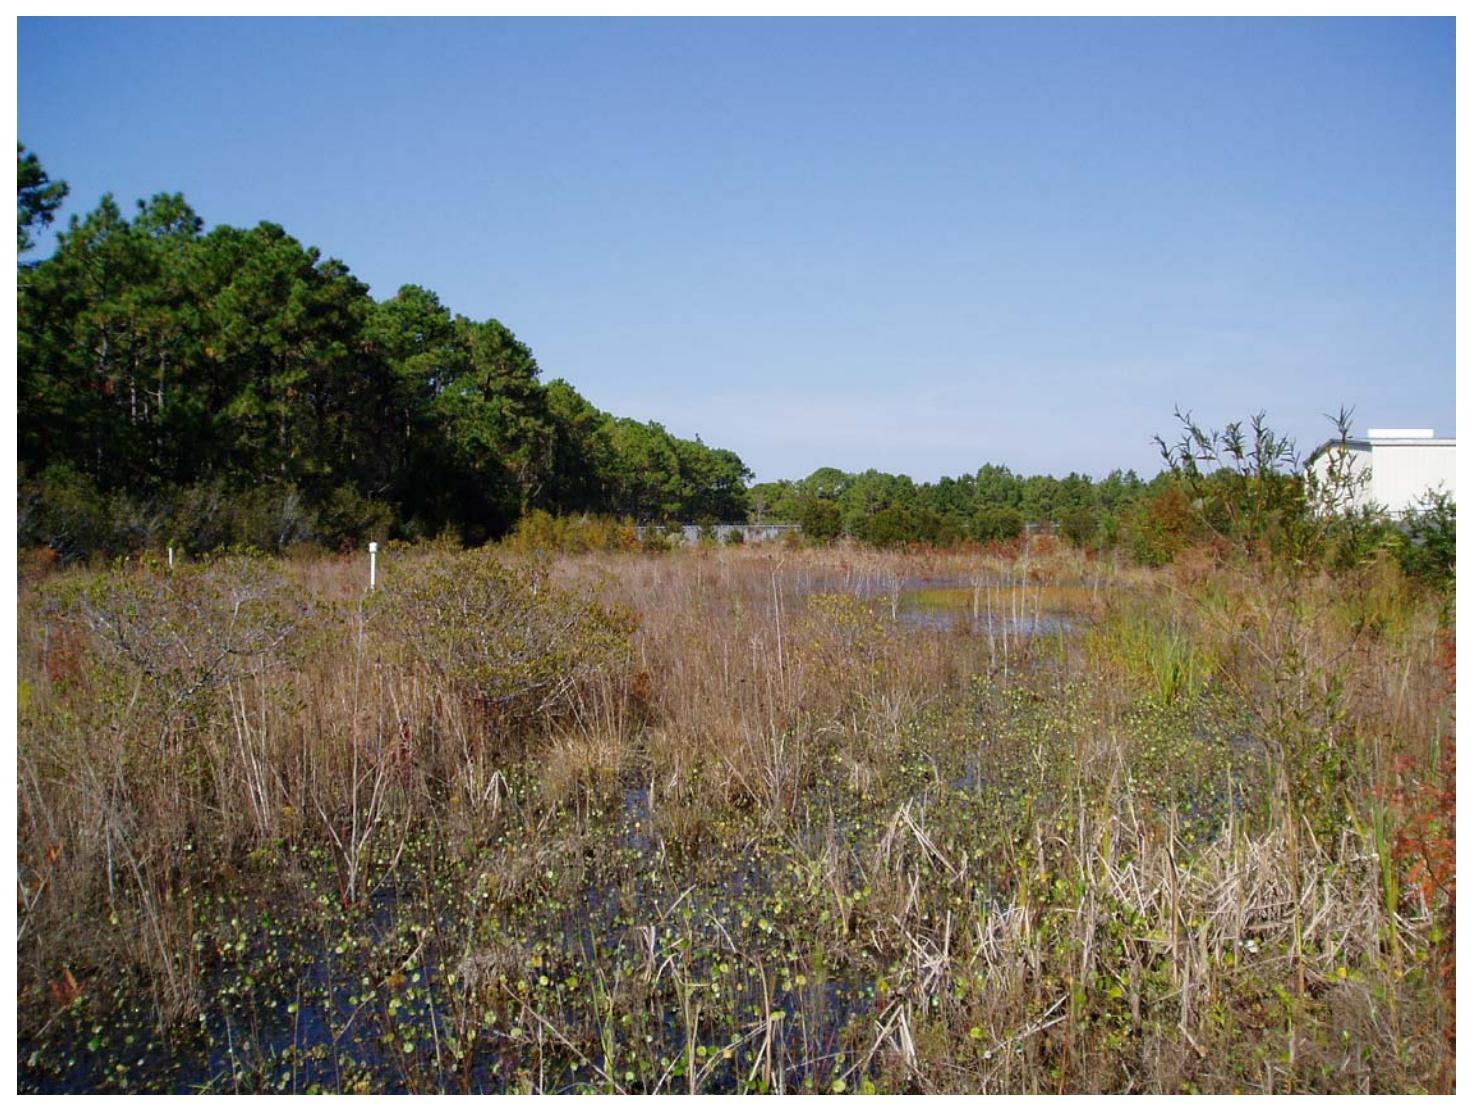
Photo 2. Upper West Cell and Plot

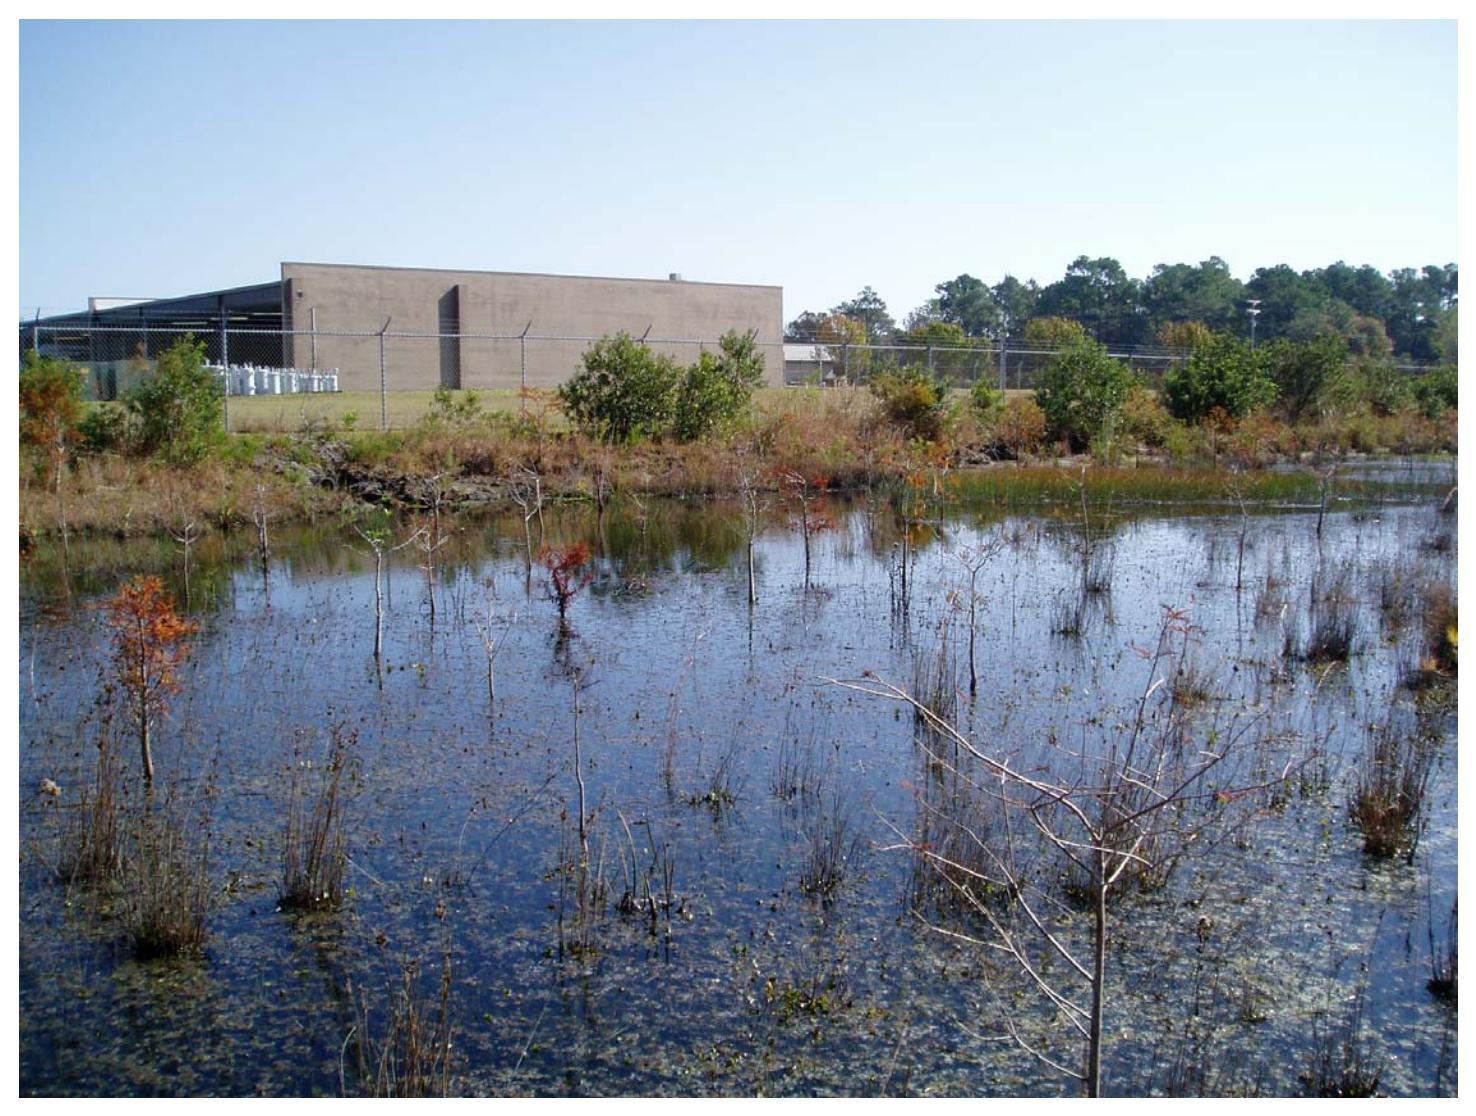
Planted trees on this site included predominantly bald cypress, water tupelo, and *Fraxinus pennsylvanica* (green ash). The recently planted trees appear to be in good shape, however, older trees are struggling. Mortality of older trees was noted. Some trees, planted in dryer areas are growing very well (Photo 4).

Table 9. Vegetative Problem Areas			
Location/Issue	Location	Probable Causes	Photo #
Invasive populations	East Cell	Hempweed intrusion Cattail intrusion	None available
Bare areas	West Cell	Tree mortality Sandy soil Excessive saturation	3

Photo 3. West Cell - above weir

Recommendations for this site are to monitor the invasive plants over time and treat or remove them if needed. Secondly, a soil fertility test is recommended. The substrate appeared to be quite sandy with no nutrients; a possible explanation for poor health of the planted trees, particularly in the area above the weir.

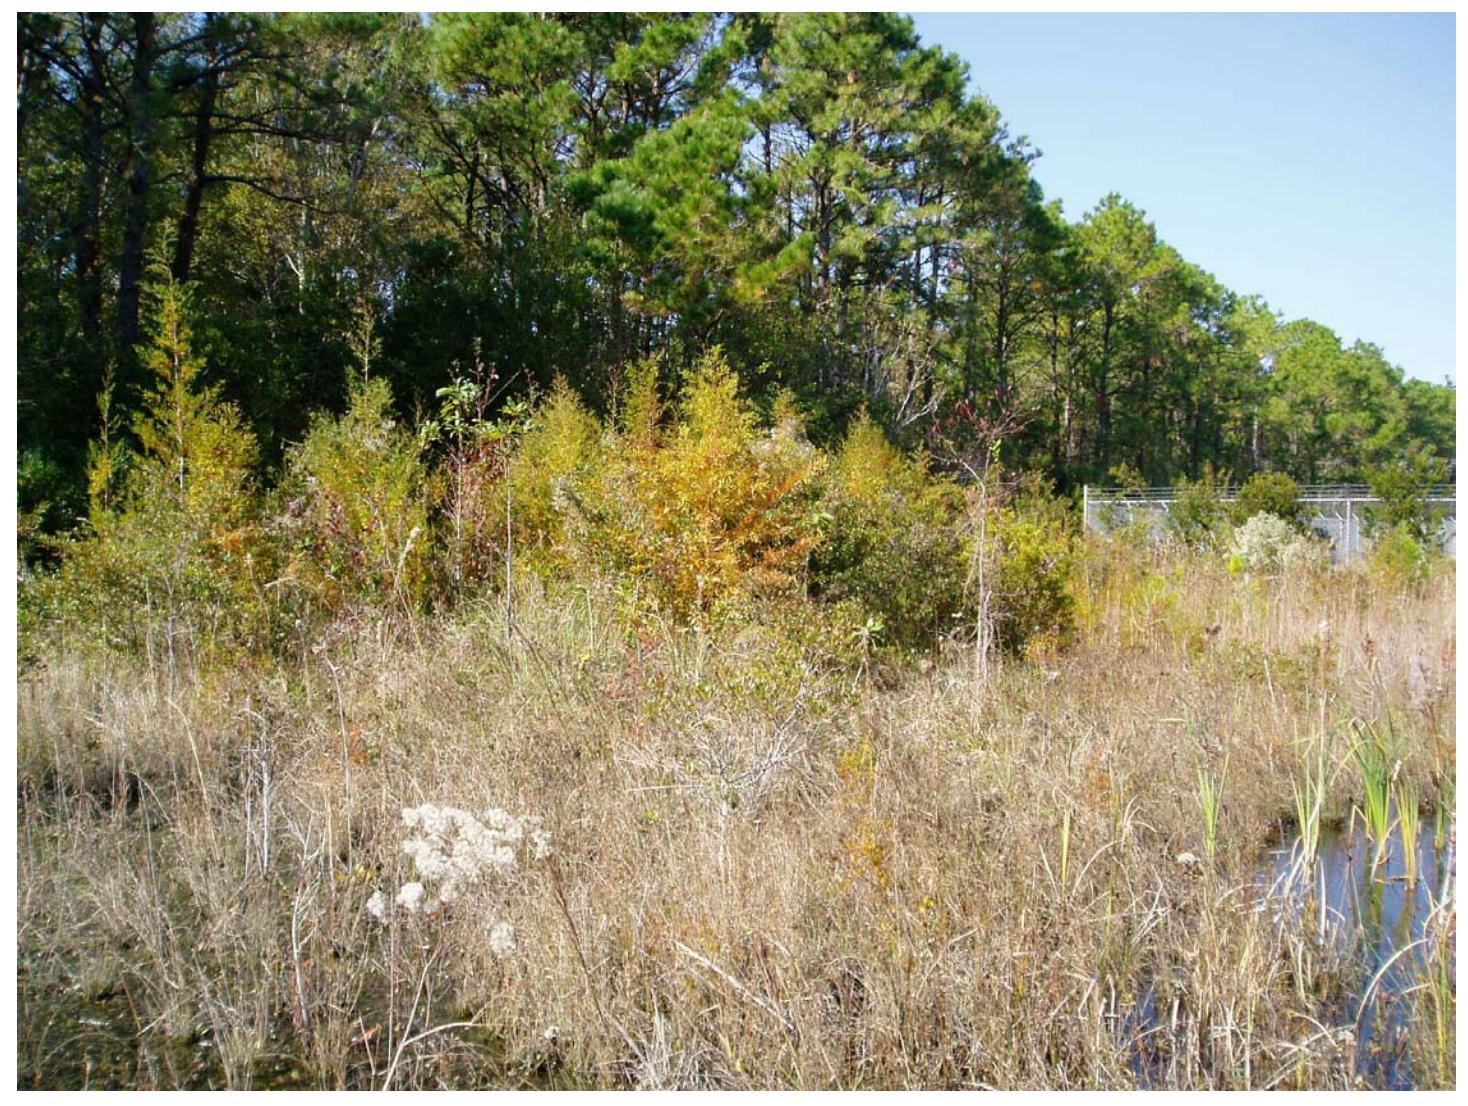
Photo 4. West Cell – Good trees in a high area.
