## MORGAN CREEK FLOODPLAIN RESTORATION SITE #258 Mason Farm Biological Reserve – UNC-Chapel Hill – Orange/Durham Co. Cape Fear River HUC# 03030002-060080

### MY-5 (2015) ANNUAL MONITORING REPORT (Final)

#### North Carolina Department of Environmental Quality Division of Mitigation Services (DEQ-DMS) -- Contract # 16-005217

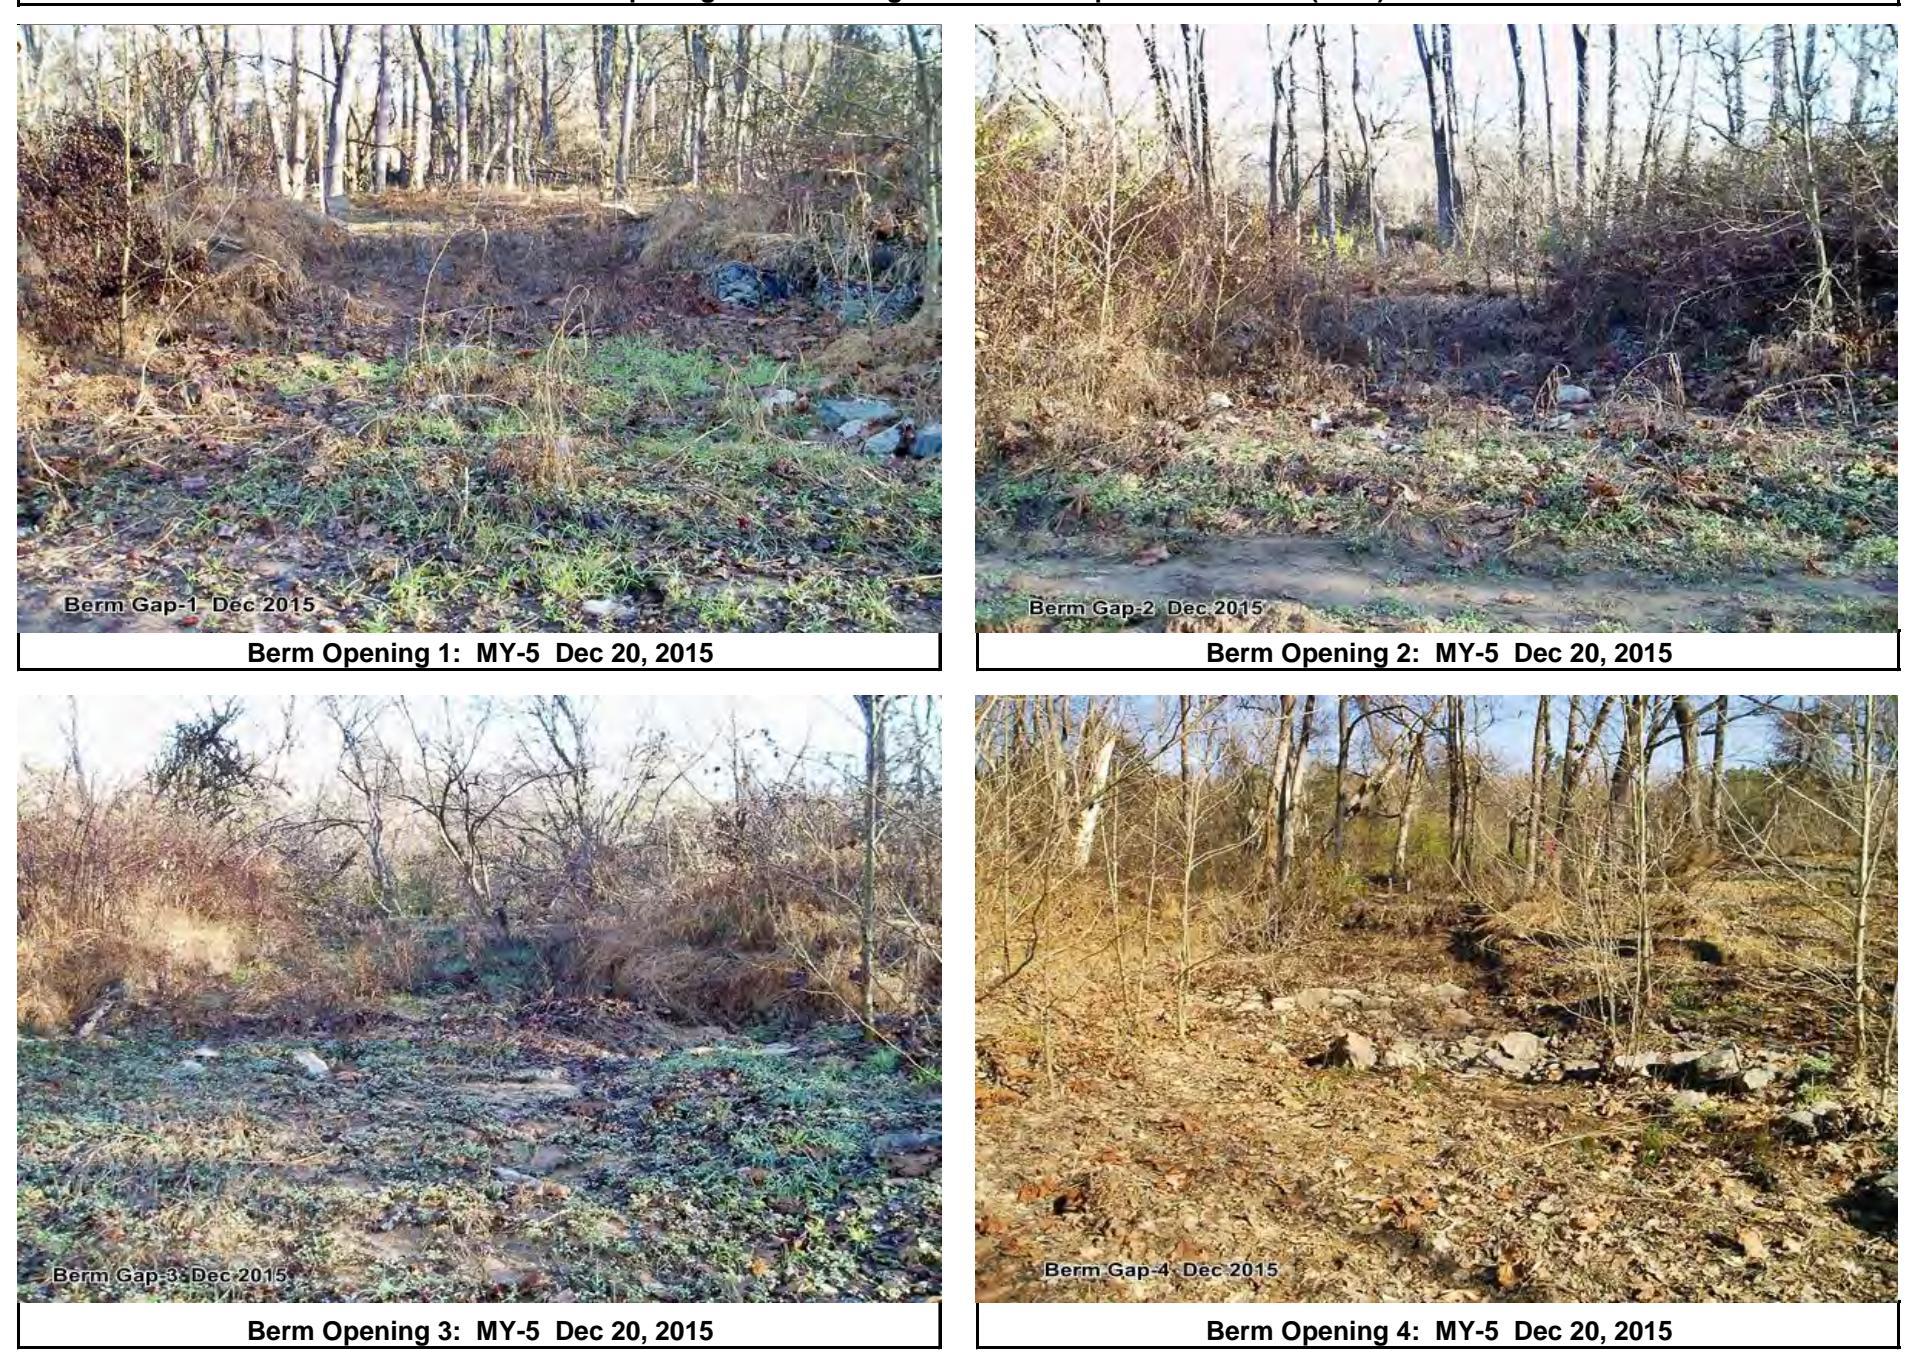
The berm gaps appear to have conveyed flow from Morgan Creek into the floodplain during at least five storm events in 2015 (Mar 5, Apr 19, Oct 2, Nov 9, and Nov 19) as documented in Table 8 and the stream gauge data included in Appendix D support files. October 2 had the highest recorded stage at the USGS gauge, and cork levels recorded on the berm gap crest gauges were probably deposited on this date. Peak water depths through the berm gaps in 2015 based on crest gauge measurements ranged from 0.7 to 2.7 feet. The berm gap erosion problems reported in 2013-2014 were repaired in 2015, and all five openings are in good condition as of Dec 2015.

Berm Opening Photos - Morgan Creek Floodplain #258 - MY5 (2015)

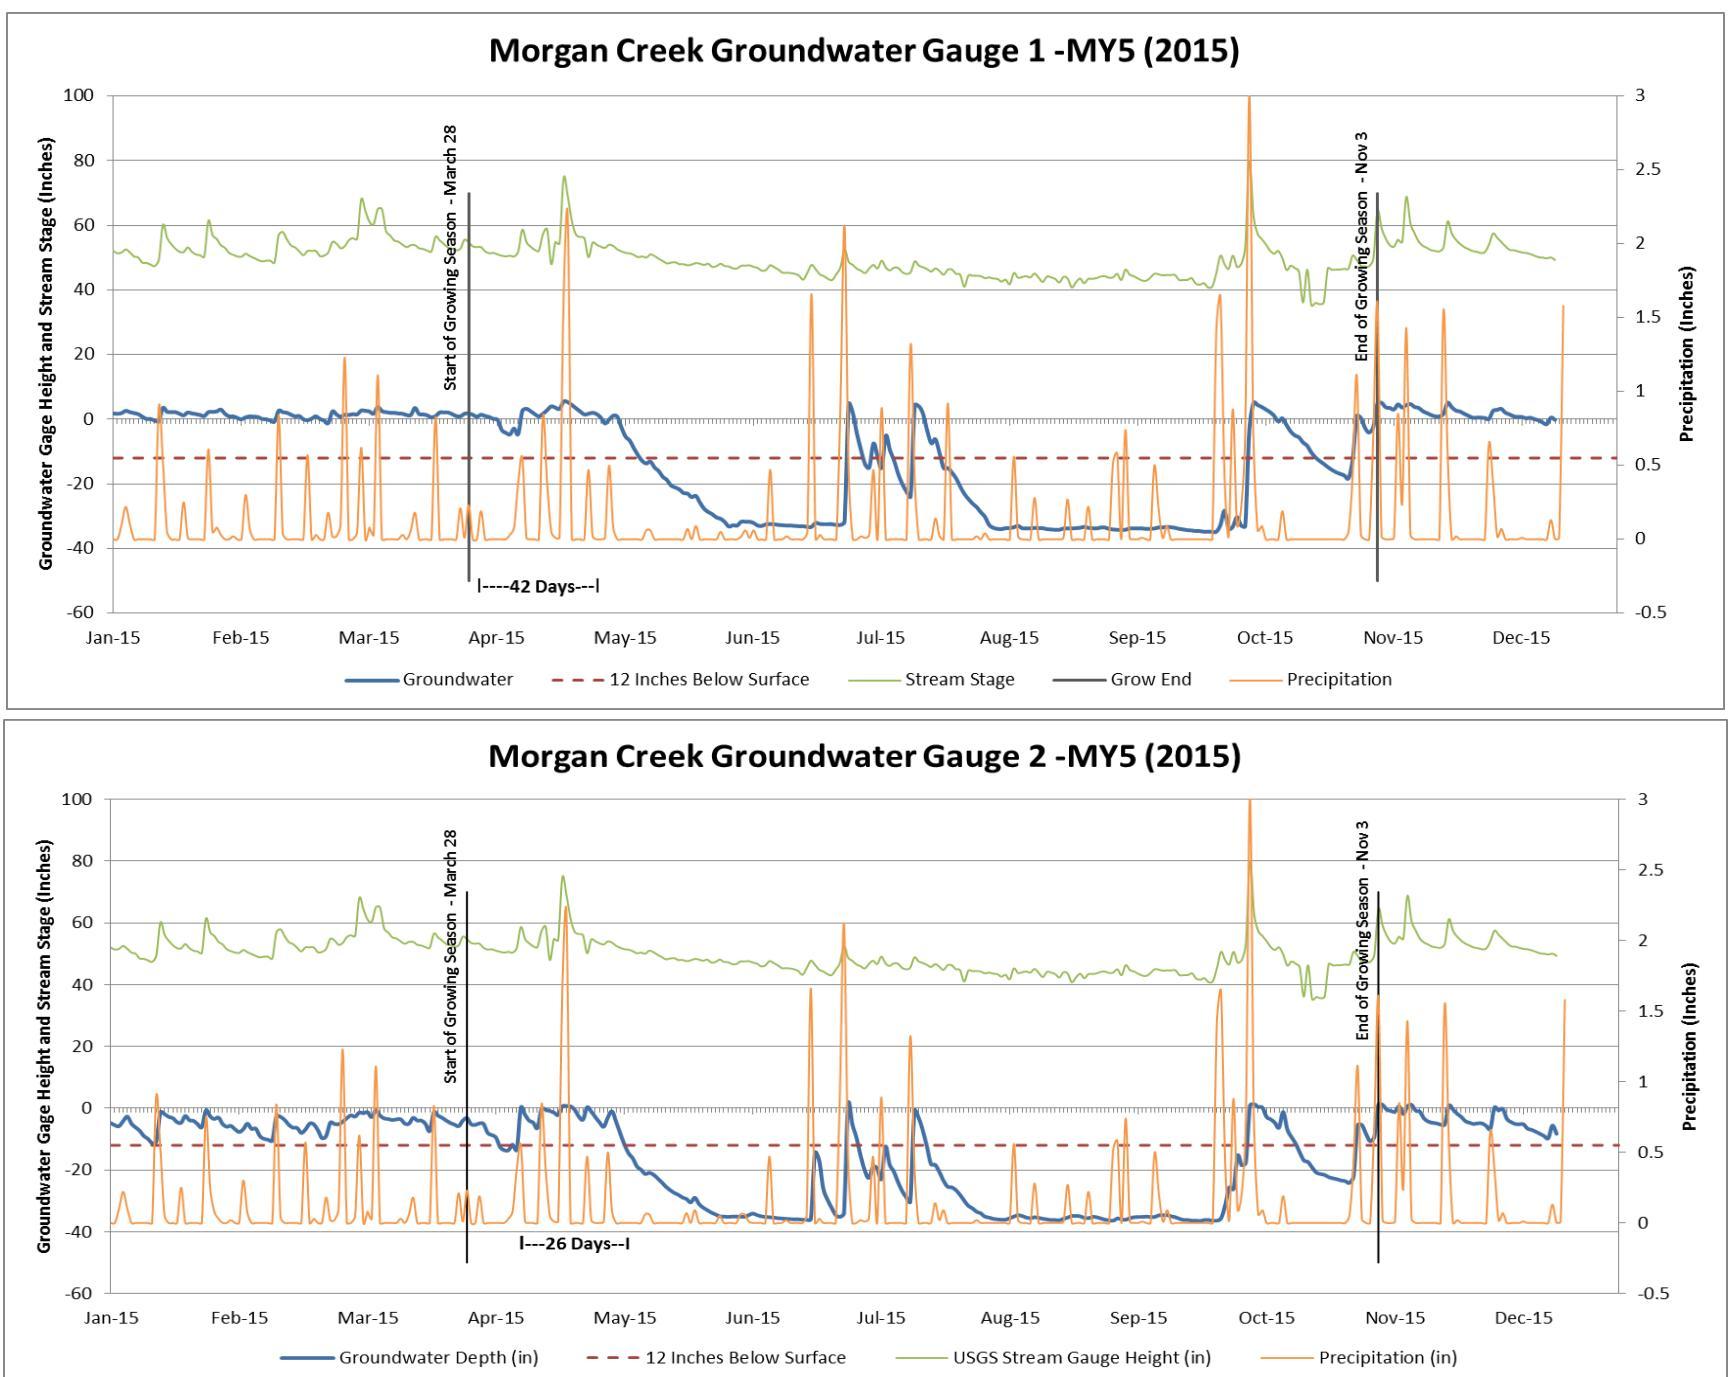
Figure 4.1. Groundwater Wells and Daily Precipitation Data, 2015 (MY5): Morgan Cr Floodplain Site #258.

Nine of the ten groundwater wells met their respective wetland hydrology success criteria in 2015 (Table 9). Only well #4 did not meet its criterion, missing the goal by only 2 days). Over the five year monitoring period (2011 to 2015), four of the five wells in Soil Unit #1 met their 27-day saturation criterion during 3 or more years. Of the five wells in Soil Unit #2 (11-day saturation criterion), well #3 succeeded during only 1 year, well #9 succeeded every year, and the new wells A, B, C all succeeded during their one year of monitoring. Daily precipitation data for 2015 were compiled from CoCoRaHS gauge # NC-DH-33 located at Meadowmont about one mile northeast of the project site.
