Subject: Year 5 Monitoring Report for Stream Mitigation of Thompsons Fork and UT; McDowell County, NC; SCO# D06030-A

# Year 5 Monitoring Report for Stream Restoration of Thompsons Fork and Unnamed Tributary

McDowell County, NC SCO # D06030-A

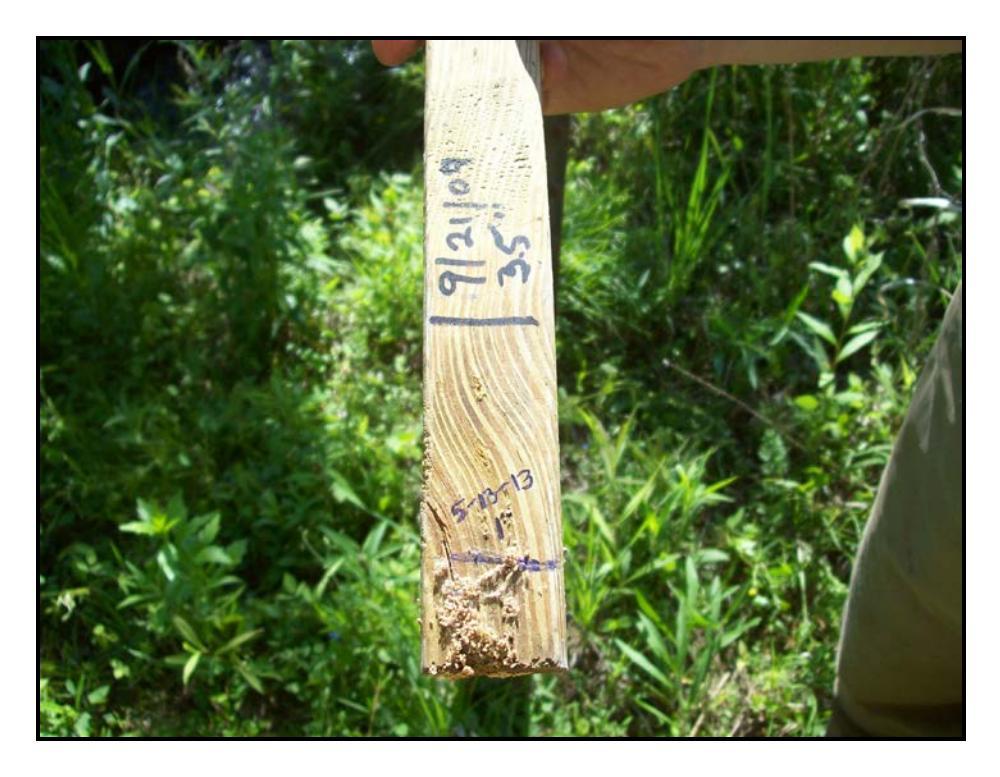
In May 2013, the crest gage on the UT was examined and determined to have experienced a bankfull event at a height of 1-inch above the bottom of the crest gage. In March 2013, the crest gage on the main stem of Thompsons Fork documented a bankfull event, at a height of 6 1/2-inches above the bottom of the crest gage. The most likely date for the monitoring year 5 bankfull event along the main stem was in association with the rain event(s) that resulted in the peak stage and discharge on January 30 and 31, 2013, as recorded at USGS Gage 02138500 Linville River at Nebo, NC. The most likely date for the monitoring year 5 bankfull event along the UT was in association with the rain event(s) that resulted in the peak stage and discharge on May 6, 2013. The discharge and gage height recorded at the Nebo station for these two events are indicated on the graphs provided on the following page.

BF 3 Crest Gage at XS-6 on UT (Year 5). (EMH&T, 5/13/13)

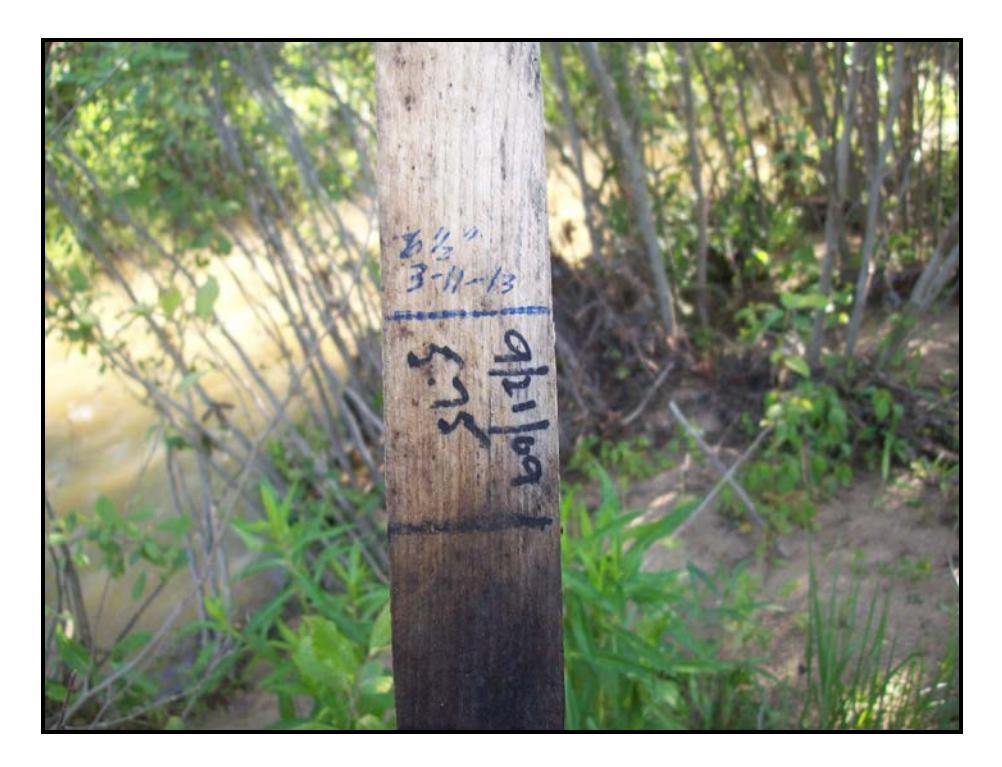
BF 6 Crest Gage at XS-7 on Mainstem (Year 5). (EMH&T, 3/11/13)

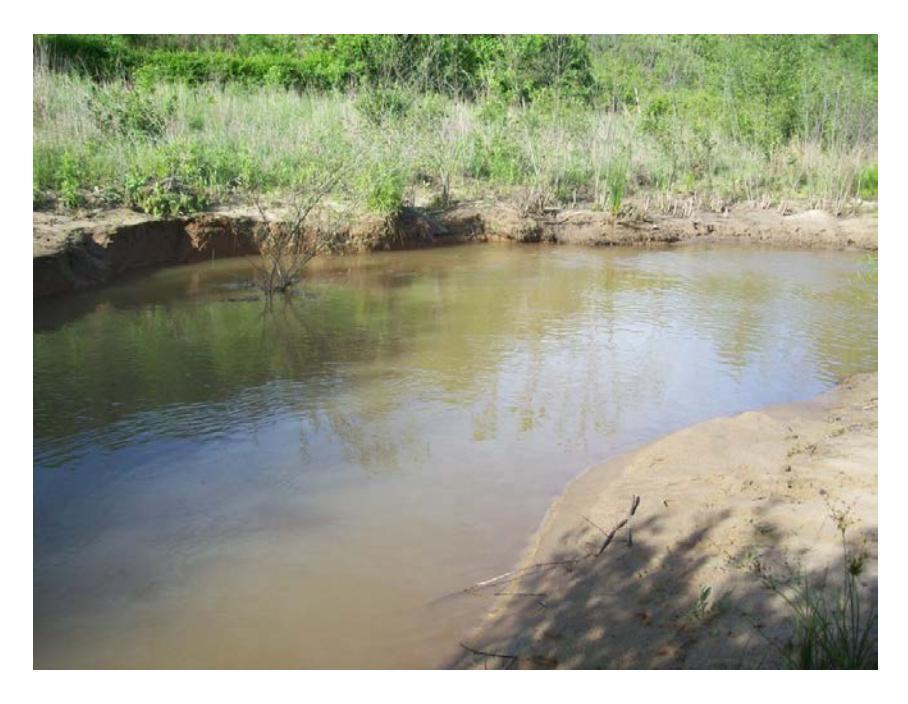
A summary of the areas of concern identified during the visual assessment of the stream for Year 5 is included in Table X. Stream problem area photos and a problem area map are included in Appendix B. In 2013, stream problem areas for Year 5 are located again at 3 different stations along the main stem of Thompsons Fork. All problem areas for 2013 are again scour and bank failure issues. The observed erosion and scour at stations 23+50 and 21+50 are the result of a beaver dam that was constructed in the spring of 2013, respectively. Even though the dam was again deconstructed within a few months of being built, significant scour and erosion resulted on both the right and left banks at these stations. It is likely that high flow events created excessive erosional flow around the sides and top of each dam.

SPA 1 Scour along left and right bank of Thompsons Fork Mainstem at station 23+50; caused by a beaver dam that was created and subsequently deconstructed in early spring, 2013. (EMH&T, 5/13/13)

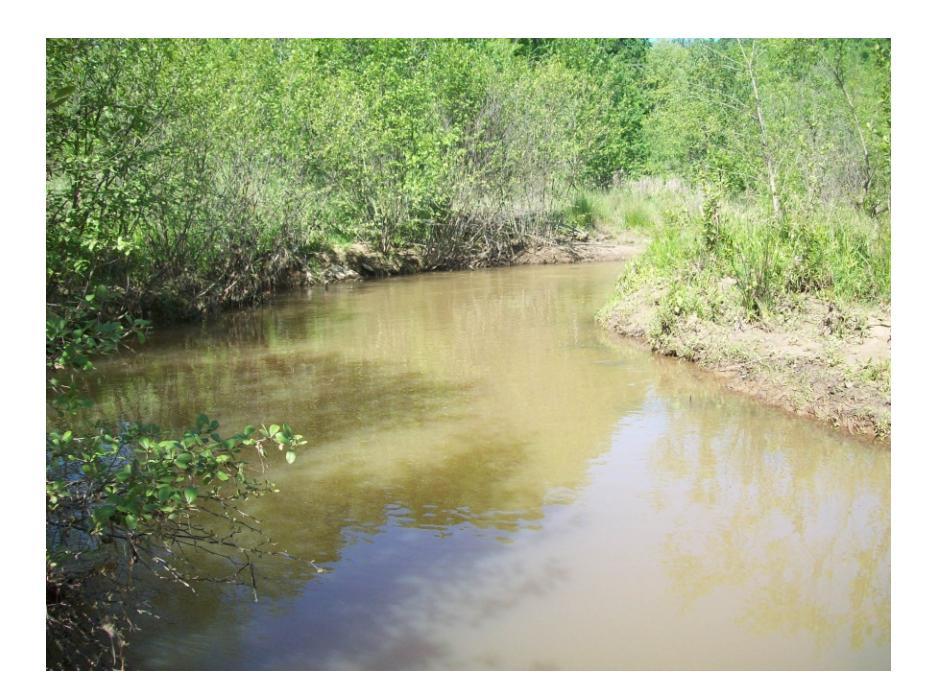
SPA 2 Scour along left and right bank of Thompsons Fork Mainstem at station 21+50; caused by a beaver dam that was created and subsequently deconstructed in early spring, 2013. (EMH&T, 5/13/13)

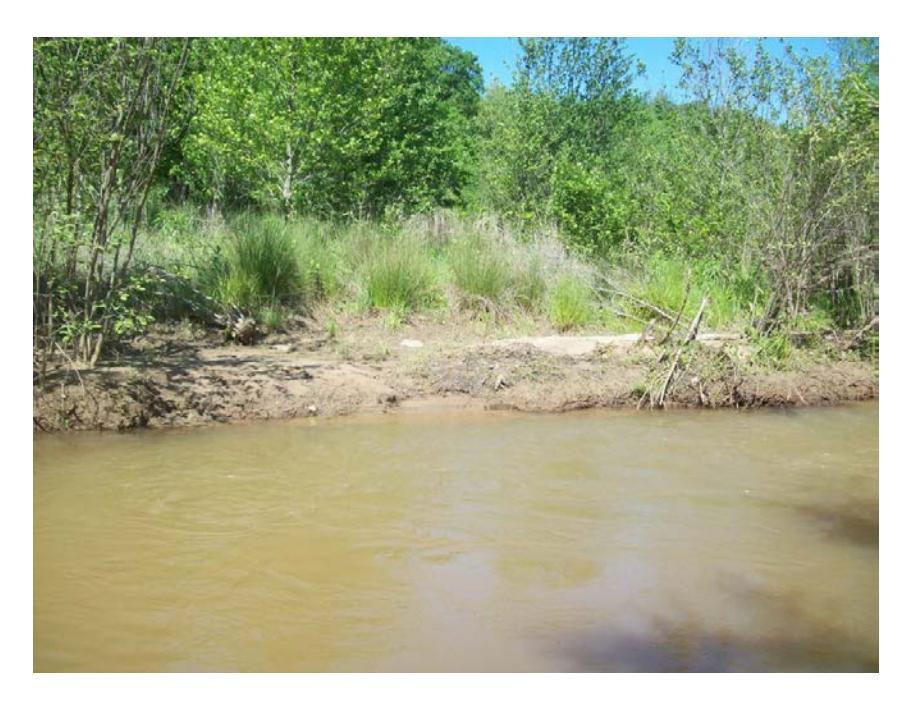
In Year 5 bank erosion has also observed on the right bank of a meander bend at station 20+75 on the main stem. It appeared that the sloughing in this area was also caused by a high flow event. Pictures of the resultant erosion at these three stations are included in the stream problem area photos located within Appendix B. At this time, they are being called stream problem areas of low concern and are demarcated by yellow scour symbols on the Stream Problem Area Map in Appendix B. Plantings and bank stabilization occurred at all three stations in fall 2013. It is expected that the bank scour sloughing at these stations will be corrected once vegetation establishes on the newly exposed soil. During Year 5 monitoring, it was also observed that a small amount of wetland vegetation is infiltrating into the UT channel near station 8+00.

SPA 3 Scour and sloughing along the right bank of Thompsons Fork Mainstem at station 20+75. (EMH&T, 5/13/13)

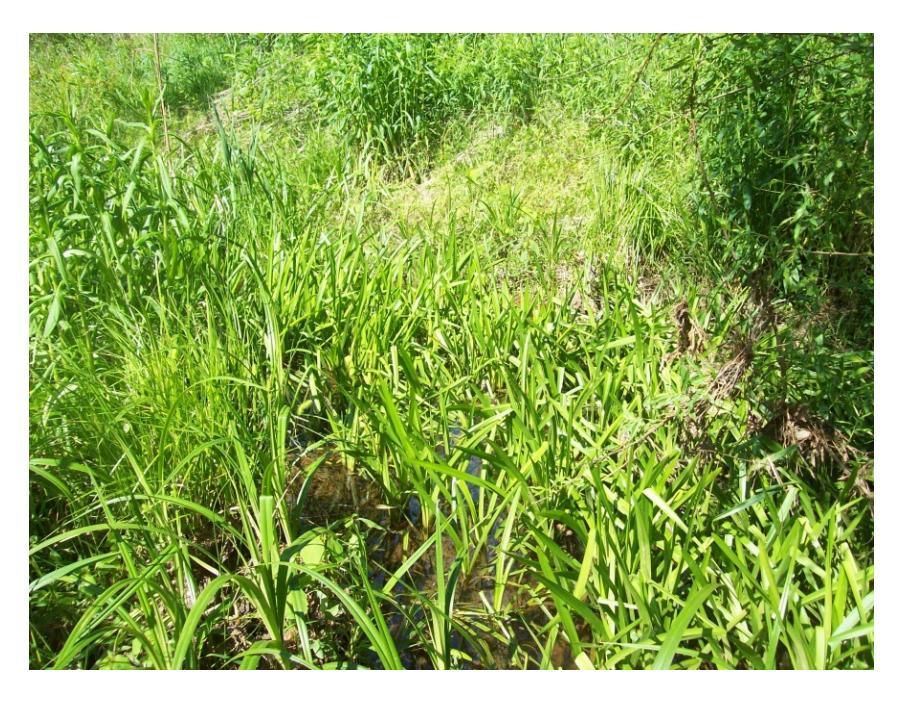
SPA 4 Infiltrating wetland vegetation within UT at station 8+00. (EMH&T, 5/13/13)
