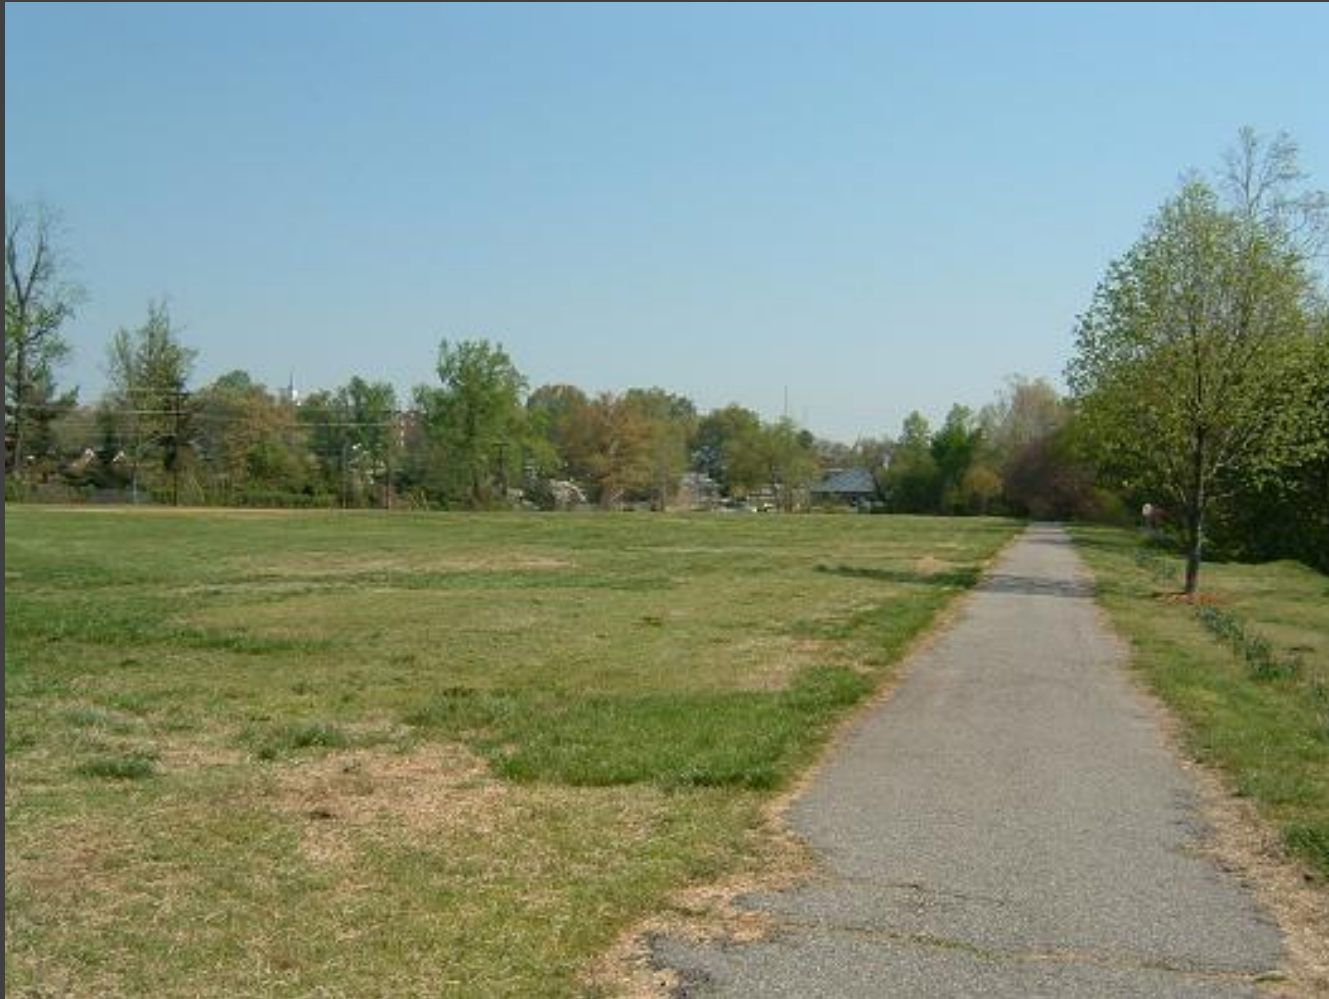
Before redevelopment, the soccer field was undulating.

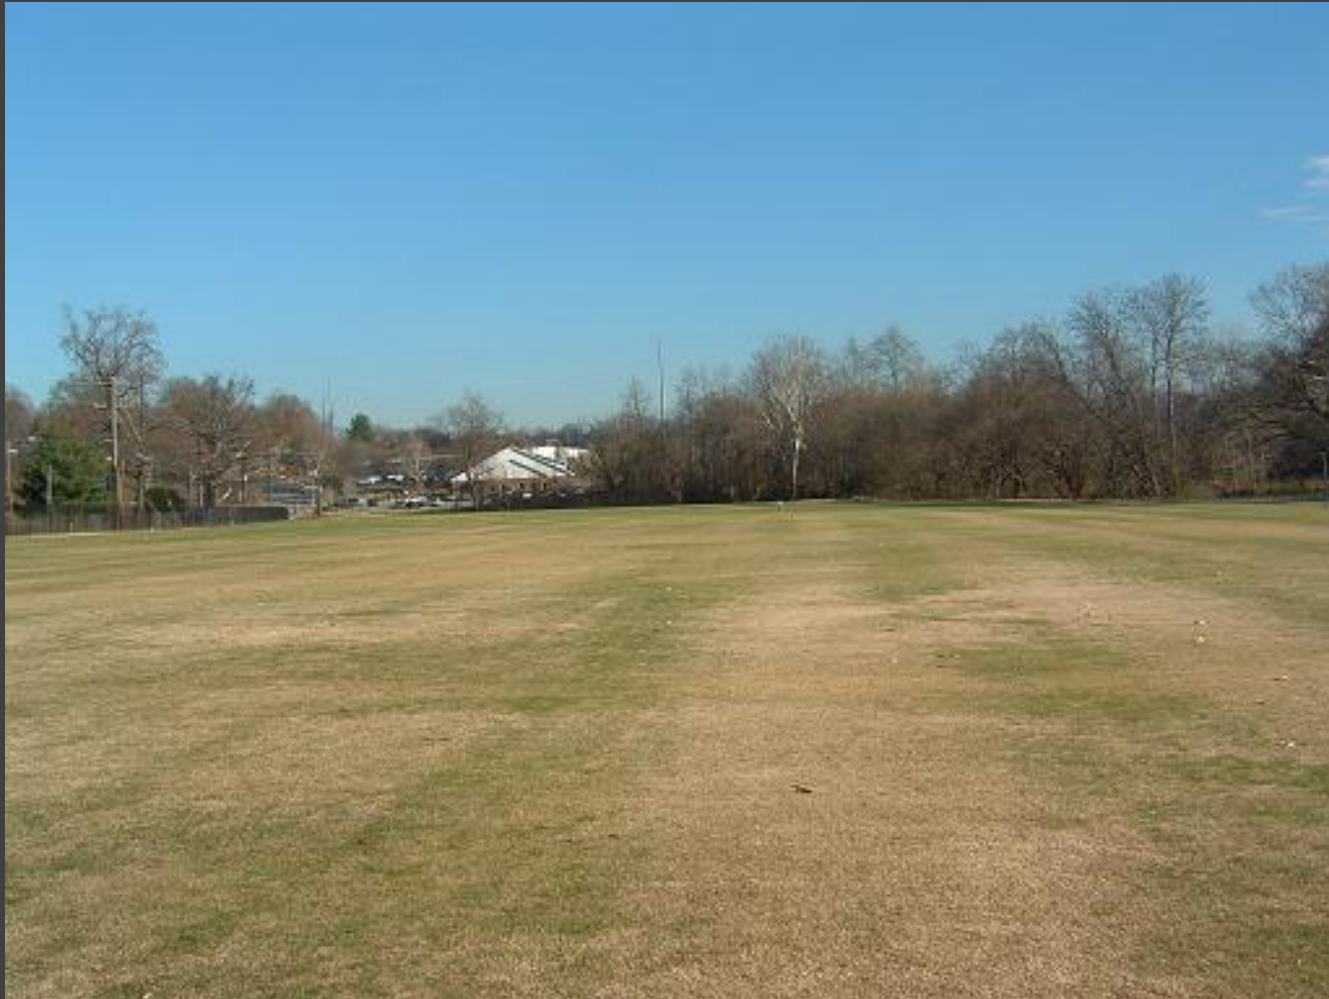
Basically the same view as the previous photo, after the surface has been smoothed and re-vegetated.

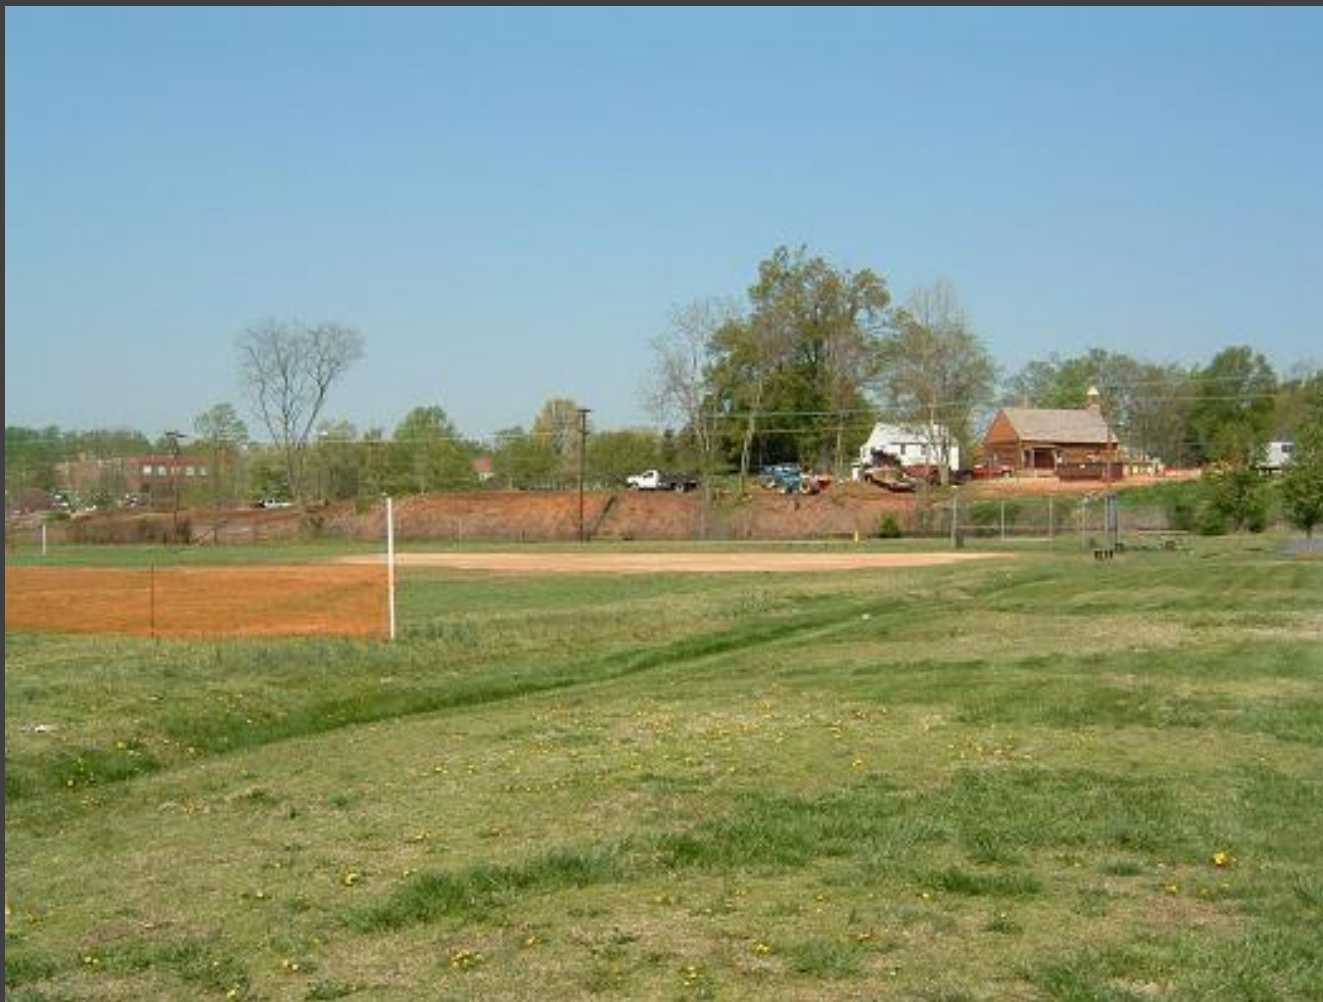
This is the way the ballfield looked prior to redevelopment; minimal seating and fencing around the uneven field. The infield and spectator areas were very basic.

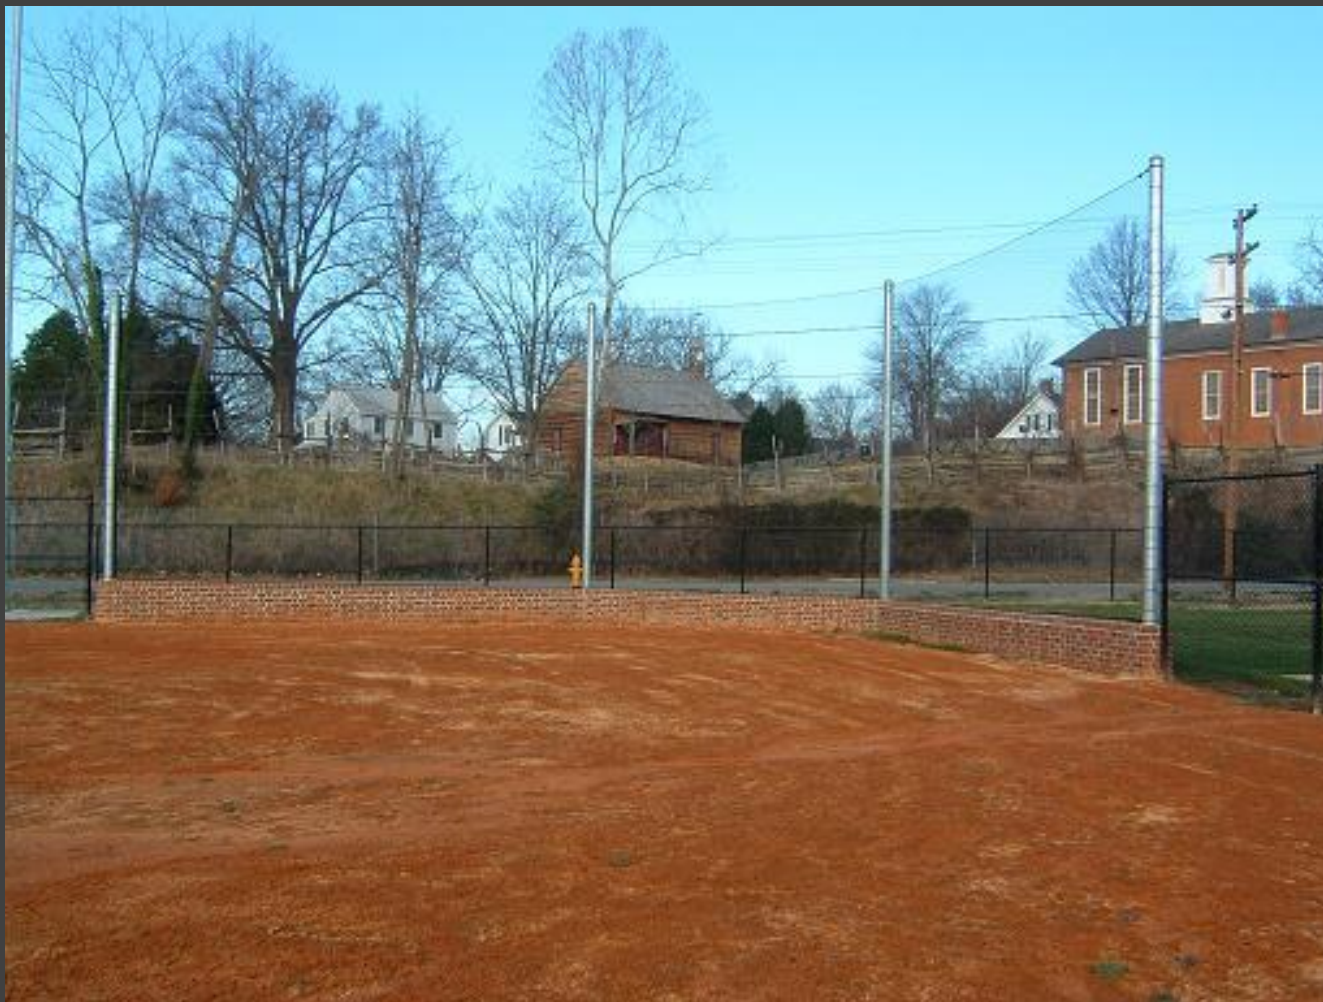
After redevelopment, the ball field has been upgraded. This photo also taken looking north, as was the previous photo.

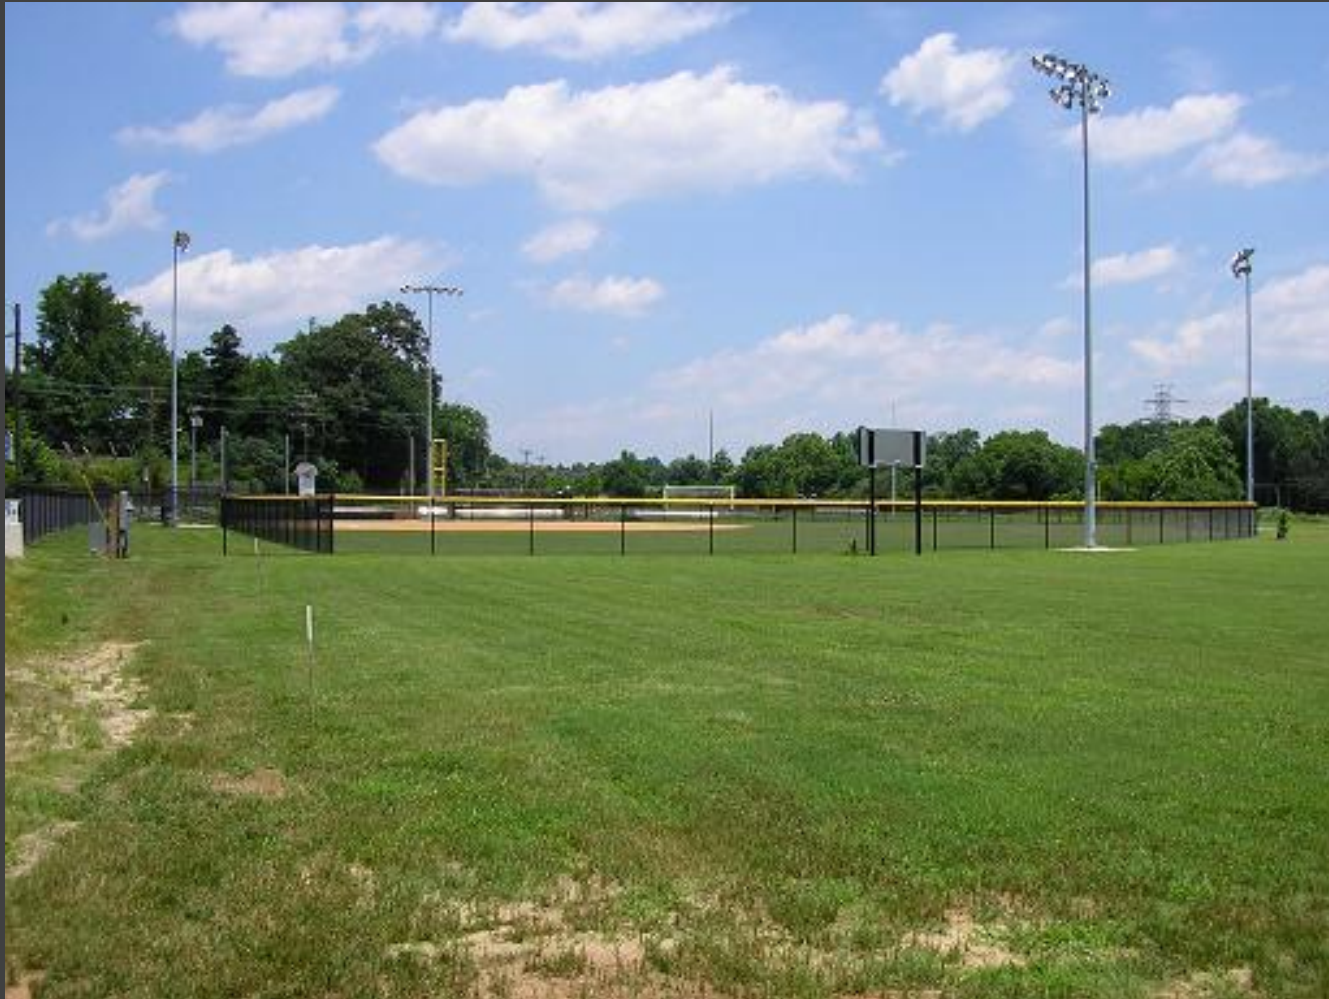
Another photo of the finished ballfield area.

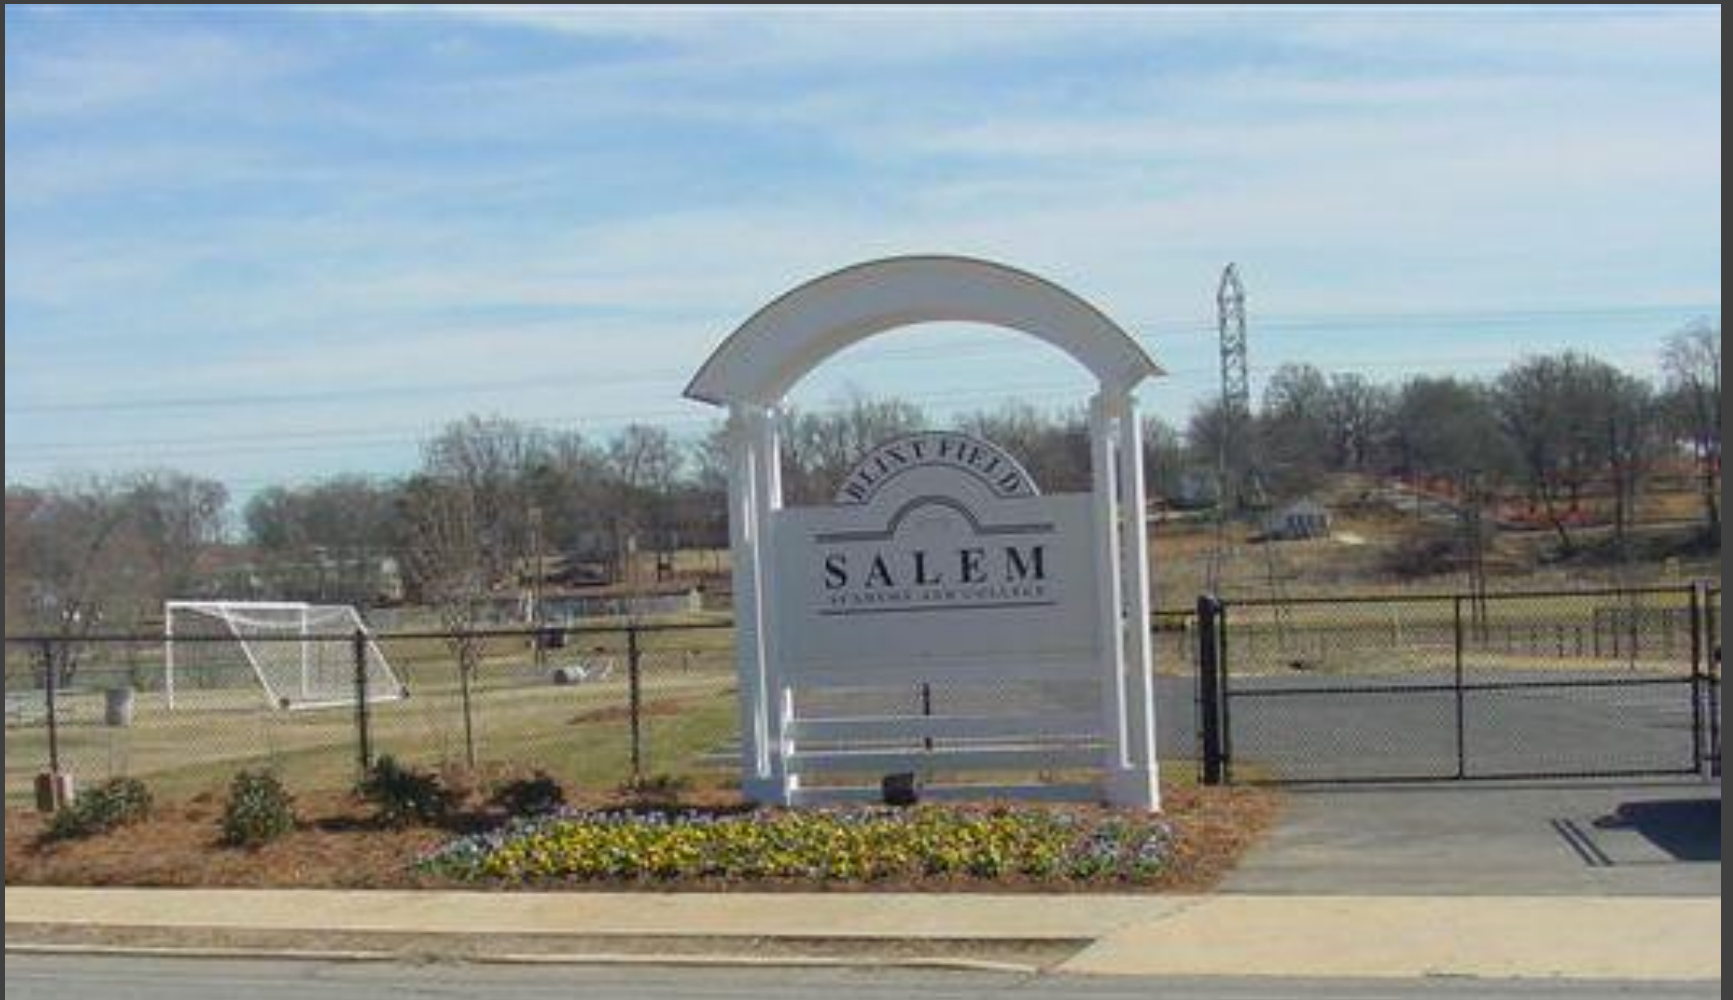
A sign and landscaping in front of the new fence surrounding the recreational fields.

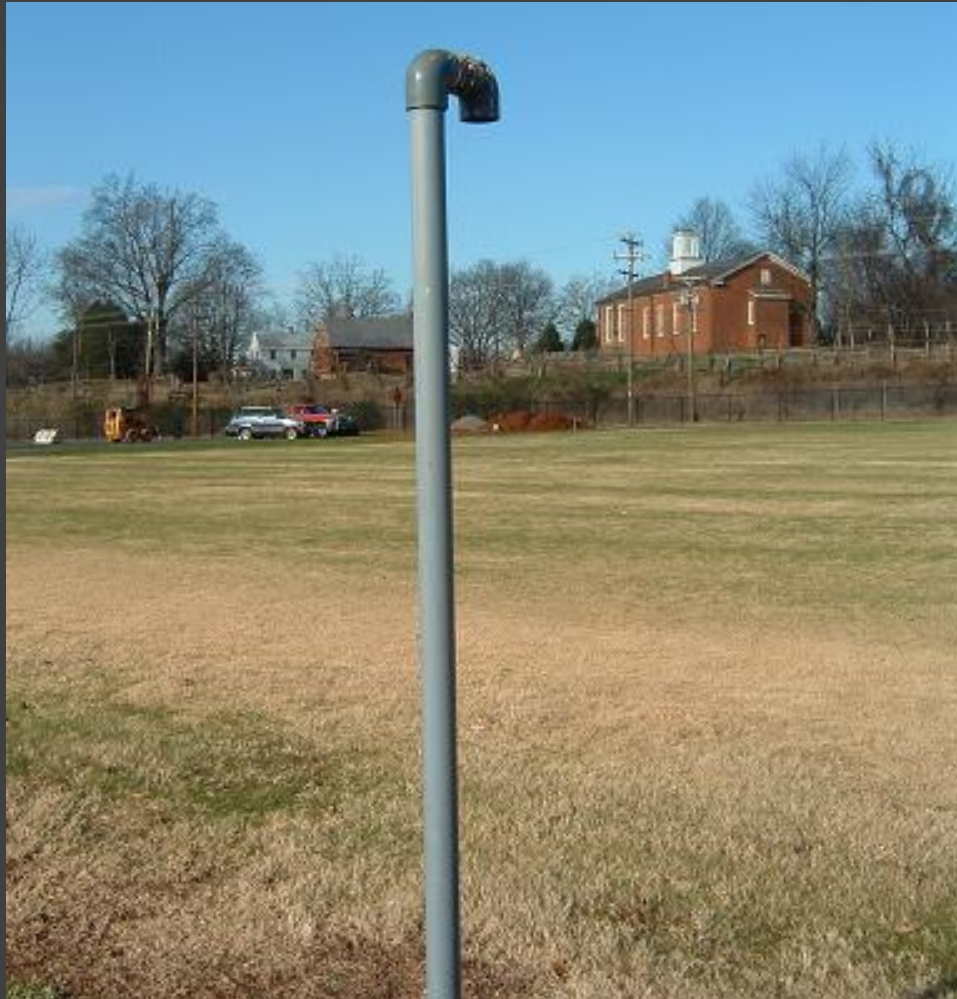
Passive methane vents were installed; final plans include vegetation and other protection around these pipes.
