# Annual Monitoring Report (MY4)

## BOSEMAN BUFFER MITIGATION SITE

Edgecombe County, NC  
NCDEQ Contract No. 7872  
DMS ID No. 100119  
DWR Project No. 2019-0800  
RFP No. 16-007711

December 2023

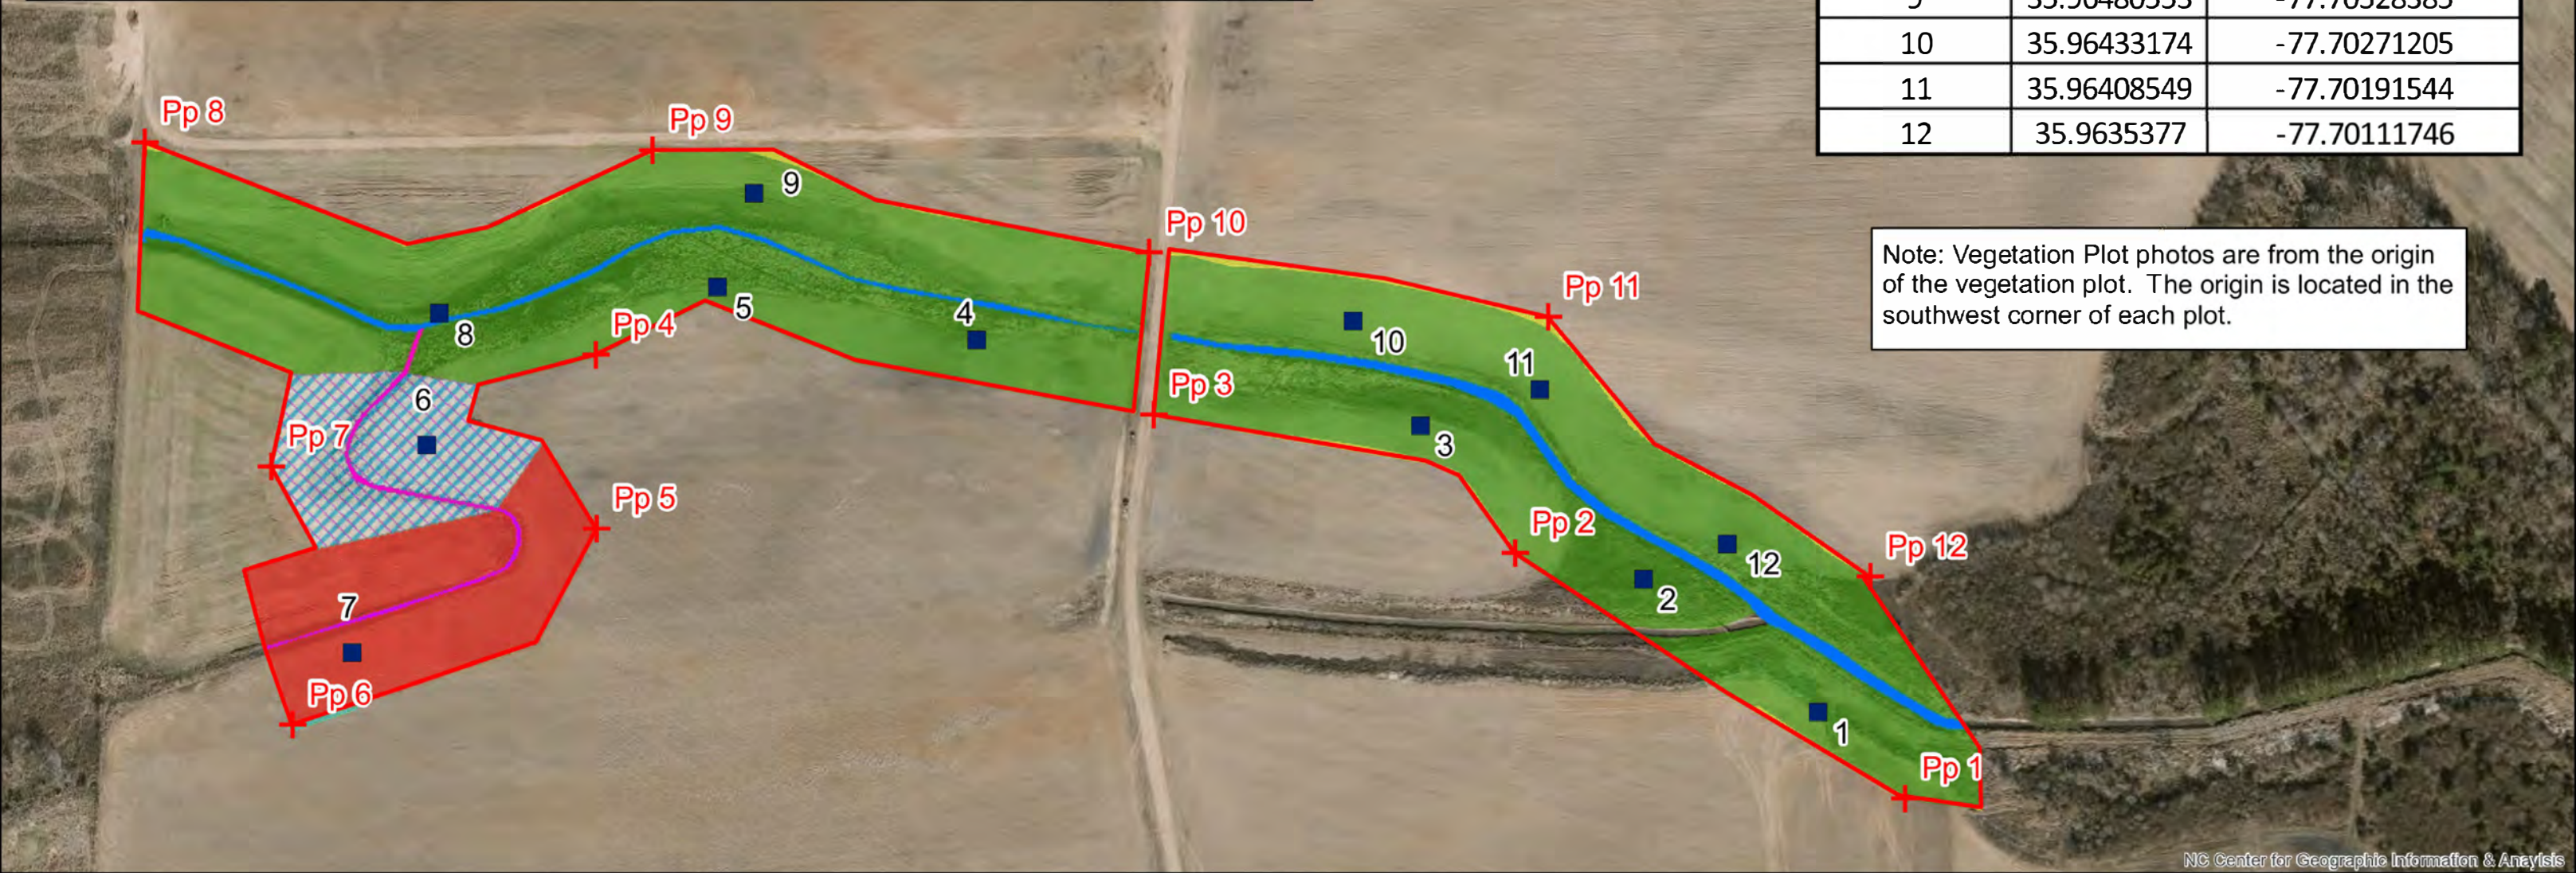
Figure 1

Current Condition Plan View  
 Boseman Buffer Mitigation Site  
 Annual Monitoring Report (MY4)  
 Tar-Pamlico 03020101  
 Edgecombe County, NC  
 December 2023  
 2017 Aerial from NCOneMap

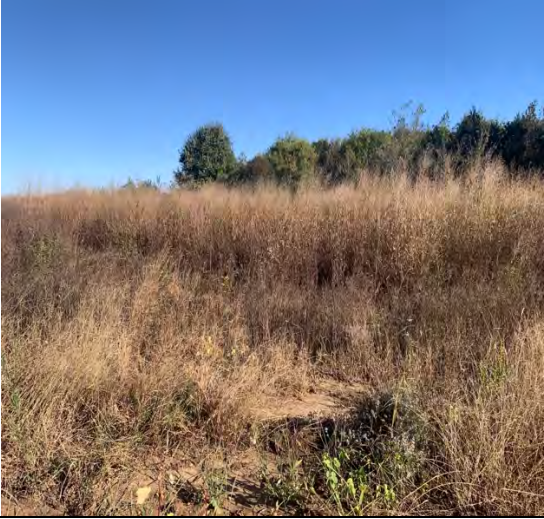
| | MY2<br>11/2021 | MY1<br>12/2020 |
|---|---|---|
| <b>Photo #1</b><br>Date: 10/23/2023<br>Feature: Photo Station 1<br>Direction: Northeast | | |

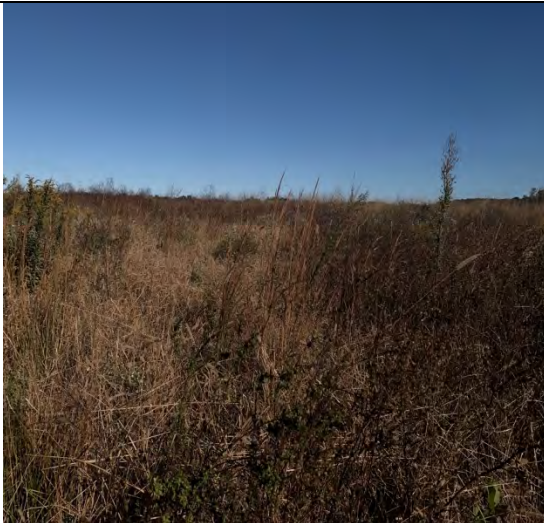
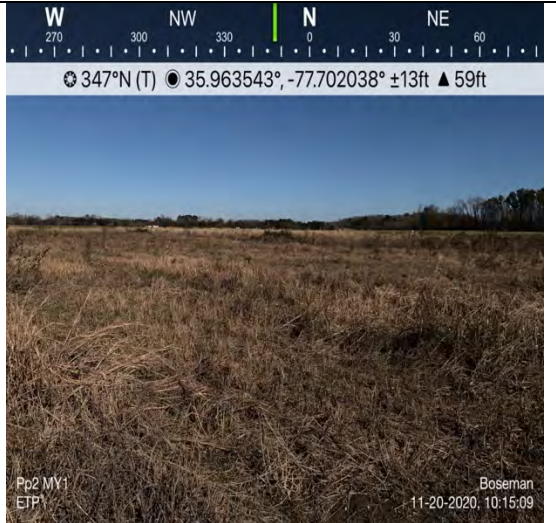
| | MY2<br>11/2021 | MY1<br>12/2020 |
|---|---|---|
| <b>Photo #2</b><br>Date: 10/23/2023<br>Feature: Photo Station 2<br>Direction: North | | |

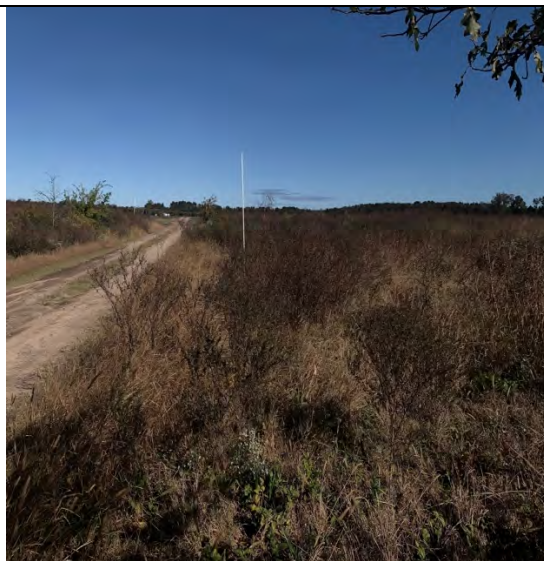
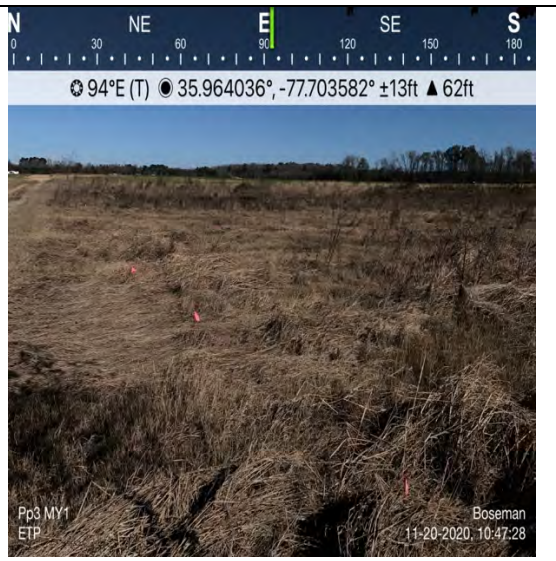
| | MY2<br>11/2021 | MY1<br>12/2020 |
|---|---|---|
| <b>Photo #3</b><br>Date: 10/23/2023<br>Feature: Photo Station 3<br>Direction: East | | |

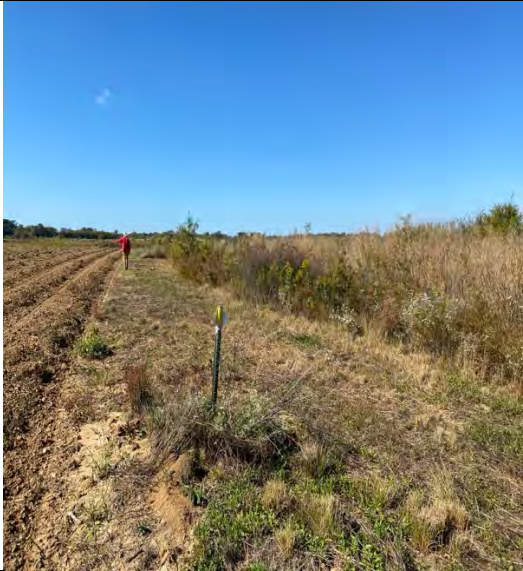
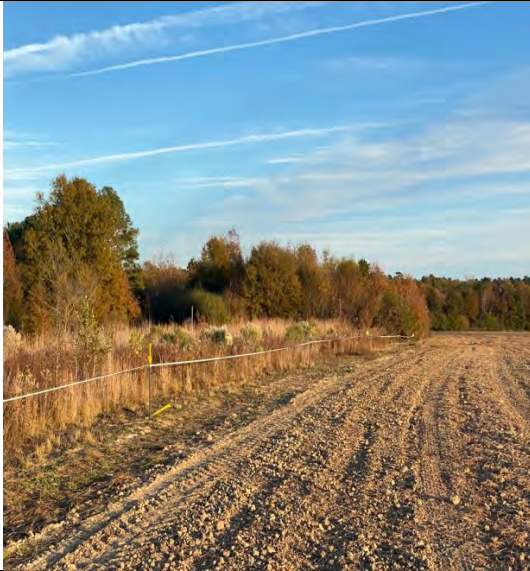
The landowner mowed into the conservation area immediately prior to the vegetation monitoring. The incursion is noted in the Appendix 2; Site Photos. Additional t-posts and conservation markers were placed along the perimeter at the three areas noted. In addition, the landowner was notified verbally of his incursion. No trees were mowed or otherwise injured by this incursion.

| MY4<br>Encroachment | | MY4<br>Updated Marking | |
|---|---|---|--|
| <div>Photo #2</div> <div>Date: 10/27/2023</div> <div>Feature: Near PP 1</div> <div>Direction: West, East</div> | | | |

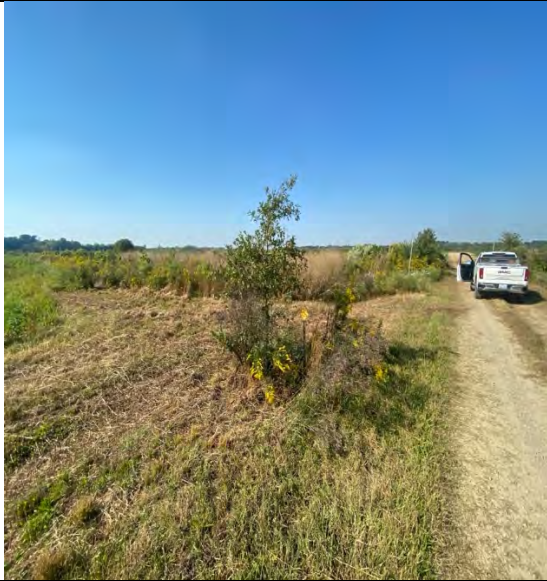
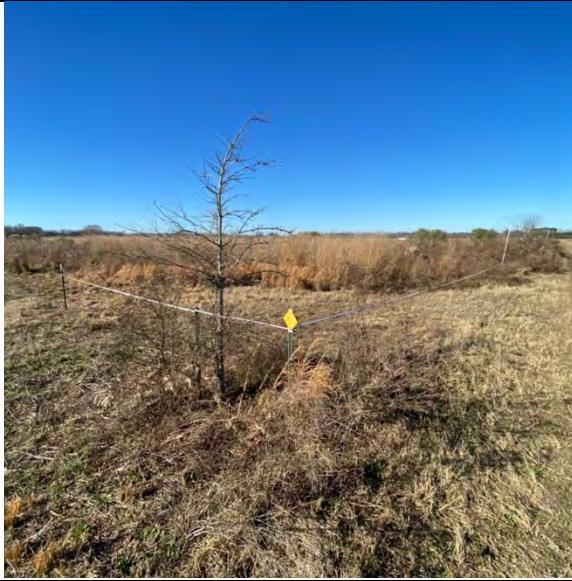
| MY4<br>Encroachment | | MY4<br>Updated Marking | |
|---|---|---|--|
| <div>Photo #3</div> <div>Date: 10/27/2023</div> <div>Feature: at PP3</div> <div>Direction: North</div> | | | |

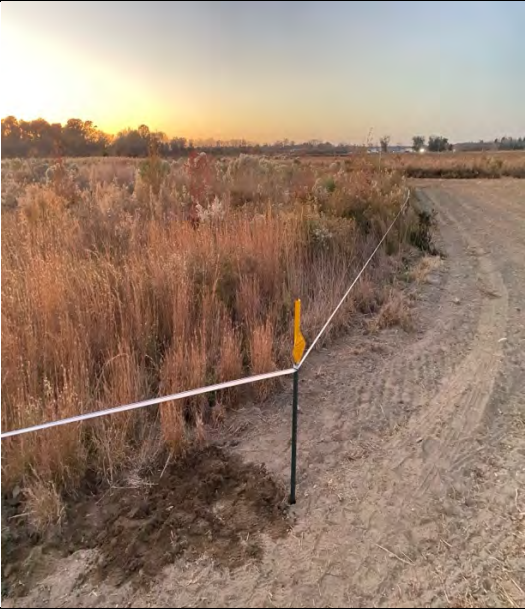
| | | MY4<br>Encroachment | MY4<br>Updated Marking |
|---|--|---|---|
| Photo #4 | | Image<br>Unavailable | |
| Feature: at PP5 | | | |
