MONITORING YEAR 4 ANNUAL REPORT

BURNETTS CHAPEL BUFFER MITIGATION SITE

Guilford County, NC
NCDEQ Contract No. 003996
NCDMS ID No. 95009

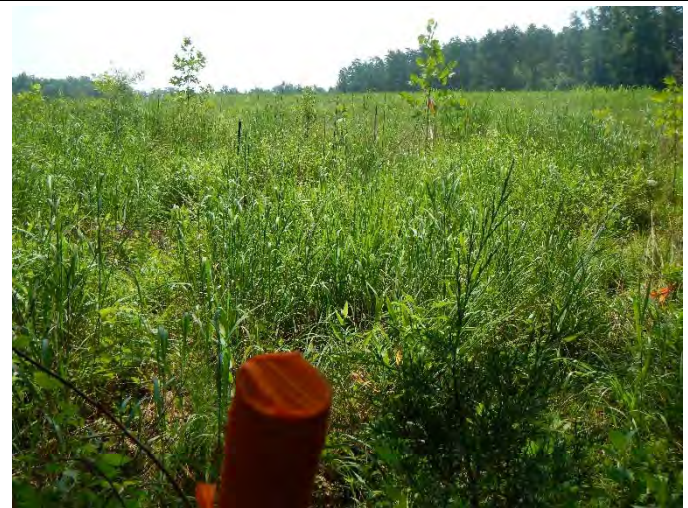
Vegetation Plot 6 (07/07/2015)

Overall, the Site has met the required buffer mitigation success criteria for MY4. Although two vegetation plots (6 and 17) did not meet the MY4 stem density criteria, the average stem density of the Site is greater than the required MY4 success criteria. Continual maintenance checks on the Site, fertilization and reseeded of the sparsely vegetated areas, and spot treatments for invasive species is planned for the current monitoring year.
