CONOCONNARA STREAM AND WETLAND MITIGATION PROJECT HALIFAX COUNTY, NORTH CAROLINA

AS-BUILT REPORT

CONOCONNARA STREAM AND WETLAND MITIGATION PROJECT AS-BUILT REPORT

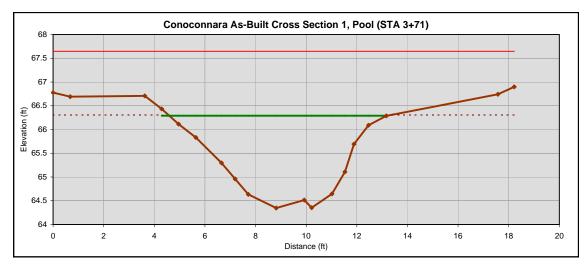
Bankfull Dimensions		
9.8	x-section area (ft.sq.)	
8.6	width (ft)	
1.1	mean depth (ft)	
1.9	max depth (ft)	
9.8	wetted parimeter (ft)	
1.0	hyd radi (ft)	
7.5	width-depth ratio

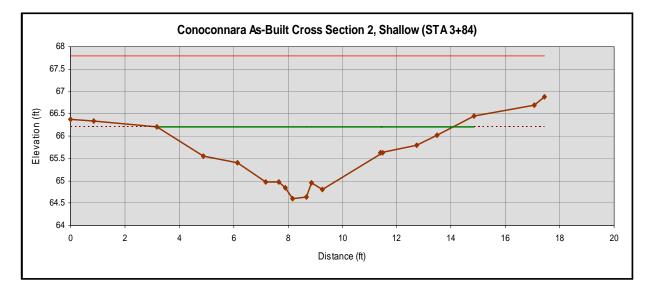
Bankfull Dimensions		
8.5	x-section area (ft.sq.)	
10.9	width (ft)	
0.8	mean depth (ft)	
1.6	max depth (ft)	
11.8	wetted parimeter (ft)	
0.7	hyd radi (ft)	
13.9	width-depth ratio

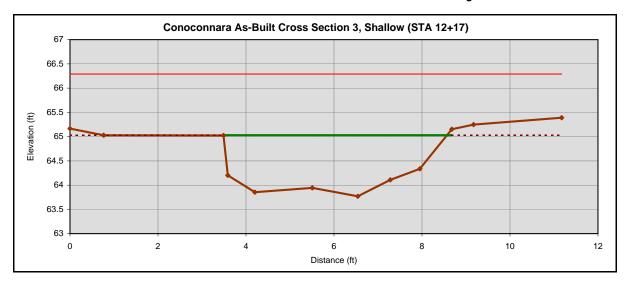
Bankfull Dimensions		
4.91	x-section area (ft.sq.)	
5.08	width (ft)	
0.97	mean depth (ft)	
1.26	max depth (ft)	
6.34	wetted parimeter (ft)	
0.77	hyd radi (ft)	
5.26	width-depth ratio

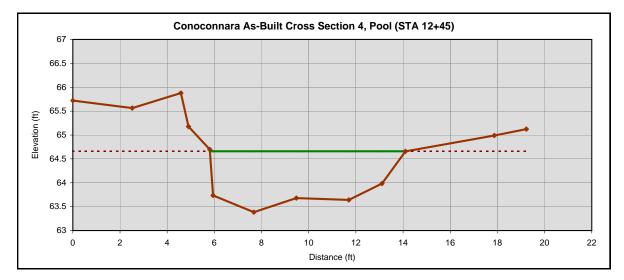
Bankfull Dimensions		
7.7	7.7 x-section area (ft.sq.)	
8.3	width (ft)	
0.9	mean depth (ft)	
1.3	max depth (ft)	
9.4	wetted parimeter (ft)	
0.8	hyd radi (ft)	
8.9	width-depth ratio

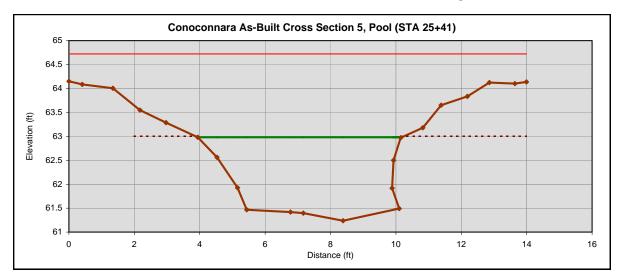
Bankfull Dimensions		
8.23	x-section area (ft.sq.)	
6.20	width (ft)	
1.33	mean depth (ft)	
1.74	max depth (ft)	
8.43	wetted parimeter (ft)	
0.98	hyd radi (ft)	
4.68	width-depth ratio

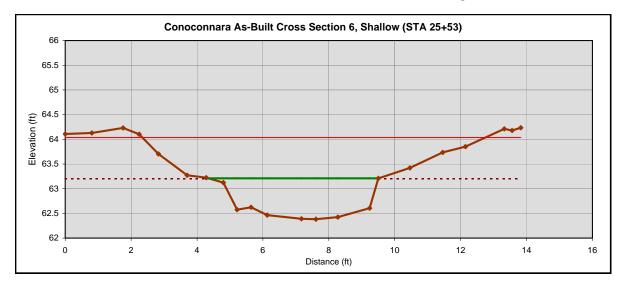
Bankfull Dimensions		
3.22	x-section area (ft.sq.)	
5.16	width (ft)	
0.62	mean depth (ft)	
0.83	max depth (ft)	
5.88	wetted parimeter (ft)	
0.55	hyd radi (ft)	
8.27	width-depth ratio

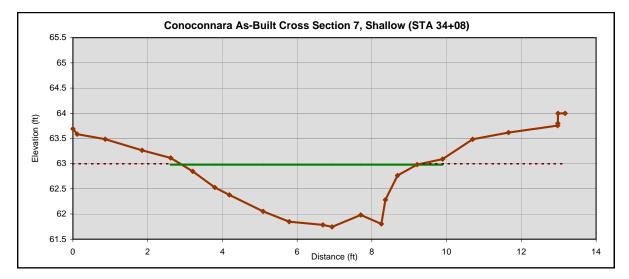
Bankfull Dimensions	
4.92	x-section area (ft.sq.)
6.30	width (ft)
0.78	mean depth (ft)
1.24	max depth (ft)
7.27	wetted parimeter (ft)
0.68	hyd radi (ft)
8.07	width-depth ratio

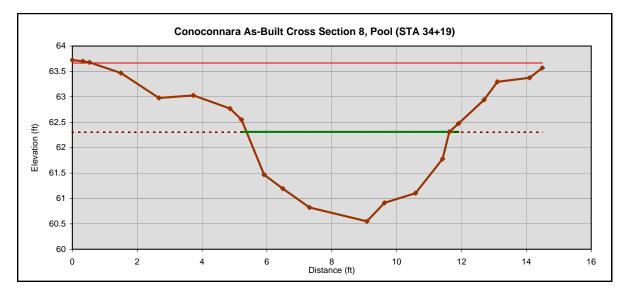
Bankfull Dimensions								
7.62								
6.25	width (ft)							
1.22	mean depth (ft)							
1.76	max depth (ft)							
7.61	wetted parimeter (ft)							
1.00	hyd radi (ft)							
5.13	width-depth ratio

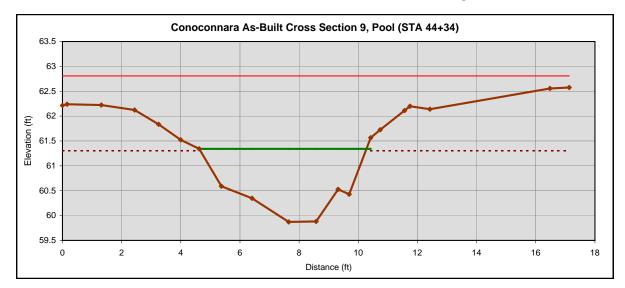
Bankfull Dimensions							
5.50	x-section area (ft.sq.)						
5.65	width (ft)						
0.97	mean depth (ft)						
1.47	max depth (ft)						
6.83	wetted parimeter (ft)						
0.81	hyd radi (ft)						
5.81	width-depth ratio

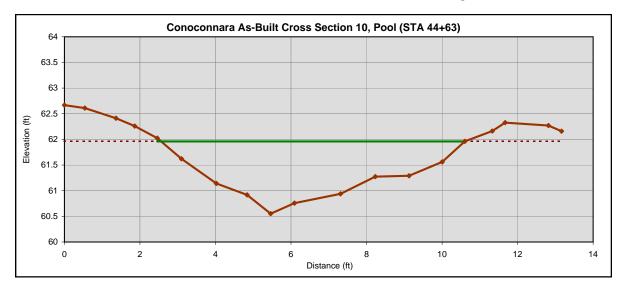
Bankfull Dimensions							
6.30	x-section area (ft.sq.)						
8.04	width (ft)						
0.78	mean depth (ft)						
1.41	max depth (ft)						
8.65	wetted parimeter (ft)						
0.73	hyd radi (ft)						
10.25	width-depth ratio

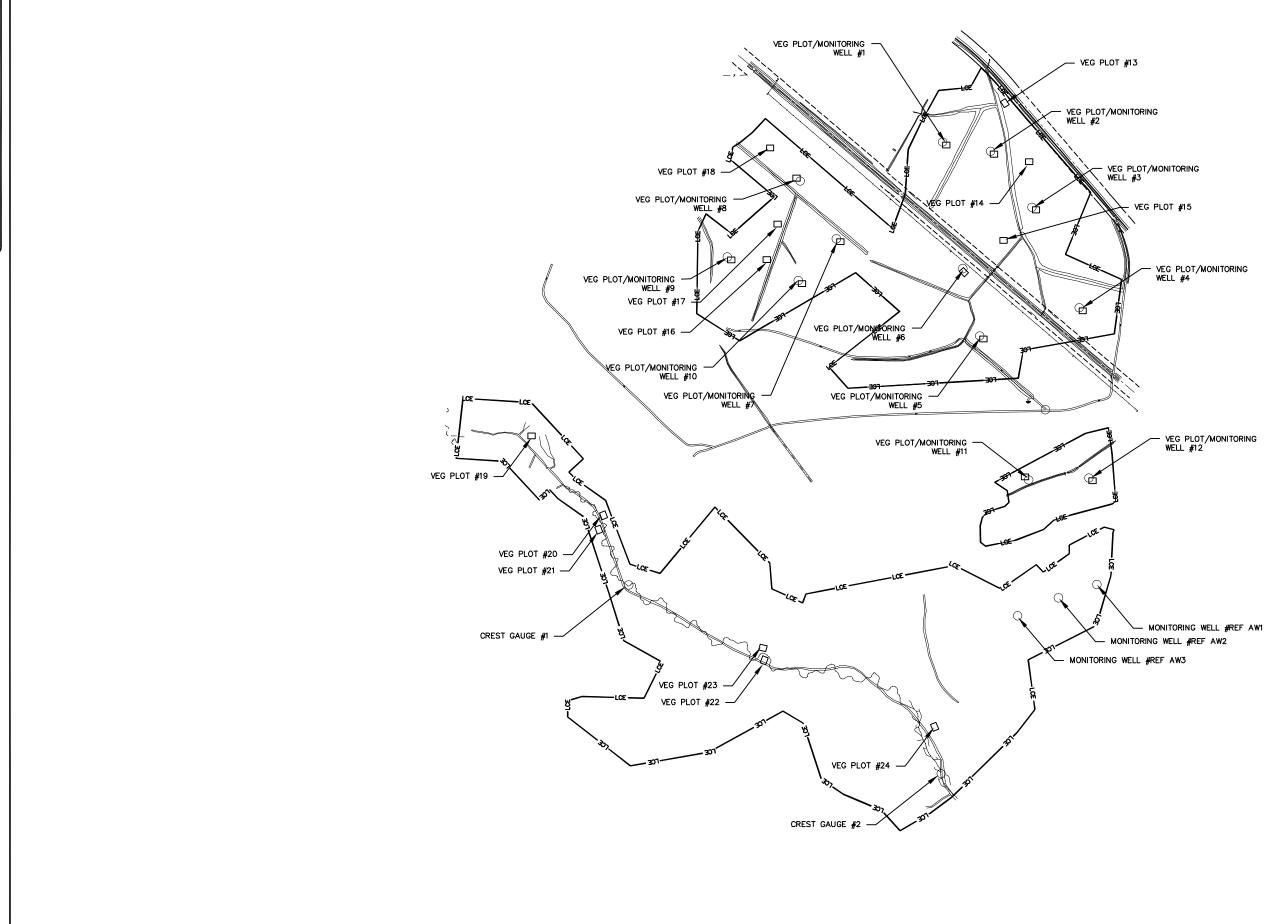
AS-BUILT Planting plan

DOWNSTREAM MULTIPLE THREAD CHANNEL

Bold cypress (Taxodium distichum)	325
Water tupelo (Nyssa aquatica)	679
Overcup oak (Quercus lyrata)	550
River Birch (Betula nigra)	600
Water oak (Quercus nigra)	156
Laurel oak (Quercus laurifolia)	300
Swamp blackgum (Nyssa biflora)	150
Carolina Ash (Fraxinus caroliniana)	650
