## ANNUAL MONITORING REPORT YEAR 3 (2012)

## FOX RUN RIPARIAN BUFFER MITIGATION SITE PITT COUNTY, NORTH CAROLINA

(EEP Contract No. 002281)

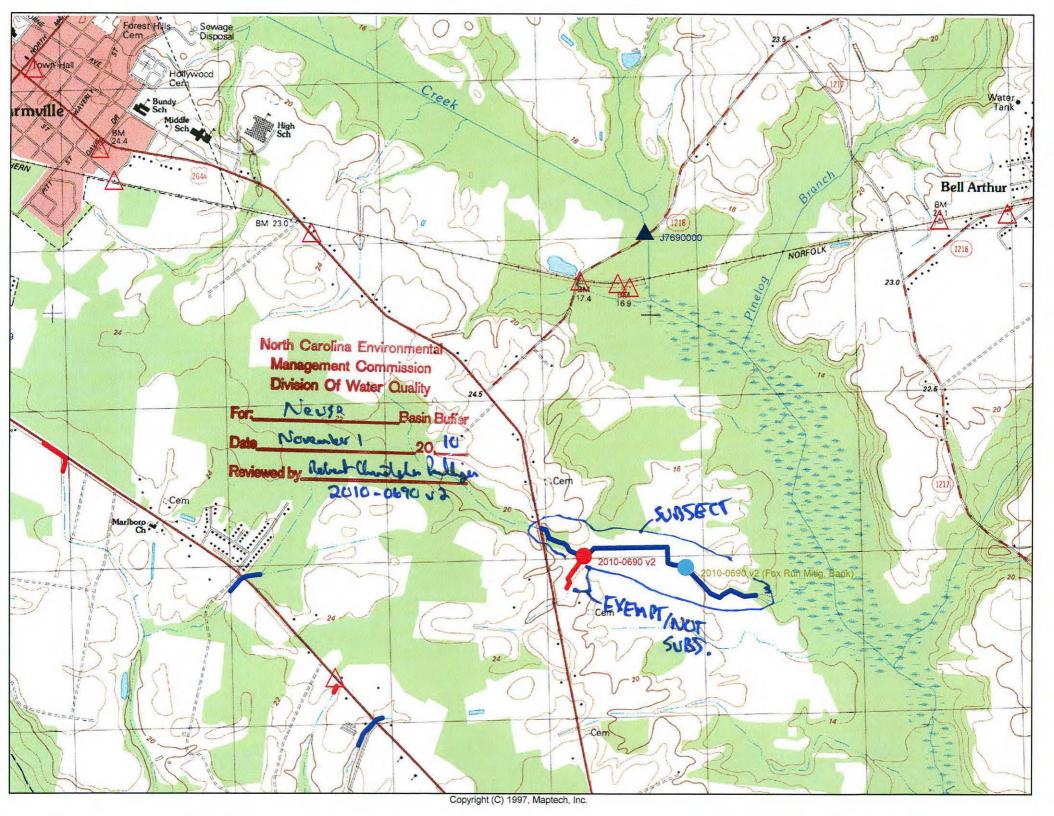
The Division of Water Quality (DWQ) has determined that the surface water circled, highlighted in blue, and labeled as "2010-0690 v2 - Fox Run" on the attached map is at least intermittent and is SUBJECT to the Neuse Buffer Rule. The portion of the surface water highlighted in red and labeled as "2010-0690 v2" on the attached map is ephemeral, and NOT SUBJECT to the Neuse Buffer Rule. These features and their associated buffers should be identified on any future plans for this property. The owner (or future owners) should notify the DWQ (and other relevant agencies) of this decision in any future correspondences concerning this property. This on-site determination shall expire five (5) years from the date of this letter.
