As-Built Baseline Monitoring Report Odell's House Buffer Mitigation Project Monitoring Year 0

NCDEQ DMS Project Identification #100041 NCDEQ DMS Contract # 7420 Neuse River Basin (CU 03020201) DWR Project # 2018-0200

Data Collection Period: March 2021
Submission Date: June 2021

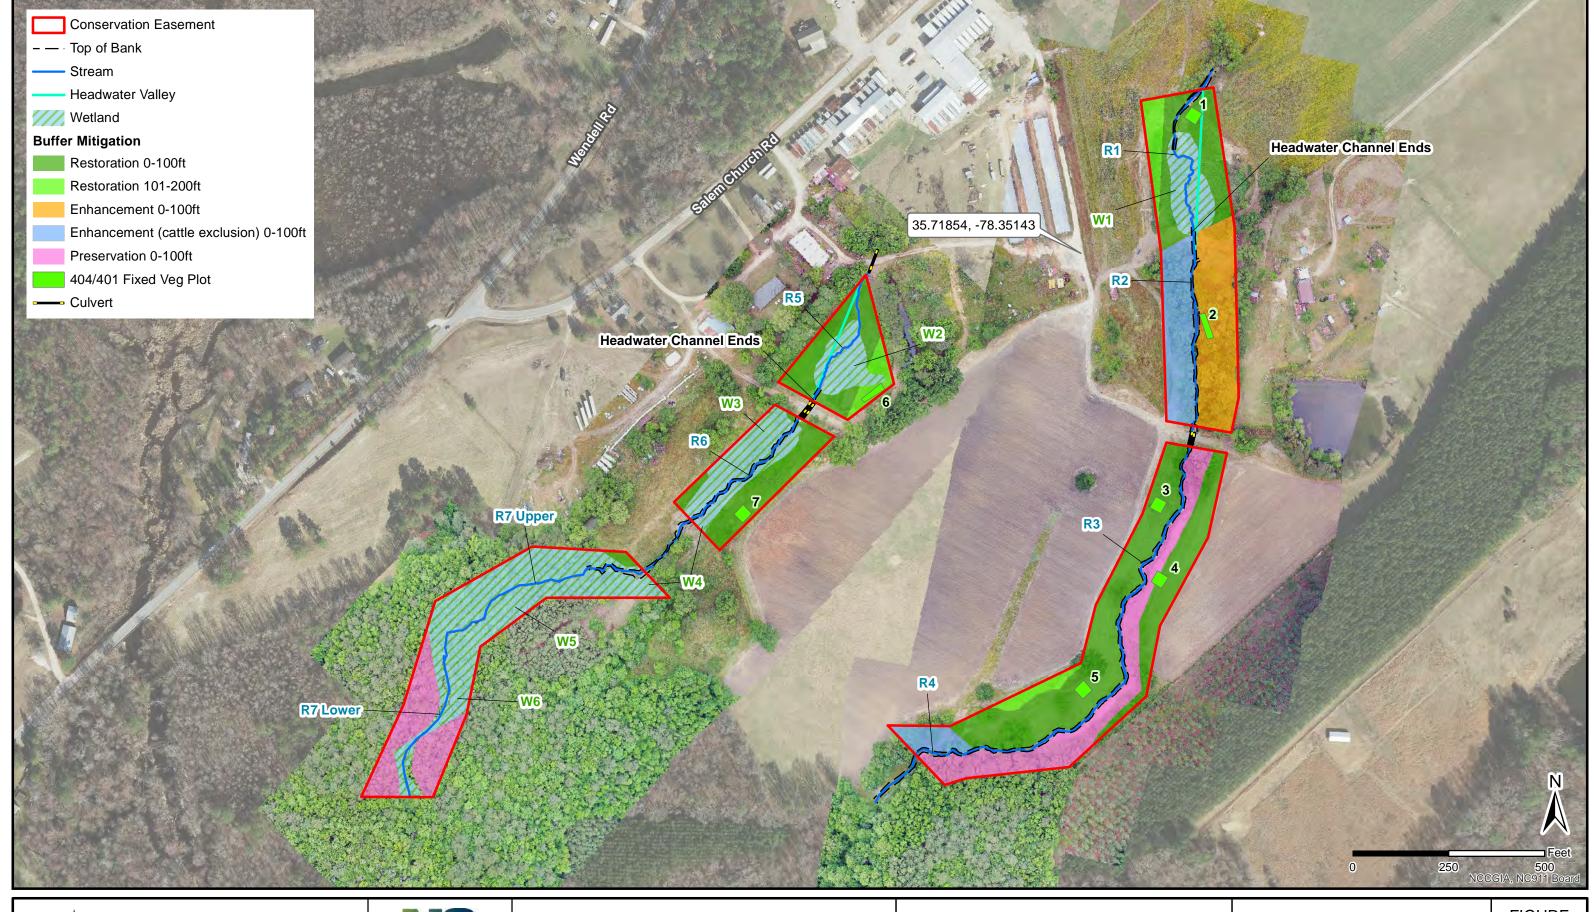
NAD 1983 2011 State Plane North Carolina FIPS 3200 FT US FIGURE 3

June 2021 MY0 Current Conditions Plan View Monitoring Year 0

Seven 100 square-meter vegetation monitoring plots were installed for DWR monitoring; covering at least two percent of the 15.092 acres of the riparian restoration area. Plots were randomly placed throughout the planted riparian areas. The location of the plots is shown on Figures 3a. Photos will be taken from all

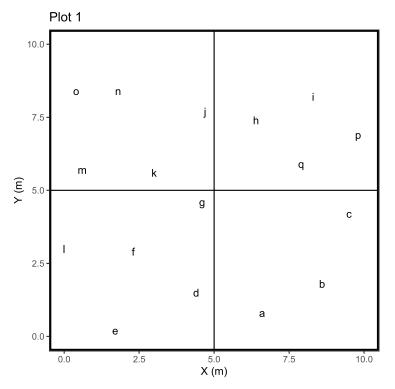
Plot	Scientific	Common	Map
ID	Name	Name	ID
1	Liriodendron	tuliptree	а
	tulipifera	·	-
1	Platanus	American	b
_	occidentalis	sycamore	
1	Liriodendron	tuliptree	С
	tulipifera	·	_
1	Platanus	American	d
_	occidentalis	sycamore	
1	Quercus nigra	water oak	е
1	Quercus	willow oak	f
	phellos		
1	Liriodendron	tuliptree	g
	tulipifera		
1	Betula nigra	river birch	h
1	Carpinus	American	i
_	caroliniana	hornbeam	
1	Hamamelis	American	j
	virginiana	witchhazel	
1	Fraxinus	green ash	k
	pennsylvanica Quercus		
1		swamp	- 1
	michauxii Quercus	chestnut oak	
1	Quercus michauxii	swamp chestnut oak	m
	Platanus	American	
1	occidentalis	sycamore	n
	Platanus	American	
1	occidentalis		0
	Liriodendron	sycamore	
1	tulipifera	tuliptree	р
_	Carpinus	American	
1	carpinus	hornbeam	q
	Caronillana	Hormbealti

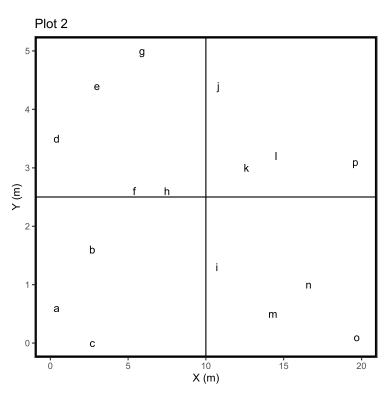
Plot	Scientific	Common	Мар
ID	Name	Name	ID
2	Quercus pagoda	cherrybark oak	а
2	Quercus pagoda	cherrybark oak	b
2	Hamamelis virginiana	American witchhazel	U
2	Betula nigra	river birch	d
2	Quercus pagoda	cherrybark oak	e
2	Betula nigra	river birch	f
2	Asimina triloba	pawpaw	g
2	Corylus americana	American hazelnut	h
2	Platanus occidentalis	American sycamore	i
2	Liriodendron tulipifera	tuliptree	j
2	Liriodendron tulipifera	tuliptree	k
2	Quercus michauxii	swamp chestnut oak	-
2	Hamamelis virginiana	American witchhazel	m
2	Quercus michauxii	swamp chestnut oak	n
2	Platanus occidentalis	American sycamore	0
2	Lindera benzoin	northern spicebush	р

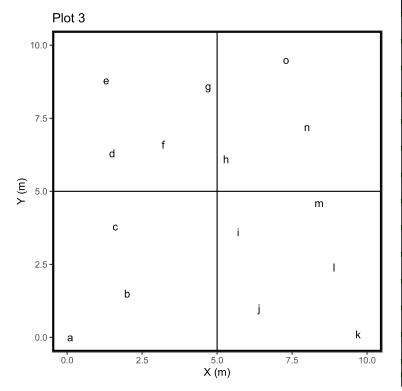
Plot	Scientific	Common	Map
ID	Name	Name	ID
3	Platanus	American	
	occidentalis	sycamore	а
3	Hamamelis	American	b
0	virginiana	witchhazel	ь
3	Quercus	willow oak	С
٥	phellos	WIIIOW Oak	·
3	Platanus	American	d
3	occidentalis	sycamore	u
3	Asimina triloba	pawpaw	e
	Platanus	American	
3	occidentalis	sycamore	f
3	Liriodendron	tuliptree	g
ช	tulipifera		
3	Quercus	cherrybark	h
5	pagoda	oak	"
3	Liriodendron	tuliptree	i
,	tulipifera		'
3	Liriodendron	tuliptree	i
	tulipifera	tunptree	,
3	Quercus	willow oak	k
,	phellos		, ,
3	Platanus	American	
	occidentalis	sycamore	
3	Liriodendron	tuliptree	m
_	tulipifera		-"
3	Betula nigra	river birch	n
3	Quercus nigra	water oak	0

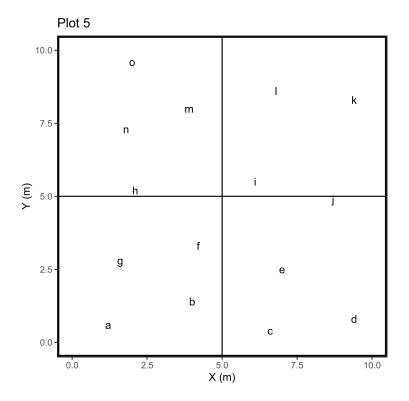
Plot	Scientific	Common	Мар	
ID	Name	Name	ID	
5	Diospyros	common	_	
5	virginiana	persimmon	а	
5	Liriodendron	Audinana a	b	
0	tulipifera	tuliptree		
5	Quercus	swamp		
)	michauxii	chestnut oak	С	
5	Platanus	American	d	
ر	occidentalis	sycamore	u	
5	Liriodendron	tuliptree		
,	tulipifera	tunptree	е	
5	Quercus	willow oak	f	
٠	phellos	WIIIOW Oak	-	
5	Lindera	northern	-	
٥	benzoin	spicebush	g	
5	Asimina triloba	pawpaw	h	
5	Liriodendron	Audina	i	
כ	tulipifera	tuliptree	1	
5	Quercus nigra	water oak	j	
5	Platanus	American	k	
٠	occidentalis	sycamore	K	
5	Liriodendron	tuliptree	1	
,	tulipifera	tunptree	- 1	
5	Liriodendron	tuliptree	m	
,	tulipifera	tunptree	ın	
5	Liriodendron	tuliptree	n	
,	tulipifera	tunptree	п	
5	Liriodendron	tuliptree	0	
,	tulipifera	tuilptiee	U

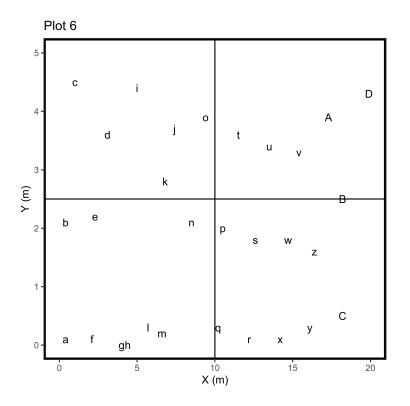
Plot	Scientific	Common	Map
ID	Name	Name	ID
6	Diospyros	common	
В	virginiana	persimmon	а
6	Quercus		
	phellos	willow oak	b
	Quercus		
6	phellos	willow oak	С
	Fraxinus		
6	pennsylvanica	green ash	d
	Quercus	cherrybark	
6	pagoda	oak	e
	Platanus	American	
6	occidentalis		f
		sycamore	
6	Fraxinus	green ash	g
	pennsylvanica		-
6	Corylus	American	h
	americana	hazelnut	
6	Quercus	willow oak	i
	phellos	WIIIOW OUK	
6	Quercus nigra	water oak	j
6	Quercus nigra	water oak	k
6	Betula nigra	river birch	1
6	Platanus	American	
ь	occidentalis	sycamore	m
	Quercus	cherrybark	
6	pagoda	oak	n
	Platanus	American	
6	occidentalis	sycamore	0
6	Betula nigra	river birch	р
6	Betula nigra	river birch	q
	Quercus	swamp	
6	michauxii	chestnut oak	r
6	Betula nigra	river birch	s
	Platanus	American	3
6	occidentalis	sycamore	t
	Platanus	American	
6			u
	occidentalis	sycamore	
6	Quercus nigra	water oak	V
6	Betula nigra	river birch	W
6	Betula nigra	river birch	Х
6	Fraxinus	green ash	y

pennsylvanica	,	,
6	Betula nigra	river birch	Z
6	Quercus	swamp	Α
0	michauxii	chestnut oak	
6	Betula nigra	river birch	В
	Fraxinus		
6	pennsylvanica	green ash	c
	Quercus	swamp	
6	michauxii	chestnut oak	D
	menduali	Chestilut Odk

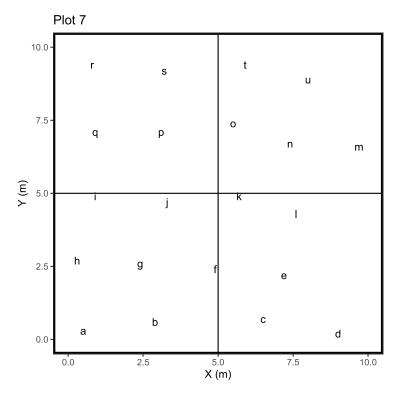
Plot	Scientific	Common	Map
ID	Name	Name	
7	Carpinus	American	_
	caroliniana	hornbeam	а
7	Platanus	American	L
/	occidentalis	sycamore	b
	Platanus	American	
7	occidentalis	sycamore	С
7	Betula nigra	river birch	d
7	Quercus	willow oak	_
	phellos	willow oak	е
7	Betula nigra	river birch	f
7	Corylus	American	_
/	americana	hazelnut	g
	Platanus	American	
7	occidentalis	sycamore	h
	Lindera	northern	
7	benzoin	spicebush	i
	Liriodendron		
7	tulipifera	tuliptree	j
7	Platanus	American	
/	occidentalis	sycamore	k
7	Platanus	American	1
/	occidentalis	sycamore	'
7	Quercus	willow oak	m
_ ′	phellos	WIIIOW OAK	""
7	Quercus	willow oak	
	phellos	WIIIOW Oak	n
7	Platanus	American	
_ ′	occidentalis	sycamore	0
7	Liriodendron	tuliptree	
_ ′	tulipifera	·	р
7	Quercus	cherrybark	_
_ ′	pagoda	oak	q
7	Quercus	willow oak	r
	phellos		'
7	Liriodendron	tuliptree	-
/	tulipifera	tunptree	S
7	Liriodendron	tuliptree	t
/	tulipifera	tunptree	·
7	Liriodendron	tuliptree	u

/	tulipifera	tuiiptree	u
