SALT TRACT MITIGATION SITE 2009 2009 Annual Monitoring Report (Year 4)

Cape Fear River Basin, Moore County, North Carolina

Submitted to: North Carolina Department of Environment and Natural Resources Ecosystem Enhancement Program Raleigh, North Carolina

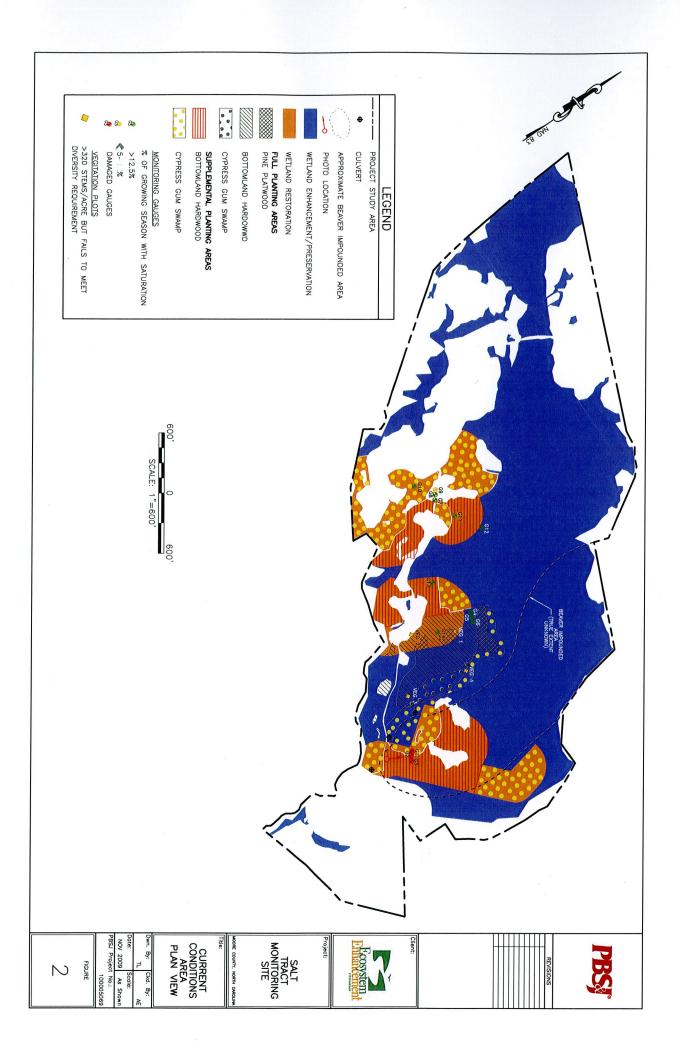
In January 2006, 13 Remote Data Systems (RDS) continuous logging groundwater gauges The on-site gauge locations are shown on Figure 2, Appendix A. were installed. The monitoring gauges record daily readings of depth to groundwater. This year's data represents the fourth growing season that the gauges have been monitored. The Site was designed to receive hydrologic inputs from rainfall, groundwater, and surface water from overbanking events. Biologists first visited the Site for Year 4 monitoring in March 2009. During the visit, Gauges 1 and 2 were found to be submerged underwater due to beaver activity and remained underwater during all subsequent site visits. As a result, there is no recorded data for these two gauges, but visual observations during site visits confirm that this area of the site stays inundated for 100 percent of the growing season. In 2009, a damaged Gauge 3 was replaced with a new Gauge 7 (the original Gauge 7 was not found, and no reference is found to it in the Louis Berger Group's Year 2 Annual Monitoring Report). The new Gauge 7 was not placed at the original Gauge 3 location due to risk of flooding. All other gauges were found in working order.

Figure 2 provides the hydrologic results for the current monitoring year. Gauges highlighted in green indicate wetland hydrology for more than 12.5 percent of the growing season. Gauges highlighted in yellow are those that had wetland hydrology between 5 and 12.5 percent of the growing season. Gauges highlighted in red are those that were found to be damaged or non-functioning.

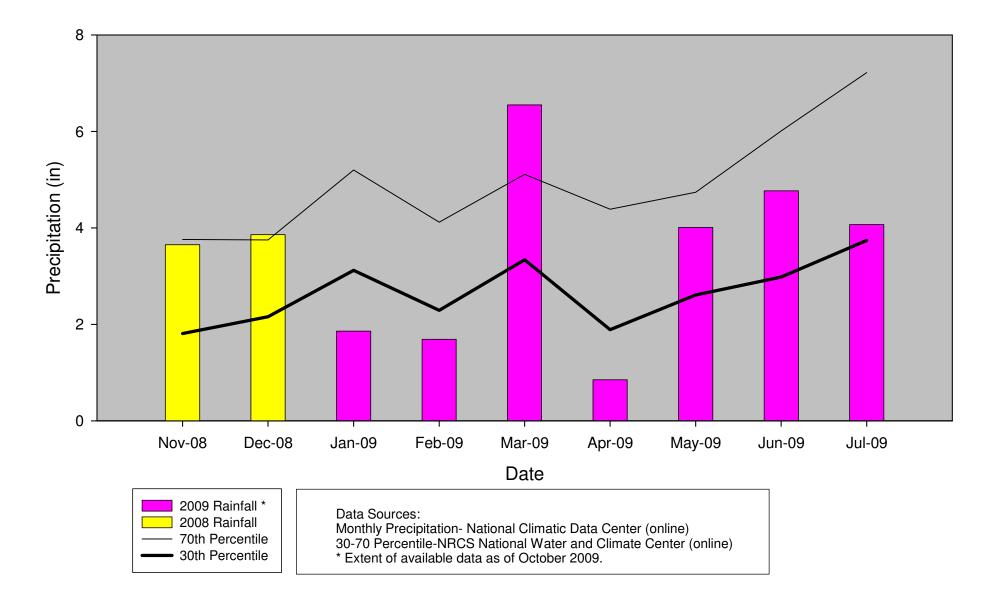
Figure 3. SALT Tract 30-70 Percentile Graph 2009 Fort Bragg WWTP, NC

Figure 3 (Appendix A) provides an evaluation of the local climate in comparison with historical data in order to determine whether 2009 was a year with "average" rainfall. The bars are the monthly rainfall totals for the 2009 hydrologic year collected from nearby weather stations. Also represented on the figure are the 30th and 70th percentiles of monthly precipitation for the Fort Bragg Wastewater Treatment Plant weather station. The historical data and monthly data were collected by the Southeast Regional Climate Data.

A normal yearly rainfall in the area is approximately 46.3 inches. The total rainfall measured from November 2008 through July 2009 was approximately 31 inches. Months with below average rainfall include: January, February, April, June and July of 2009. November 2008, December 2008, March 2009 and May 2009 all received above average rainfall.

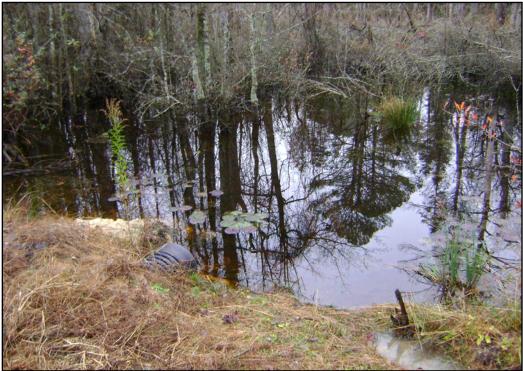
Culvert 1 - November 23, 2009.

In 2009, unauthorized improvements were made within the conservation easement to an access road that enters the site from the south. Improvements included the installation of three culverts and resurfacing the road with gravel. These improvements have reduced water levels in the adjacent wetlands that include both wetland restoration and enhancement areas. Photos of the culverts and the improved access road are included in Appendix C, pages C9-C10. EEP has been notified of these changes.

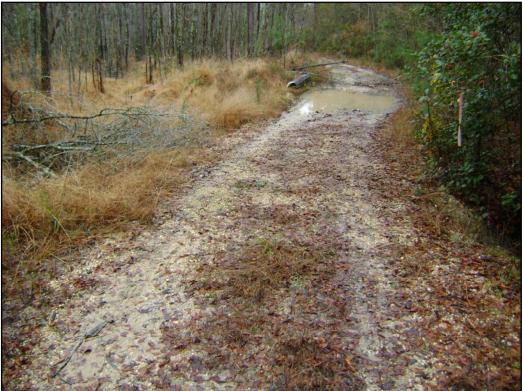
Road with culverts installed - November 23, 2009.
