**FINAL**  
**Baseline Monitoring Document and As-Built Baseline Report**  
**St. Clair Creek Restoration Project**

Beaufort County, North Carolina

EEP Project ID No. 95015

**Submission Date – July 2014**

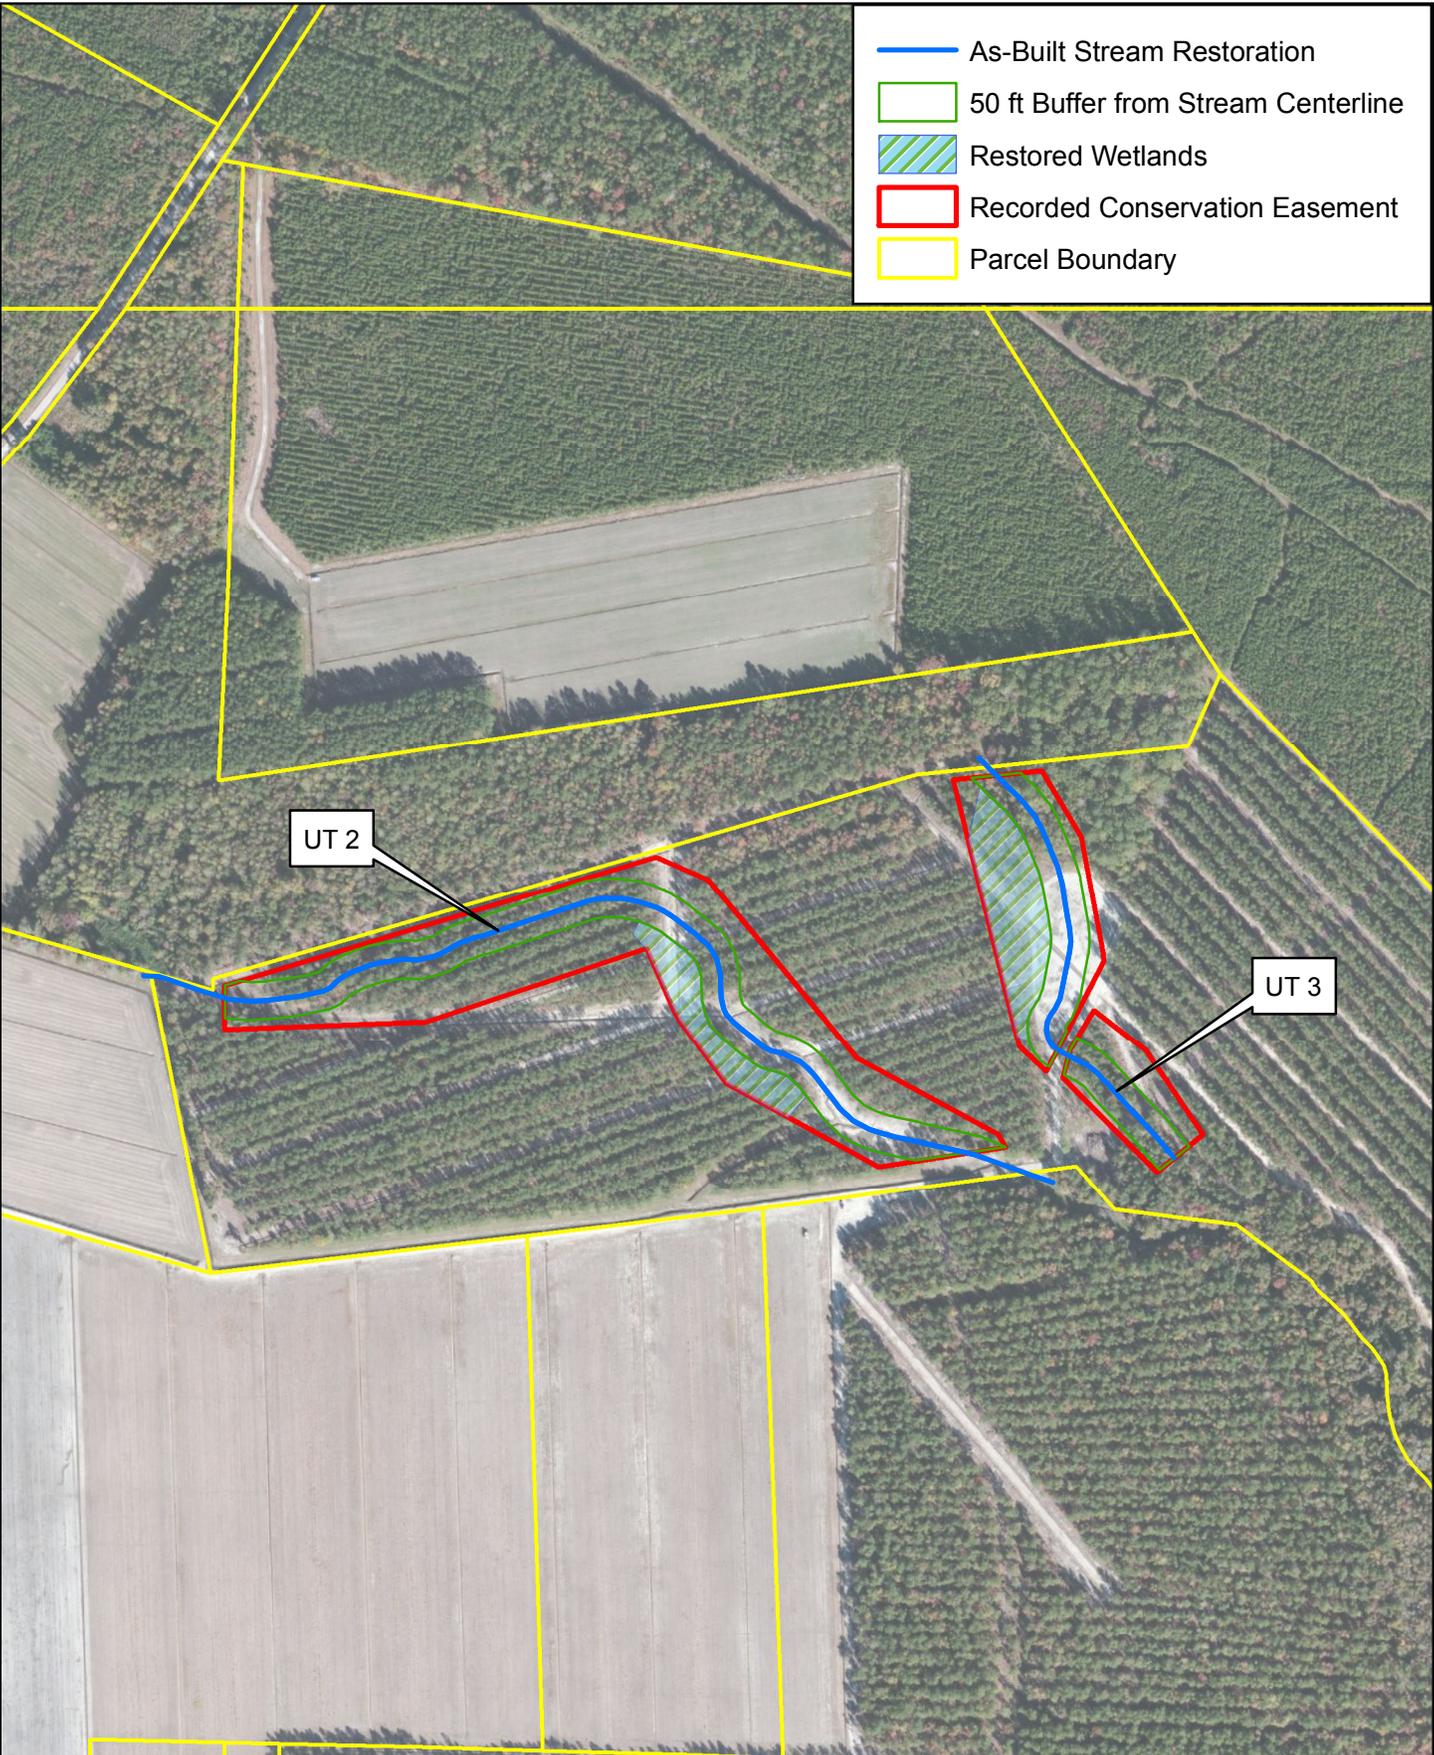
**Figure 2**  
**Restoration**  
**Summary Map**  
**St. Clair Creek Site**

- As-Built Stream Restoration
- 50 ft Buffer from Stream Centerline
- Restored Wetlands
- Recorded Conservation Easement
- Parcel Boundary

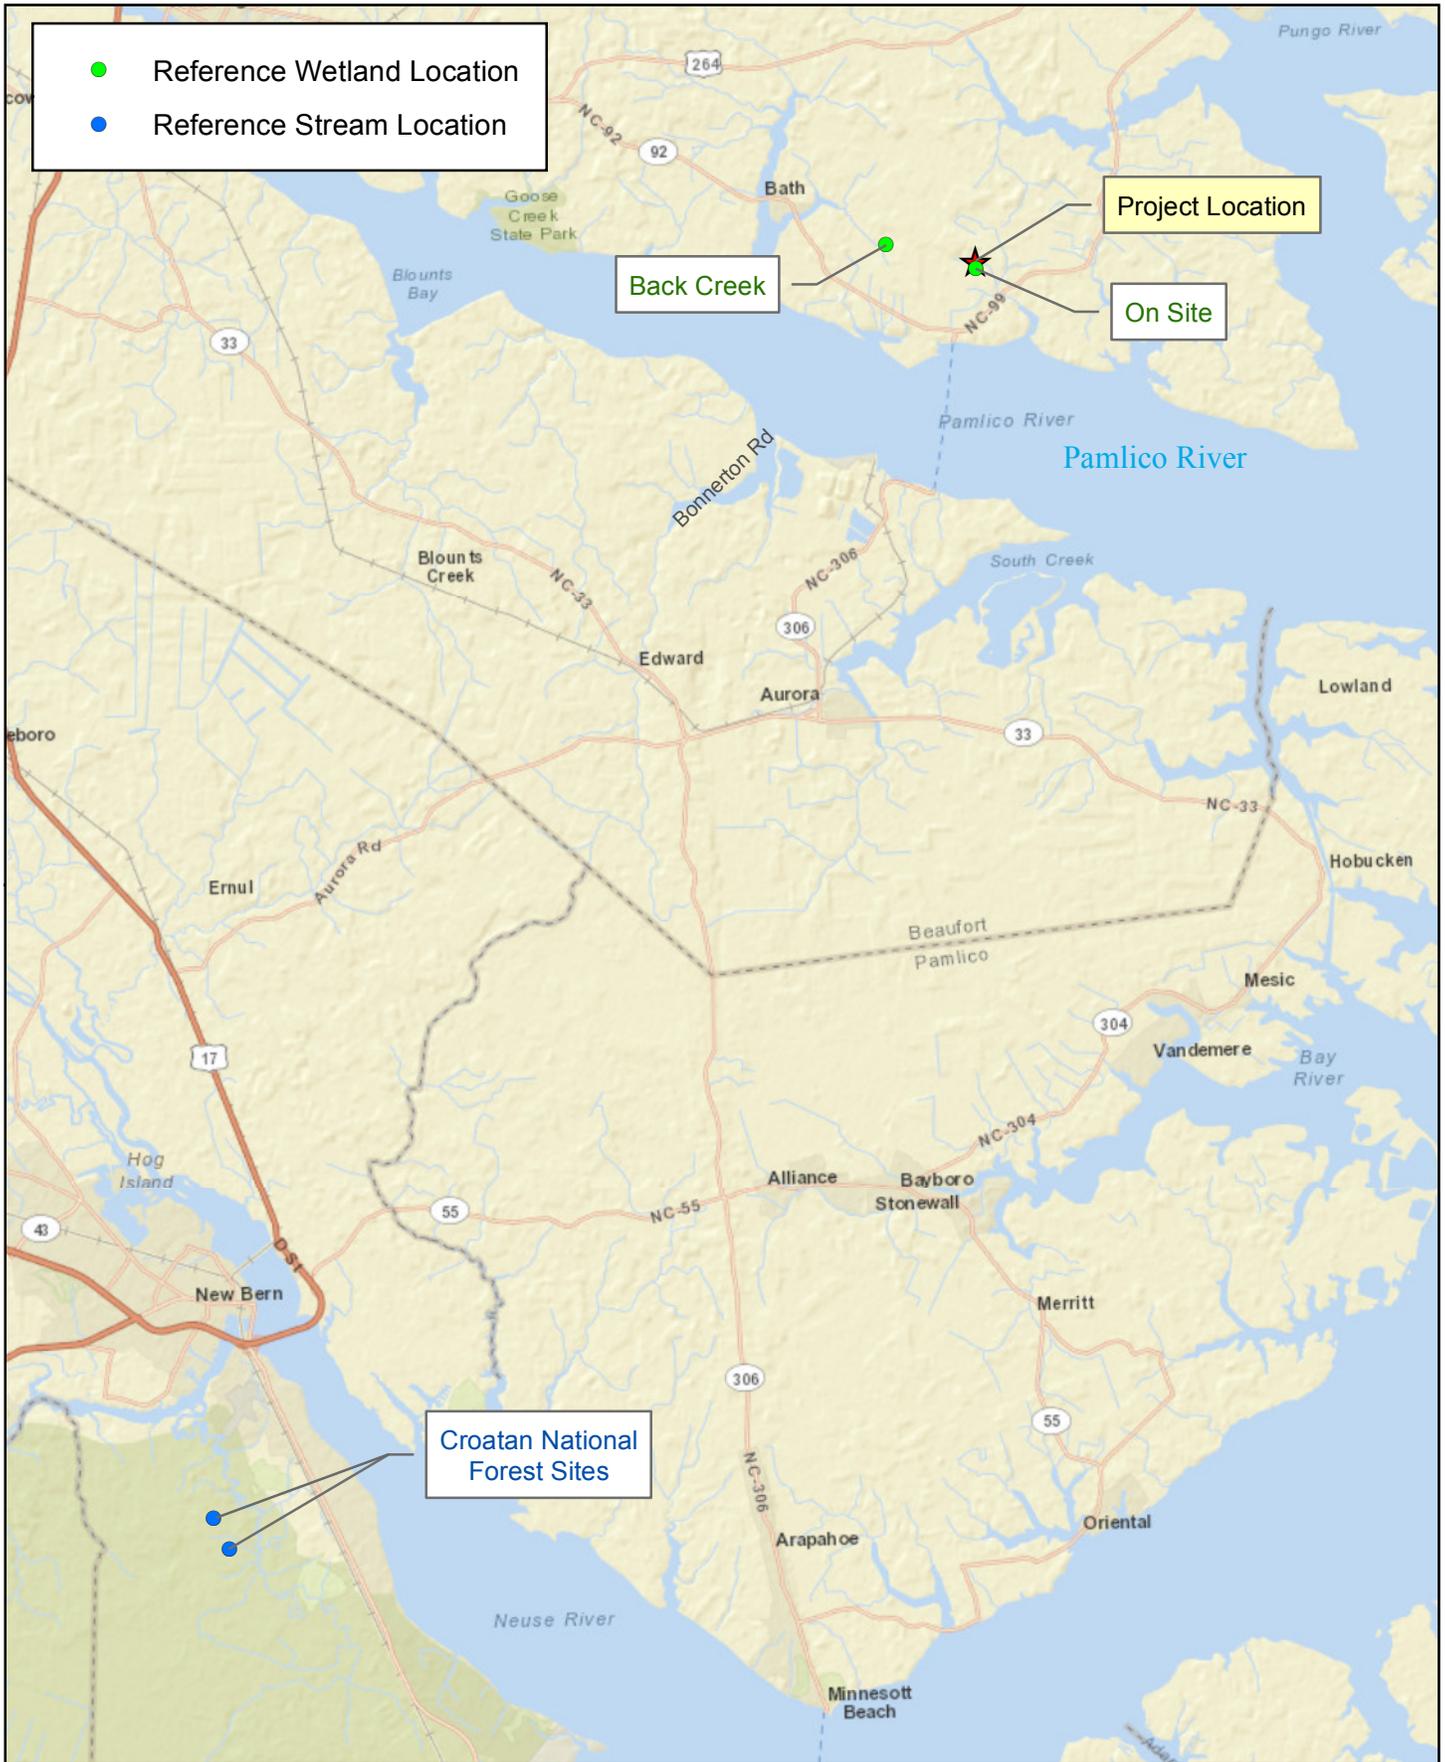
- Reference Wetland Location
- Reference Stream Location

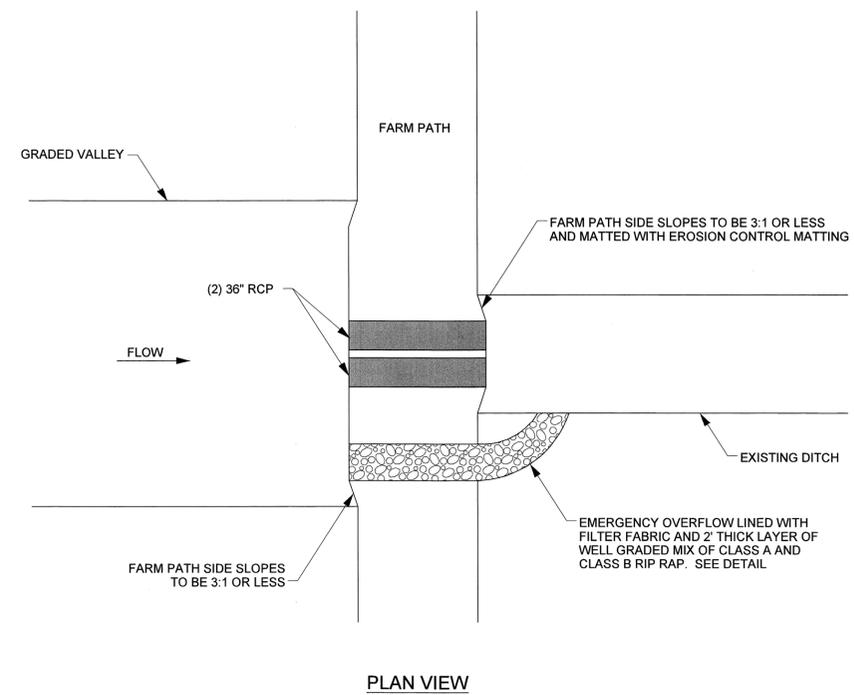
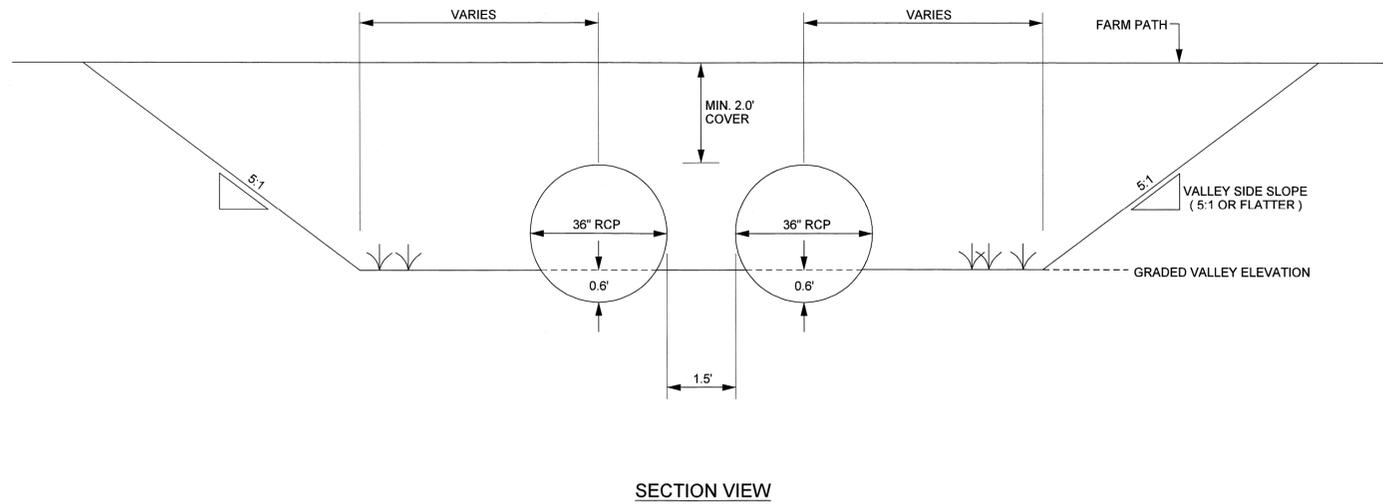
### PERMANENT ROAD CULVERT CROSSING

- NOTES:
1. CULVERTS TO BE SET TO THE ELEVATIONS SHOWN ON THE PLAN & PROFILE.
  2. CULVERTS MUST HAVE A MINIMUM OF 2' OF COVER. ADJUST ROAD GRADE TO ENSURE THE COVER REQUIREMENT IS MET.

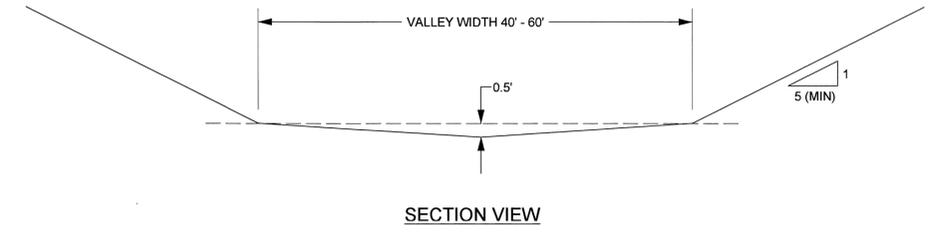
### TYPICAL GRADED VALLEY

- NOTES:
1. GRADE VALLEY TO DESIGN GRADES SHOWN ON PROFILE.
  2. MICROTOPOGRAPHY IS ALLOWED TO FORM NATURALLY.

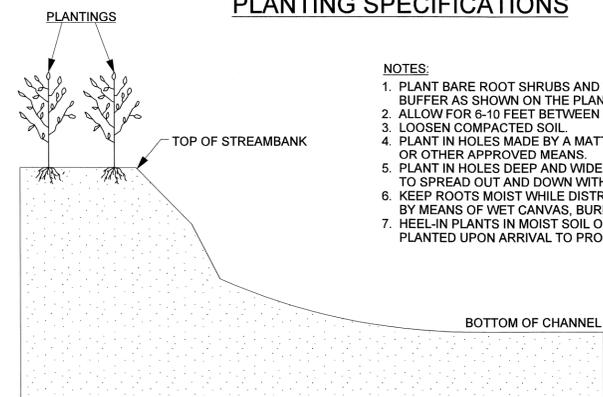
CROSS SECTION VIEW OF BARE ROOT PLANTING

- NOTES:
1. PLANT BARE ROOT SHRUBS AND TREES TO THE WIDTH OF THE BUFFER AS SHOWN ON THE PLANS.
  2. ALLOW FOR 6-10 FEET BETWEEN PLANTINGS, DEPENDING ON SIZE.
  3. LOOSEN COMPACTED SOIL.
  4. PLANT IN HOLES MADE BY A MATTOCK, DIBBLE, PLANTING BAR, OR OTHER APPROVED MEANS.
  5. PLANT IN HOLES DEEP AND WIDE ENOUGH TO ALLOW THE ROOTS TO SPREAD OUT AND DOWN WITHOUT J-ROOTING.
  6. KEEP ROOTS MOIST WHILE DISTRIBUTING OR WAITING TO PLANT BY MEANS OF WET CANVAS, BURLAP, OR STRAW.
  7. HEEL-IN PLANTS IN MOIST SOIL OR SAWDUST IF NOT PROMPTLY PLANTED UPON ARRIVAL TO PROJECT SITE.

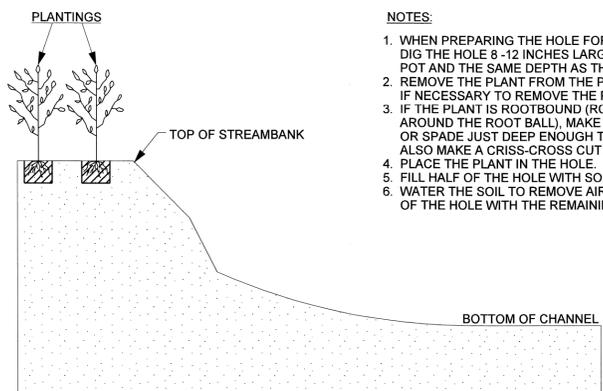
CROSS SECTION VIEW OF CONTAINER PLANTING

- NOTES:
1. WHEN PREPARING THE HOLE FOR A POTTED PLANT OR SHRUB DIG THE HOLE 8-12 INCHES LARGER THAN THE DIAMETER OF THE POT AND THE SAME DEPTH AS THE POT.
  2. REMOVE THE PLANT FROM THE POT. LAY THE PLANT ON ITS SIDE IF NECESSARY TO REMOVE THE POT.
  3. IF THE PLANT IS ROOTBOUND (ROOTS GROWING IN A SPIRAL AROUND THE ROOT BALL), MAKE VERTICAL CUTS WITH A KNIFE OR SPADE JUST DEEP ENOUGH TO CUT THE NET OF ROOTS. ALSO MAKE A CRISS-CROSS CUT ACROSS THE BOTTOM OF THE BALL.
  4. PLACE THE PLANT IN THE HOLE.
  5. FILL HALF OF THE HOLE WITH SOIL (SAME SOIL REMOVED FOR BACKFILL).
  6. WATER THE SOIL TO REMOVE AIR POCKETS AND FILL THE REST OF THE HOLE WITH THE REMAINING SOIL.

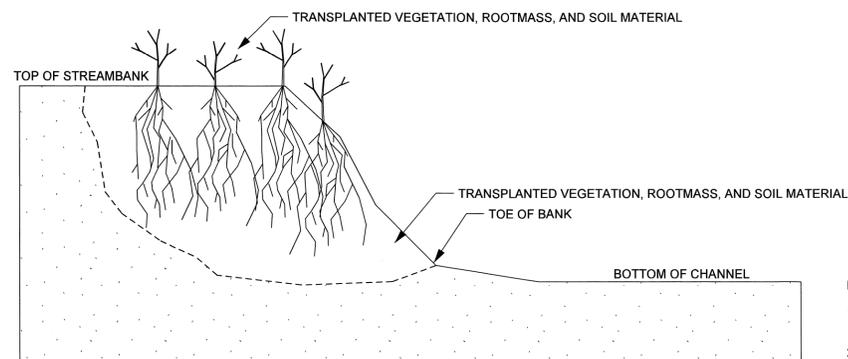
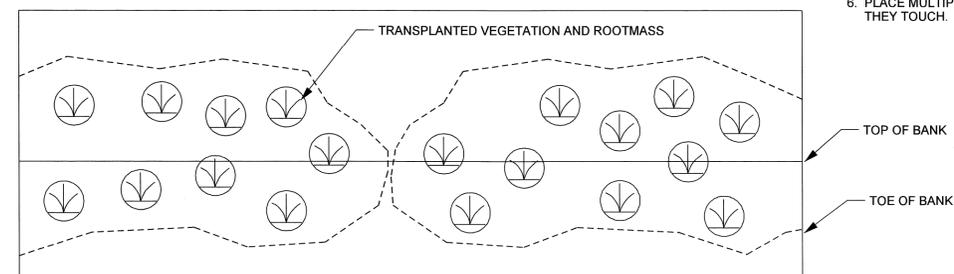
### TRANSPLANTED VEGETATION

- NOTES:
1. EXCAVATE A HOLE IN THE BANK TO BE STABILIZED THAT WILL ACCOMMODATE THE SIZE OF TRANSPLANT TO BE PLACED. BEGIN EXCAVATION AT THE TOE OF THE BANK.
  2. EXCAVATE TRANSPLANT USING A FRONT END LOADER. EXCAVATE THE ENTIRE ROOT MASS AND AS MUCH ADDITIONAL SOIL MATERIAL AS POSSIBLE. IF ENTIRE ROOT MASS CANNOT BE EXCAVATED IN ONE BUCKET LOAD, THE TRANSPLANT IS TOO LARGE AND ANOTHER SHOULD BE SELECTED.
  3. PLACE TRANSPLANT IN THE BANK TO BE STABILIZED SO THAT VEGETATION IS ORIENTATED VERTICALLY.
  4. FILL IN ANY HOLES AROUND THE TRANSPLANT AND COMPACT.
  5. ANY LOOSE SOIL LEFT IN THE STREAM SHOULD BE REMOVED.
  6. PLACE MULTIPLE TRANSPLANTS CLOSE TOGETHER SUCH THAT THEY TOUCH.

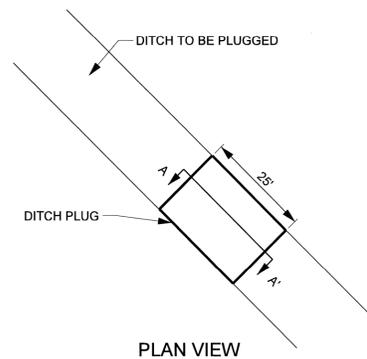
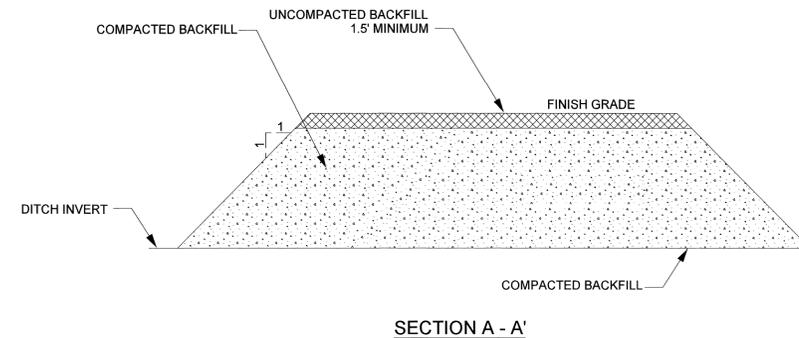
### DITCH PLUG

- NOTE:  
COMPACT BACKFILL USING ON-SITE HEAVY EQUIPMENT IN 10 INCH LIFTS.

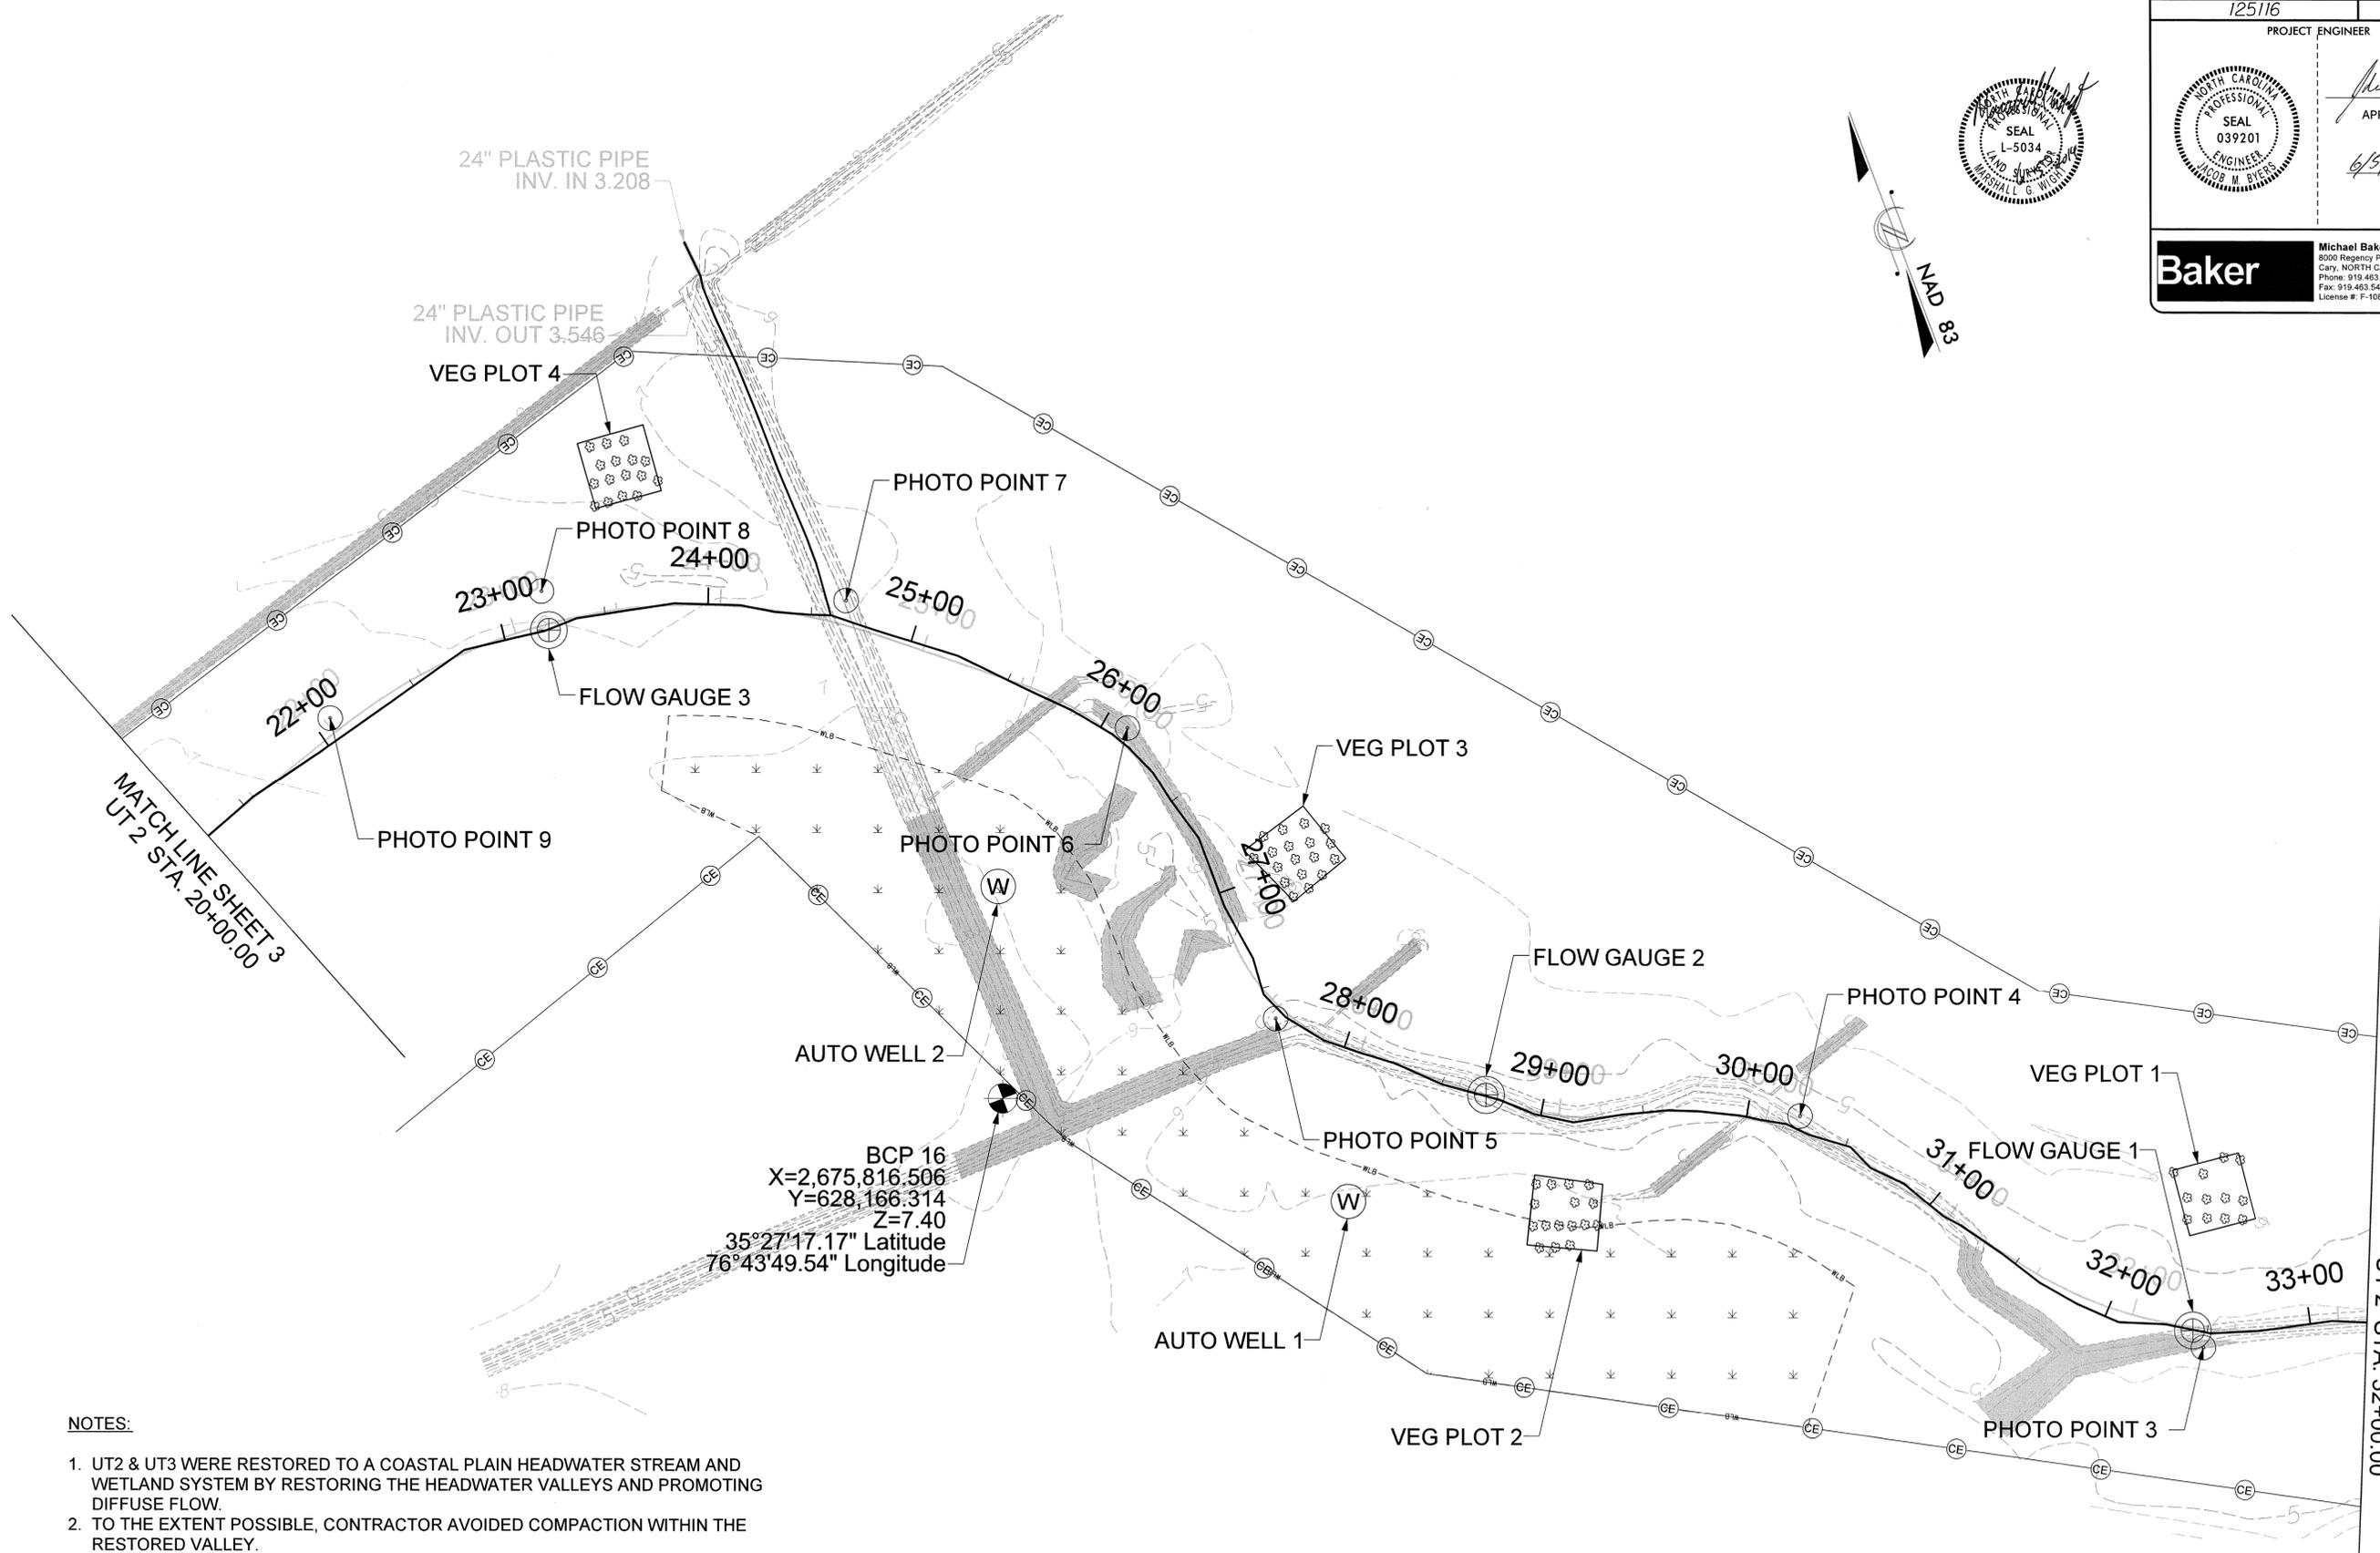
1. UT2 & UT3 WERE RESTORED TO A COASTAL PLAIN HEADWATER STREAM AND WETLAND SYSTEM BY RESTORING THE HEADWATER VALLEYS AND PROMOTING DIFFUSE FLOW.
2. TO THE EXTENT POSSIBLE, CONTRACTOR AVOIDED COMPACTION WITHIN THE RESTORED VALLEY.
3. EXCAVATED MATERIALS WERE USED TO FILL EXISTING DITCHES AND TO ELEVATE EXISTING FARM ROADS AS DIRECTED BY THE ENGINEER.
4. CONTRACTOR ENSURED A MINIMUM OF 2' OF COVER OVER ALL PROPOSED CULVERTS UNDER FARM ROADS.

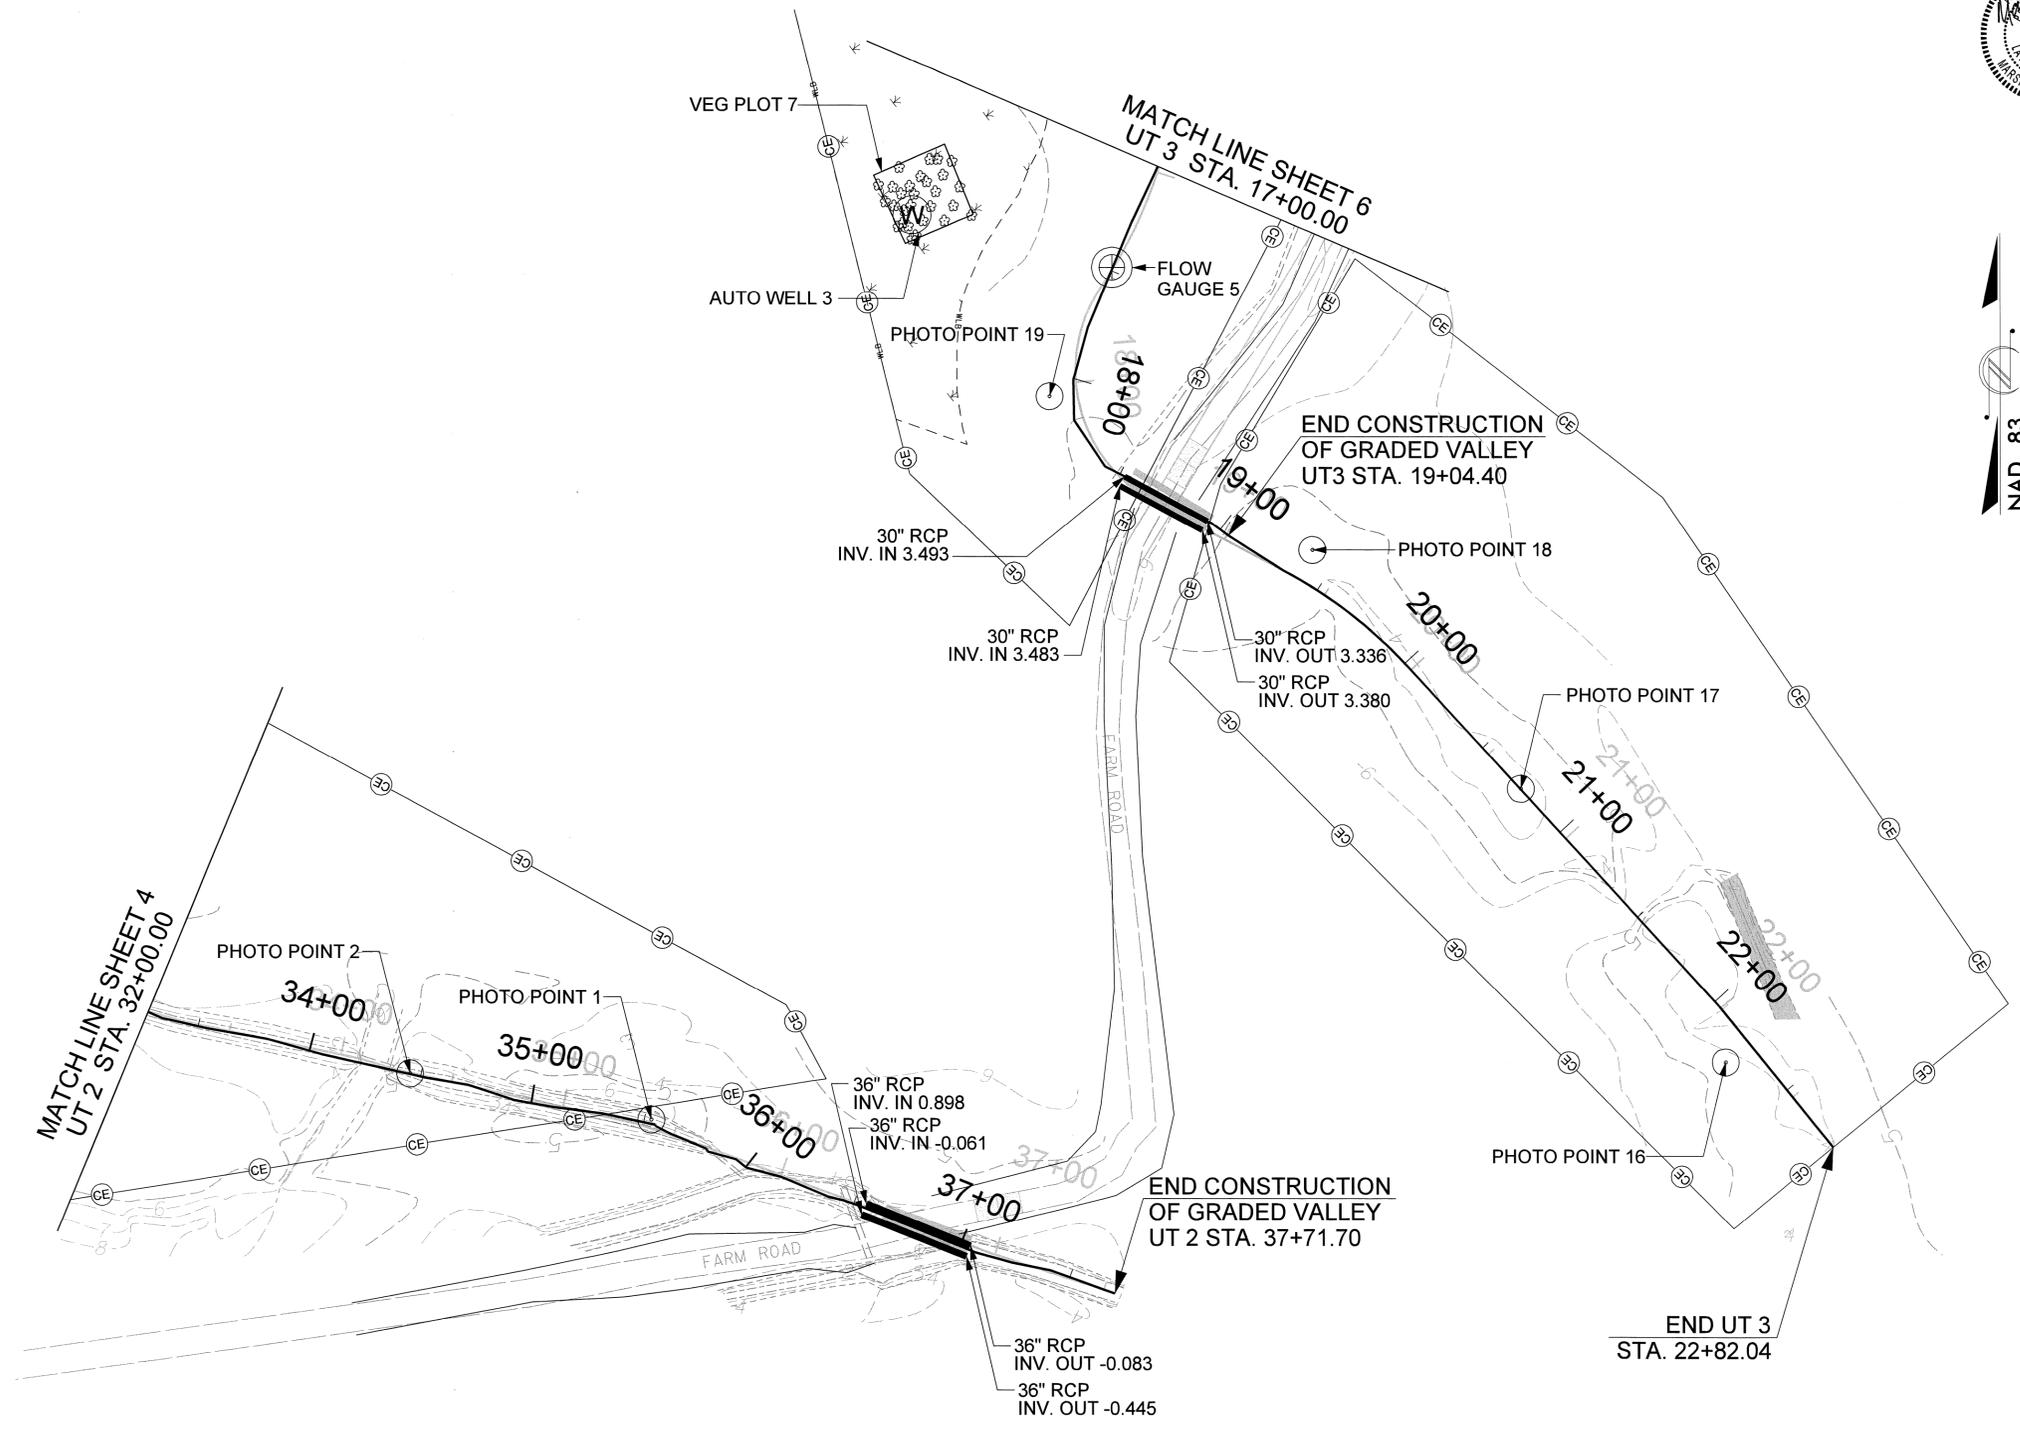
1. UT2 & UT3 WERE RESTORED TO A COASTAL PLAIN HEADWATER STREAM AND WETLAND SYSTEM BY RESTORING THE HEADWATER VALLEYS AND PROMOTING DIFFUSE FLOW.
2. TO THE EXTENT POSSIBLE, CONTRACTOR AVOIDED COMPACTION WITHIN THE RESTORED VALLEY.
3. EXCAVATED MATERIALS WERE USED TO FILL EXISTING DITCHES AND TO ELEVATE EXISTING FARM ROADS AS DIRECTED BY THE ENGINEER.
4. CONTRACTOR ENSURED A MINIMUM OF 2' OF COVER OVER ALL PROPOSED CULVERTS UNDER FARM ROADS.
5. UT3 FROM APPROXIMATELY STA. 19+50 TO STA. 22+78 WAS NOT BE DISTURBED EXCEPT TO GRADE THE HIGH AREA AT APPROXIMATE STA. 21+40 TO FILL THE EXISTING DITCH.

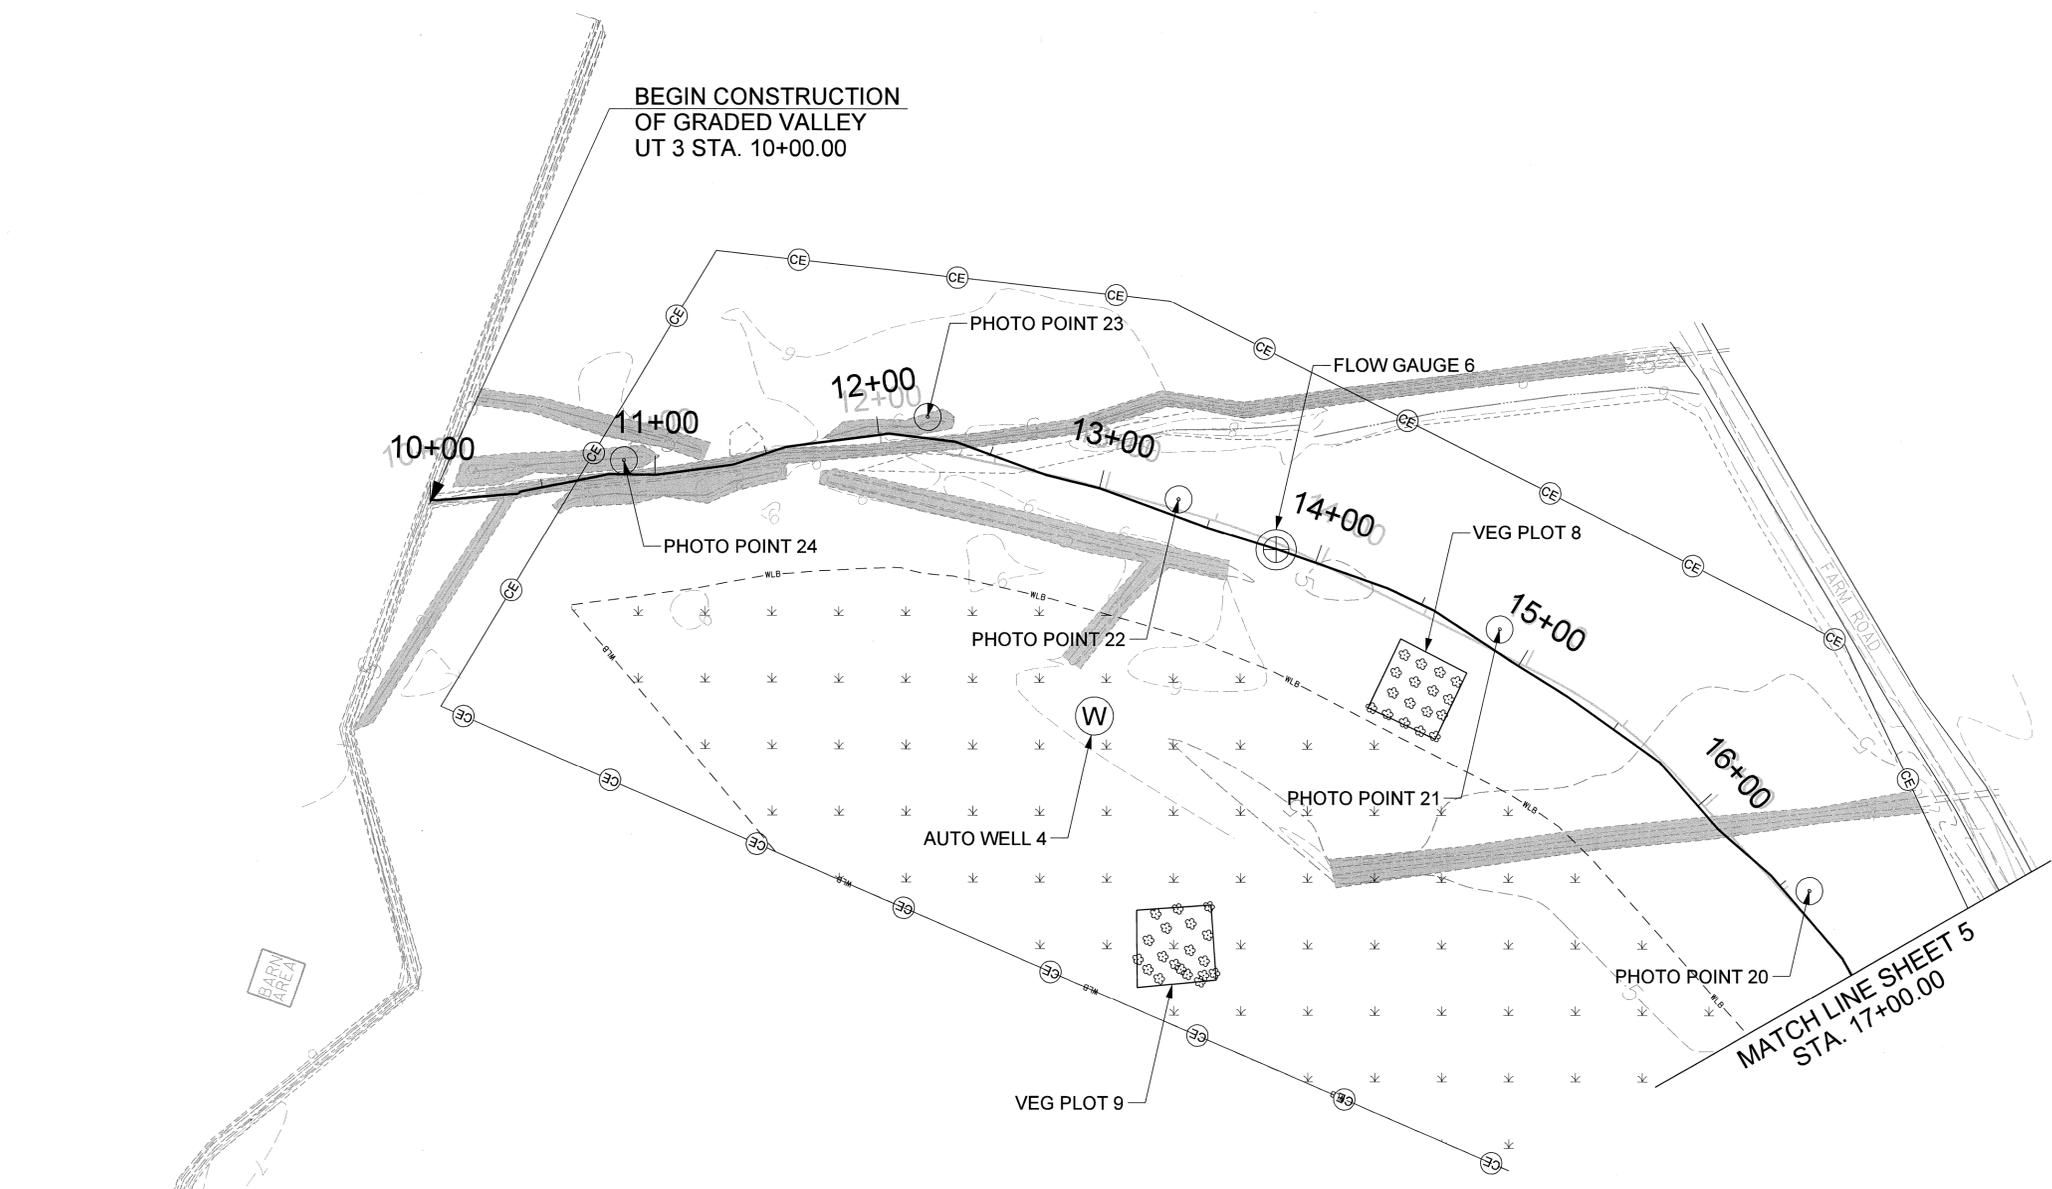
1. UT2 & UT3 WERE RESTORED TO A COASTAL PLAIN HEADWATER STREAM AND WETLAND SYSTEM BY RESTORING THE HEADWATER VALLEYS AND PROMOTING DIFFUSE FLOW.
2. TO THE EXTENT POSSIBLE, CONTRACTOR AVOIDED COMPACTION WITHIN THE RESTORED VALLEY.
3. EXCAVATED MATERIALS WERE USED TO FILL EXISTING DITCHES AND TO ELEVATE EXISTING FARM ROADS AS DIRECTED BY THE ENGINEER.
4. CONTRACTOR ENSURED A MINIMUM OF 2' OF COVER OVER ALL PROPOSED CULVERTS UNDER FARM ROADS.
