UT ALTAMAHAW SITE EEP Project No. 92837

MONITORING YEAR 1 (2012) FINAL SUBMITTAL Construction Completed February 2011

Alamance County, NC State Construction Project No. 09-0762301

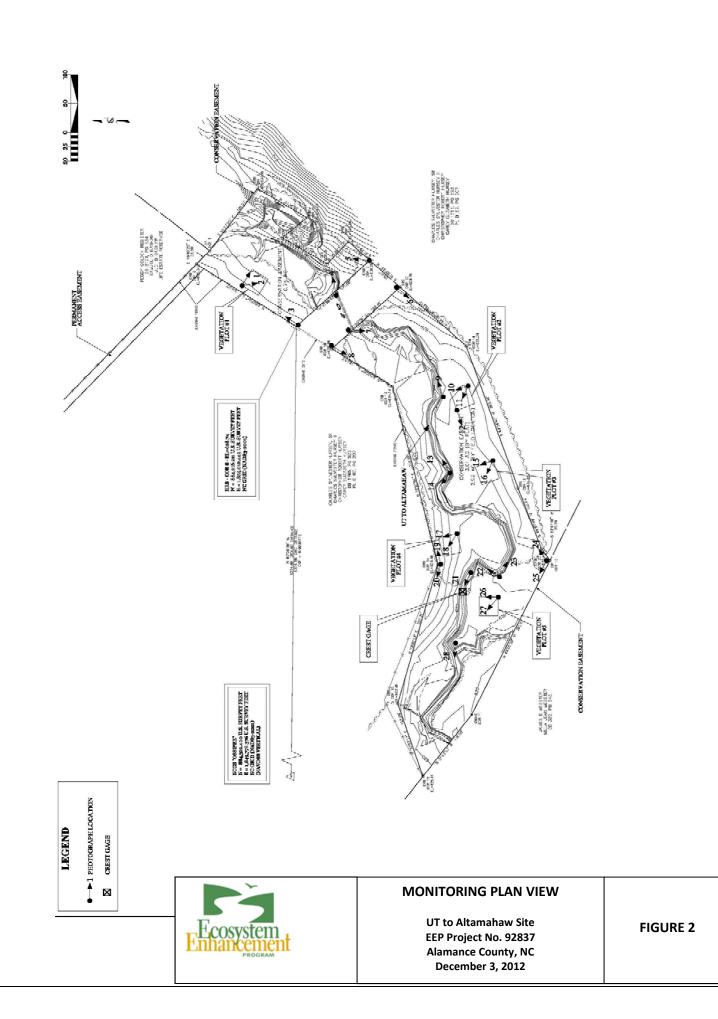
Figure 2. Monitoring Plan View Figure 3. Current Condition Plan View (CCPV) Table 6. Vegetation Condition Assessment Table Photograph Comparisons

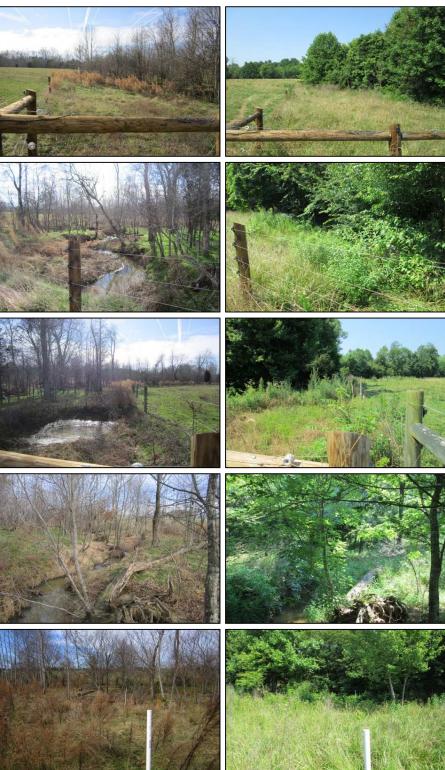
Photo # and Location **Baseline Condition 2012** MY 1 2012 Photostation 1. Facing south east along y-axis of Vegetation Plot 1. Photostation 2. Facing south across Vegetation Plot 1. Photostation 3. Facing northeast towards Vegetation Plot 1. Photostation 4. Facing east (upstream) along UT Altamahaw Creek. Photostation 5. Facing north from east corner of existing crossing.

Photostation 6. Facing southwest from south corner of existing crossing.

Photostation 7. Facing south along UT Altamhaw Creek from existing crossing.

Photostation 8. Facing southwest from corner at existing west corner of crossing.

Photostation 9. Facing upstream along UT Altamahaw Creek north of Vegetation Plot 2.

Photostation 10. Facing north along x-axis of Vegetation Plot 2.

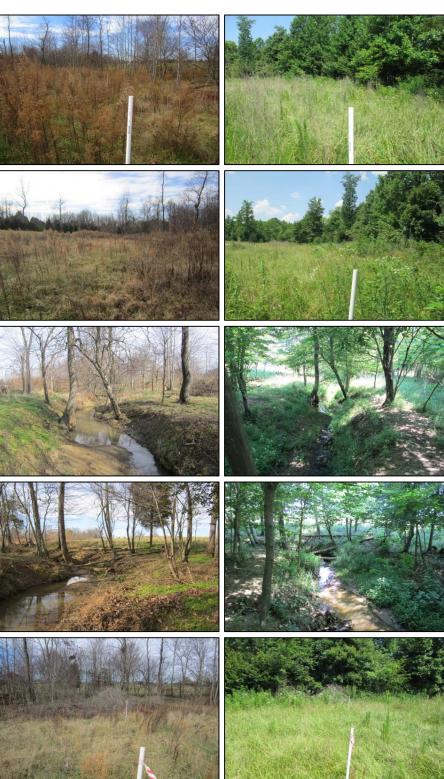
Photostation 11. Facing northwest across Vegetation Plot 2.

Photostation 12. Facing west at riparian area from Vegetation Plot 2.

Photostation 13. Facing upstream along UT Altamahaw Creek.

Photostation 14. Facing downstream along UT Altamahaw Creek.

Photostation 15. Facing north along x-axis of Vegetation Plot 3.

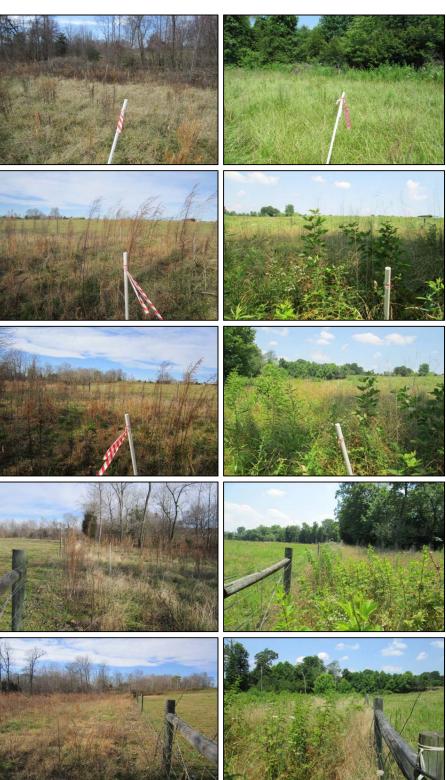
Photostation 16. Facing northwest across Vegetation Plot 3.

Photostation 17. Facing north along x-axis of Vegetation Plot 4.

Photostation 18. Facing northwest across Vegetation Plot 4.

Photostation 19. Facing northwest along easement boundary.

Photostation 20. Facing northeast along easement boundary.

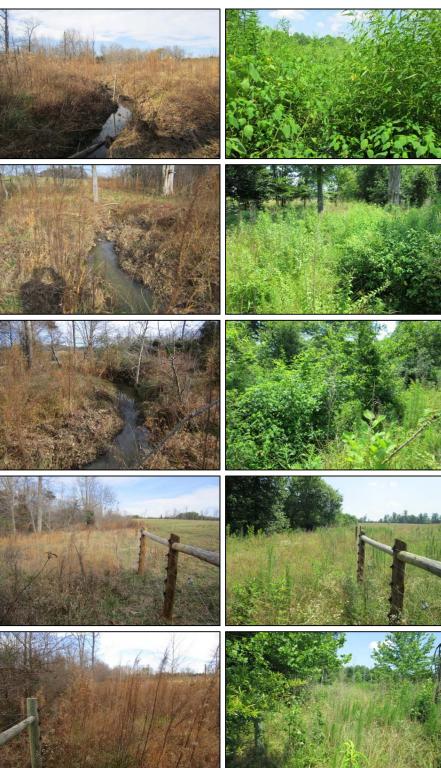
Photostation 21. Facing downstream along UT Altamahaw Creek at the crest gage.

Photostation 22. Facing downstream along UT Altamahaw Creek.

Photostation 23. Facing upstream along UT Altamahaw Creek.

Photostation 24. Facing northwest along southern easement boundary.

Photostation 25. Facing northwest along southern easement boundary.

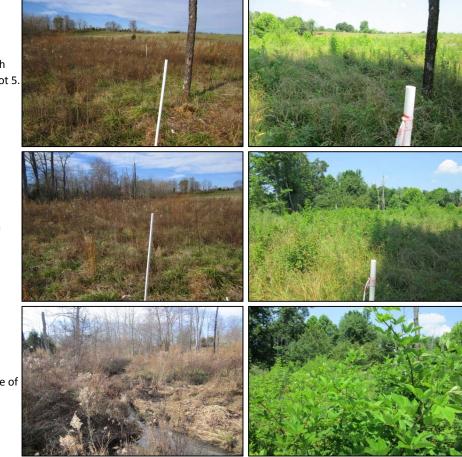
Photostation 26. Facing north along x-axis of Vegetation Plot 5.

Photostation 27. Facing northwest across Vegetation Plot 5.

Photostation 28. Facing downstream from confluence of two unnamed tributaries.

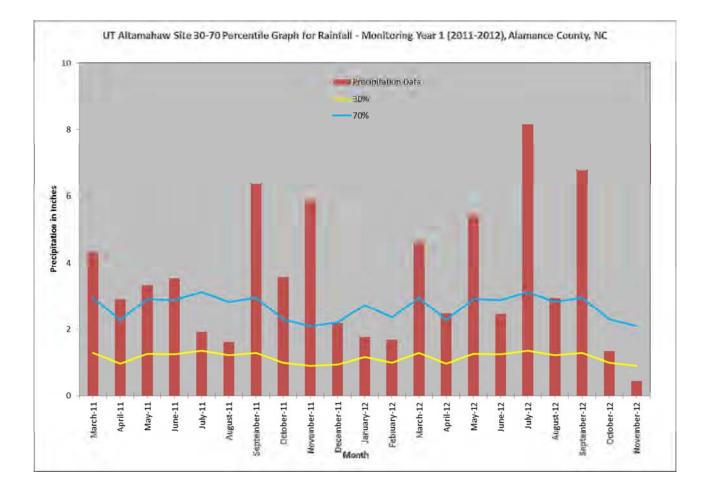
Table 12. Verification of Bankfull Events Table 13. Monthly Rainfall Data

* Based on daily rainfall data prior to installation of Crest Gage. Approximately 2.4 inches of rain was recorded over a span of two days.
