# UT to Rocky River (Smith Tract) Stream and Buffer Restoration, Enhancement, and Preservation Chatham County, North Carolina

# **Mitigation Report**

March 20, 2007

UT to Rocky River Stream Restoration, Enhancement, and Preservation Project, SCO# 040614001 Mitigation Report March 20, 2007

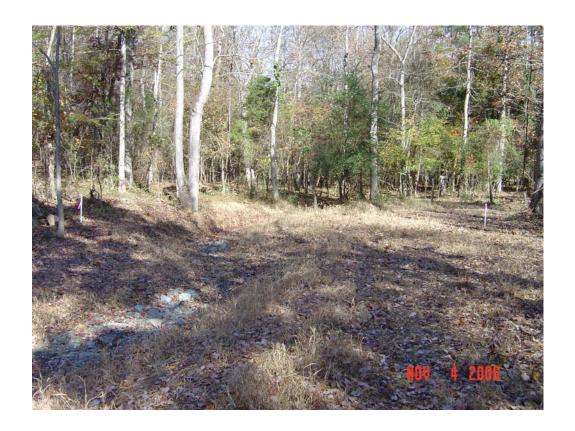
Project: UT to Rocky River
Location: Reach 2 Permanent Cross Section #2 Pool
Date: 11/27/2006

Left Permanent Benchmark Elevation: Note: Cross Section taken from left to right looking downstream Photo Reference Location: Looking upstream

Dimension: Permanent cross sections were established in the frequency of one for every 20 bankfull widths along the length of the reach. Cross section sites were selected such that approximately half are placed in riffles and half are placed in pools. Measurements of W/D ratio, entrenchment ratios, and low bank height ratio will be monitored yearly. The location of the cross sections was GPS'd. There is one cross section along Reach 1 and five cross sections along Reach 2.
