Lake Waccamaw Hydrilla Monitoring Report

August 26th - 27th, 2020

NC Aquatic Weed Control Program

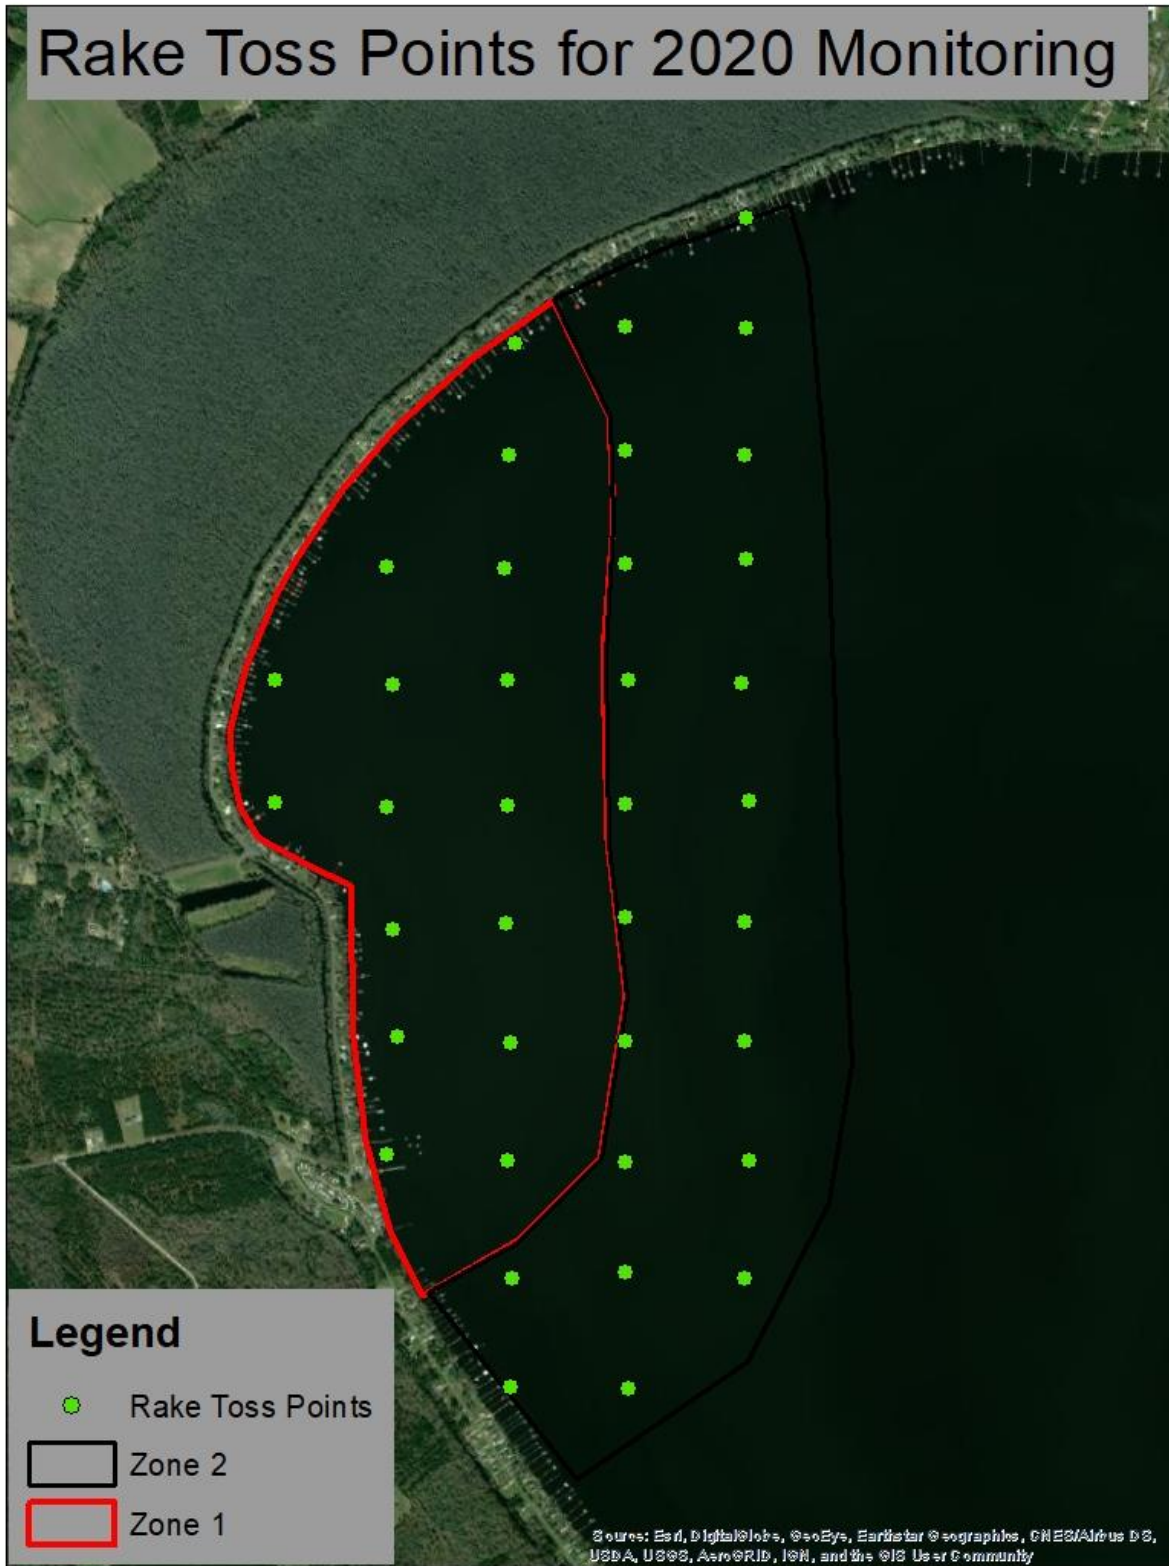
Map 2. Rake sampling points. Note: Zone 2 is defined by a black line, which is difficult to see on this image.

Rake tosses were conducted at pre-determined points (see Map 2 & Table 1) and conducted whenever SAV showed up on the real-time image display of the hydro-acoustic unit (Lowrance HDS). Rake tosses did not recover any plants. Mussels were recovered regularly. On a couple occasions the real-time display suggested presence of SAV; however, even targeted rake tosses recovered no plants.

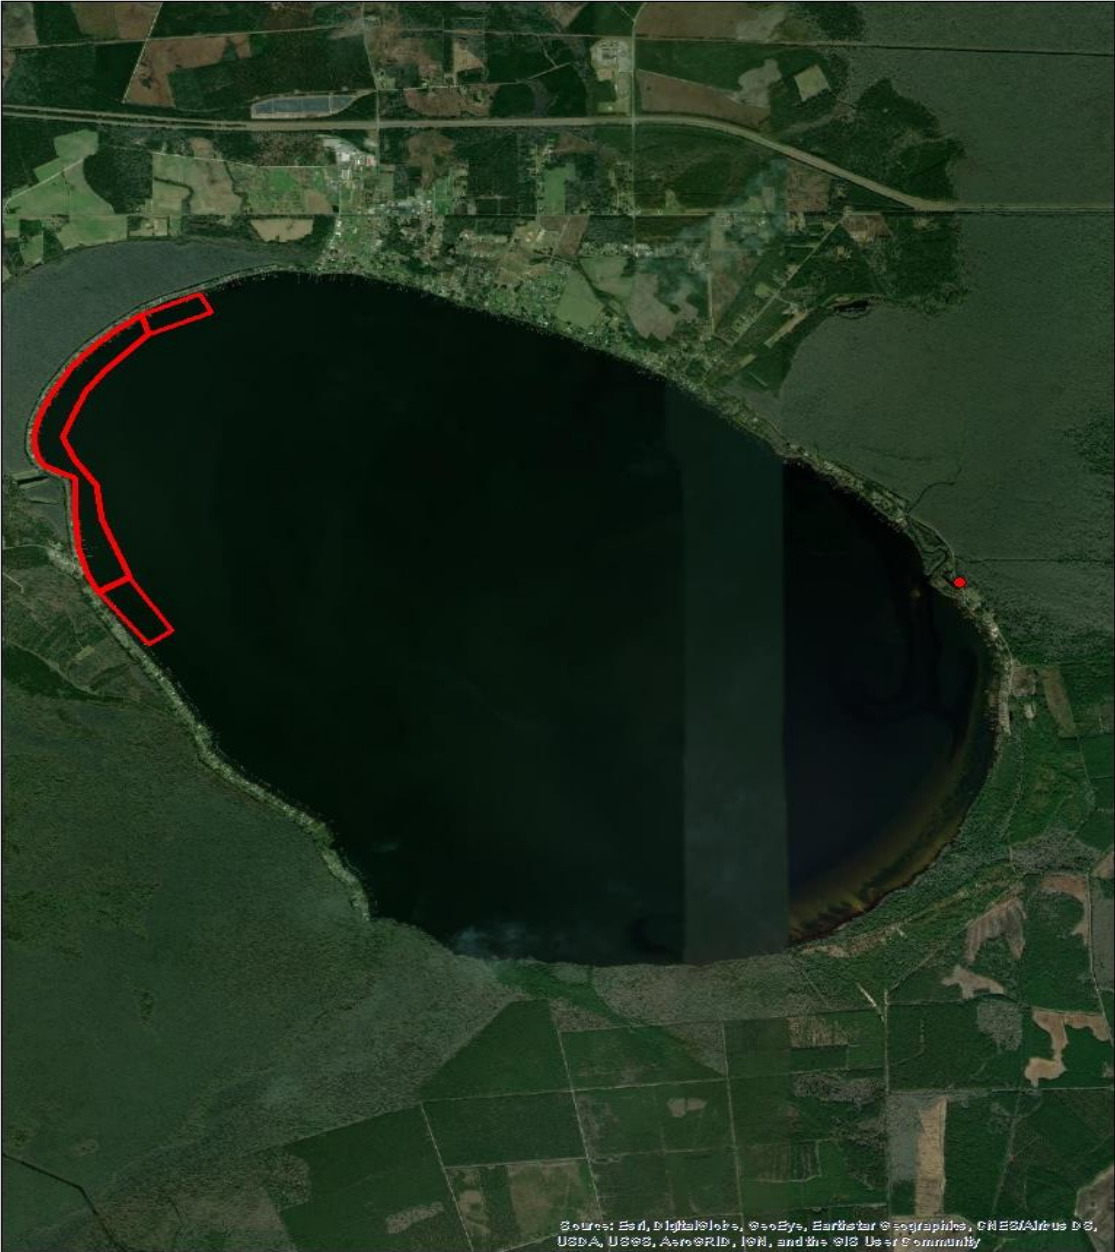
Map 3. Area where Hydrilla monitoring was conducted (red polygons).

Hydro-acoustic data was collected to determine the bio-volume (BV) of SAV along the shoreline within Zone 1 & 2 to a depth of 6 feet. See Map 3 and Diagram 1.

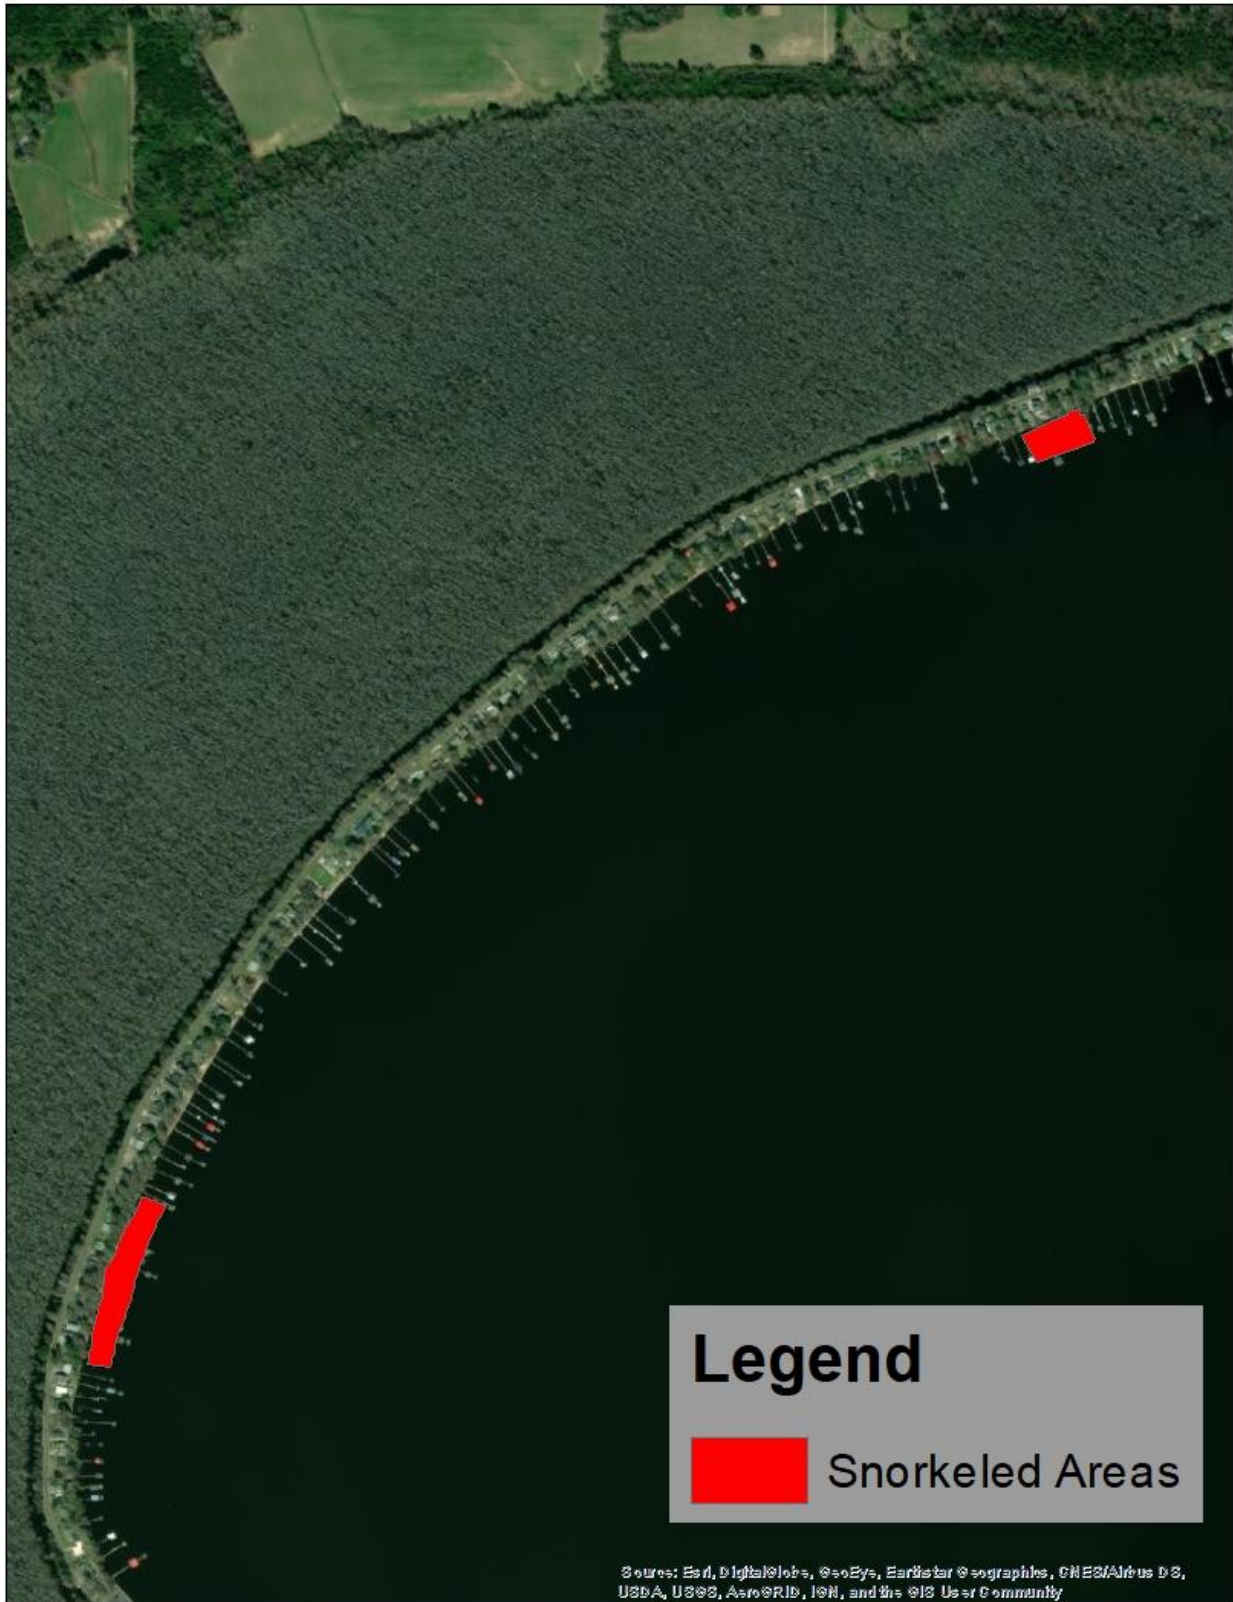
Map 4. Area that was inspected via snorkeling & wading (highlighted in red).

Visual investigation via snorkeling and wading was conducted 8/26/20, see Map 4. Conditions were good. Water was tannic but no suspended particles. No submersed vegetation, only Narrowleaf Spatterdock (*Nuphar luteum* ssp. *sagittifolium*) was observed. Areas that were snorkeled during the previous monitoring cycle had Spatterdock with Chara (at low density) associated with it, but the areas snorkeled during this monitoring cycle had little to no Spatterdock. An additional snorkeling event was performed. This additional event was done outside of the monitoring area. At the south end of the lake a single transect was snorkeled from ~3' depth to ~1' depth running perpendicular to the shoreline. There was a significant amount of Lavender Bladderwort (*Utricularia resupinata*) observed and in some areas the density was such that it resembled carpet. Also observed were softball-sized masses/tangles of *Eleocharis* which were associated with fish nests and some of these tangles formed a ring just inside the edge of the fish net.

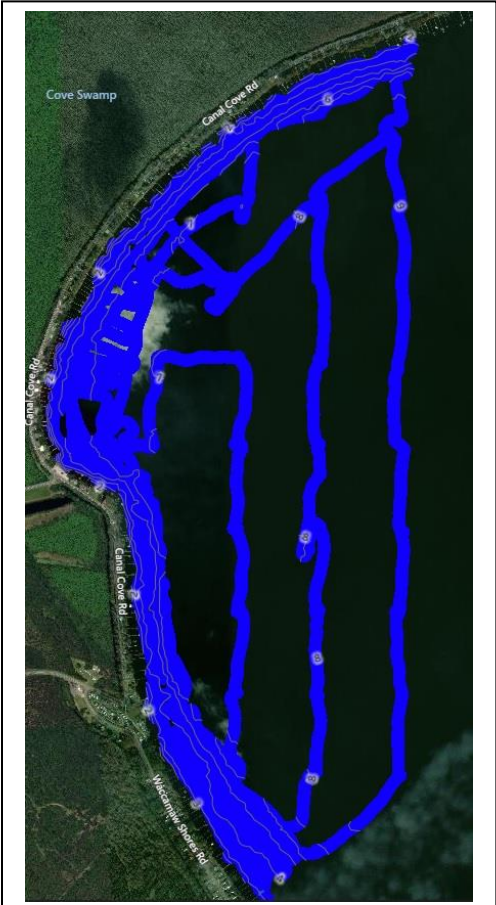
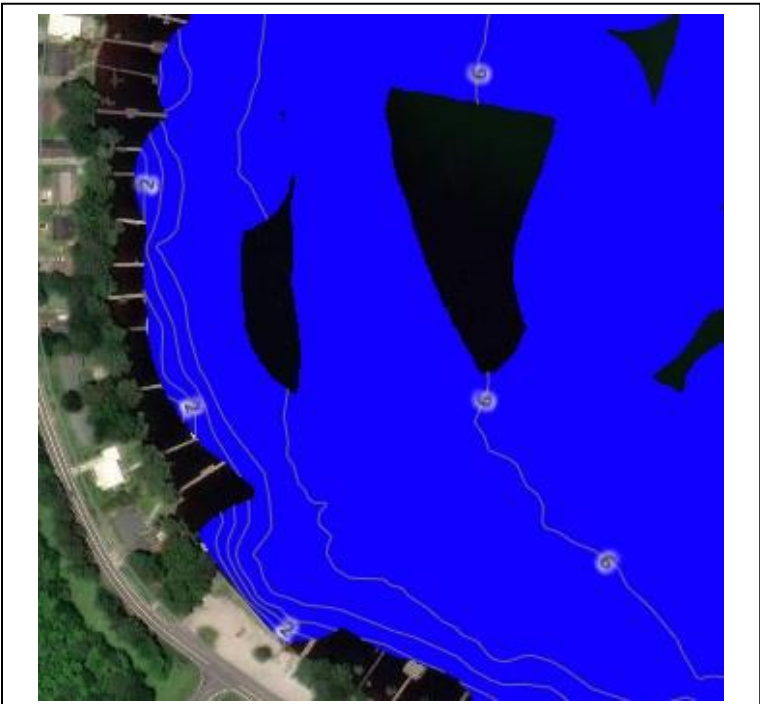
Zone 1 and 2 combined.

Diagram 1. Biobase website screenshot collection.

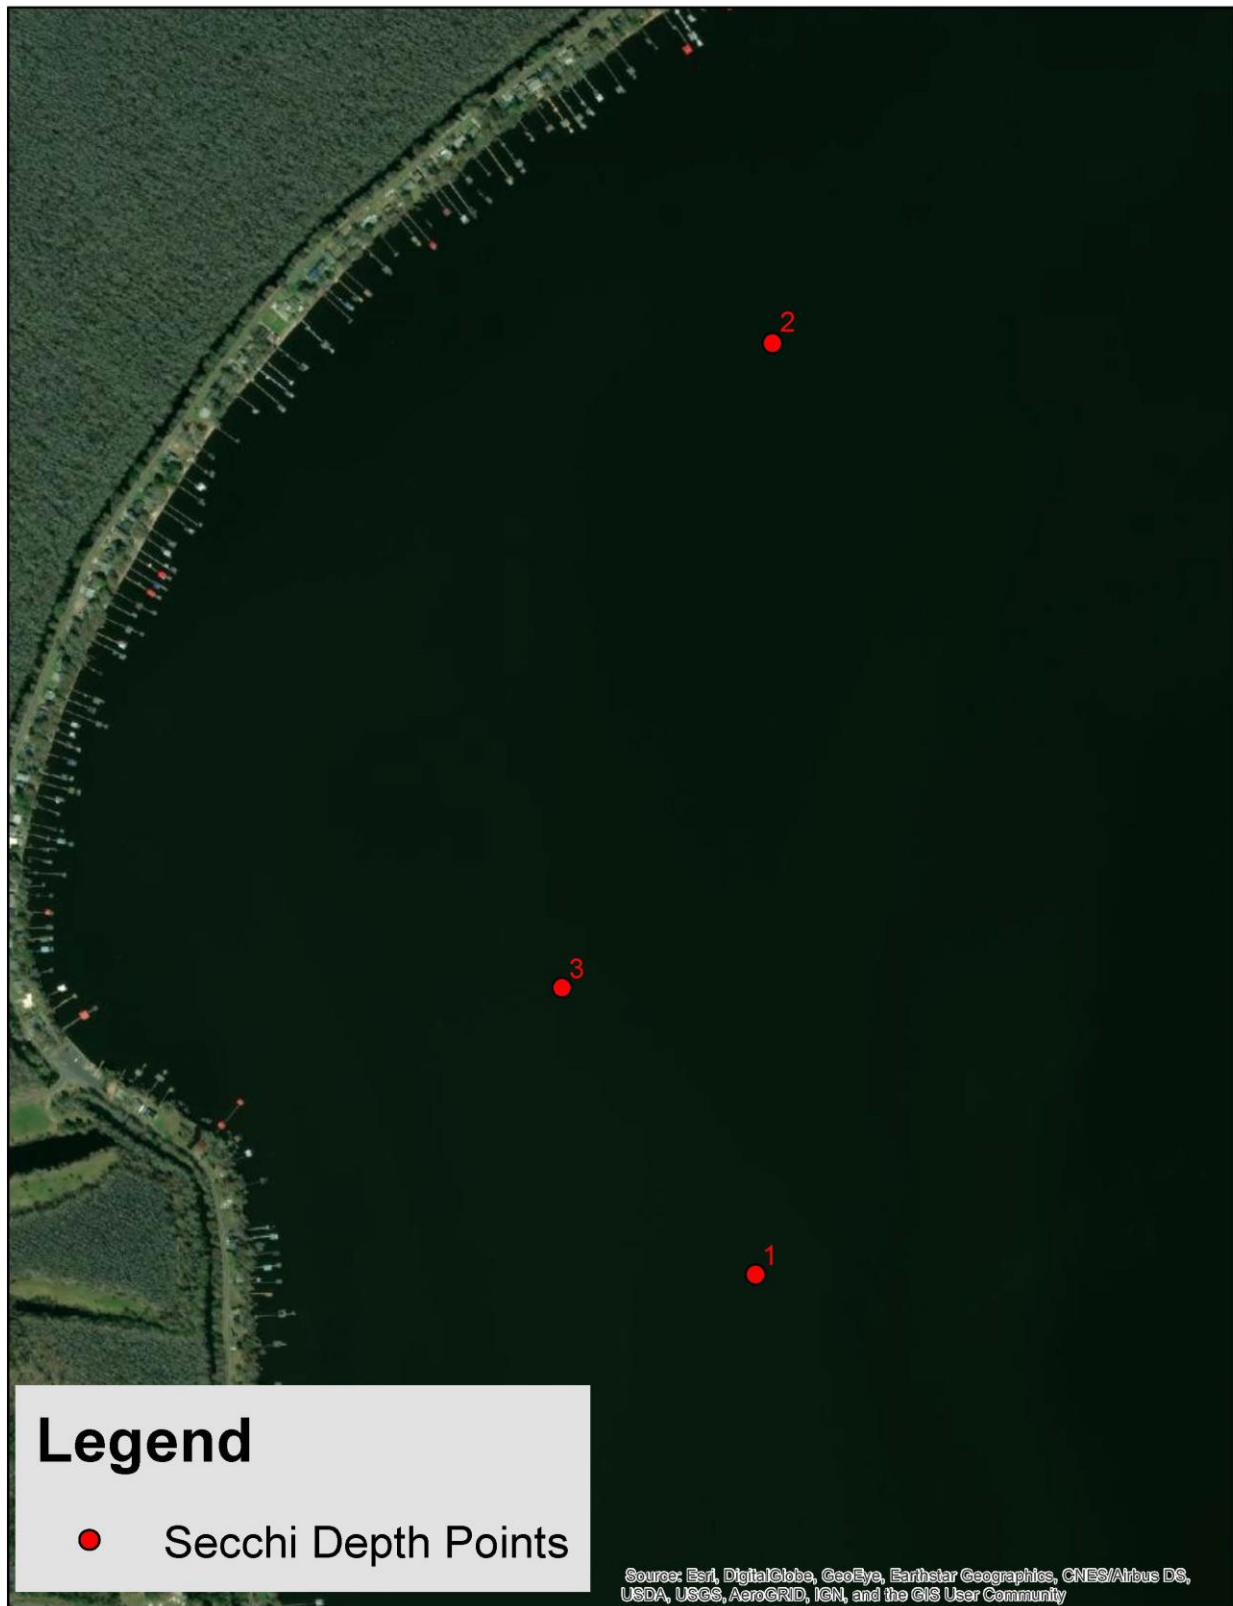
Map 5. Map of Secchi disk locations.

Secchi depths were also recorded at different locations within Zone 1 (see Map 5 and Table 2). The average Secchi reading across the three sites was just under 3 feet.
