**2020 White Lake  
Aquatic Vegetation Survey**

**Survey Conducted by:  
North Carolina State University**

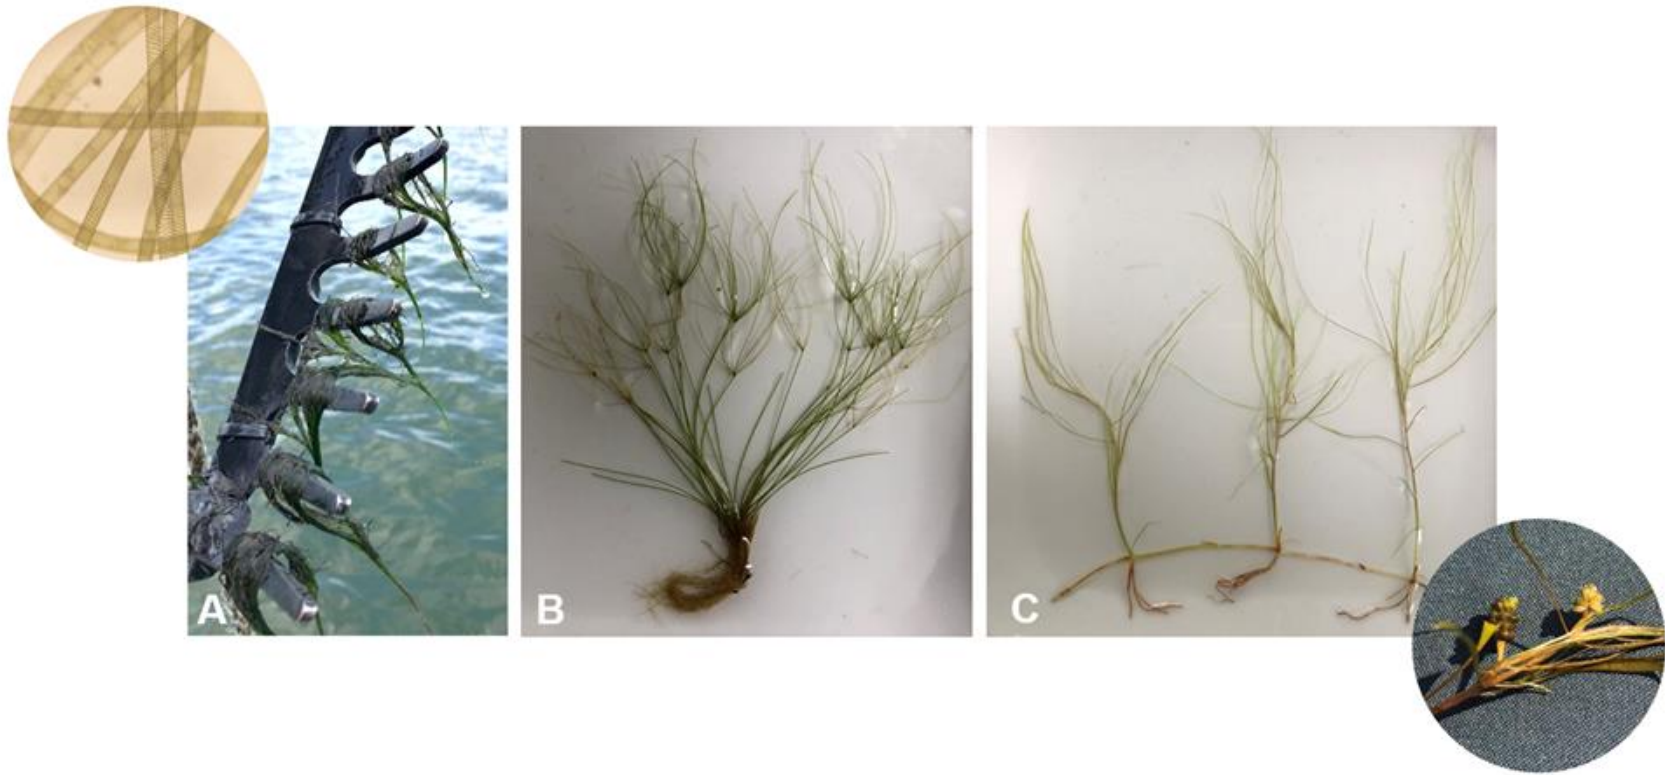
**Figure 5.** Tuckerman's Pondweed (*Potamogeton confervoides*) look-alikes in White Lake:  
a) filamentous algae, b) slender spikerush, c) Tuckerman's pondweed

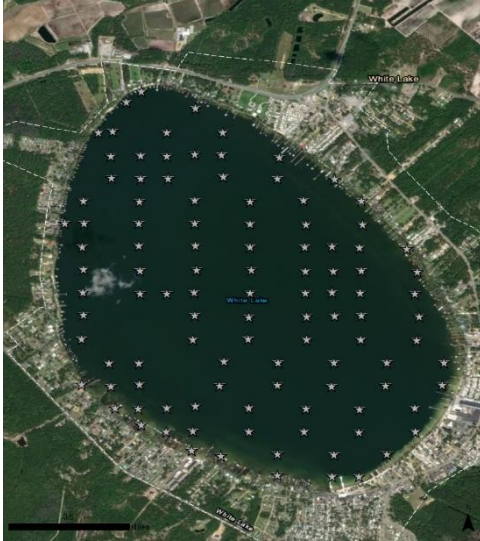
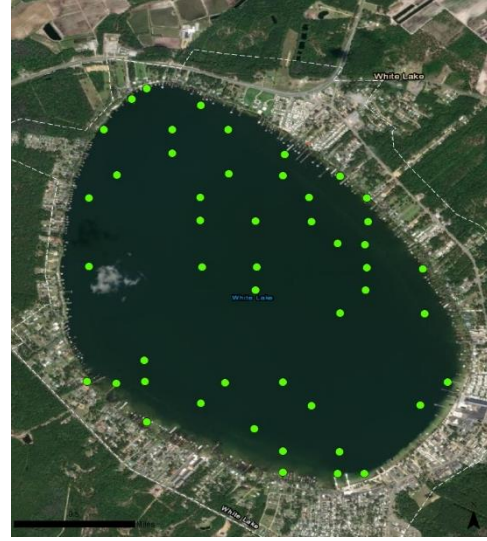
**Figure 13.** Results of June 2020 SAV survey at White Lake

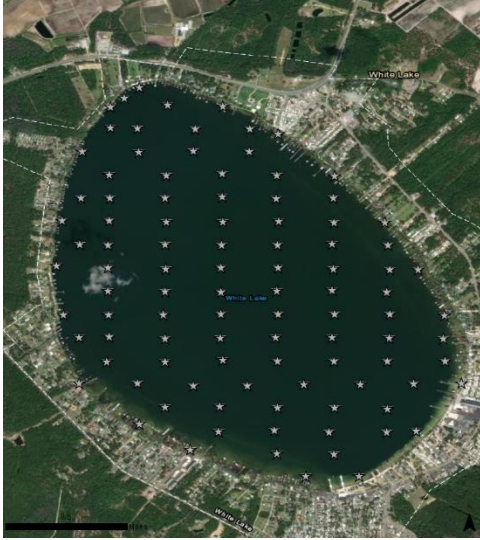
**Figure 14. Results of August 2020 SAV survey at White Lake**
