# 2022 DWR Submerged Aquatic Vegetation Survey Report Lake Devin

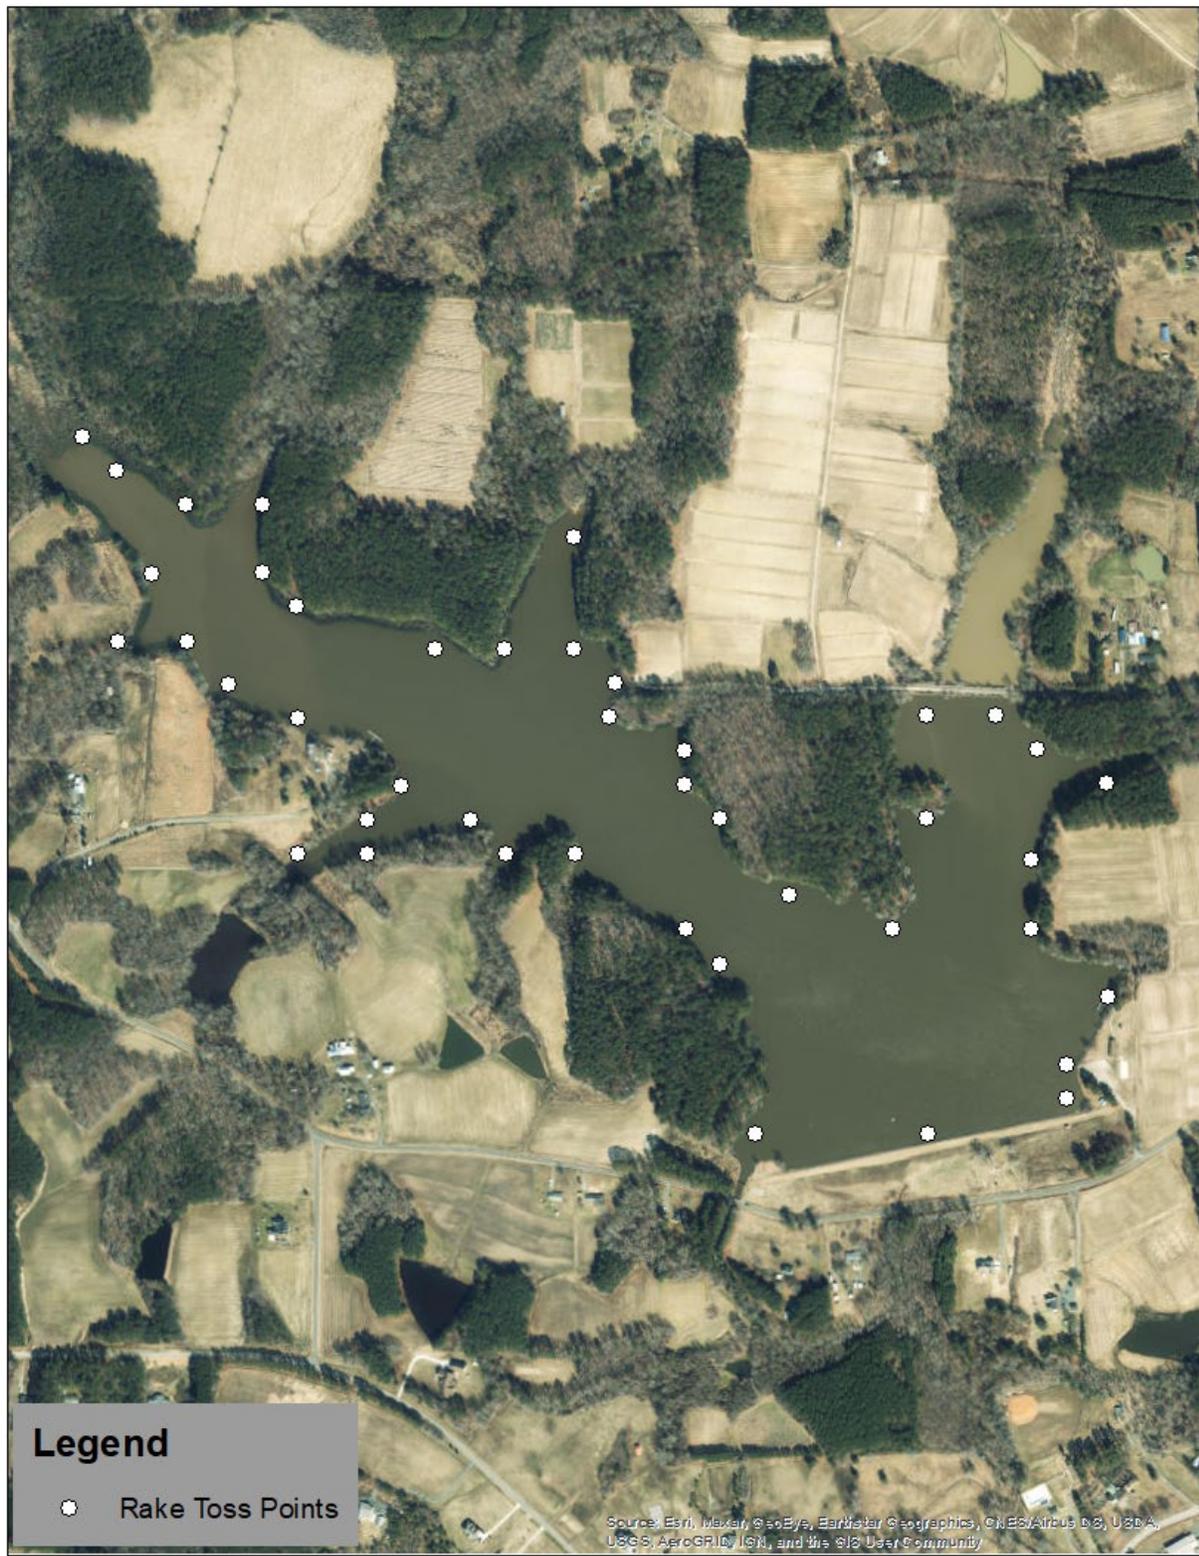
Figure 1. Map showing pre-determined rake toss point locations in Lake Devin.

A full-lake survey was completed on September 28<sup>th</sup>. Using a point-intercept method, a total of 43 points were sampled at Lake Devin (Figure 1). Rake coverage was quantified using a scale from 0 to 4 (0 = no vegetation; 1 (Trace) = <25%; 2 (Sparse)= 25% - 50%; 3 (Moderate)= 50% - 75%; 4 (Dense)= 75% - 100%). Additionally, a recording fathometer (SONAR) was used to map and record the bottom. Approximately 5 miles of SONAR were logged. The SONAR data was uploaded to a third-party company, Biobase, to quantify the depth and biovolume data. Biovolume is a percentage of the water column taken up by vegetation when vegetation is present. All of this was then combined with the rake-toss data using GIS software to estimate coverage.

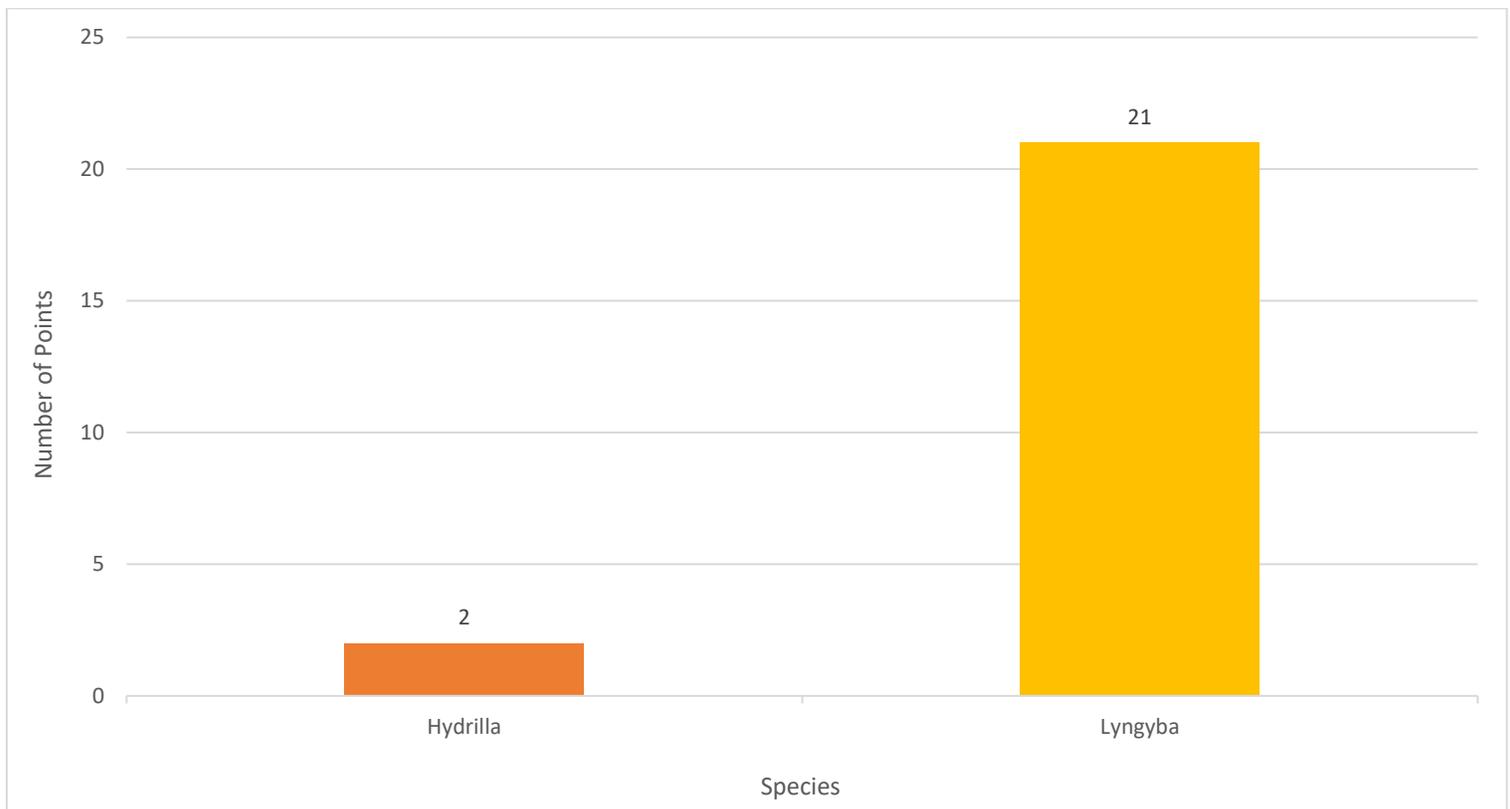
Figure 2. Relative abundance during the 2022 Lake Devin survey.

SAV was found at 21, or 49%, of the rake toss points. Species found during the survey included Hydrilla (*Hydrilla verticillata*) and the blue-green algae Lyngbya (*Microseira wollei*). (Table 1; Figures 2 – 5). Both species have been found during past surveys.

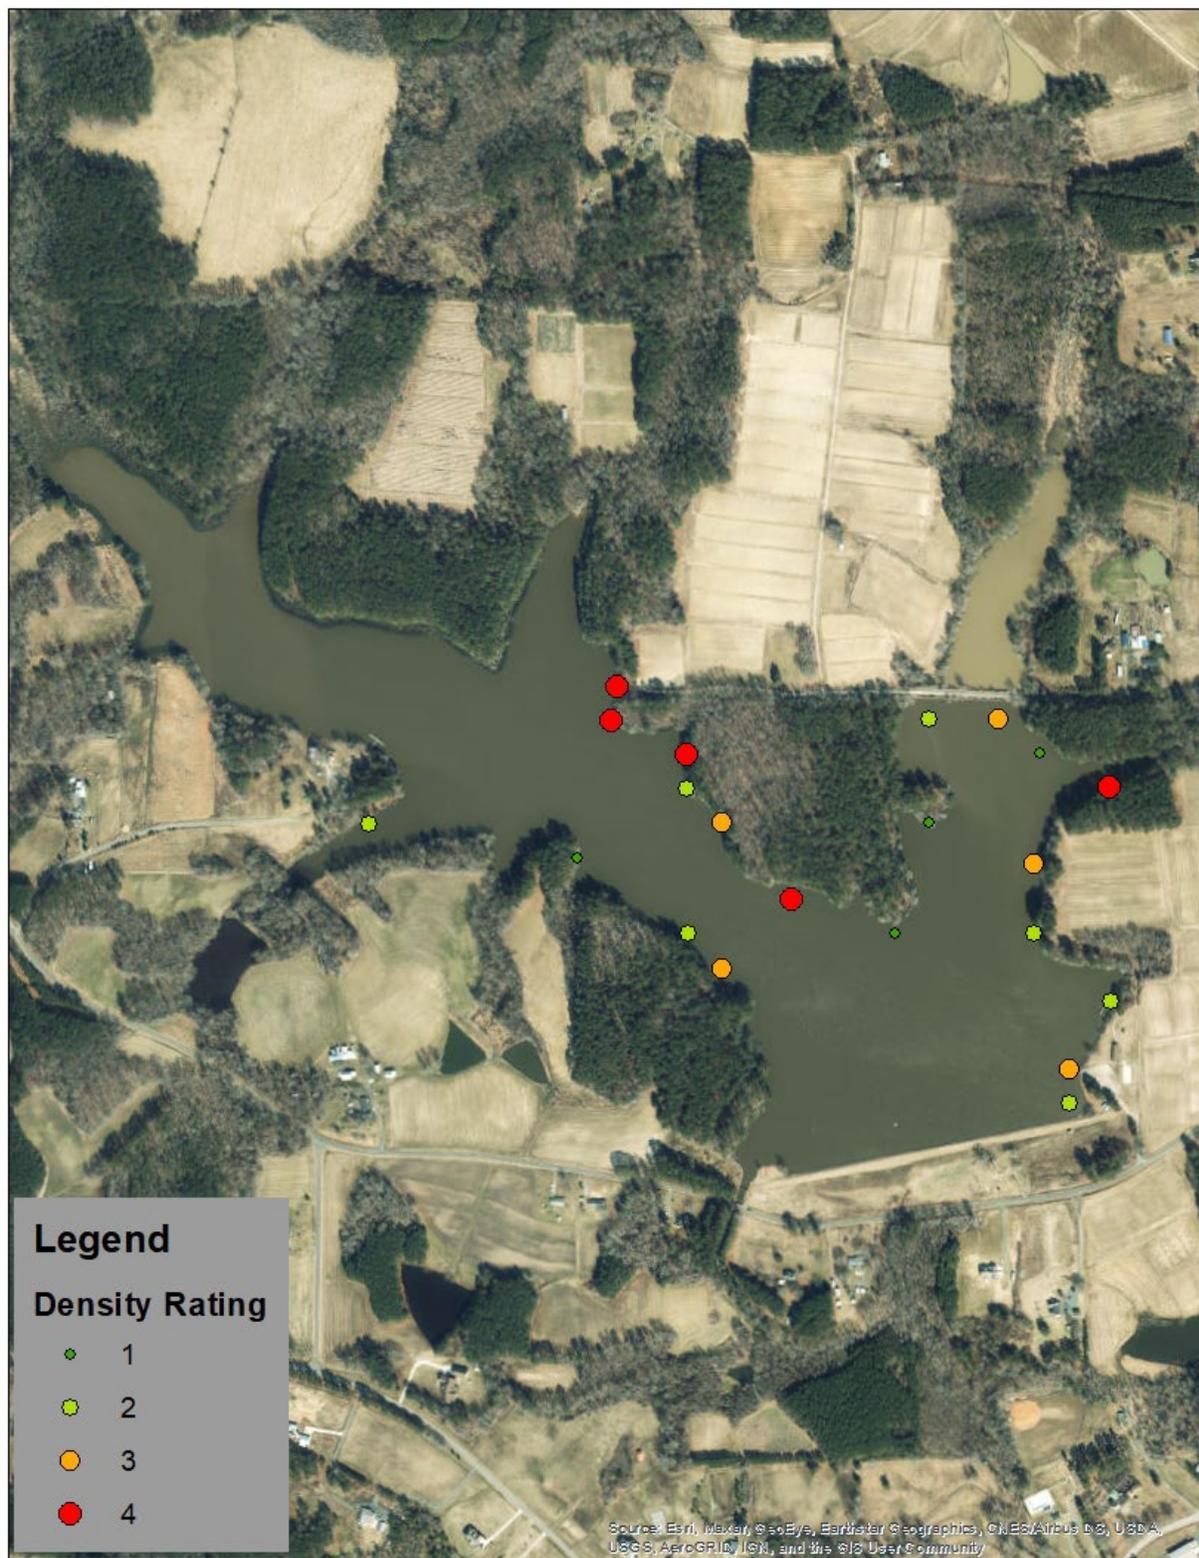
Figure 3. Map showing density rating at each rake toss point.

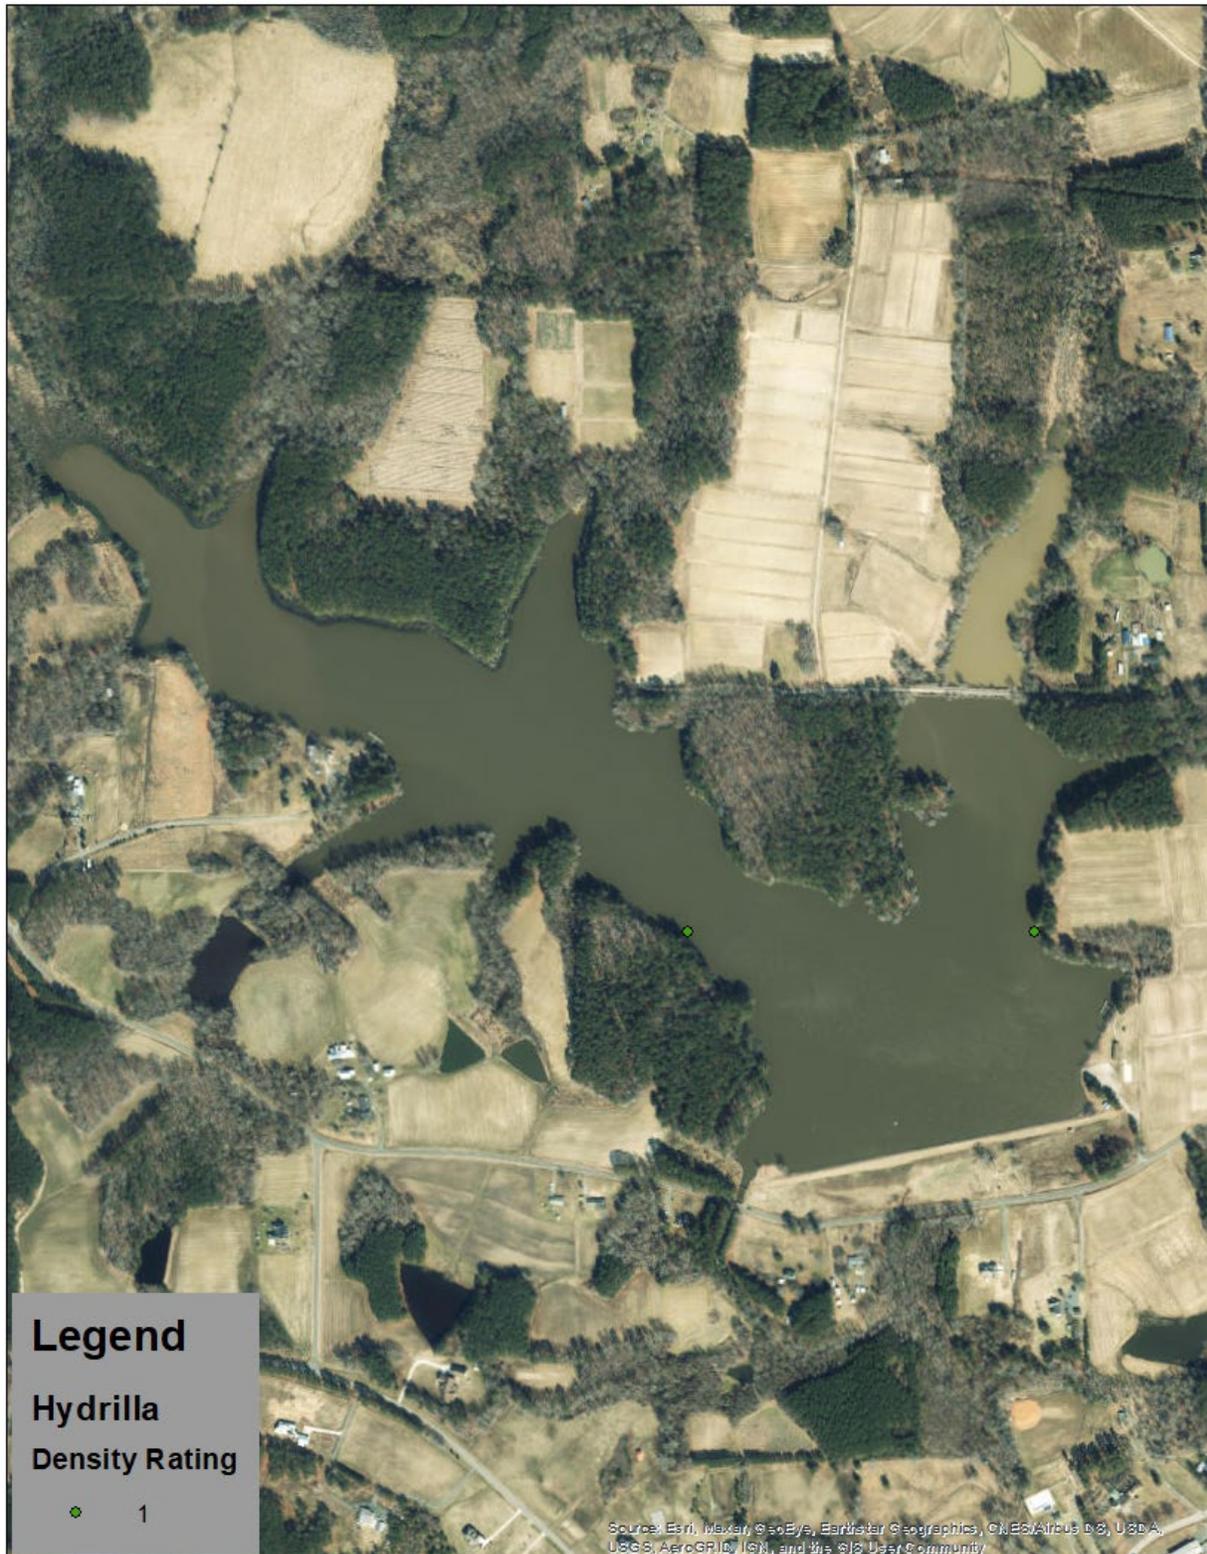
Figure 4. Map location of Hydrilla and density rating.

Hydrilla was significantly less in 2022 than in 2021. In 2021, the estimated Hydrilla coverage in the lake was 29 acres but in 2022 it was less than 1 acre. The estimated coverage of Lyngbya in the lake was 5.4 acres (Figure 6).

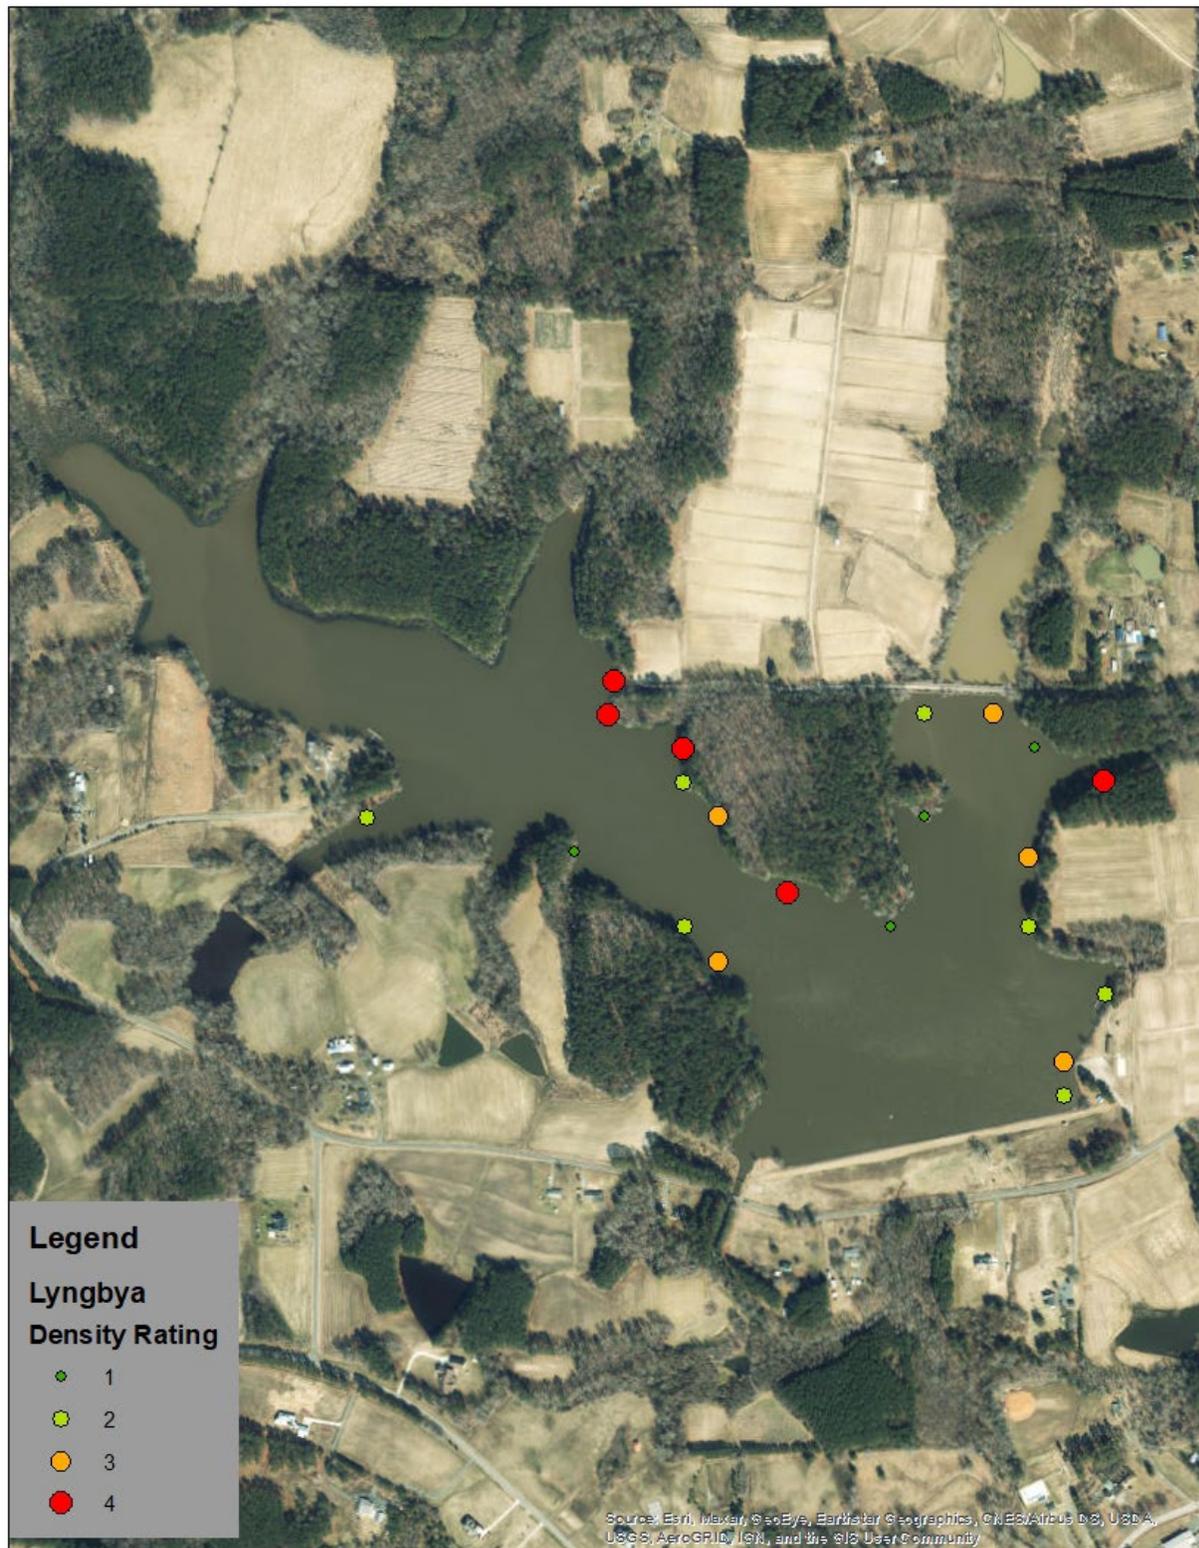
Figure 5. Map showing location of Lyngbya and density rating.

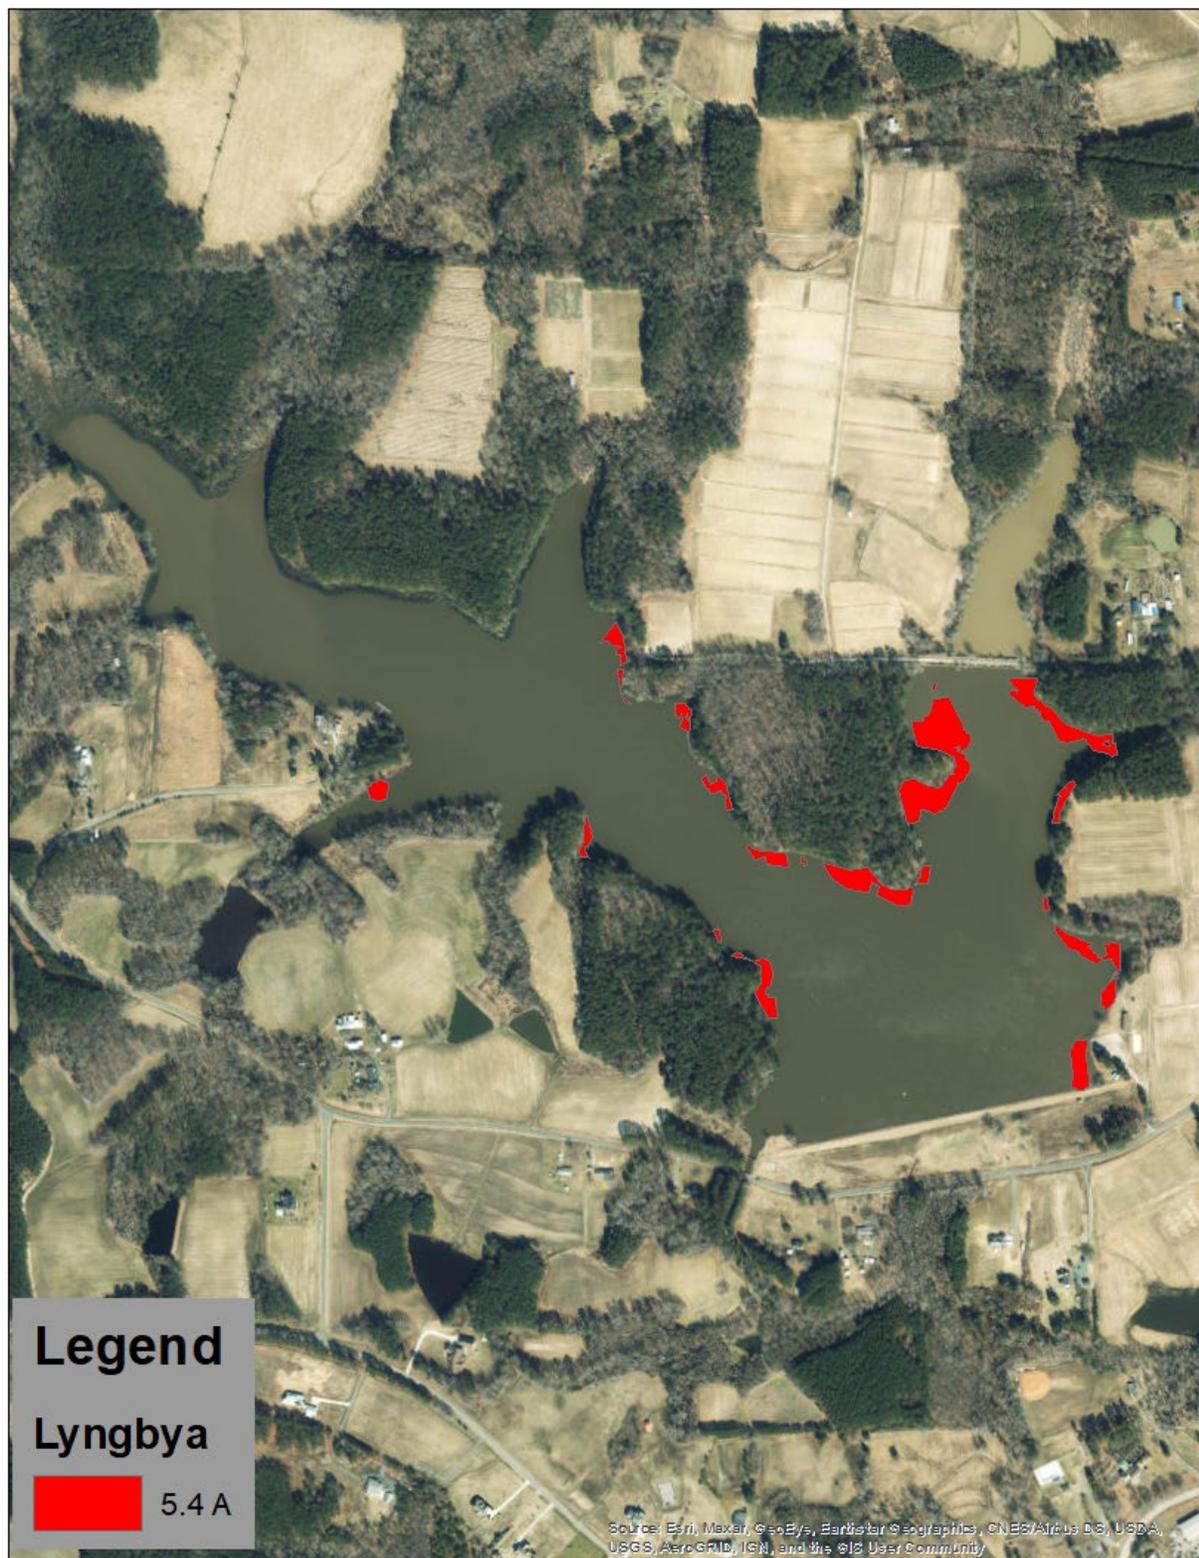
Figure 6. Map showing Lyngbya coverage in 2022.
