2022 DWR Submerged Aquatic Vegetation Survey Report

William B. Umstead State Park

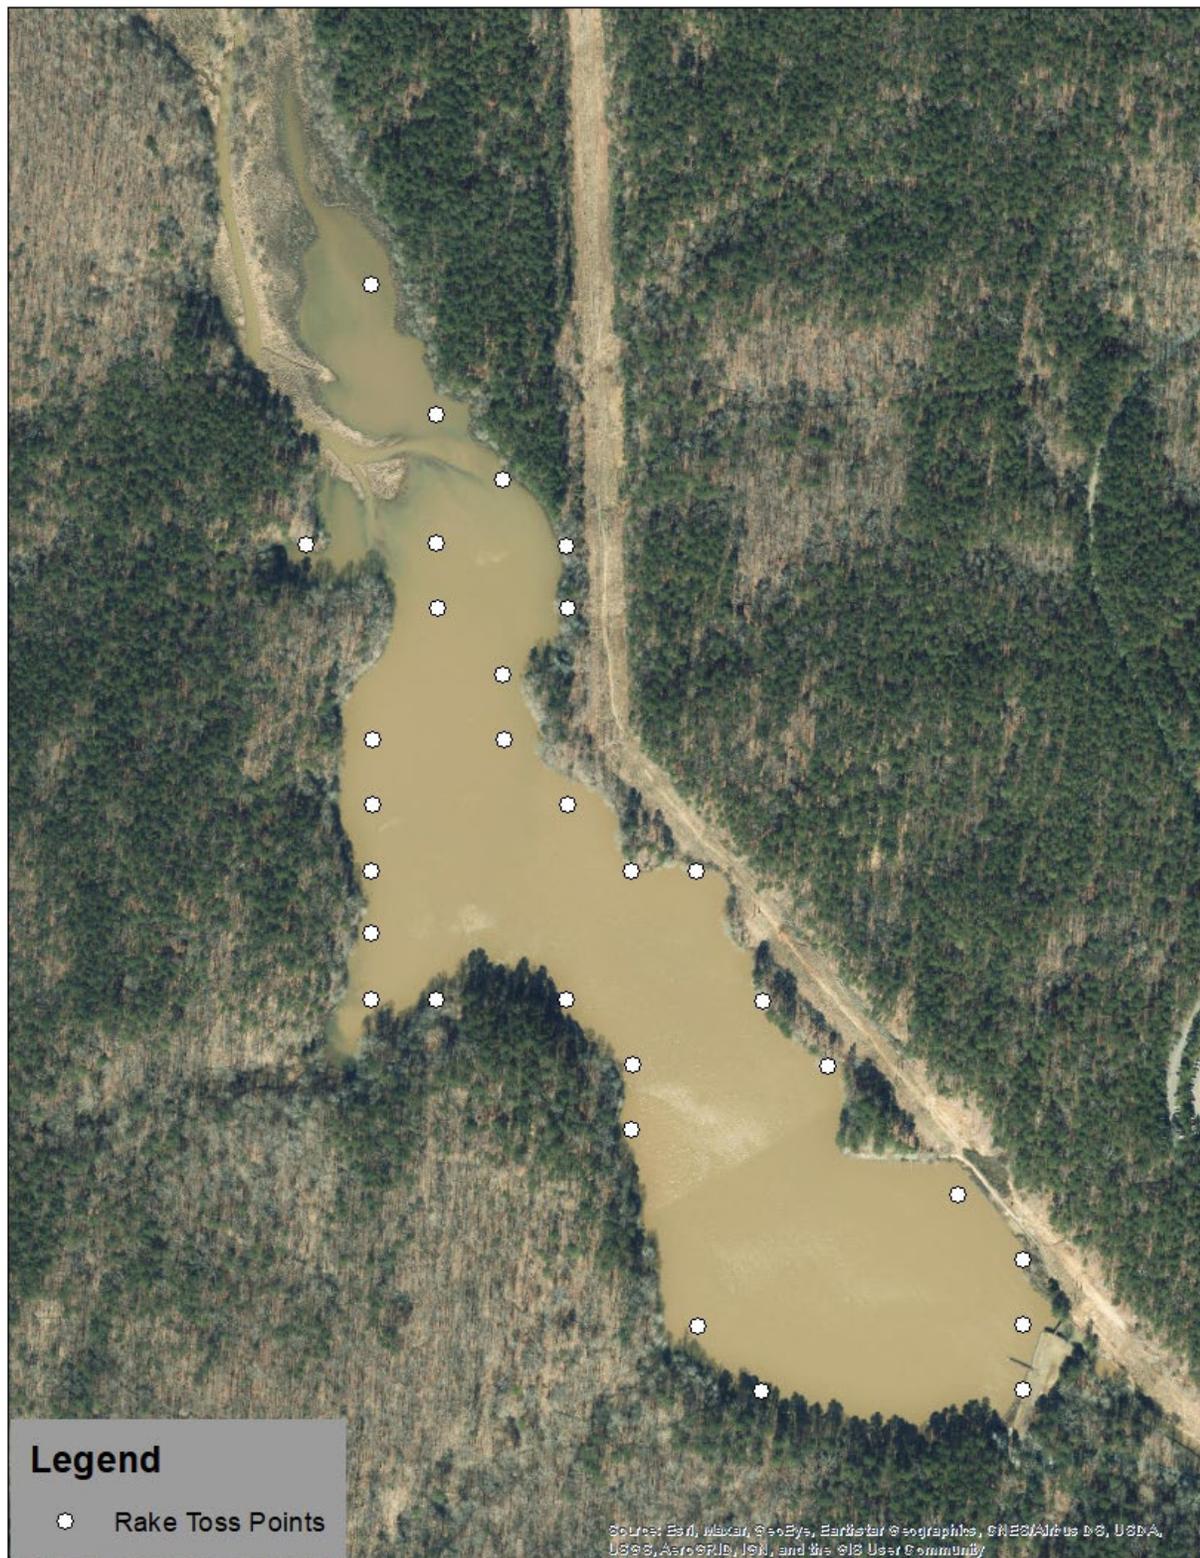
Figure 1. Map showing pre-determined rake toss points at Big Lake.

The AWCP completed a full-lake survey of Big Lake was completed on October 12th, 2022. Using a point-intercept method, a total of 30 points were sampled (Figure 1). At Big Lake three rake tosses were conducted at pre-determined points throughout the lake to determine presence/absence of SAV as well as quantify rake coverage. Rake coverage was quantified using a scale from 0 to 4 (0 = no vegetation; 1 (Trace) = <25%; 2 (Sparse) = 25% - 50%; 3 (Moderate) = 50% - 75%; 4 (Dense) = 75% - 100%). Additionally, a recording fathometer (SONAR) was used to map and record the bottom. Approximately 3.5 miles of SONAR were logged. The SONAR data was uploaded to a third-party company, Biobase, to quantify the depth and biovolume data. Biovolume is a percentage of the water column taken up by vegetation, when vegetation is present. All of this was then combined with the rake-toss data using GIS software to estimate coverage. At Reedy Creek Lake and Sycamore Lake a visual survey was completed. The survey of Reedy Creek Lake was completed on October 13, 2022, and the survey of Sycamore Lake was completed on October 12th, 2022. Approximately 1.2 miles of SONAR were logged at Sycamore Lake.

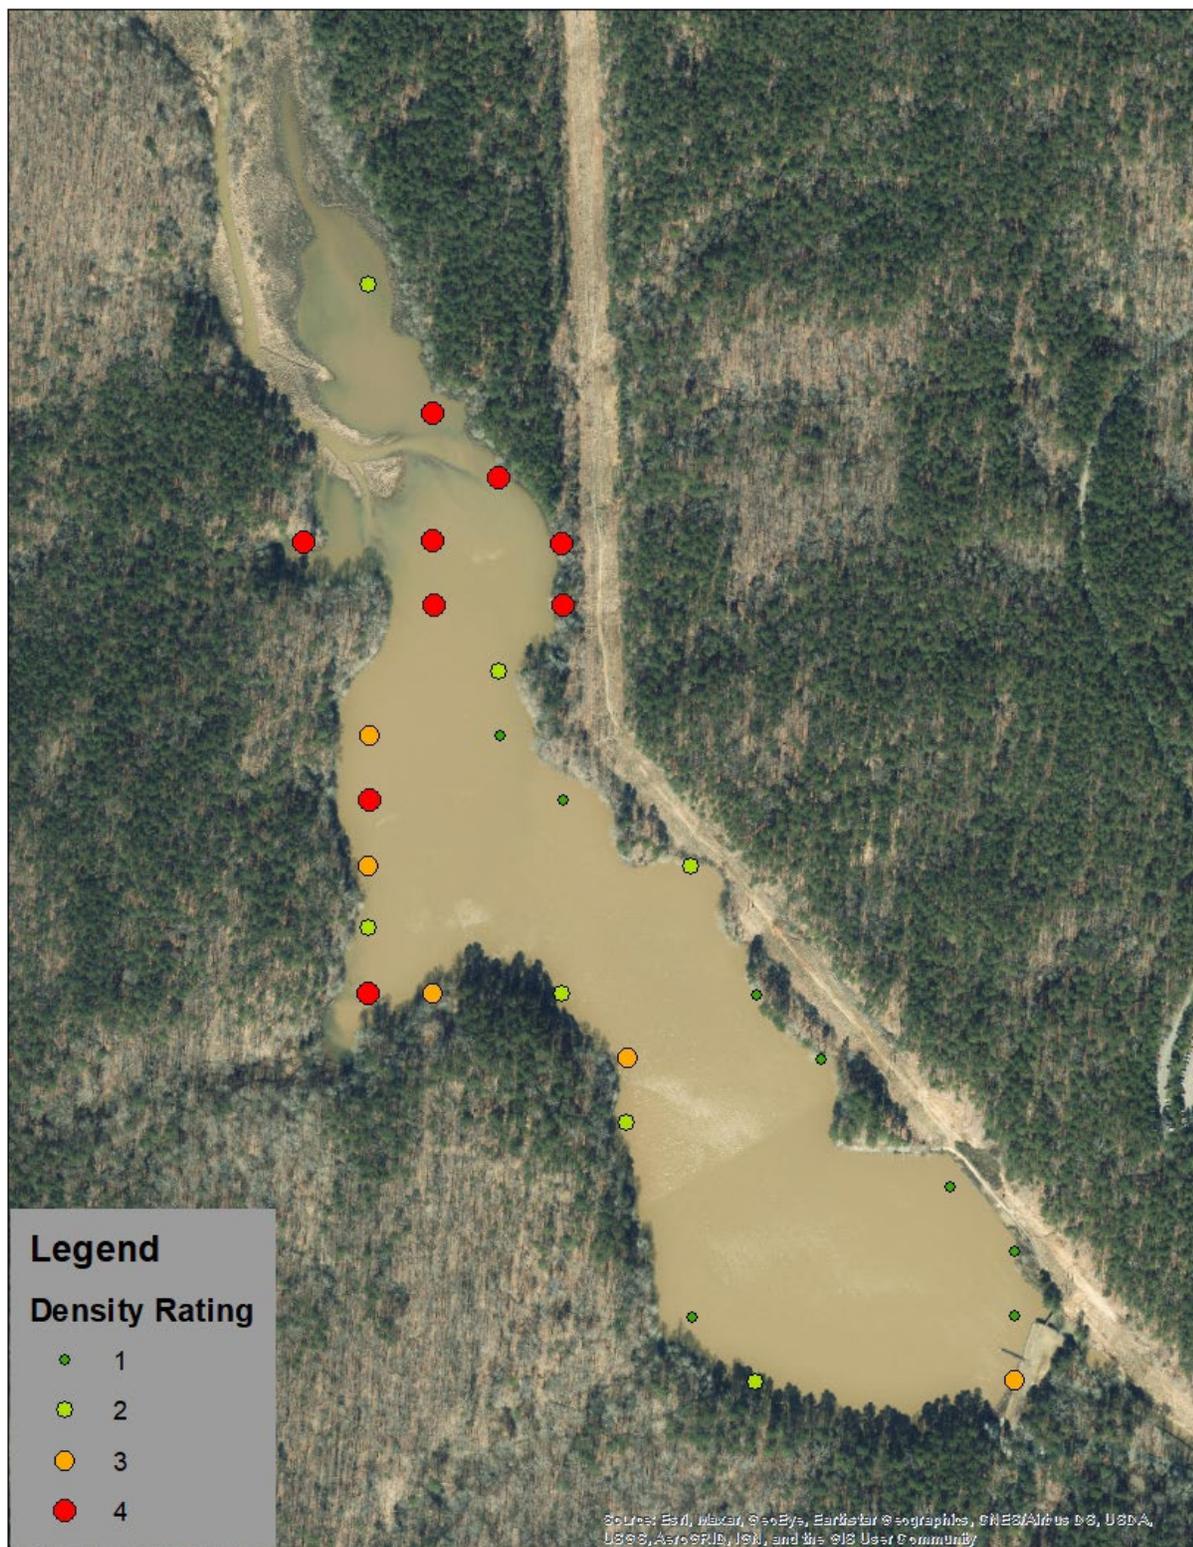
Figure 2. Map showing location and density of SAV.

SAV was found at 29, or 97%, of the points sampled (Figure 2). Species found during the survey include Chara (*Chara spp.*), Hydrilla (*Hydrilla verticillata*), and Southern Naiad (*Najas guadalupensis*) (Figures 3 – 5).

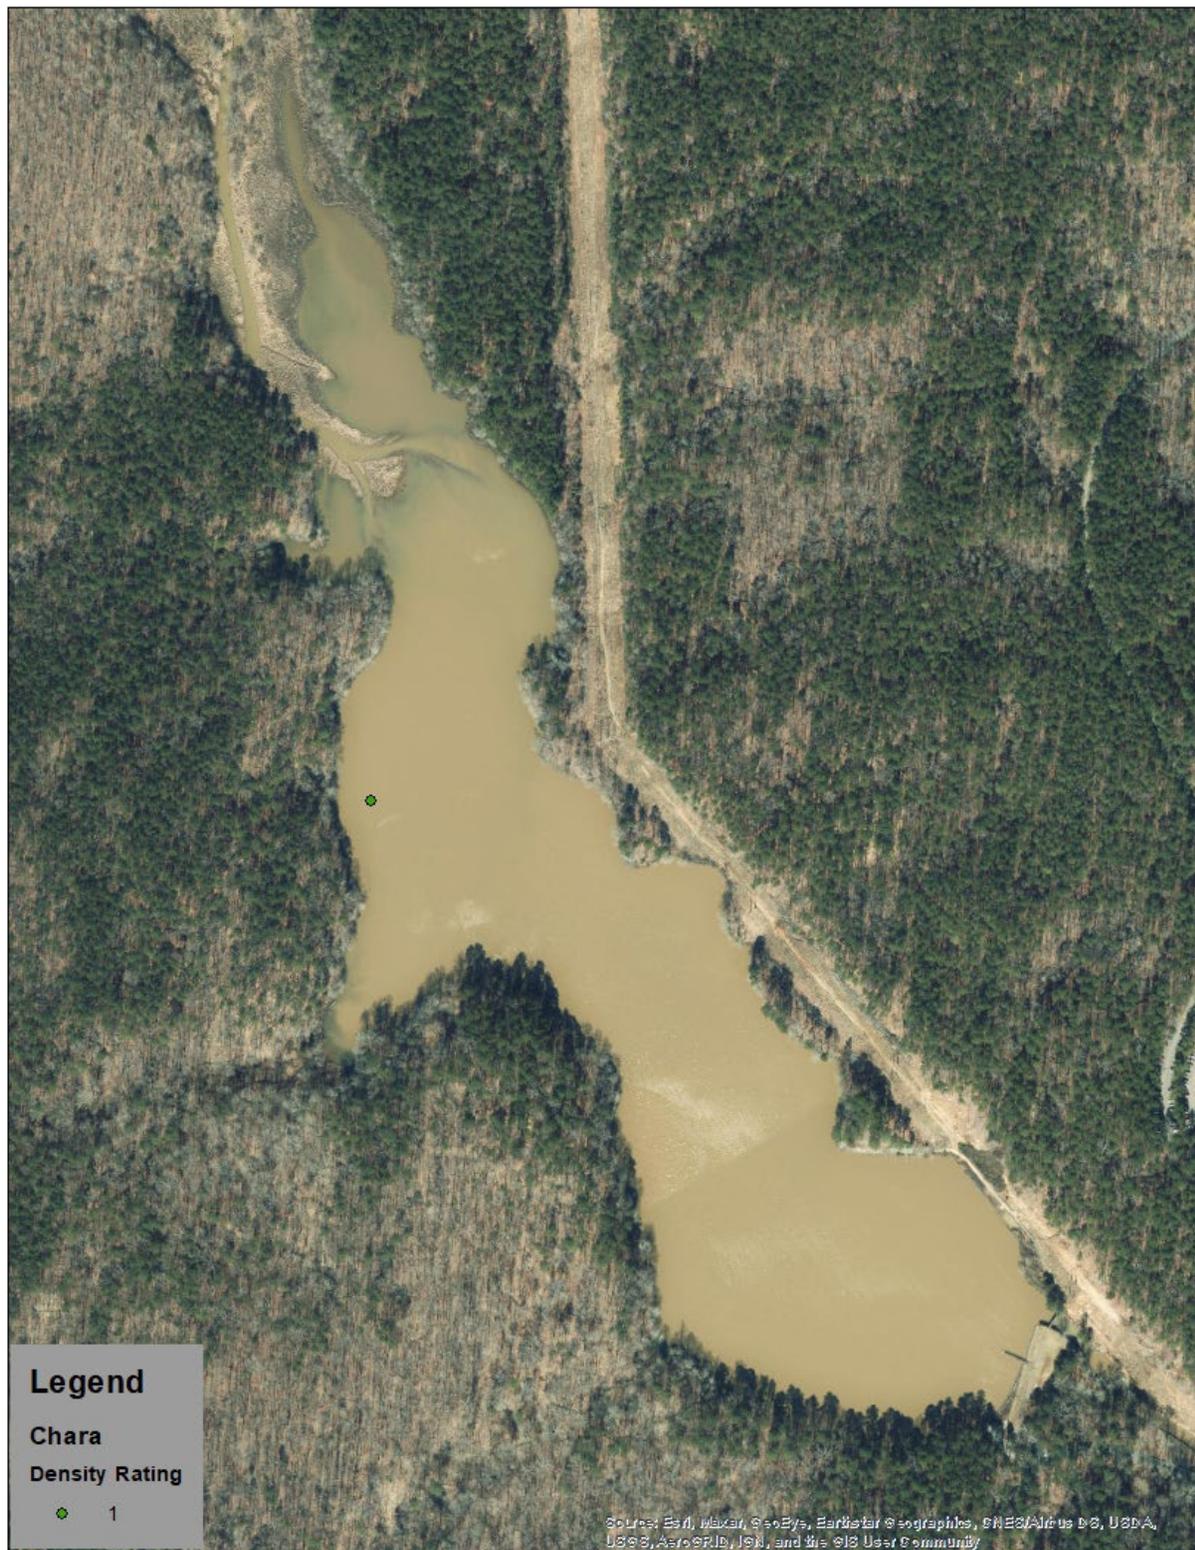
Figure 3. Map showing location and density rating of Chara.

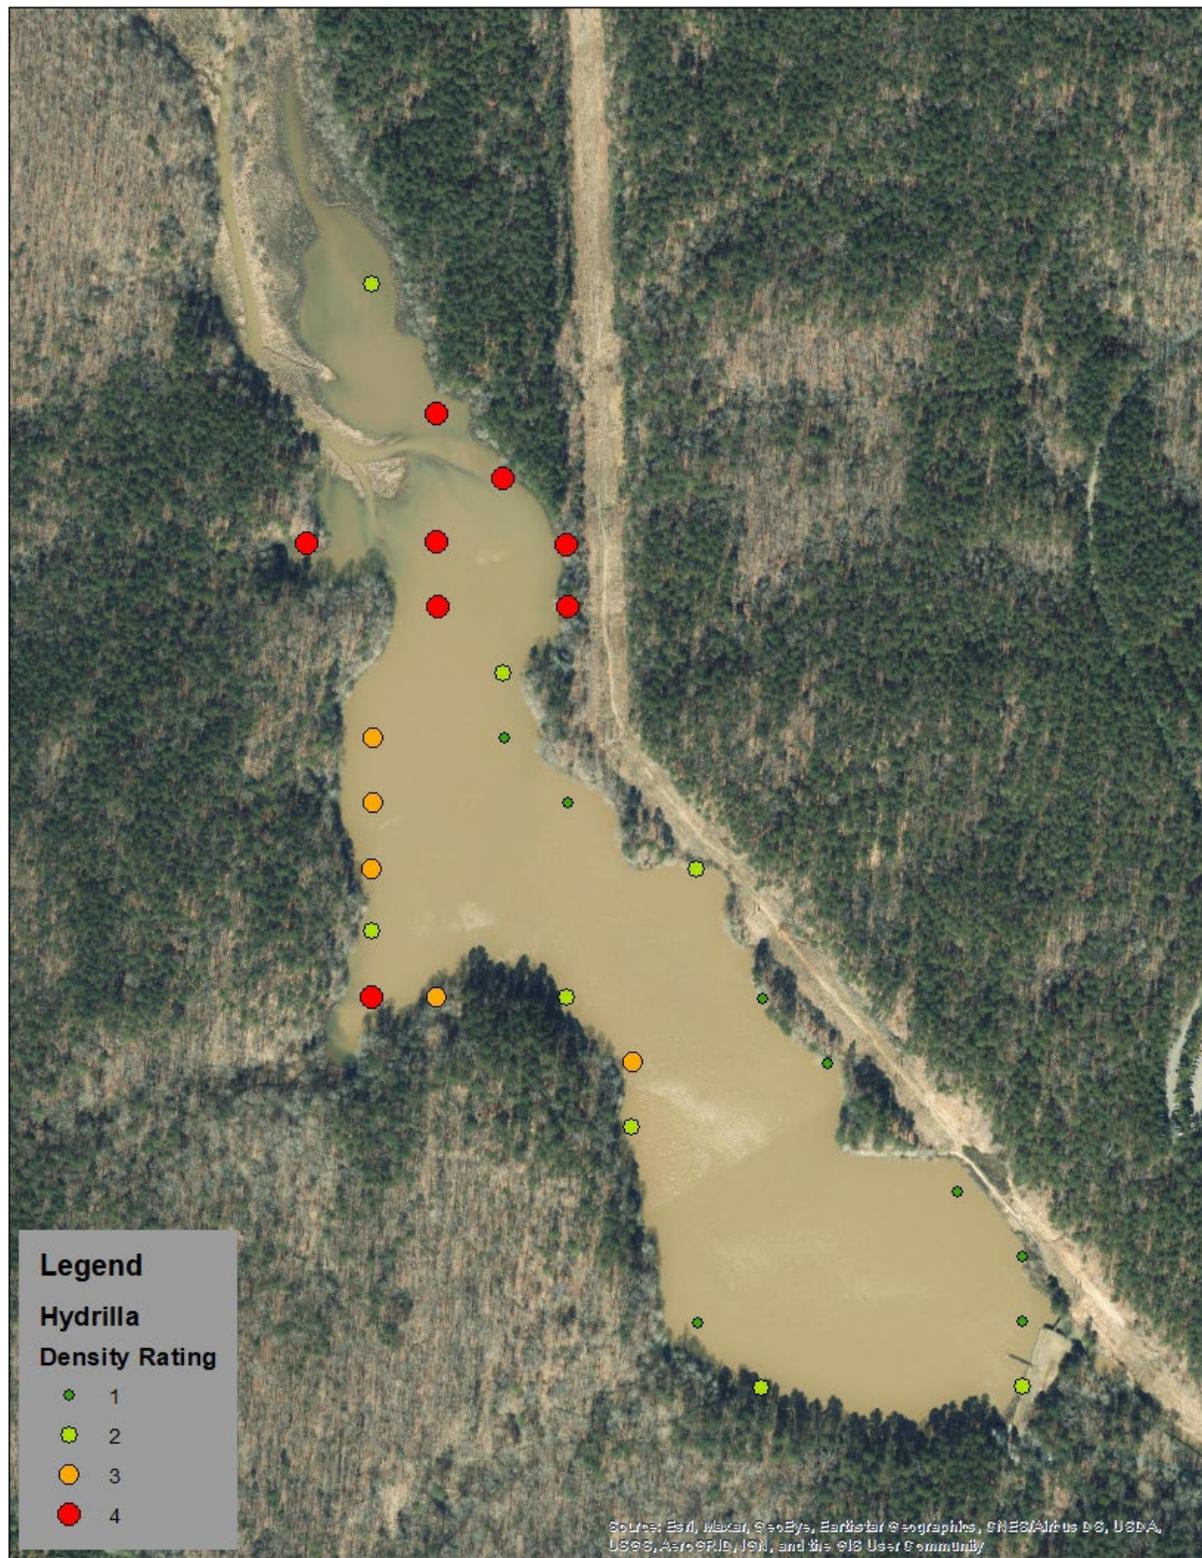
Figure 4. Map showing location and density rating of Hydrilla.

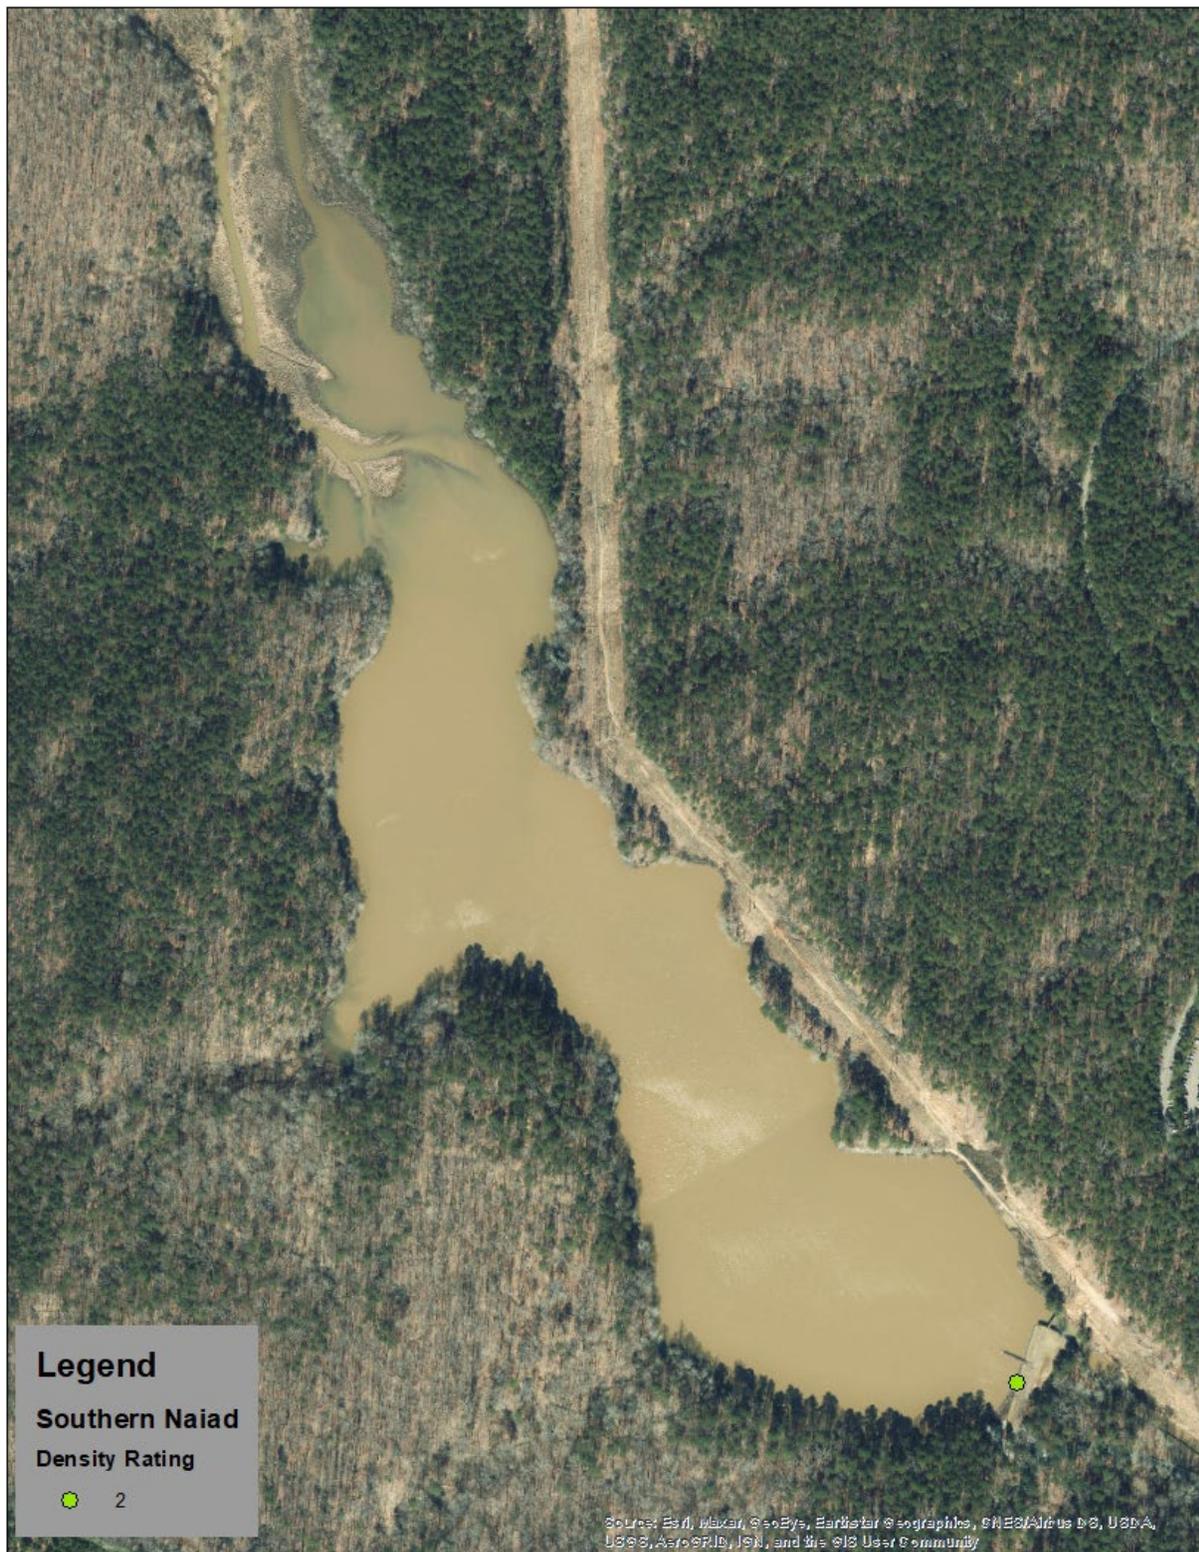
Figure 5. Map showing location and density rating of Southern Naiad.

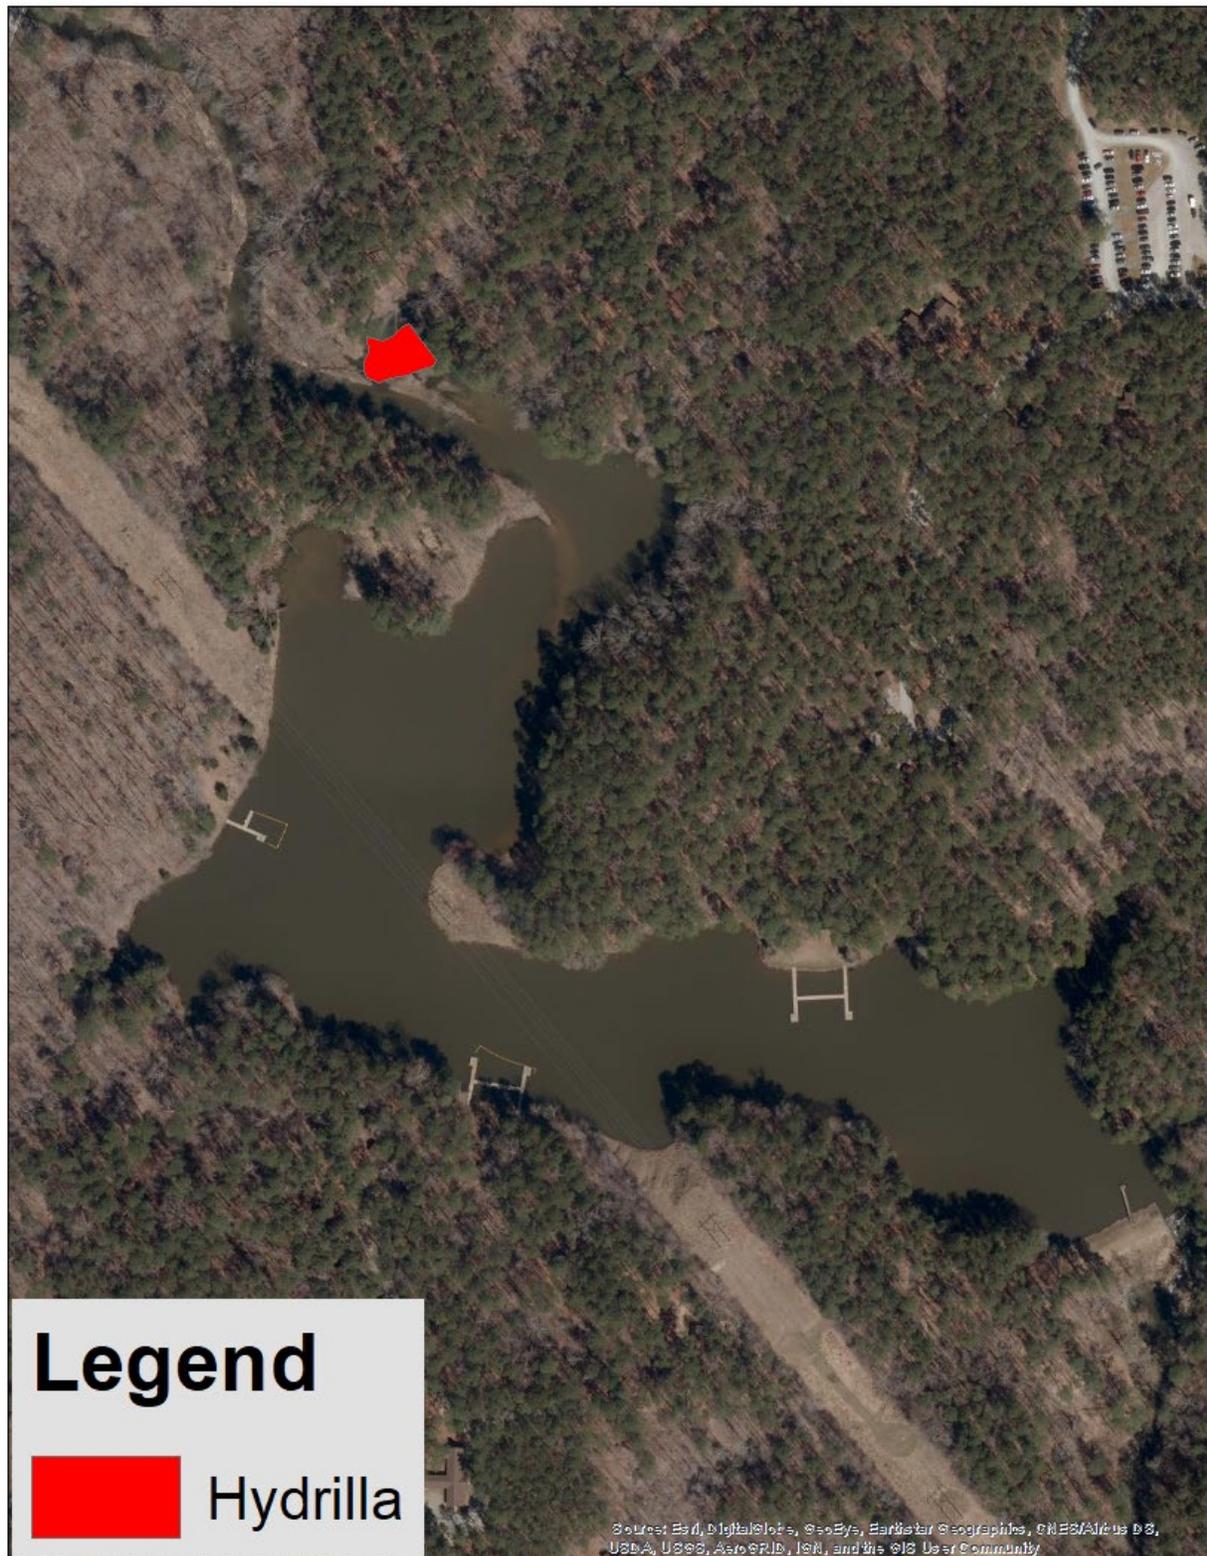
The visual inspection of Sycamore Lake found only a handful of Hydrilla plants growing at the upper end of the lake (Figure 6). There was no other SAV observed during the survey.

Figure 6. Map showing Hydrilla coverage in Sycamore Lake in 2021 (~0.1 acres).
