Inlet Hazard Area Boundaries, 2025 Update:

Science Panel Recommendations to the
North Carolina Coastal Resources Commission

August 1, 2025

NC Coastal Resources Commission's Science Panel on Coastal Hazards
& NC Division of Coastal Management

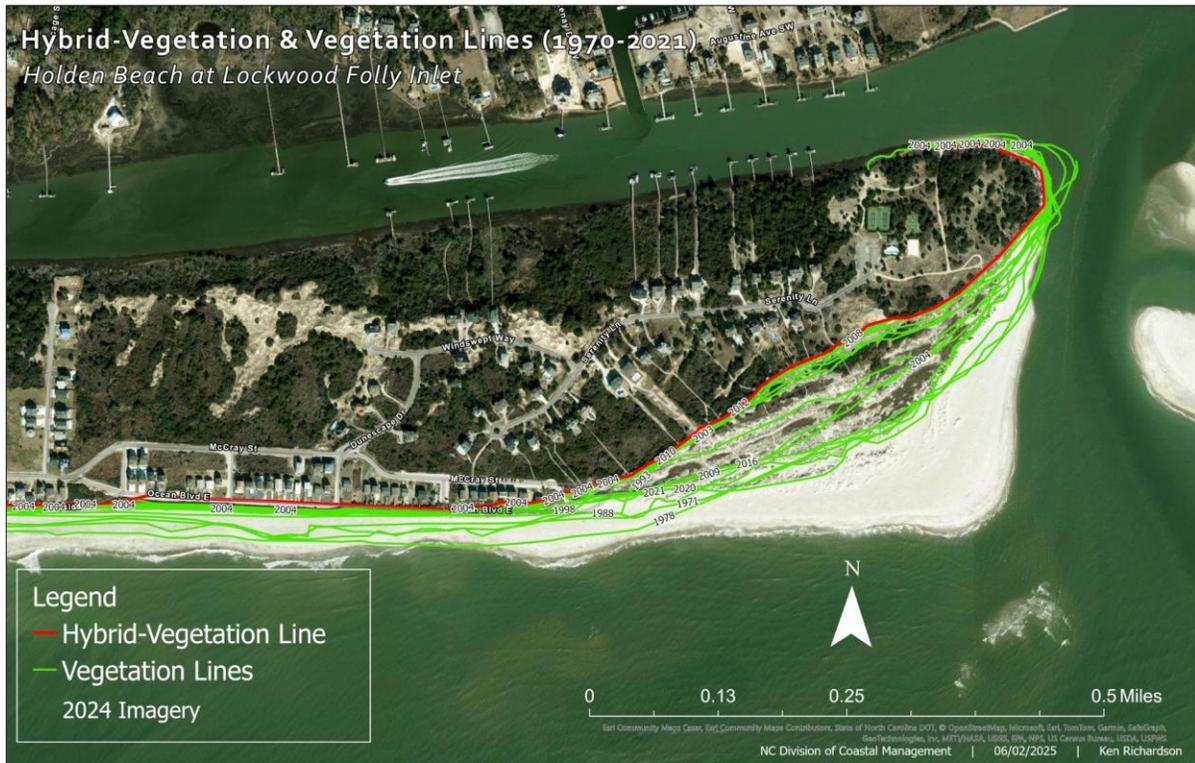
Figure 2a. The Hybrid-Vegetation (red line) represents the landward-most position of the vegetation line (green lines) during the period of study and is therefore a composite line, composed of segments from different dates. This example illustrates HVL at Lockwood Folly Inlet, Holden Beach.

To overcome this limitation, the HVL was devised as a more reliable indicator of the range of short-term variation. The HVL represents the landward-most position of the vegetation line at each inlet over the period of study and is therefore composed of segments from different years/dates (**Figures 2a & b**).

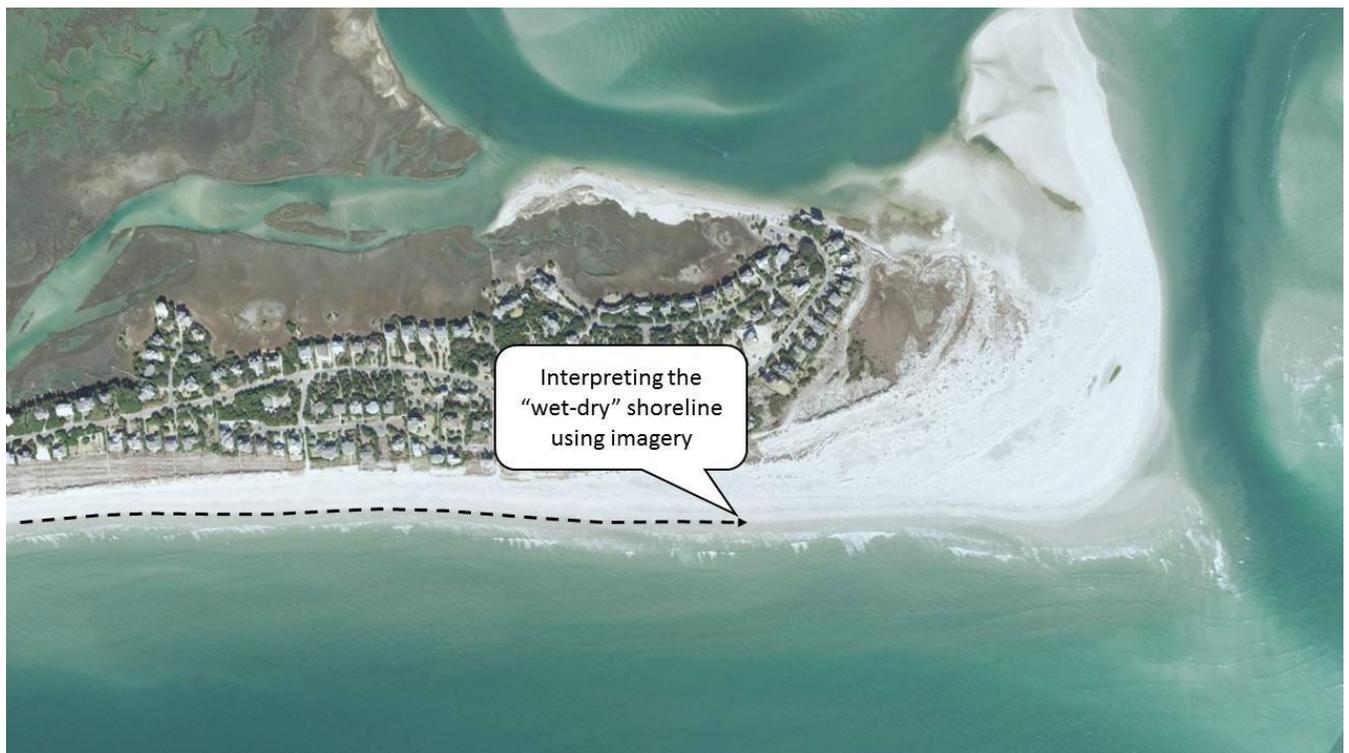
Figure 3. Interpretation of the "wet-dry" shoreline (black dashed line) using orthophotography.

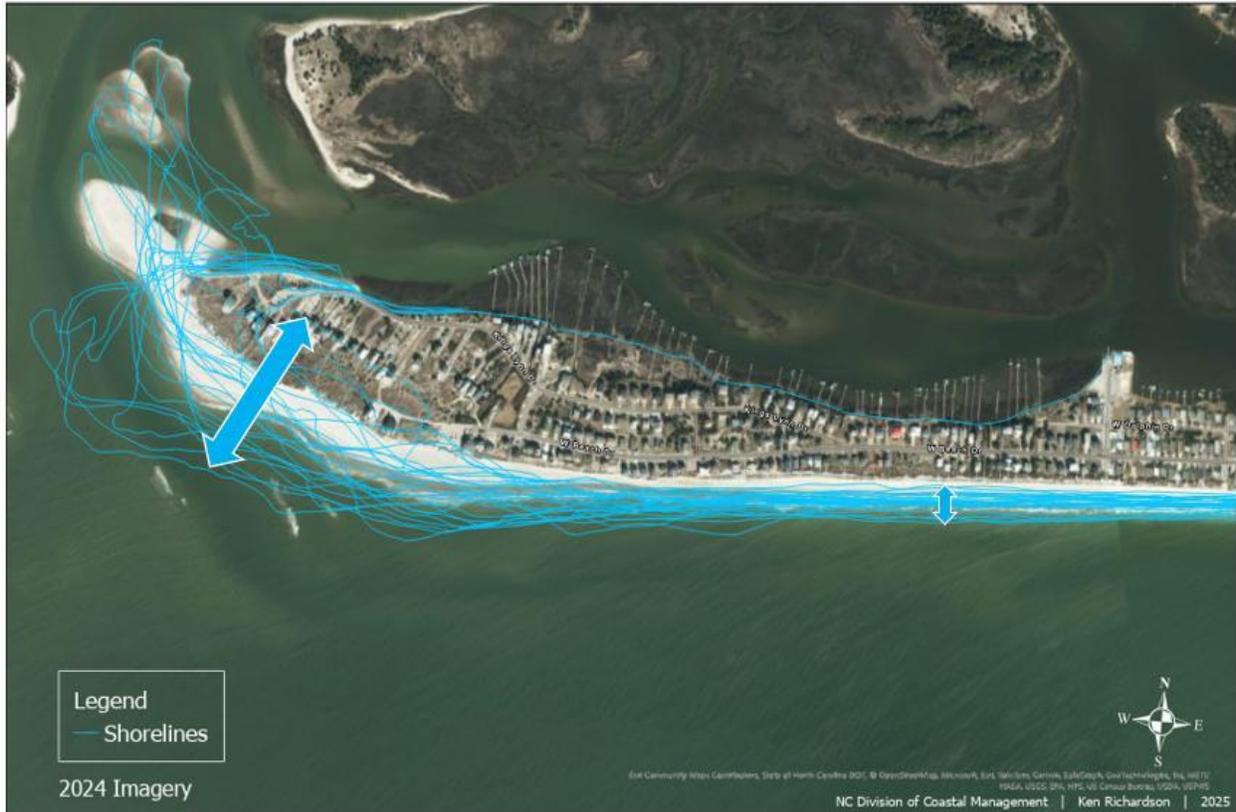
Figure 8. This map highlights the greater variability in shoreline position near inlets compared to farther away.

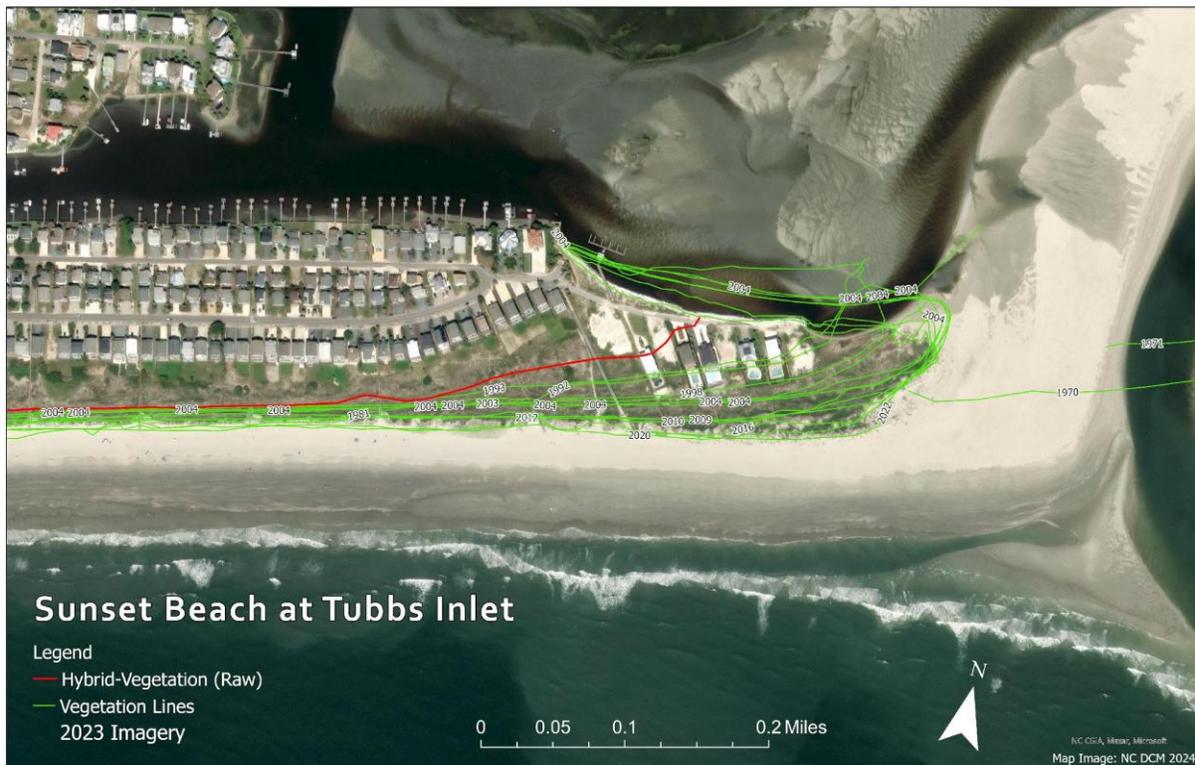
Figure 14. Tubbs Inlet at Sunset Beach. Vegetation Lines mapped: 1981, 1992, 1993, 1998, 2003, 2004, 2009, 2010, 2012, 2016, 2020, 2022. Vegetation line segments making up the HVL within the updated IHA: 1981, 1993, 1998, 2003, 2004.

Because of the relocation and the dredging of feeder channels behind both Sunset Beach and Ocean Isle for land development around the time of the inlet relocation, 1970 and 1971 data were excluded, and only shoreline data after 1971 (starting with 1981 data) were used in the analyses (**Figure 11**). The HVL at Sunset Beach is determined using 1981, 1993, 1998, 2003 and 2004 vegetation lines (**Figure 14**).

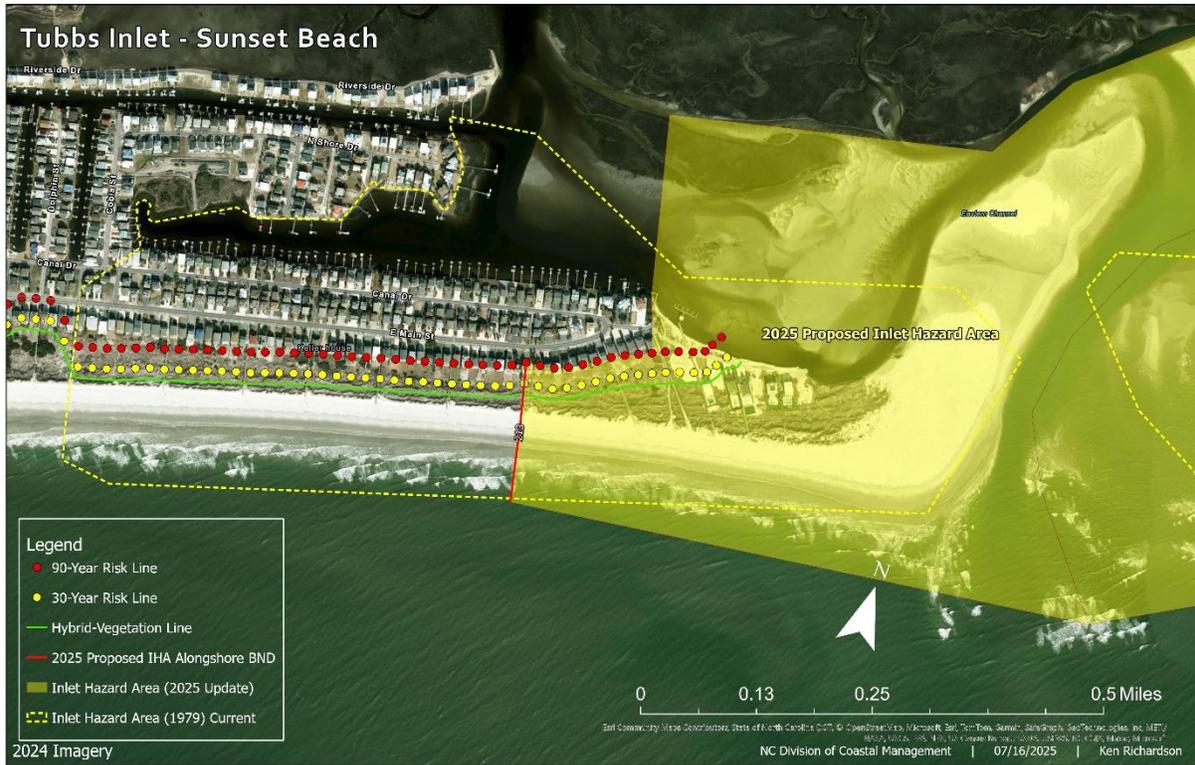
Figure 15. Tubbs Inlet at Sunset Beach: Updated IHA boundary in relation to transect 213 (alongshore IHA boundary), HVL, 30- and 90-Year Risk Lines, and current (1979) IHA boundary.

Applying the $STD \Delta > 1$ threshold identifies the alongshore IHA boundary at transect 213 (**Figure 13**). The landward IHA boundary was defined using the 90-Year Risk Line starting at transect 213 and moving in the direction of the inlet until reaching transect 222; where the boundary is then extended from the 90-Year Risk Line approximately 300 feet to the riprap along the backbarrier shoreline where erosion has been persistent and is influenced by inlet processes and the hydrodynamic fluctuations between Jinks Creek and the inlet (**Figure 15**).

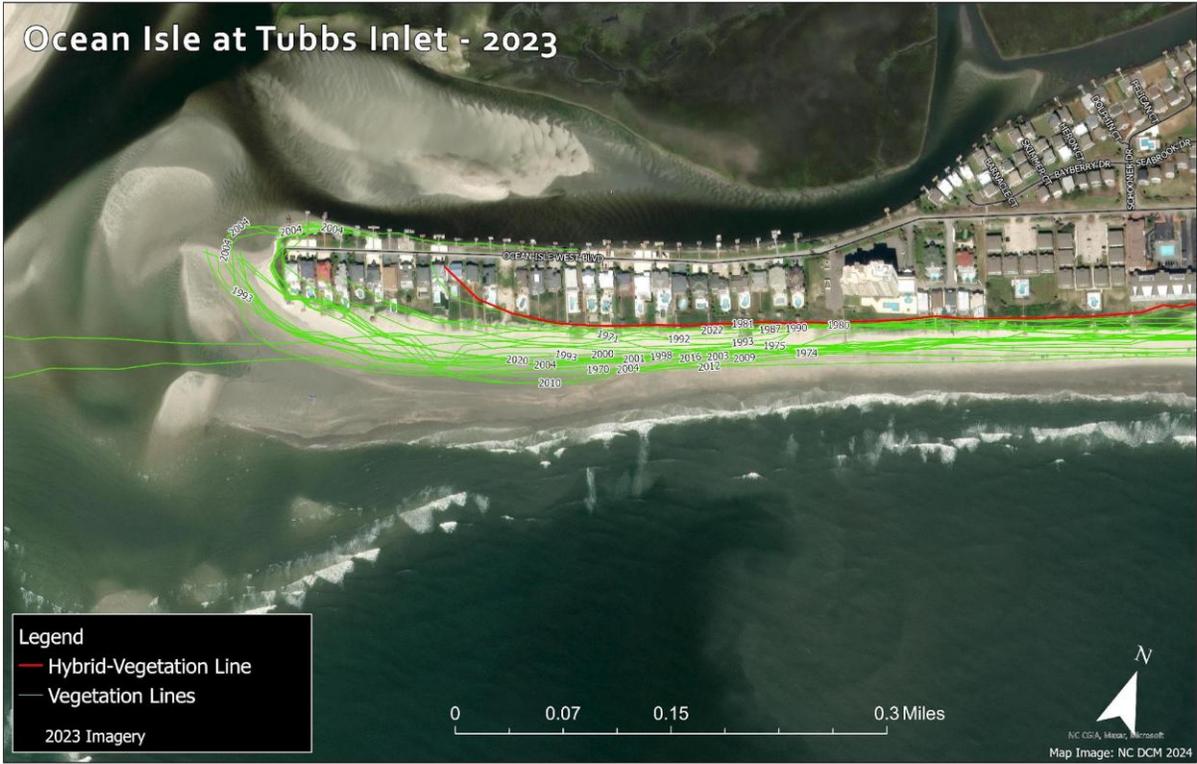
Figure 19. Tubbs Inlet at Ocean Isle. Vegetation Lines mapped: 1970, 1971, 1974, 1975, 1980, 1981, 1987, 1990, 1992, 1993, 1998, 2000, 2001, 2003, 2004, 2009, 2010, 2012, 2016, 2020, 2022. Vegetation line segments making up the HVL within the updated IHA: 1980, 1981, 1993.

The HVL within the 2024 IHA includes 1980, 1981, and 1993 vegetation lines (**Figure 19**). Applying the $STD \Delta > 1$ threshold, identifies the alongshore IHA boundary at transect 27 (**Figure 18**). The landward IHA boundary was defined using the 90-Year Risk Line starting at transect 27 and moving in the direction of the inlet (**Figure 20**).

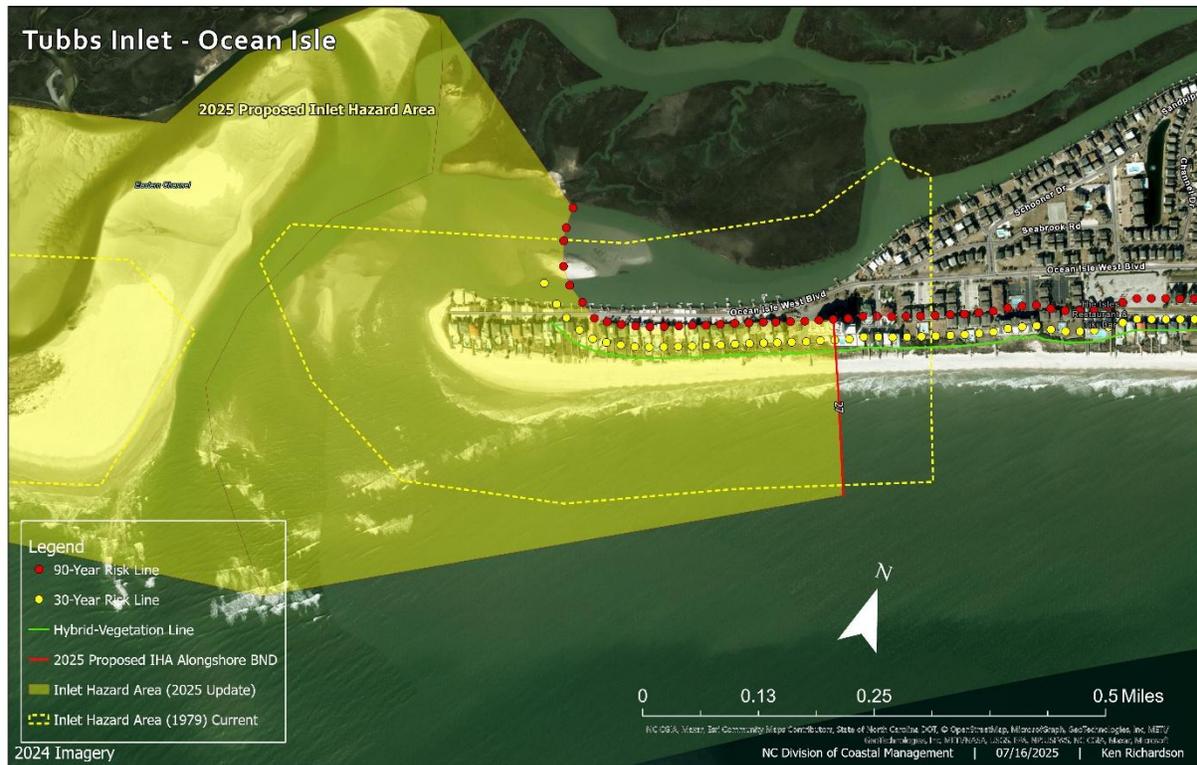
Figure 20. Tubbs Inlet at Ocean Isle: Updated IHA boundary in relation to transect 27 (alongshore IHA boundary), HVL, 30- and 90-Year Risk Lines, and current (1979) IHA boundary.

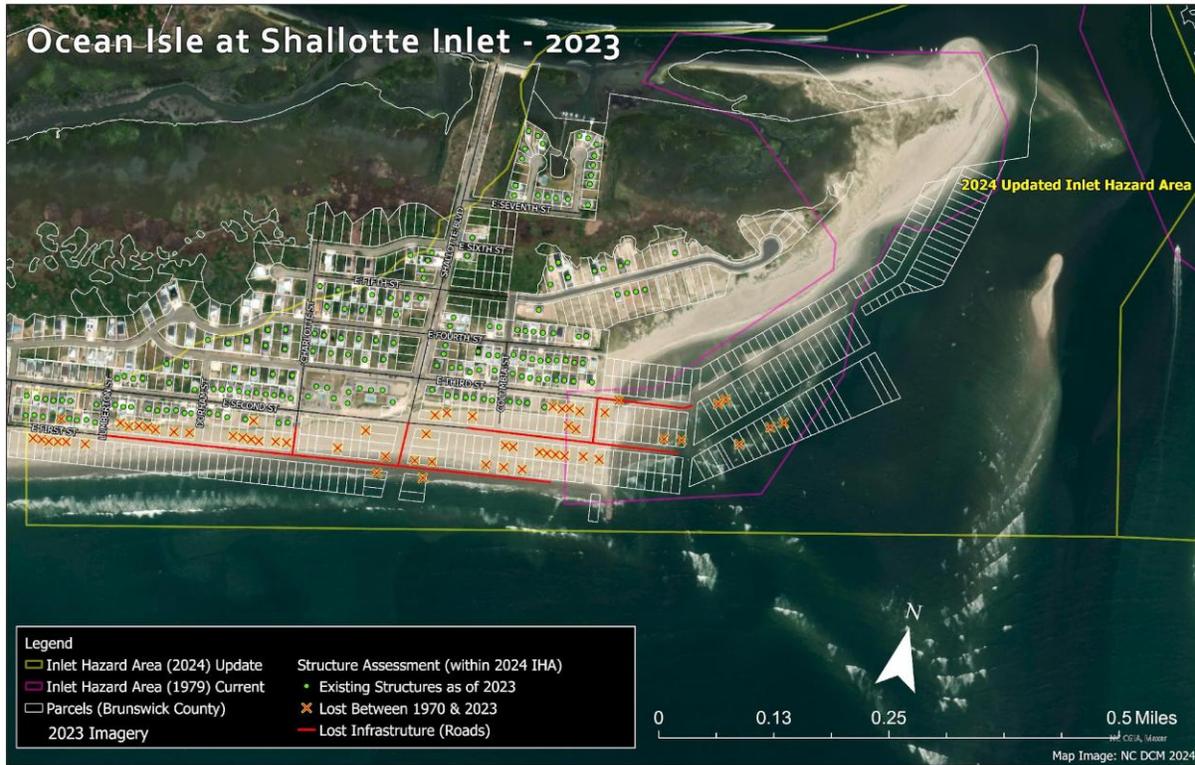
Figure 22. This map illustrates existing structures (green dots), and structures lost to erosion (houses indicated by red x-marks and roads indicated by red lines) relative to conditions in 2023. Based on an inventory for the period between 1970 and 2023, 58 structures and approximately 286 platted parcels and one mile of surfaced road within the 2024 IHA have been lost or relocated as a result of erosion. Currently, there are 185 structures within the 2024 IHA.

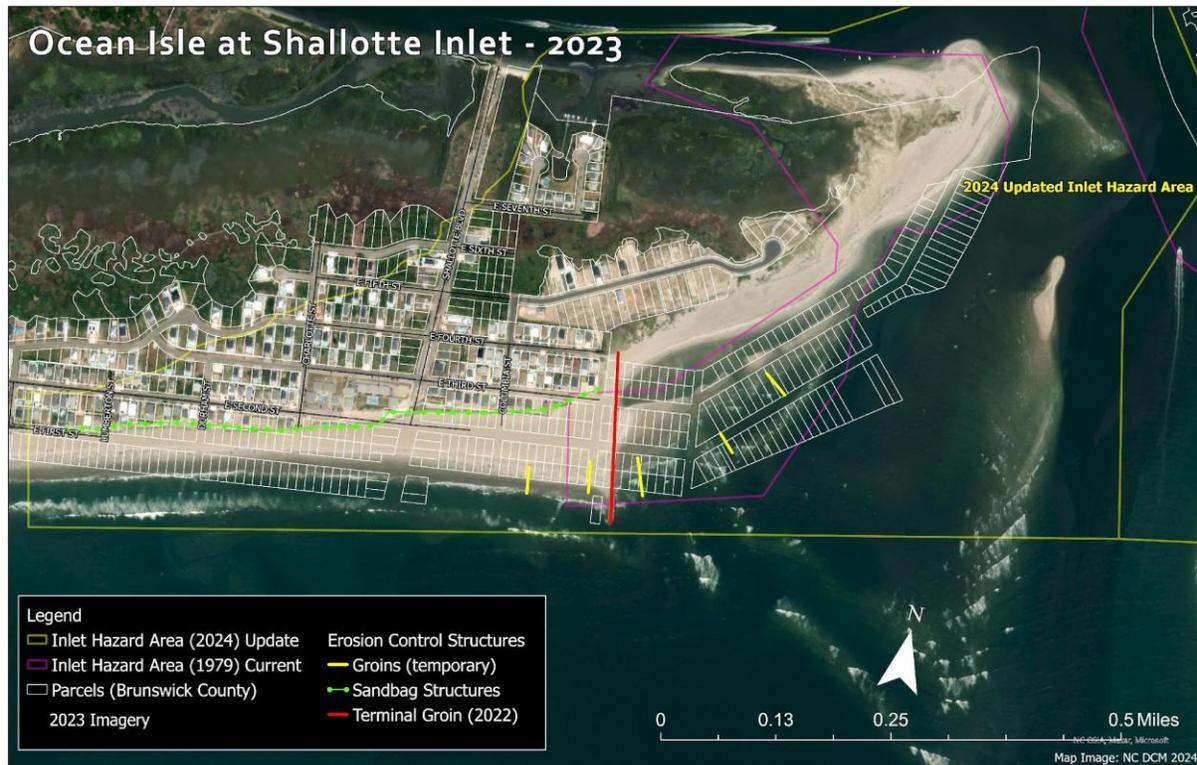
Figure 24. This map illustrates conditions in 2023 relative to the variety of erosion control structures applied in efforts to stabilize the shoreline. Small temporary groins (shore-perpendicular yellow lines) were installed before 1992 followed by sandbag structures (green dotted line) over the course of time, until construction of the terminal groin (red line) was completed in 2022.

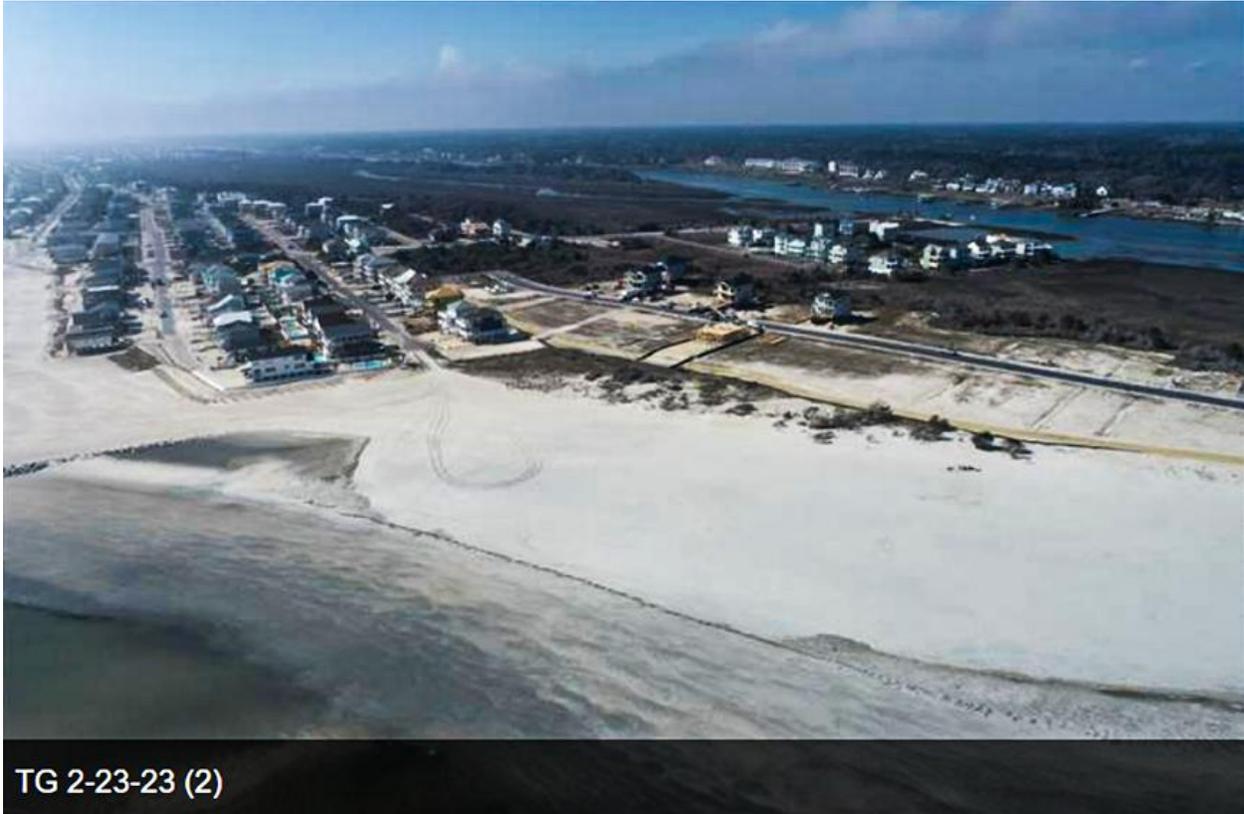
TG 2-23-23 (2)

Figure 25. This image captures the inlet shoreline at the terminal groin as it appeared on February 23, 2023. Post-construction, the inlet beach is wide, and the terminal groin, located in the middle left of the photo, is mostly covered. A newly built road and ongoing construction are visible in the mid-center of the image. Photo source: Town of Ocean Isle Beach, NC.

Recognizing the need for a more permanent solution, the Town Ocean Isle Beach completed construction of a 500-foot granite boulder terminal groin. The groin was designed to serve as a long-lasting barrier to erosion, with hopes of holding the shoreline in place and protecting the vulnerable east end of Ocean Isle. While the terminal groin represents an ambitious and costly effort, its effectiveness remains to be seen, as more time is needed to fully assess its impact on erosion patterns and shoreline stability (**Figures 25 and 26**).

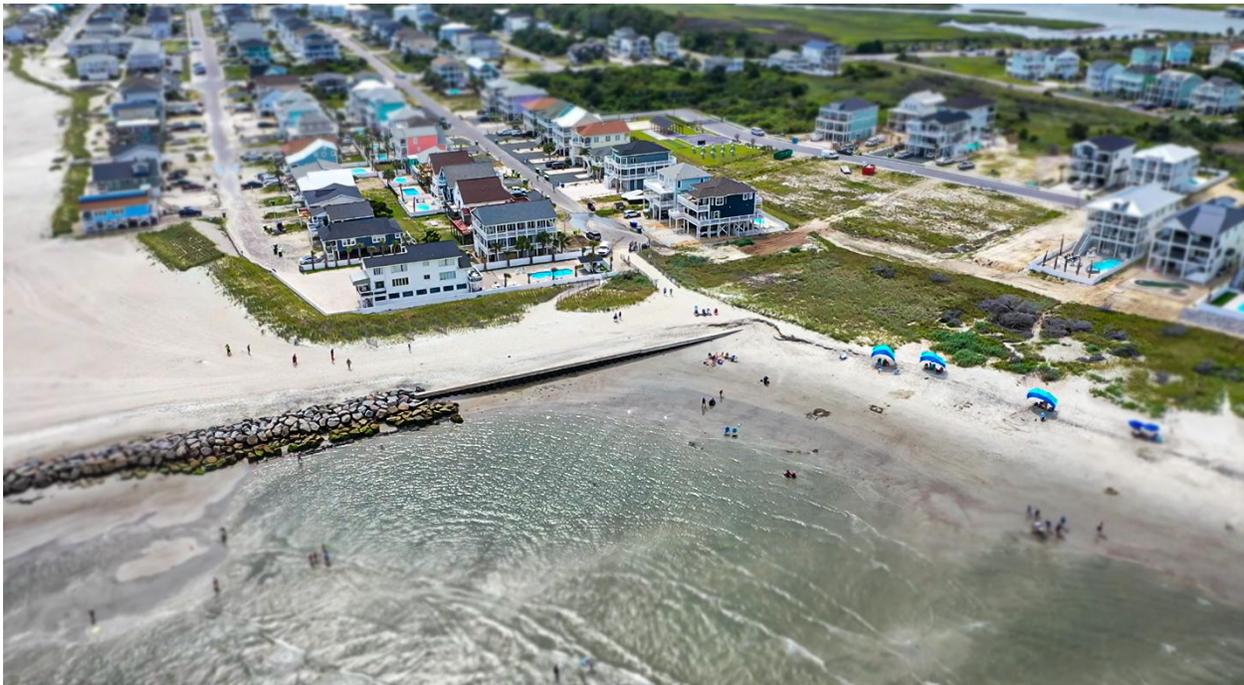
Figure 26. This image captures the inlet shoreline at the terminal groin as it appeared on June 25, 2024. Since 2023 (Figure 35), erosion on the inlet side of the groin has resulted in continued landward movement of the shoreline, exposing the groin's anchor, and approaching the vegetation in front of the new development. Photo source: NC DCM and DWR.

The terminal groin is expected to affect shoreline stability immediately to its west by eventually reducing erosion and retaining sediment; however, the eastern side, adjacent to the inlet, will continue to be significantly influenced by the dynamic processes of the inlet. This area will likely experience varying degrees of erosion and sediment deposition, making it challenging to predict long-term outcomes. Therefore, a longer period of observation is necessary to fully assess the overall performance and effectiveness of the structure in stabilizing the shoreline. Additionally, ongoing, detailed monitoring is crucial, especially at the landward terminus of the structure, where persistent shoreline erosion continues to be a concern.

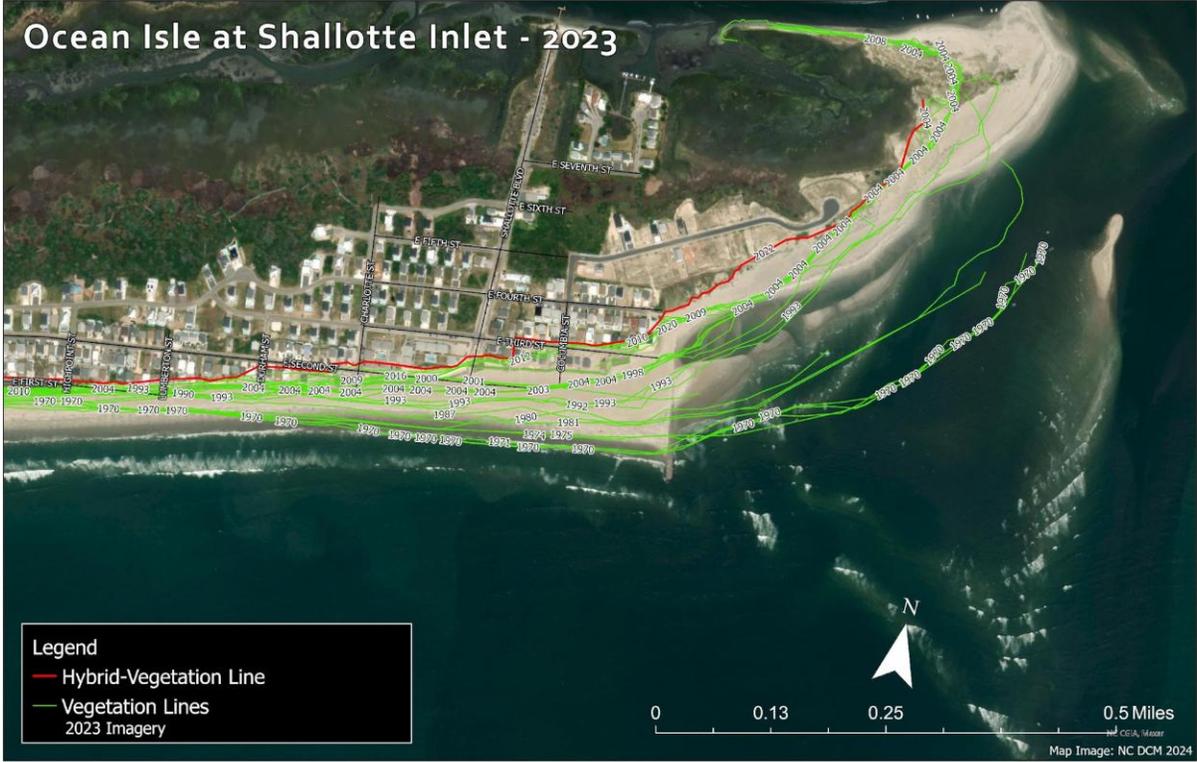
Figure 30. Shallotte Inlet at Ocean Isle. Vegetation Lines mapped: 1970, 1974, 1975, 1980, 1981, 1987, 1990, 1992, 1993, 1998, 2000, 2001, 2003, 2004, 2008, 2009, 2010, 2012, 2016, 2020, 2022. Vegetation line segments making up the HVL: 2000, 2001, 2003, 2004, 2008, 2009, 2010, 2012, 2020, 2022.

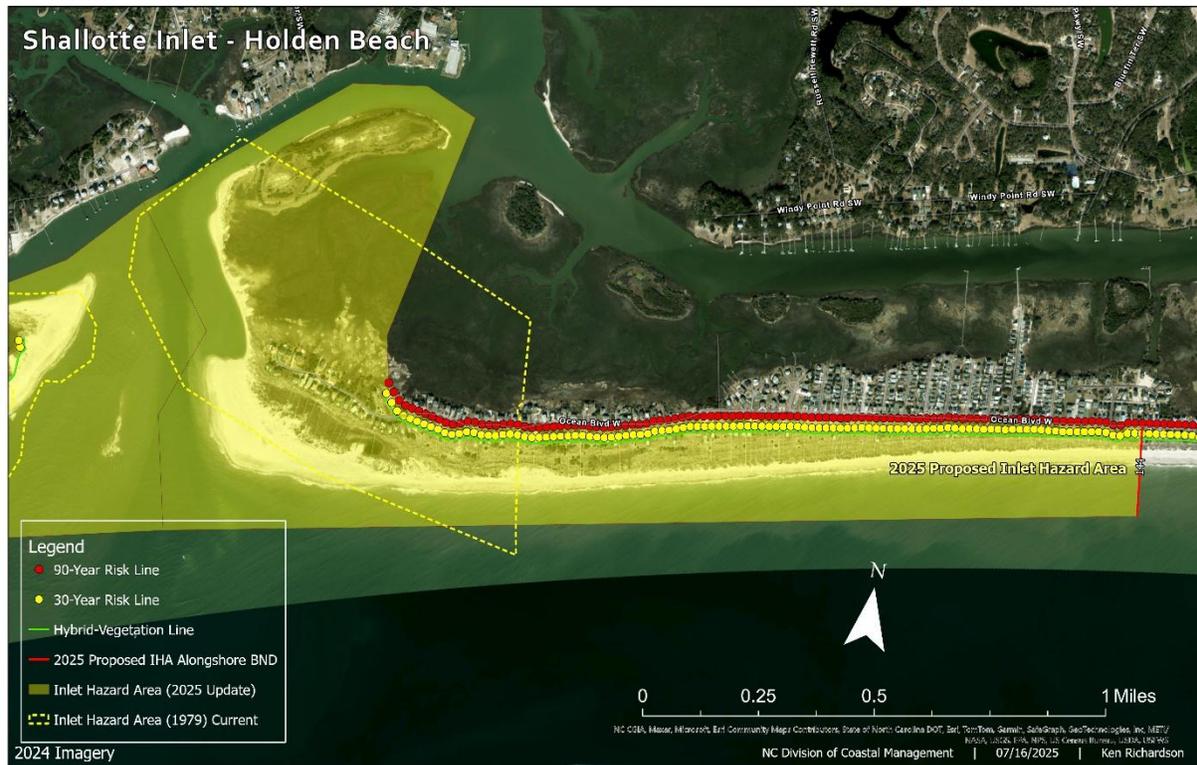
Figure 36. Shallotte Inlet at Holden Beach: Updated IHA boundary in relation to transect-144 (alongshore IHA boundary), HVL, 30- and 90-Year Risk Lines, and current (1979) IHA boundary.

Applying the $STD \Delta > 1$ threshold identifies the alongshore IHA boundary at transect-144 (Figure 34). The landward IHA boundary was defined using the 90-Year Risk Line starting at transect 144 and moving in the direction of the inlet. Where the end of the HVL intersects the marsh (landward side of Holden Beach), the IHA boundary is extended across the marsh to intersect the ICW (Figure 36).

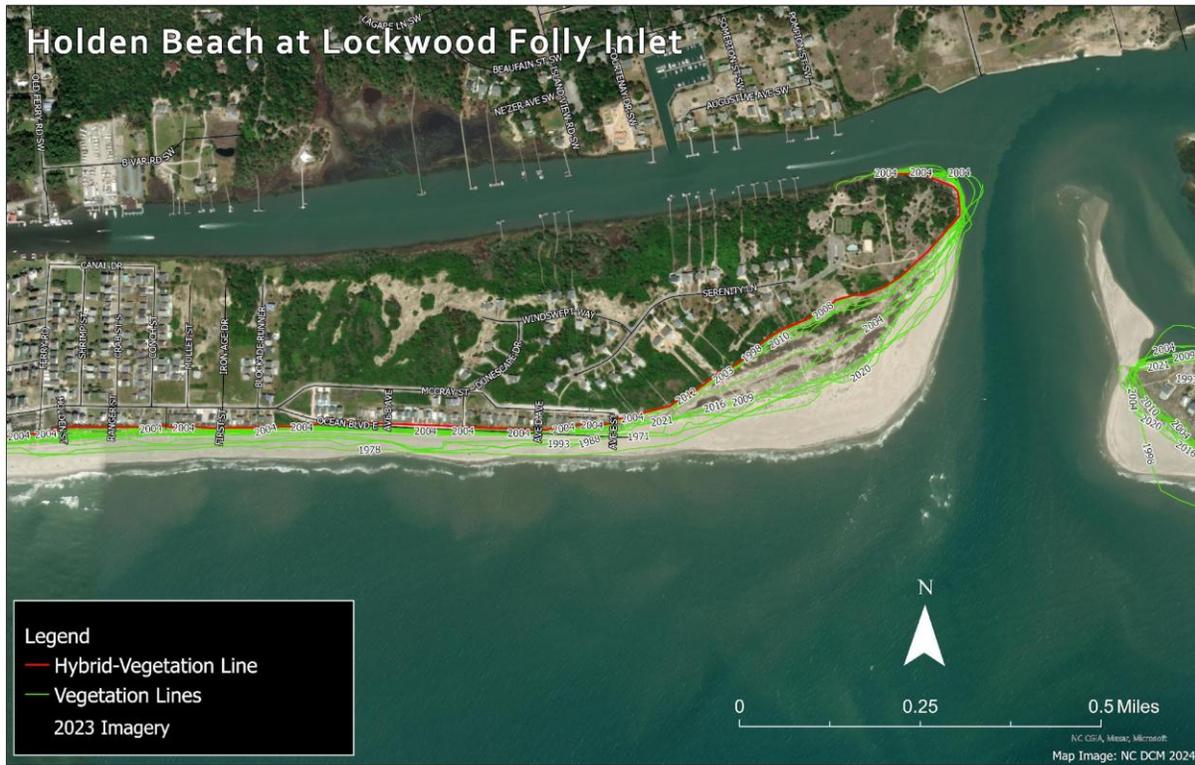
Figure 40. Lockwood Folly Inlet at Holden Beach. Vegetation Lines mapped: 1971, 1978, 1988, 1993, 1998, 2003, 2004, 2008, 2009, 2010, 2012, 2016, 2020, 2021, 2022. Vegetation line segments making up the HVL: 1993, 1998, 2003, 2004, 2008, 2009, 2010, 2012, 2020, 2021.

The shoreline and vegetation data for the Holden Beach side of Lockwood Folly Inlet are shown in **Figures 37 and 40**. The HVL is comprised of vegetation lines from 1993, 1998, 2003, 2004, 2008, 2009, 2010, 2012, 2020, 2021 (**Figure 40**). Because the $STD \Delta > 1$ boundary would not include the area where homes were lost as recently as the early 90s (as well as in 70s and 80s), the boundary identified with the $STD > 15\text{-m}$ boundary is used instead. This yields an alongshore IHA boundary at transect 478 (**Figure 39**). Notably this is the same transect that would have been identified using the previously applied STD increase approach, lending further confidence to this transect as the most appropriate boundary. The landward IHA boundary was defined using the 90-Year Risk Line starting at transect 478 and moving in the direction of the inlet. Where the HVL ends and at the last 90-Year Risk Line point adjacent to the inlet, the IHA boundary is extended across approximately 250 feet to intersect the ICW (**Figure 41**).

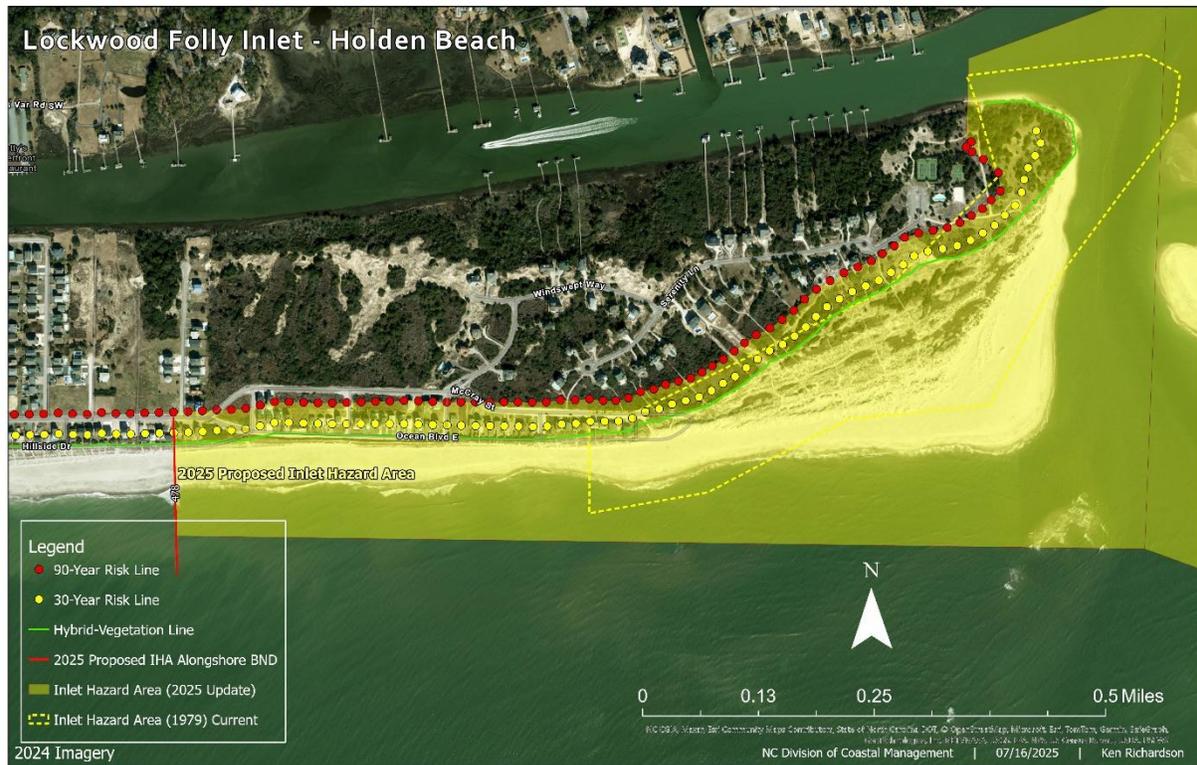
Figure 41. Lockwood Folly Inlet at Holden Beach: Updated IHA boundary in relation to transect-478 (alongshore IHA boundary), HVL, 30- and 90-Year Risk Lines, and current (1979) IHA boundary.

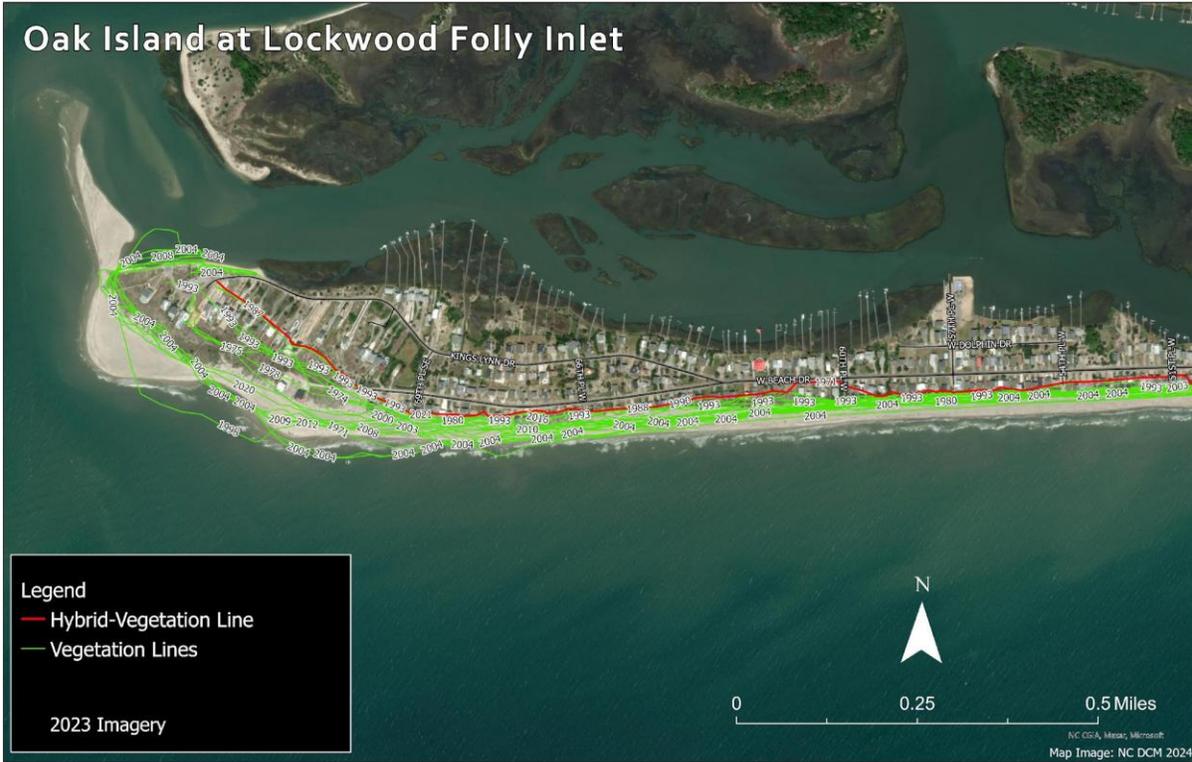
Figure 45. Lockwood Folly Inlet at Oak Island. Vegetation Lines mapped: 1971, 1974, 1975, 1978, 1979, 1980, 1987, 1988, 1990, 1993, 1998, 2000, 2003, 2004, 2008, 2009, 2010, 2012, 2016, 2020, 2021. Vegetation line segments making up the HVL: 1971, 1987, 1988, 1990, 1993, 2016, 2021.

The HVL is comprised of 1971, 1987, 1988, 1990, 1993, 2016, and 2021 vegetation lines (**Figure 45**). Applying the STD 15-m threshold identifies the IHA alongshore boundary at transect 81, whereas the STD $\Delta > 1$ identifies the boundary at transect 49 (for comparison, STD increase suggests that inlet influence extends to at least transect 86). An accretionary dune feature exists centered around transect 63 and the visible associated landward shift in the HVL ends at transect

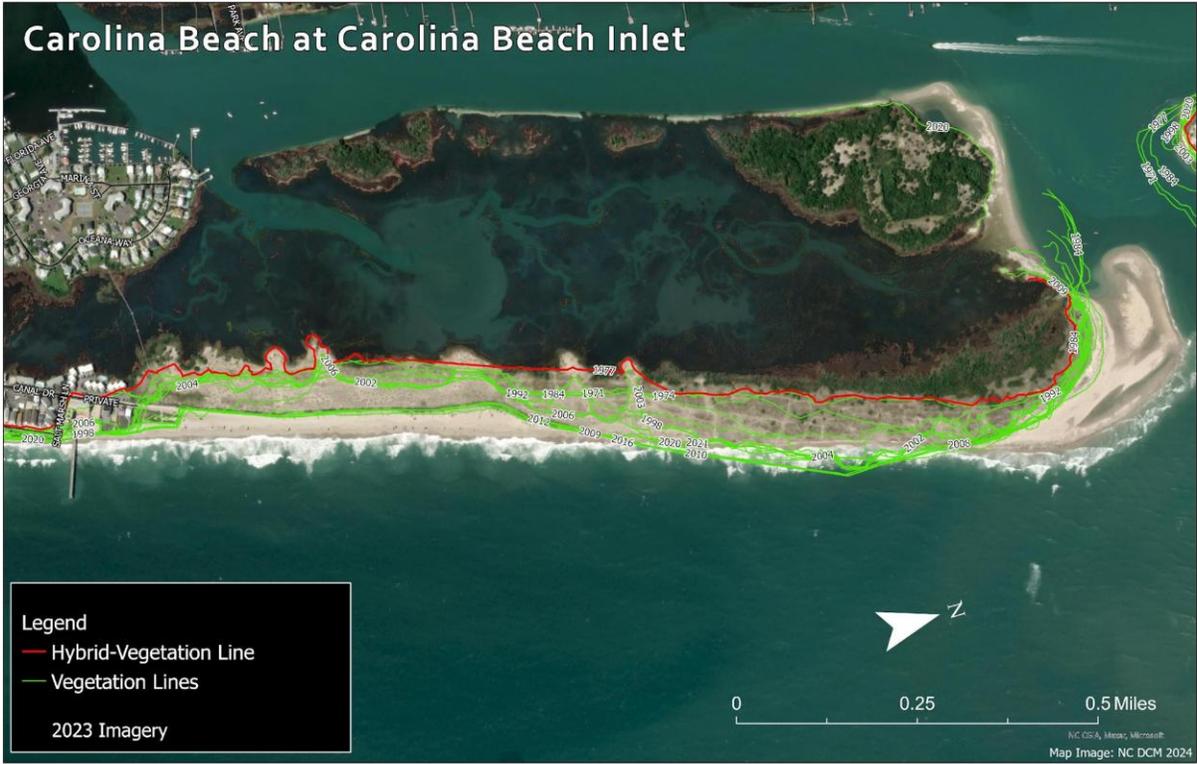
Figure 50. Carolina Beach Inlet at Carolina Beach. Vegetation Lines mapped: 1971, 1974, 1977, 1984, 1992, 1998, 2002, 2003, 2004, 2006, 2008, 2009, 2010, 2012, 2016, 2020, 2021. Vegetation line segments making up the HVL: 1971, 1974, 1977, 1984, 1992, 1998, 2002, 2003, 2004, 2006, 2008, 2009, 2010, 2012.

Vegetation and shoreline data for the Carolina Beach side of Carolina Beach Inlet are shown in **Figures 47 and 50**. Analysis of shoreline data from 1971 to 2021 shows long-term accretion along the oceanfront with erosion measured adjacent to the inlet channel (**Figures 47 and 48**), though these findings are influenced by a shore-parallel granite rock structure, routine beach nourishment and maintenance dredging activities at Carolina Beach Inlet. Applying the $STD \Delta > 1$ threshold, identifies the alongshore IHA boundary at transect 2119 (**Figure 49**). Note that inlet influence to the south of this transect is limited by the existing rock structure. The landward IHA boundary was defined using the 90-Year Risk Line starting at transect 2119 and moving in the direction of the inlet. From the last 90-Year Risk Line point adjacent to the inlet, the IHA boundary is extended to intersect the ICW (**Figure 51**).

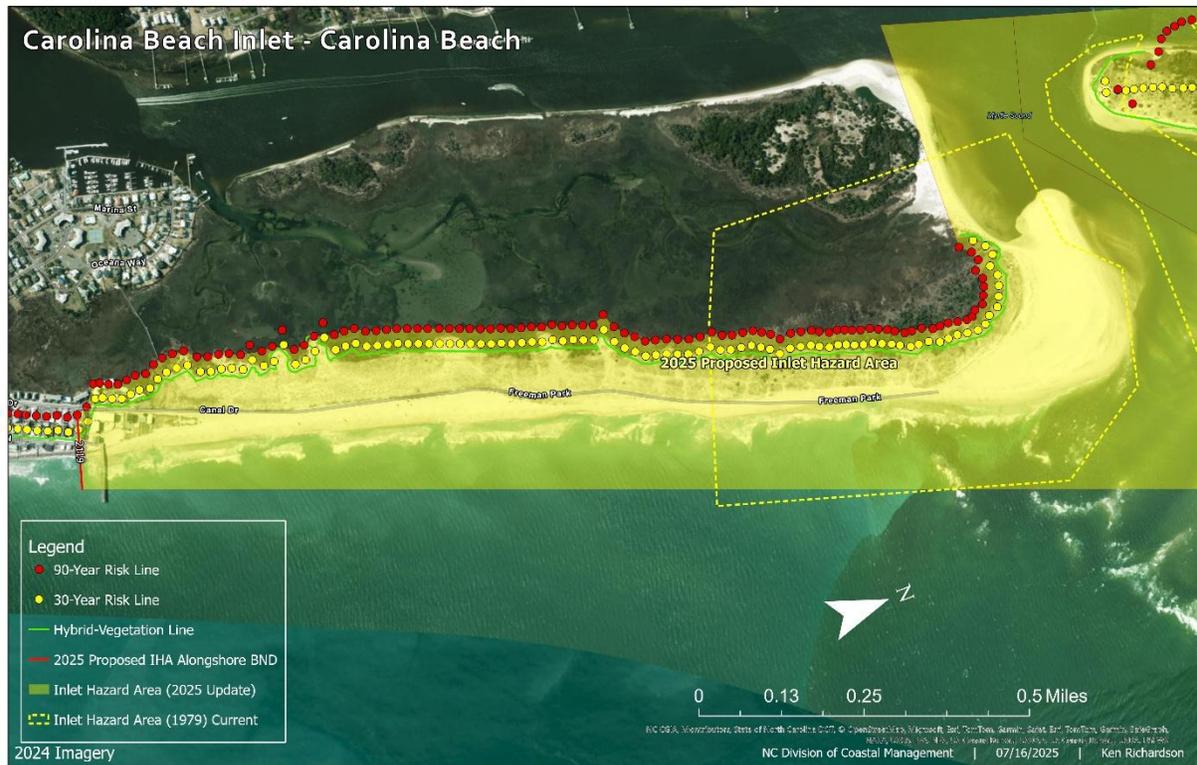
Figure 51. Carolina Beach Inlet at Carolina Beach HVL and the recommended IHA boundary with the 30- and 90-Year Risk Lines.

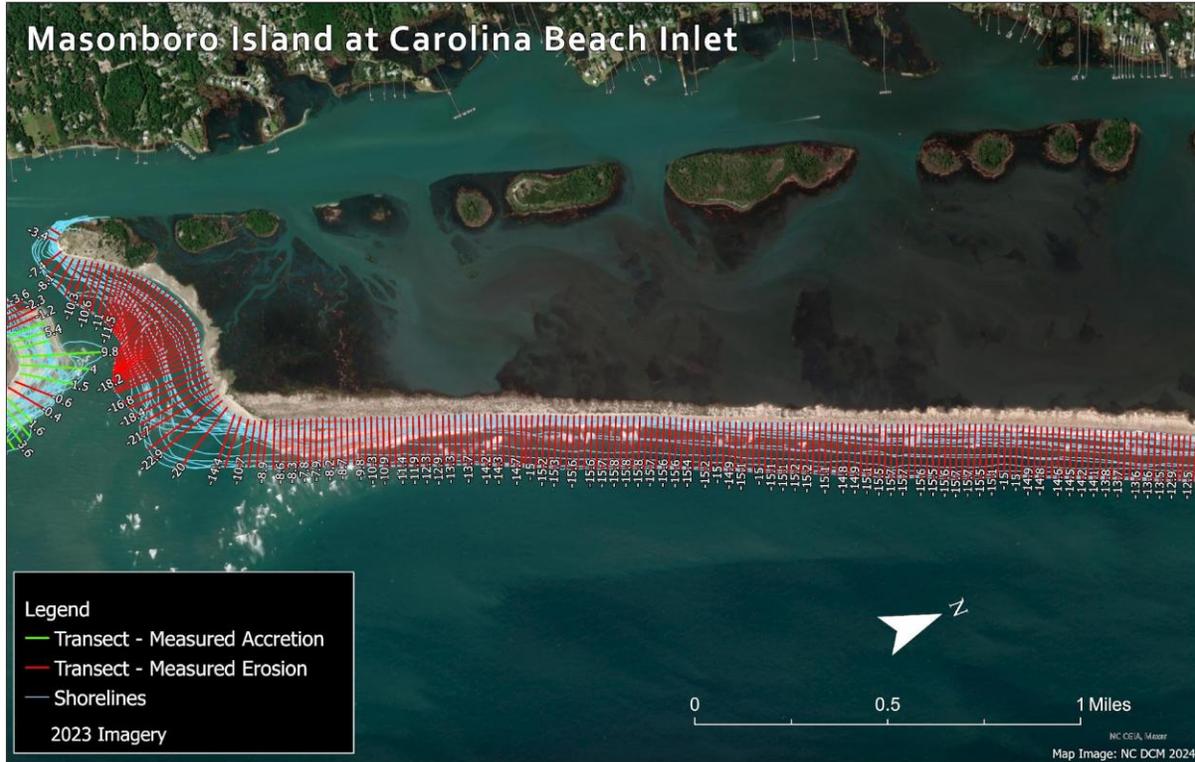
Figure 52. Carolina Beach Inlet at Masonboro Island. Shorelines included in the analysis: 1971, 1974, 1977, 1984, 1992, 1997, 1998, 2000, 2002, 2003, 2004, 2006, 2008, 2009, 2010, 2012, 2016, 2020, 2021.

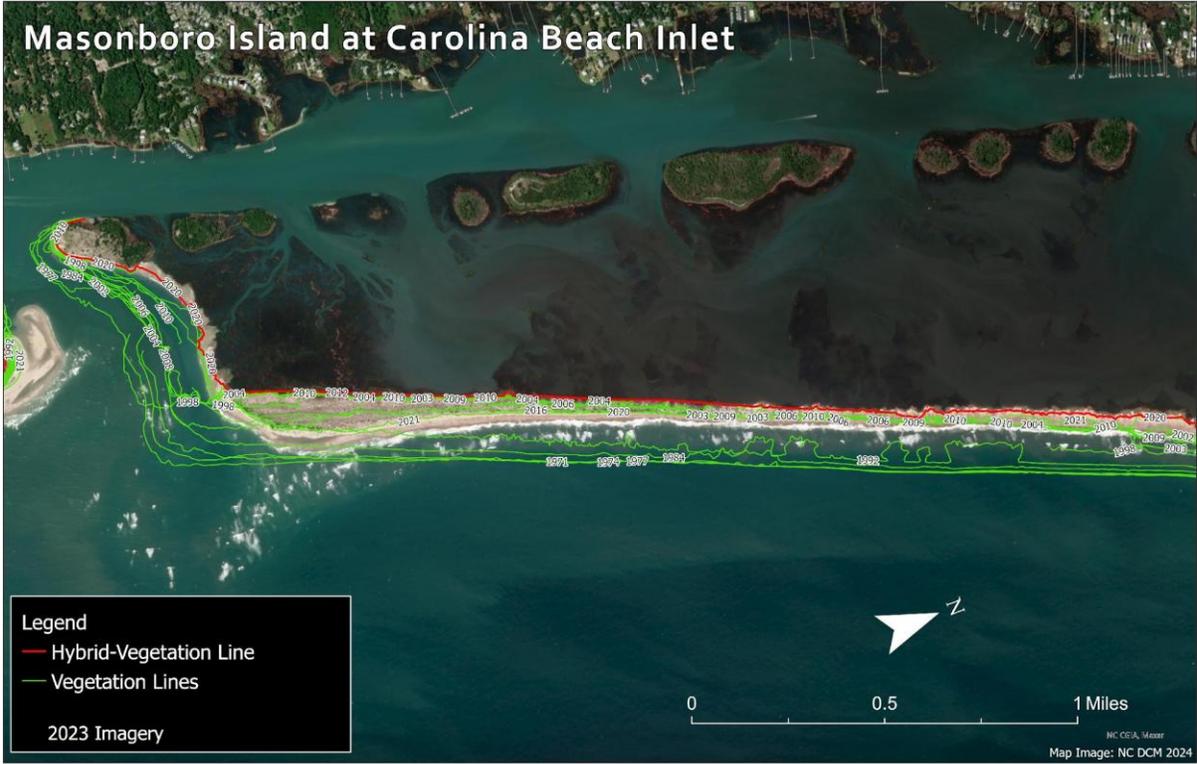
Figure 53. Carolina Beach and Masonboro Inlets at Masonboro Island. Vegetation Lines mapped: 1971, 1974, 1977, 1984, 1992, 1998, 2000, 2002, 2003, 2004, 2006, 2008, 2009, 2010, 2012, 2016, 2020. Vegetation line segments making up the HVL: 1974, 1977, 1984, 1998, 2000, 2002, 2003, 2004, 2006, 2008, 2010, 2012, 2016, 2020, 2021.

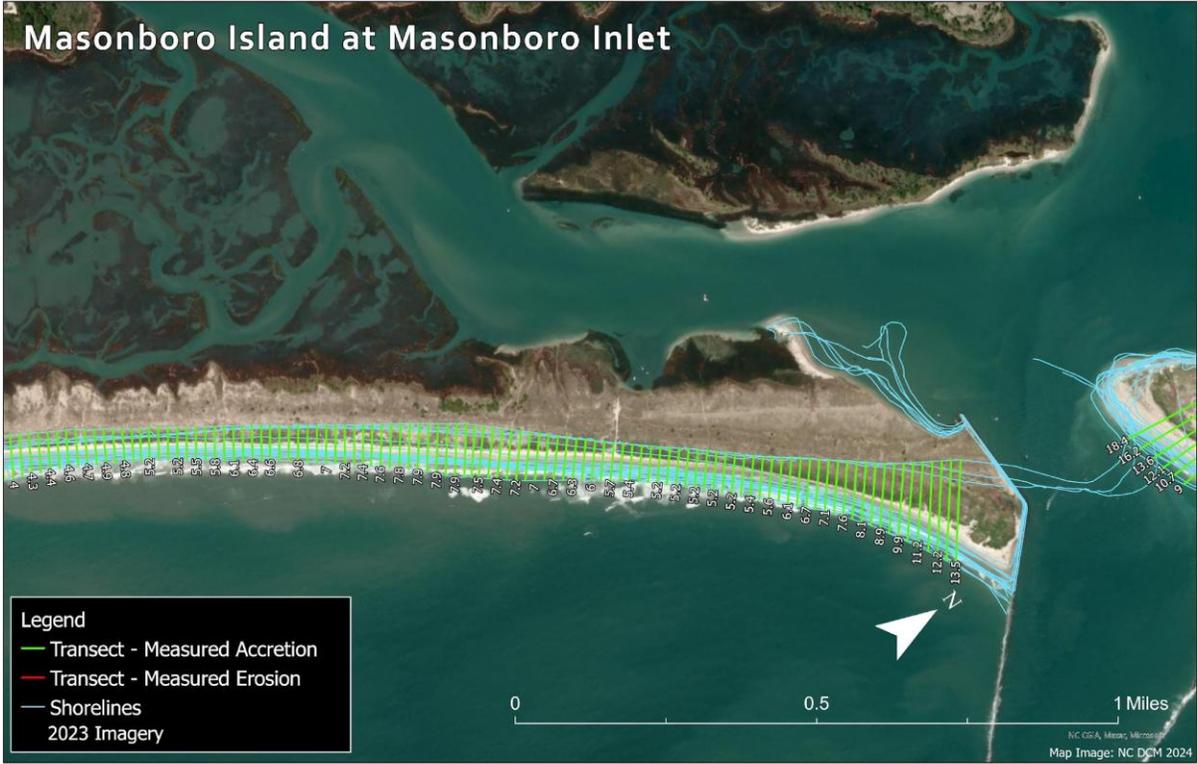
Figure 54. Masonboro Inlets at Masonboro Island. Shorelines included in the analysis: 1971, 1974, 1977, 1984, 1992, 1997, 1998, 2000, 2002, 2003, 2004, 2006, 2008, 2009, 2010, 2012, 2016, 2020, 2021.
