Inlet Hazard Area Boundaries, 2025 Update:

Science Panel Recommendations to the
North Carolina Coastal Resources Commission

August 1, 2025

NC Coastal Resources Commission's Science Panel on Coastal Hazards
& NC Division of Coastal Management

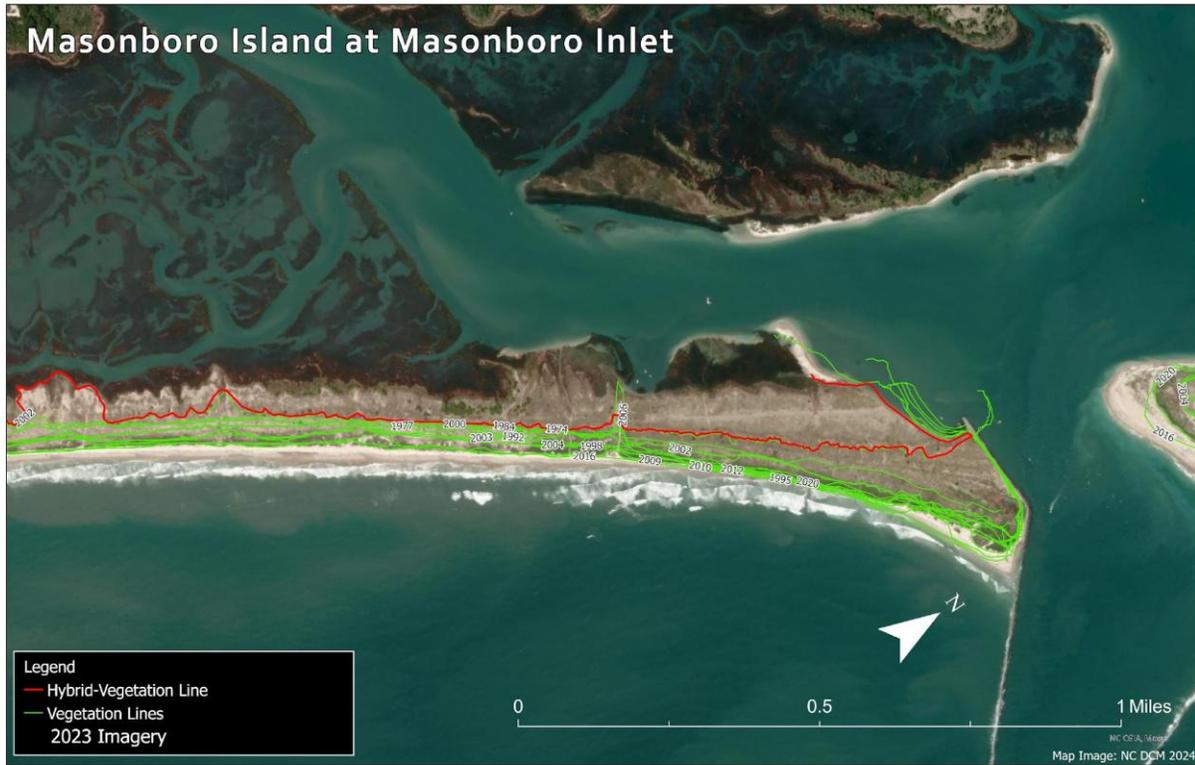
Figure 55. Carolina Beach and Masonboro Inlets at Masonboro Island. Vegetation Lines mapped: 1971, 1974, 1977, 1984, 1992, 1998, 2000, 2002, 2003, 2004, 2006, 2008, 2009, 2010, 2012, 2016, 2020, 2021. Vegetation line segments making up the HVL: 1974, 1977, 1984, 1998, 2000, 2002, 2003, 2004, 2006, 2008, 2010, 2012, 2016, 2020, 2021.

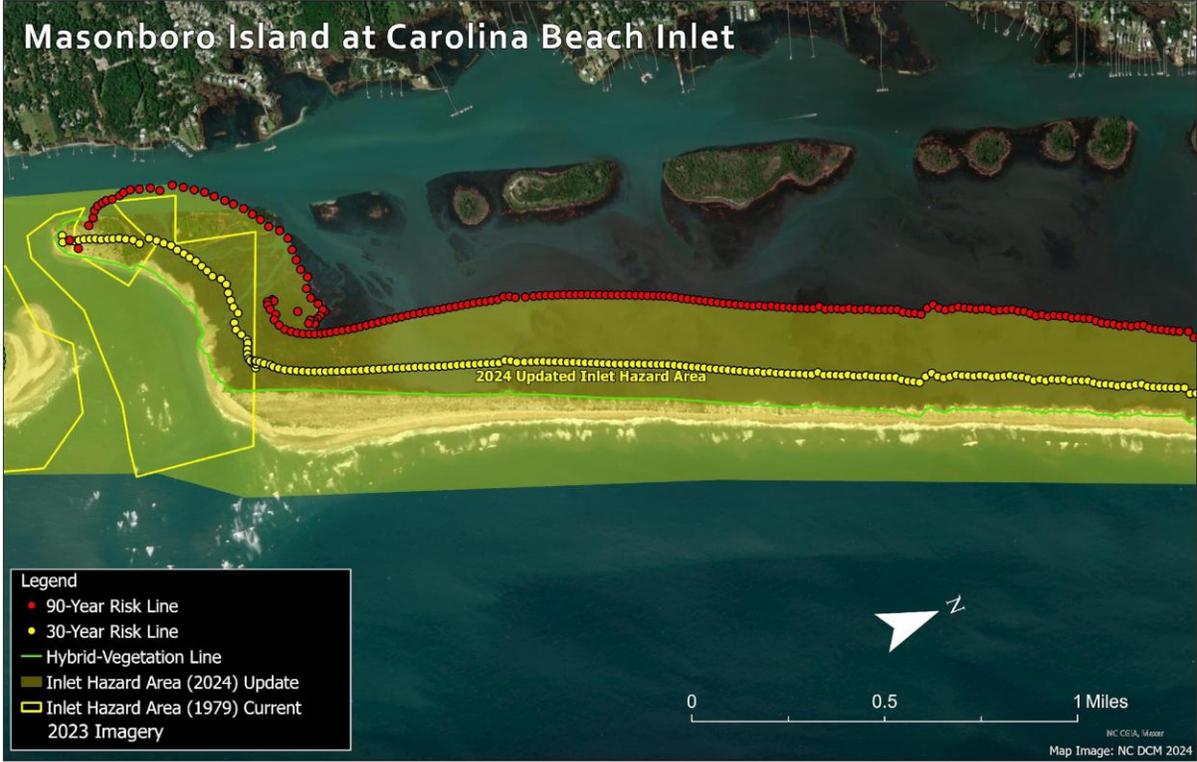
Figure 59. Carolina Beach Inlet at Masonboro Island HVL and the recommended IHA boundary with the 30- and 90-Year Risk Lines.

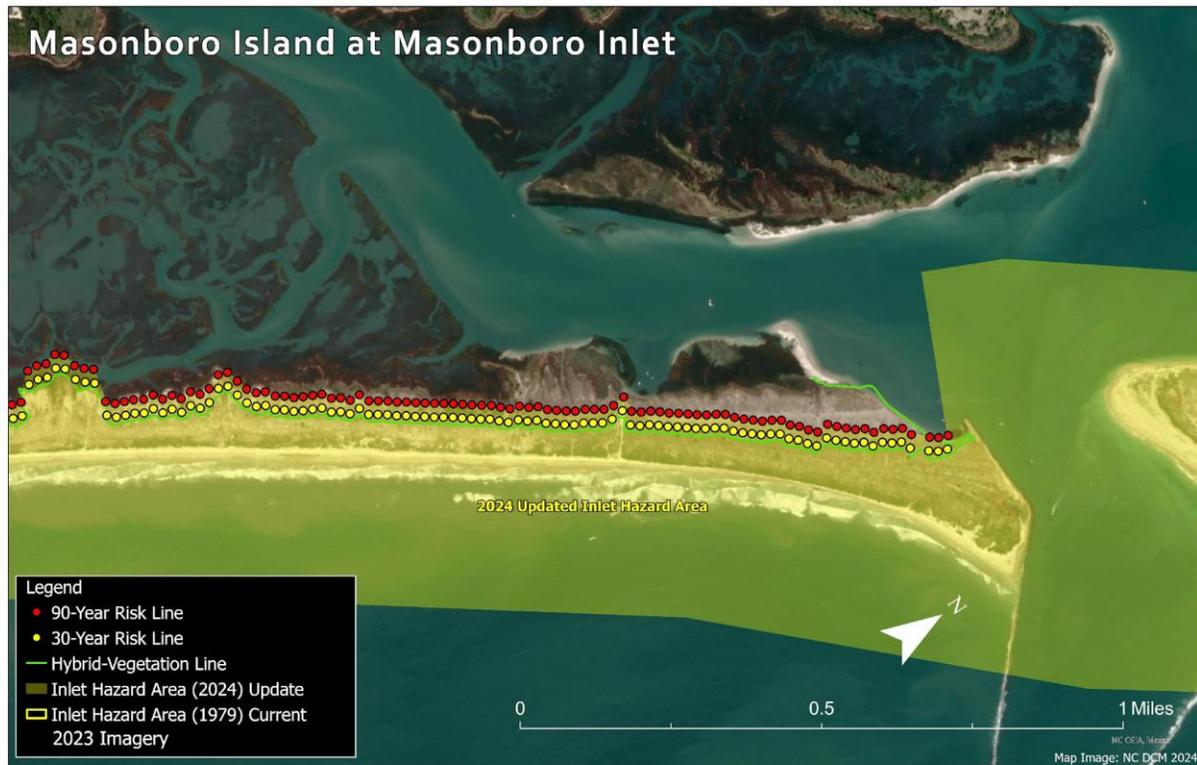
Figure 60. Masonboro Inlet at Masonboro Island HVL and the recommended IHA boundary with the 30- and 90-Year Risk Lines.

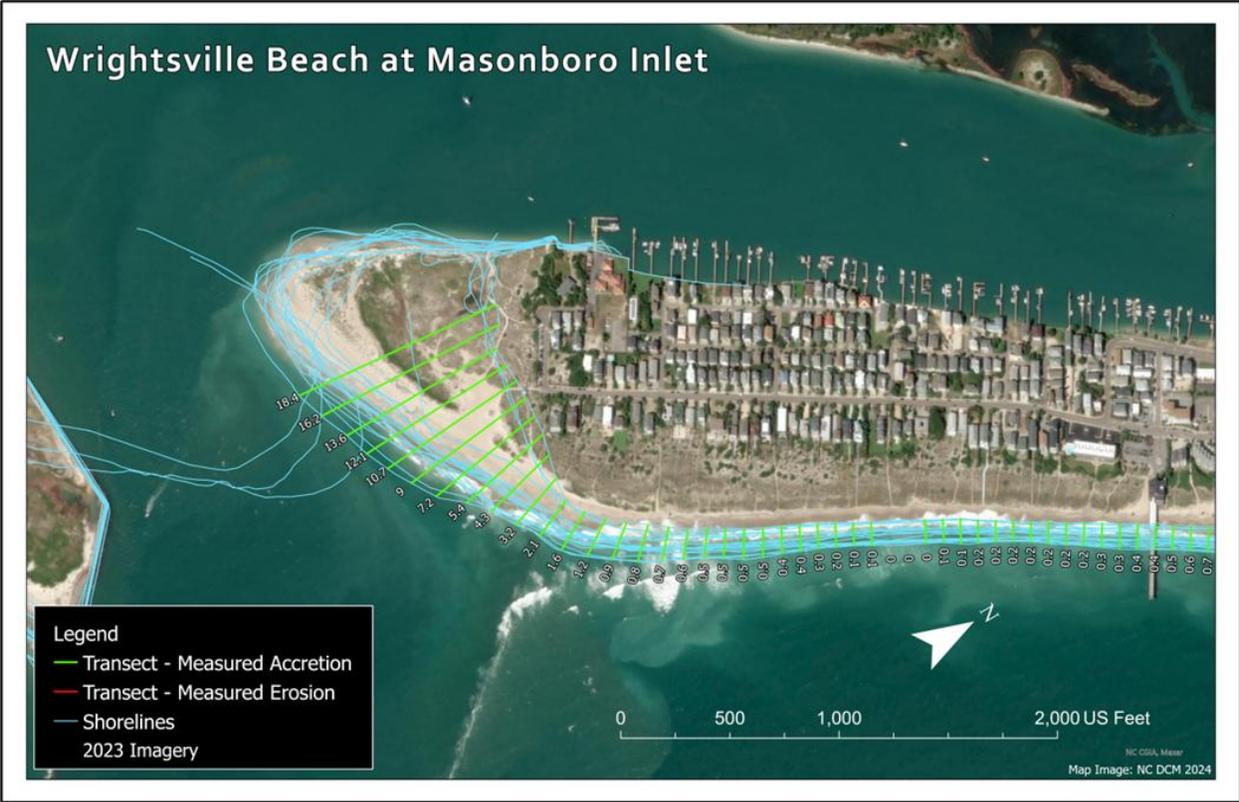
Figure 61. Masonboro Inlet at Wrightsville Beach. Shorelines included: 1973, 1974, 1977, 1984, 1992, 1995, 1997, 1998, 2000, 2002, 2003, 2004, 2006, 2009, 2010, 2012, 2016, 2020.

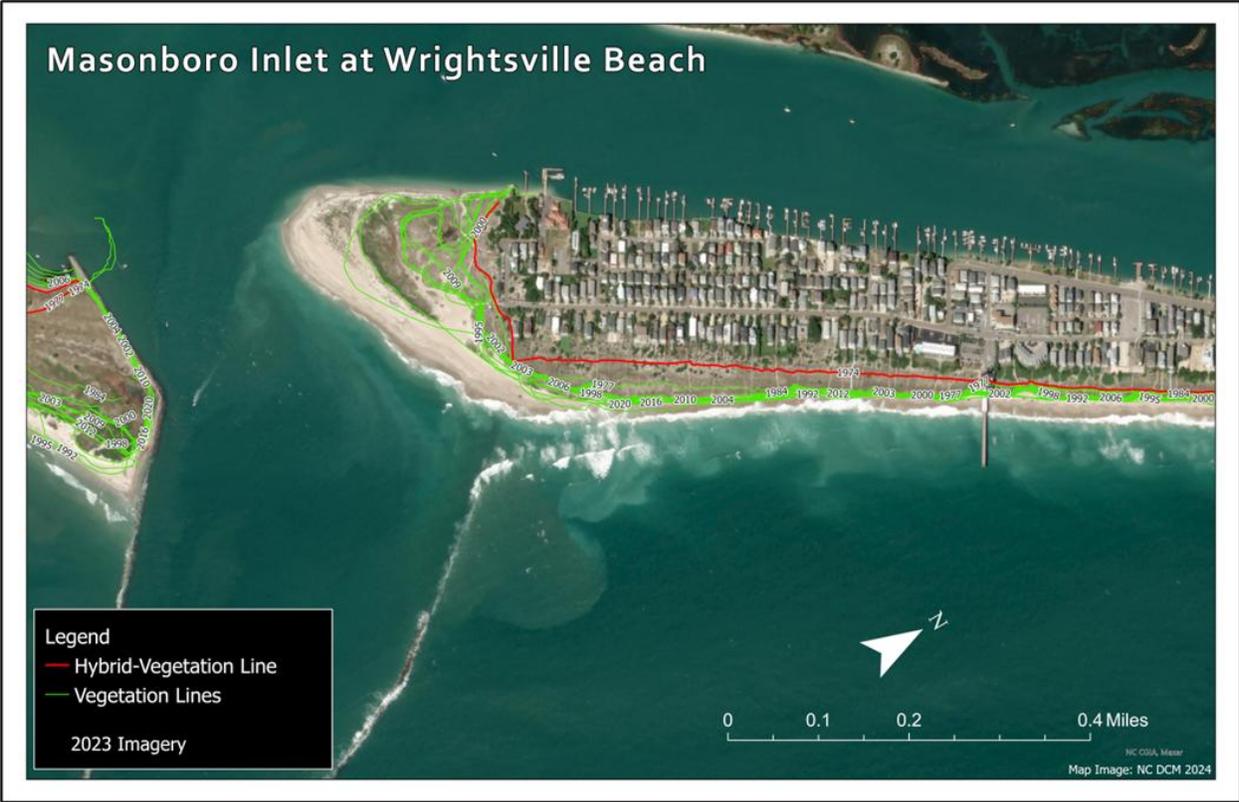
Figure 64. Masonboro Inlet at Wrightsville Beach. Vegetation Lines mapped: 1992, 1995, 1998, 2000, 2002, 2003, 2004, 2006, 2009, 2010, 2012, 2016. Vegetation line segments making up the HVL: 1992, 1998, 2000, 2002, 2003, 2004, 2009, 2010, 2020.

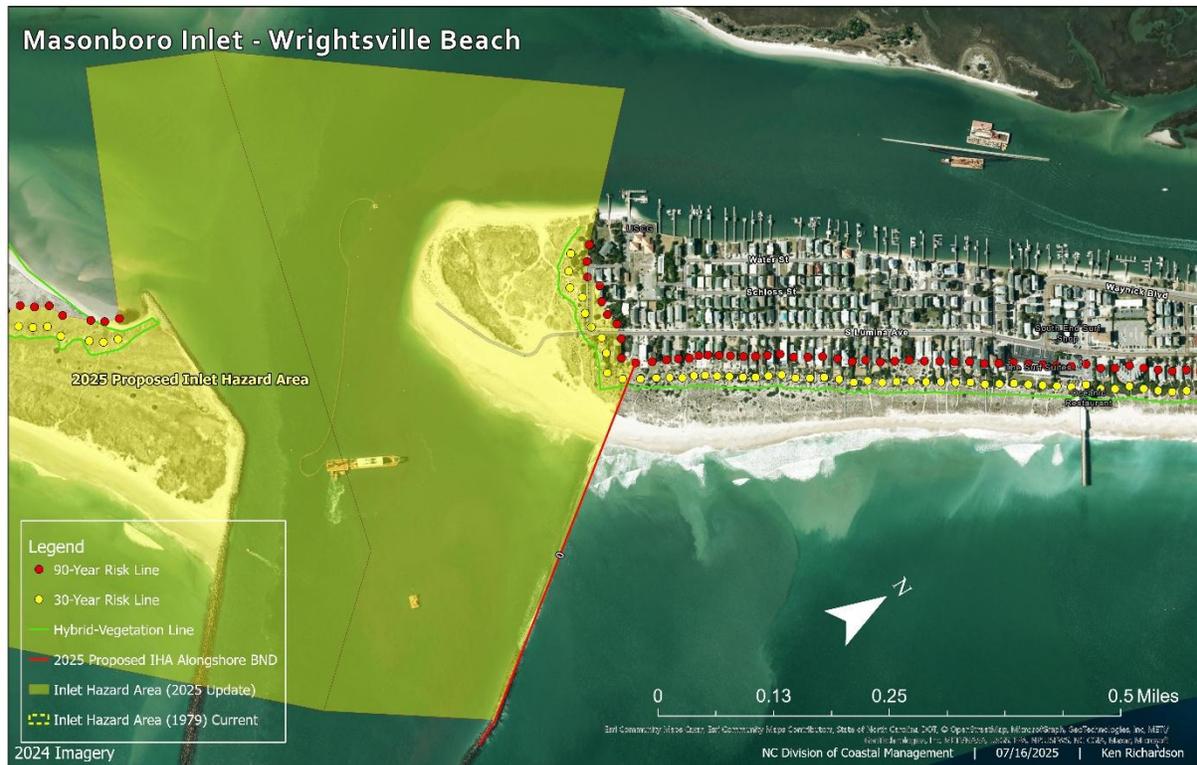
Figure 65. Masonboro Inlet at Wrightsville Beach HVL and the recommended IHA boundary with the 30- and 90-Year Risk Lines.

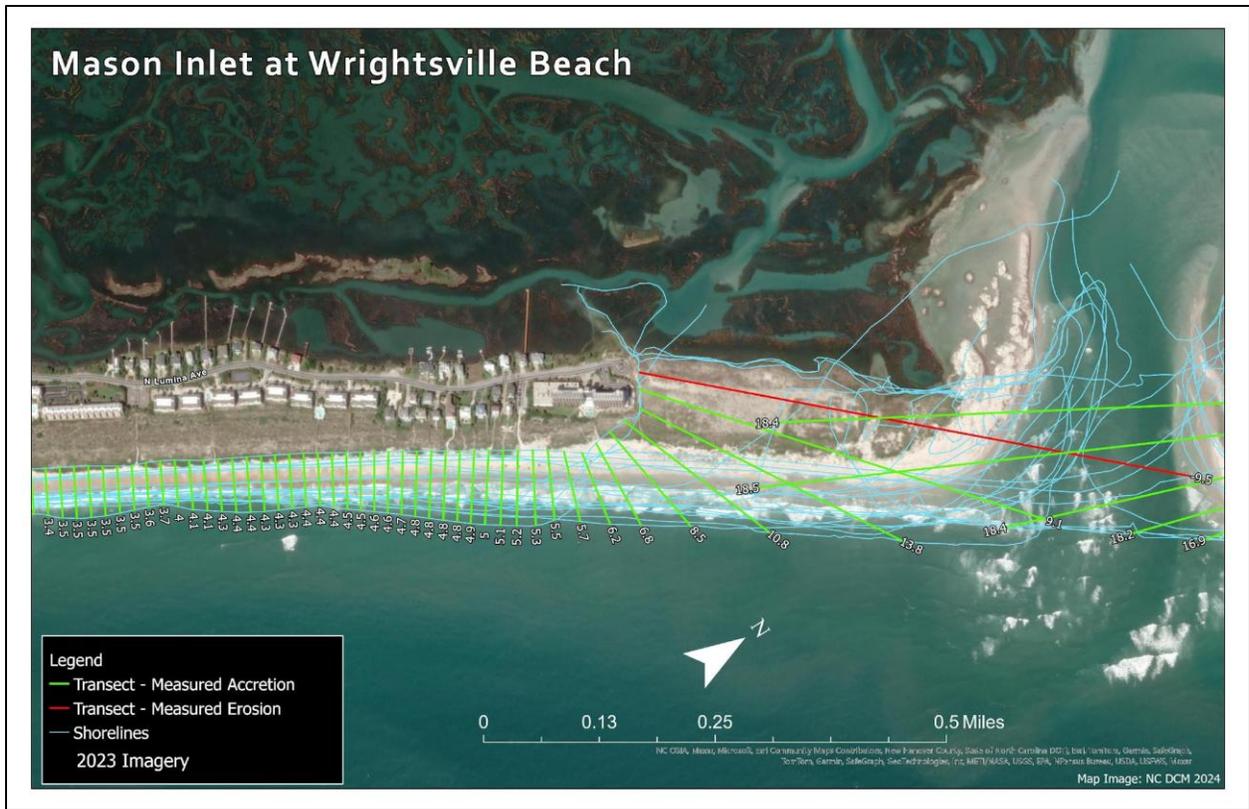
Figure 66. Mason Inlet at Wrightsville Beach. Shorelines included: 1971, 1973, 1977, 1987, 1992, 1997, 1998, 2002, 2003, 2004, 2006, 2009, 2010, 2012, 2016, 2019, 2020.

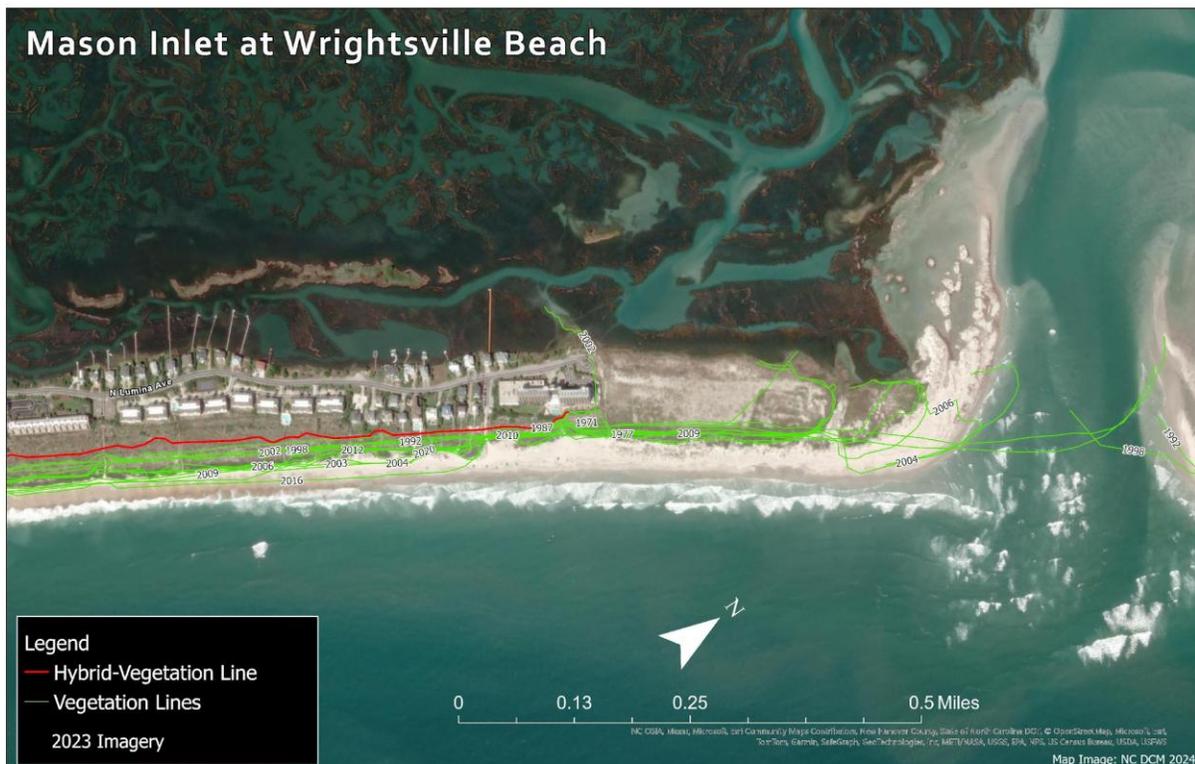
Figure 69. Mason Inlet at Wrightsville Beach. Vegetation Lines mapped: 1971, 1977, 1987, 1992, 1998, 2002, 2003, 2004, 2006, 2009, 2010, 2012, 2016, 2019, 2020. Vegetation line segments making up the HVL: 1971, 1987, 2002, 2003, 2006, and 2010.

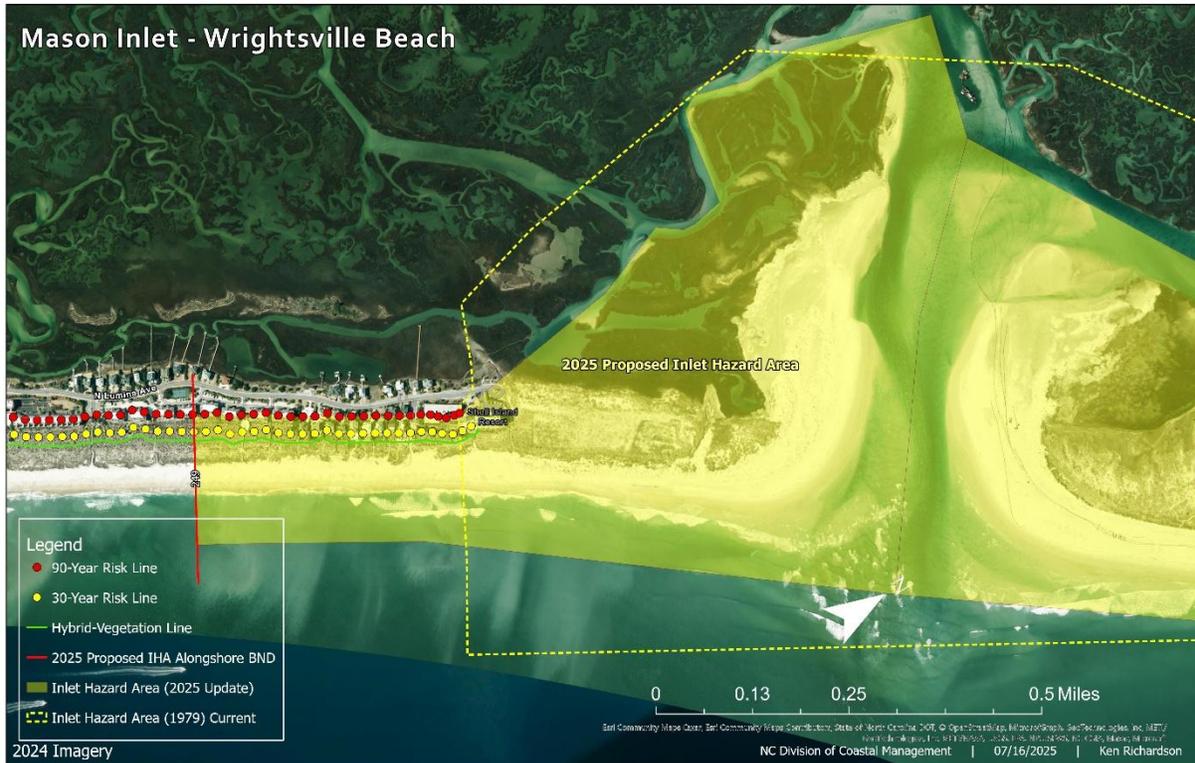
Figure 70. Mason Inlet at Wrightsville Beach HVL and the recommended IHA boundary with the 30- and 90-Year Risk Lines.

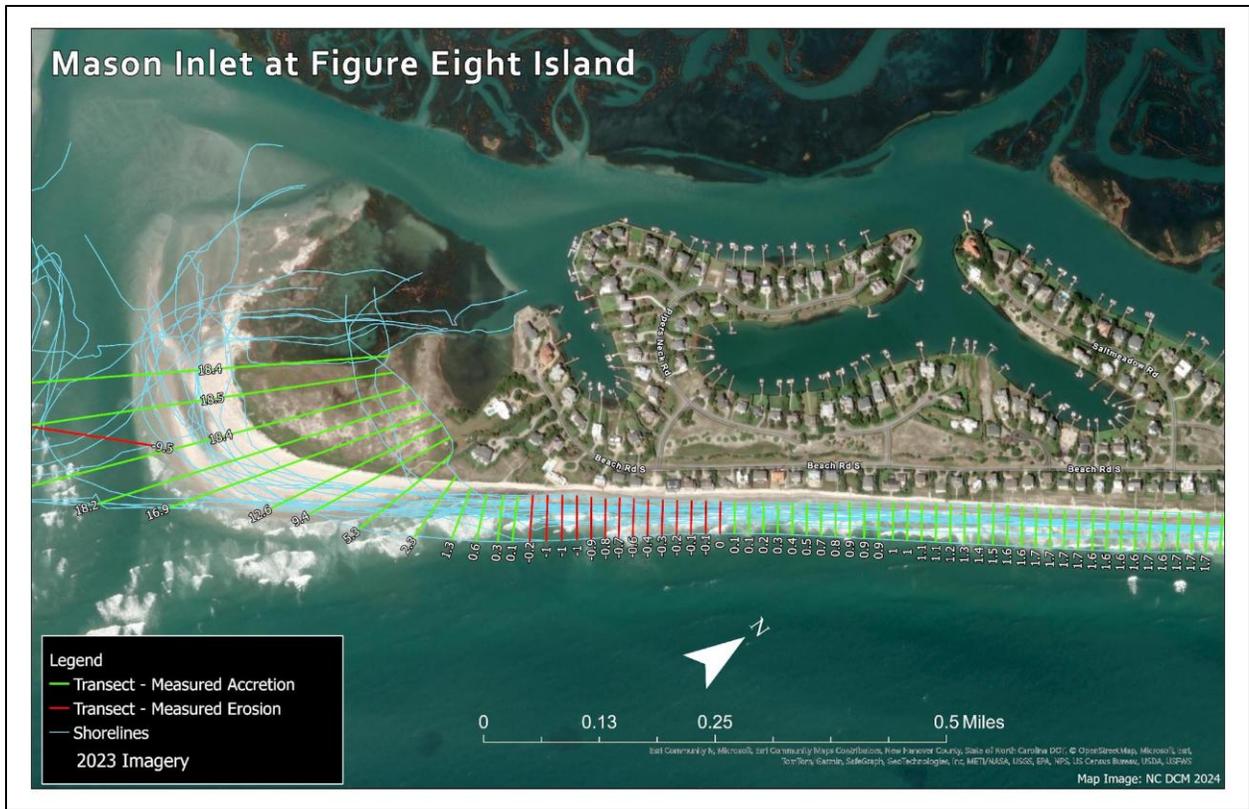
Figure 80. Mason Inlet at Figure Eight Island. Shorelines included in the analysis: 1971, 1973, 1977, 1987, 1992, 1997, 1998, 2002, 2003, 2004, 2006, 2009, 2010, 2012, 2016.

Like the Wrightsville Beach side of Mason Inlet, post-2002 data were used to identify the alongshore IHA boundary, while all data (1970-2020) were used to calculate the long-term shoreline change and calculate 30 and 90-Year Risk Lines. Shoreline and vegetation data for the Figure Eight Island side of Mason Inlet are presented in **Figures 80 and 83**. Analysis of shoreline data shows long-term accretion from 1970 to 2020 (**Figures 80 and 81**) with measured erosion between transects 14 and 27. These findings are influenced by routine beach nourishment and maintenance dredging activities at Mason Inlet. As with the Wrightsville Beach side of the inlet, the data used in the analysis reflects the ongoing inlet maintenance and nourishment projects. If these management actions change, the inlet processes and therefore IHA boundaries will change. The HVL is based on the 1971, 1977, 1998, 2002, 2004 and 2012 vegetation lines (**Figure 83**). Applying $STD \Delta > 1$ identifies the alongshore IHA boundary at transect 42 (**Figure 82**). The landward IHA boundary follows the 90-Year Risk Line, starting at transect 42 and continuing towards the inlet until the last 90-Year Risk Line point, where it is extended across the marsh to meet the tidal creek (**Figure 84**).

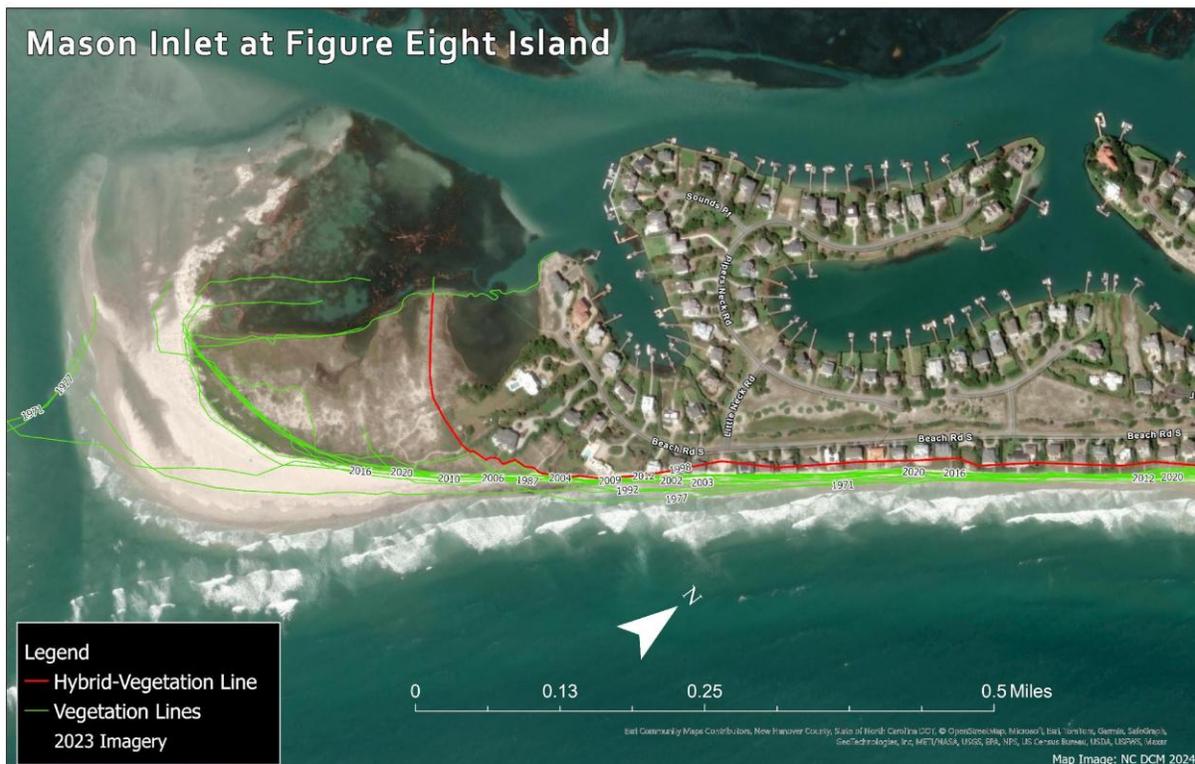
Figure 83. Mason Inlet at Figure Eight Island. Vegetation Lines mapped: 1971, 1977, 1987, 1992, 1998, 2002, 2003, 2004, 2006, 2009, 2010, 2012, 2016, 2020. Vegetation line segment(s) making up the Hybrid-Vegetation Line: 1971, 1977, 1998, 2002, 2004 and 2012.

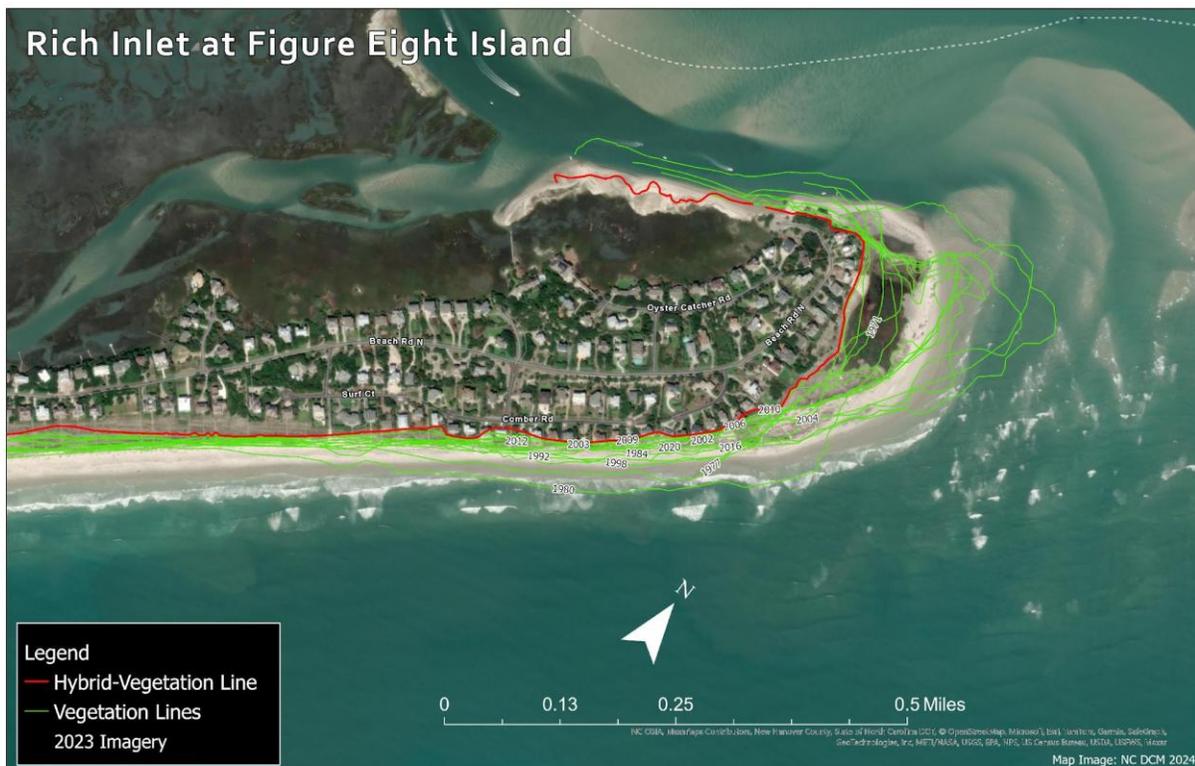
Figure 88. Rich Inlet at Figure Eight Island. Vegetation Lines mapped: 1971, 1977, 1980, 1984, 1992, 1998, 2002, 2003, 2004, 2006, 2009, 2010, 2012, 2016, 2020. Vegetation line segments making up the HVL: 1984, 1998, 2002, 2006, 2009, 2010, 2012, 2016.

The shoreline and vegetation data for Figure Eight Island at Rich Inlet are shown in **Figures 85 and 88**. Analysis of shoreline data from 1971 to 2020 shows long-term erosion along the oceanfront from transect 225 to transect 263 (average is -3.3, mean is -3.4, maximum is -5.7 feet/year); while accretion was measured within the inlet as a result of regular spit formation (**Figures 85 and 86**). The HVL for the area within the IHA is comprised of segments from 1984, 1998, 2002, 2006, 2009, 2010, 2012, 2016 vegetation lines (**Figure 88**). Applying $STD \Delta > 1$ identifies transect 225 as the IHA alongshore boundary (**Figure 87**). The 90-Year Risk line is recommended as the landward limit of the IHA then extending to intersect Beach Road. (**Figure 89**).

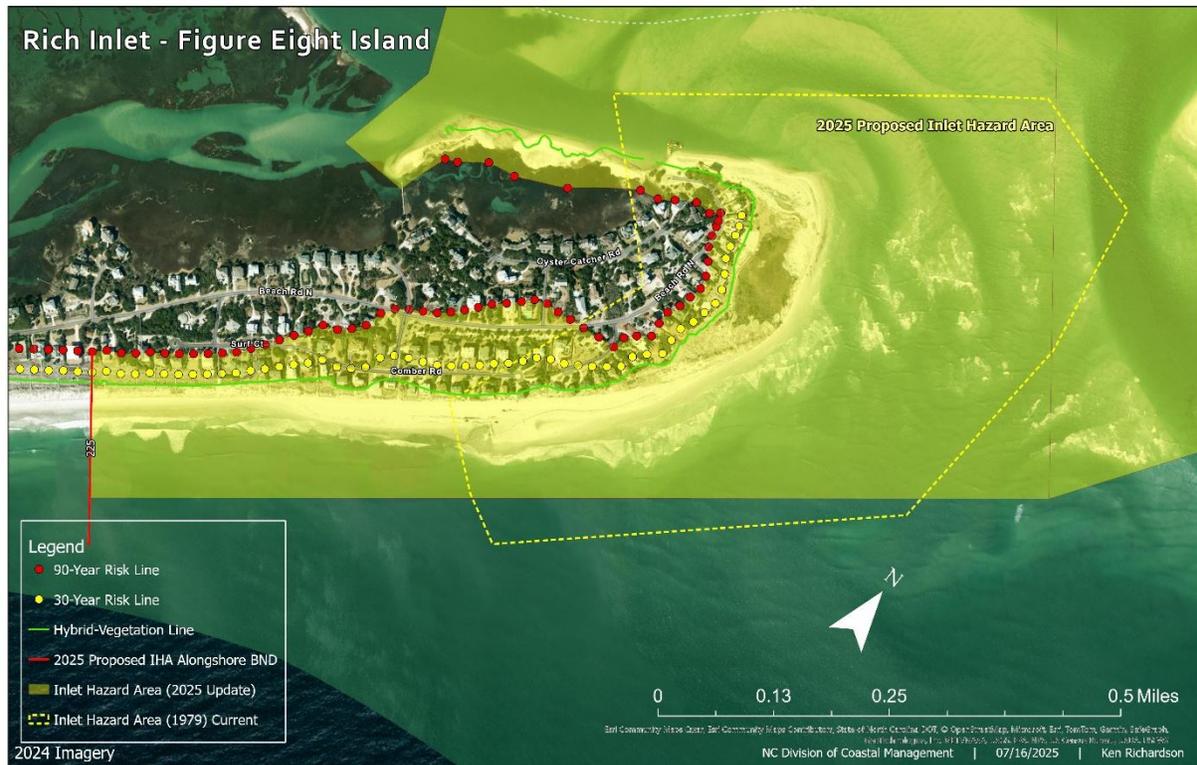
Figure 89. Rich Inlet at Figure Eight Island HVL and the recommended IHA boundary with the 30- and 90-Year Risk Lines.

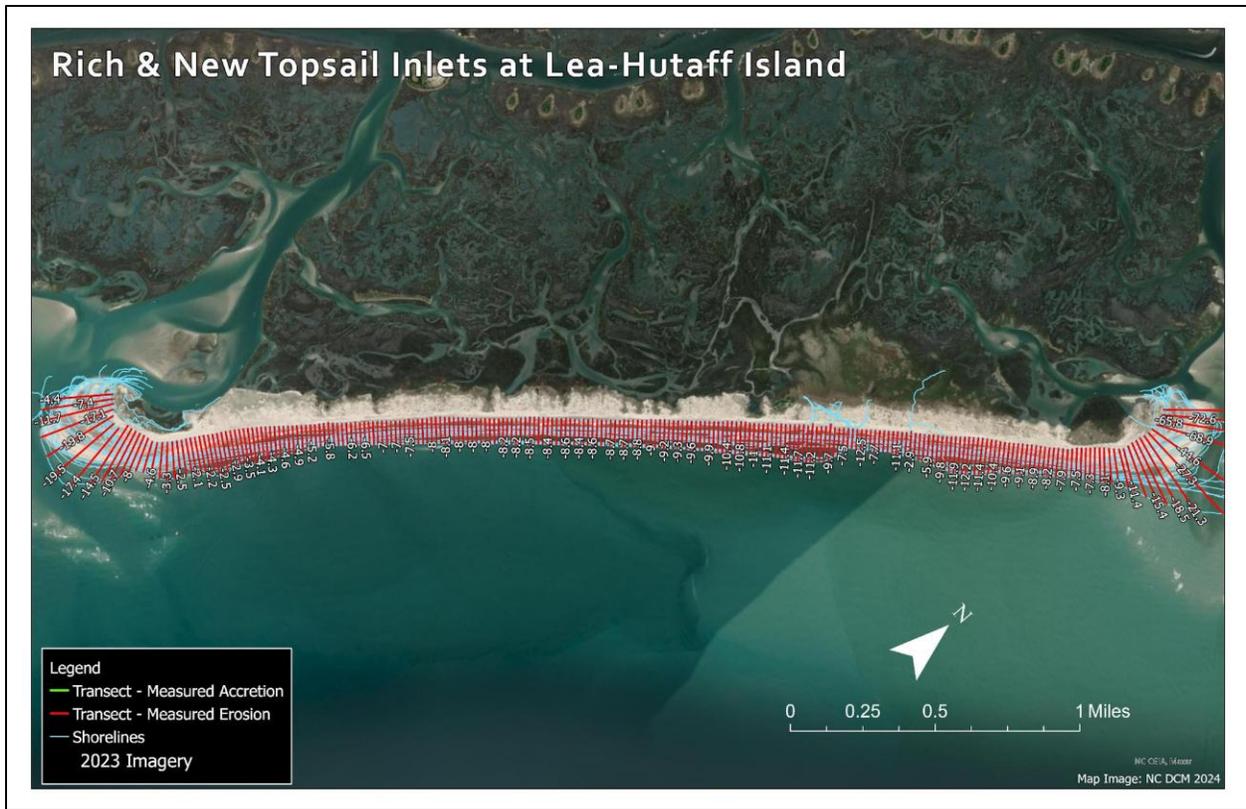
Figure 90. Shorelines included in the analysis: 1971, 1973, 1974, 1976, 1980, 1984, 1992, 1995, 1997, 1998, 2000, 2004, 2006, 2008, 2009, 2010, 2012, 2016, 2019, 2020, 2021.

The Lea and Hutaff Islands (also known as Coke and No-Name Islands) were joined in 1997 by the closure of Old Topsail Inlet. The resulting Lea-Hutaff Island is strongly influenced by the adjacent Rich and New Topsail Inlets. The shoreline and vegetation data are shown in **Figures 90 and 93**. Similar to Masonboro Island, the standard deviation of relative shoreline position and erosion rates are high for most of the island (**Figures 90, 91 and 92**); standard deviation average is 167, median is 150, high is 502 and lowest is 110 feet; erosion rate average is -8.4, median is -8.6, high is -17.6 and lowest is -2.6 feet/year. Based on their narrow and low-lying topography, lack of dune ridges and regular and extensive overwash (**Figure 94**), the Panel recommends that the boundary of the IHA include the entire island (**Figure 95**).

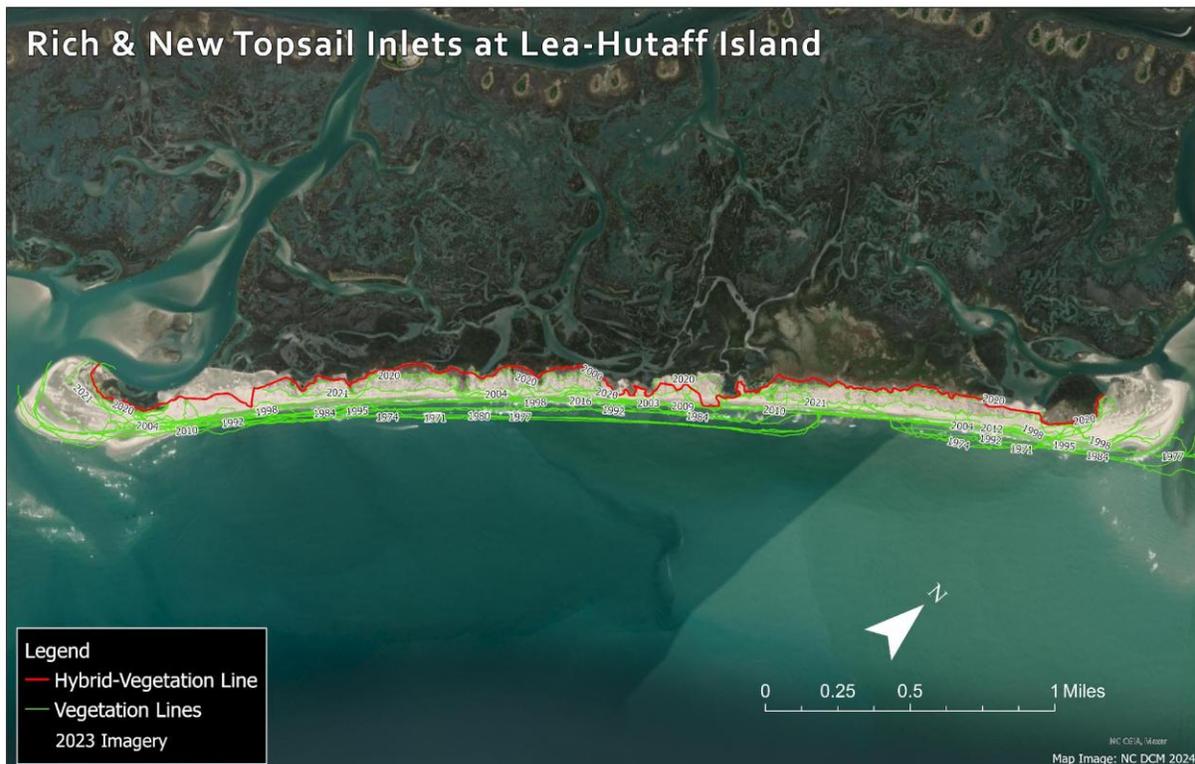
Figure 93. Rich and New Topsail Inlets at Lea-Hutaff Island. Vegetation Lines mapped: 1971, 1973, 1974, 1976, 1980, 1984, 1992, 1995, 1997, 1998, 2000, 2004, 2006, 2008, 2009, 2010, 2012, 2016, 2019, 2020, 2021. Vegetation line segments making up the HVL: 1998, 2000, 2004, 2010, 2012, 2016, 2020, 2021.

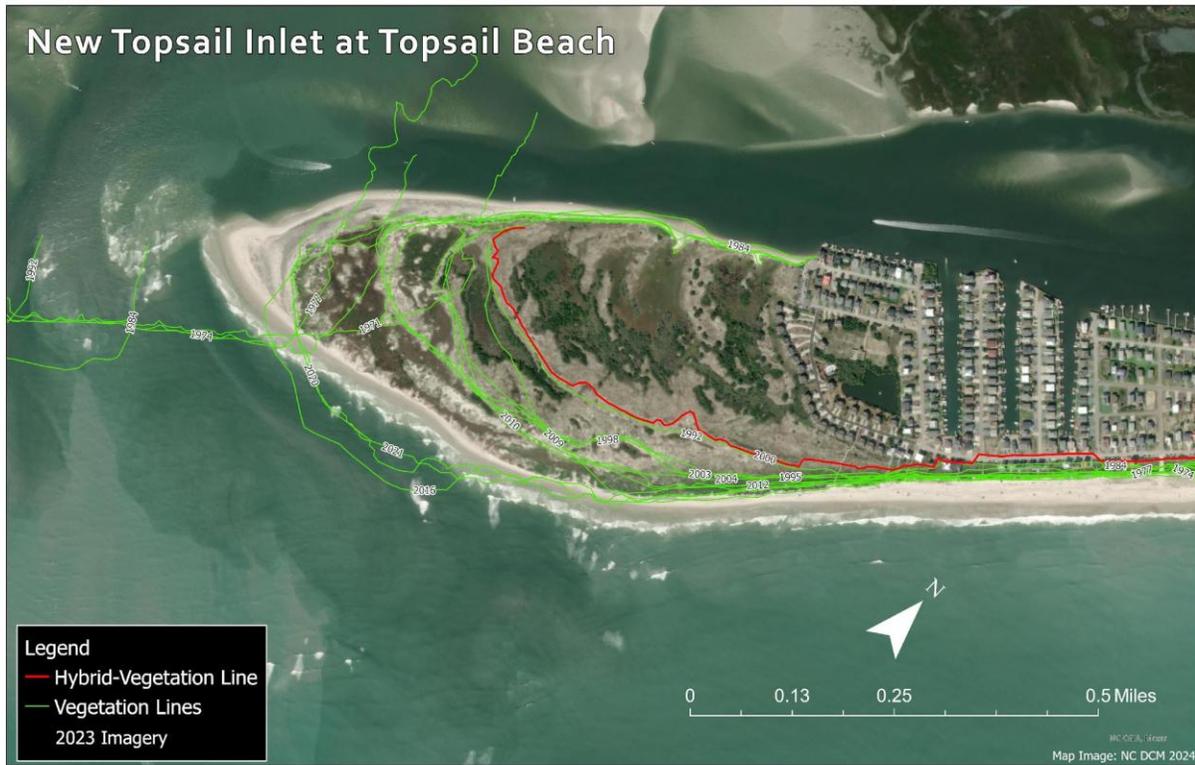
Figure 99. New Topsail Inlet at Topsail Beach. Vegetation Lines mapped: 1971, 1974, 1977, 1984, 1992, 1995, 1997, 1998, 2000, 2003, 2004, 2008, 2009, 2010, 2011, 2012, 2016, 2019, 2020, 2021. To account for the inlet's rapid migration, the HVL within the inlet was based on a ~30-year period (1991-2021); all vegetation lines were considered on the oceanfront.

The shoreline and vegetation data for Topsail Beach at New Topsail Inlet are shown in **Figures 96 and 99**. New Topsail Inlet's rapid southward migration reduces erosion risks on the north side of the inlet. Since a migration reversal is unlikely, in such cases it is recommended to limit the inlet analysis to the most recent 30 years. For the Topsail Beach side of New Topsail Inlet, the computation of the HVL used the full record (1971-2021) on the oceanfront but was limited to an approximate 30-year data record (1991-2016) within the inlet because of the rapid migration (**Figure 99**). Due to erosion caused by Hurricanes Bertha and Fran (1996), the inlet HVL is defined primarily by the year 2000 vegetation line (Figure 226). It is recommended that this 30-year adjustment should be reevaluated during each IHA update. If the inlet continues to migrate, the IHA is expected to move south with the inlet.

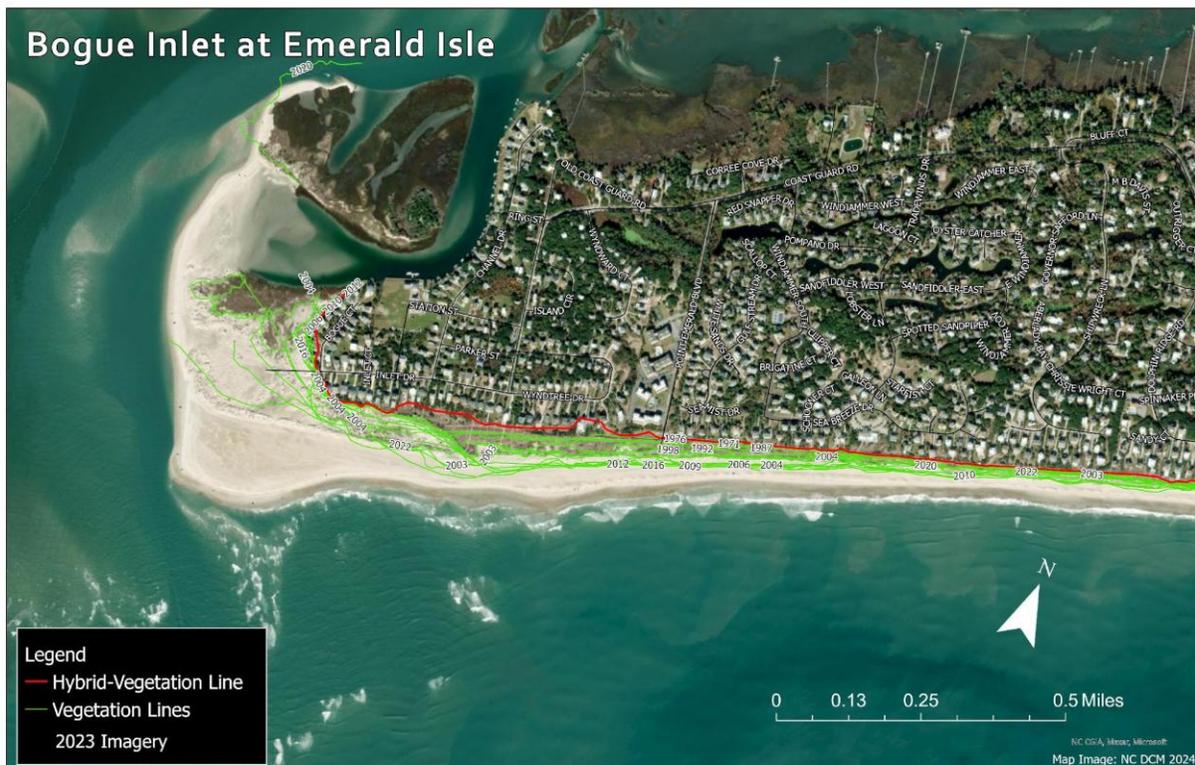
Figure 109. Bogue Inlet at Emerald Isle. Vegetation Lines mapped: 1971, 1976, 1987, 1992, 1998, 2003, 2004, 2006, 2009, 2010, 2012, 2016, 2020, 2022, and; vegetation line composite segments making up the HVL: 1971, 1976, 1987, 1992, 2006, 2009, 2010, 2012.

Shoreline and vegetation data for the Emerald Isle side of Bogue Inlet are presented in **Figures 106 and 109**. Analysis of shoreline data from 1971 and 2022 shows long-term accretion (**Figures 106 and 107**), though these findings are influenced by routine beach nourishment and channel realignment activities at Bogue Inlet. The HVL is a composite of 1971, 1976, 1987, 1992, 2006, 2009, 2010, 2012 vegetation lines (**Figure 109**). Applying $STD \Delta > 1$ identifies the alongshore IHA boundary at transect 75 (**Figure 108**). The landward IHA boundary follows the 90-Year Risk Line, starting at transect 75 and continuing towards the inlet until the last 90-Year Risk Line point, where it follows the remaining 300 feet of Inlet Road, then intersecting the creek adjacent to the U.S Coast Guard Base at Emerald Isle, then intersecting Bogue Sound (**Figure 110**).

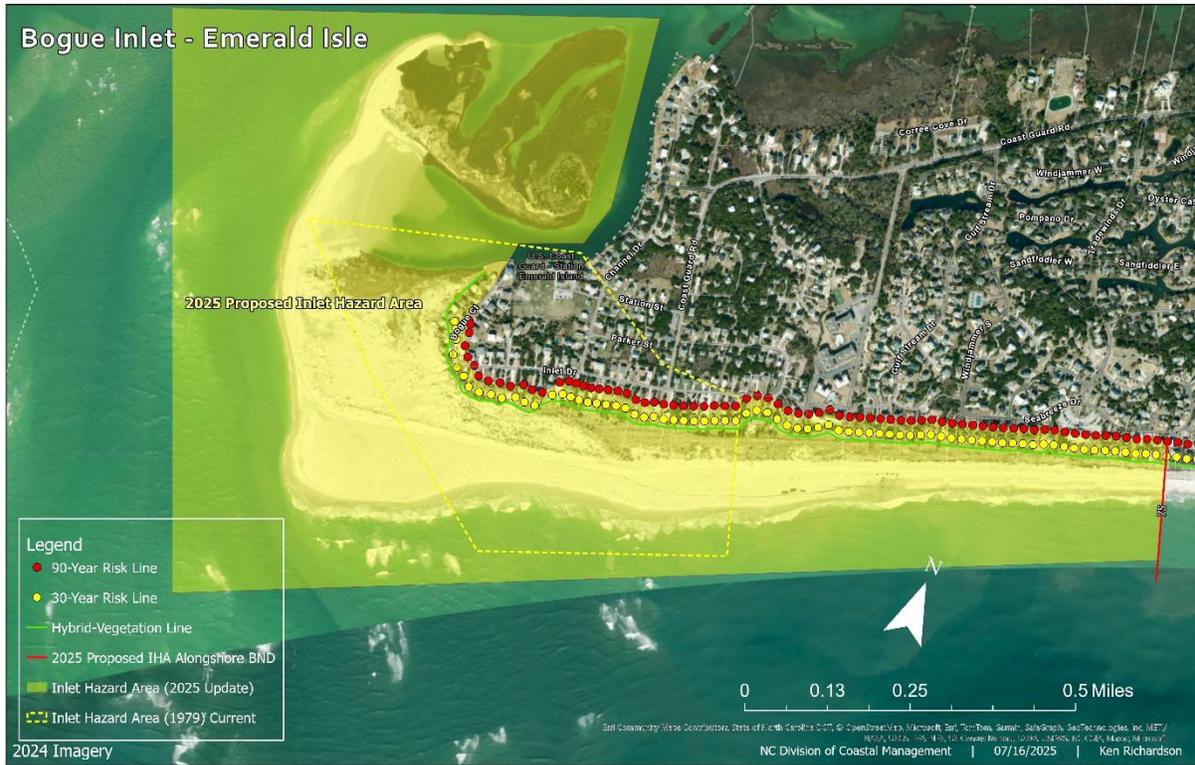
Figure 110. Bogue Inlet at Emerald Isle HVL and the recommended IHA boundary with the 30- and 90-Year Risk Lines.

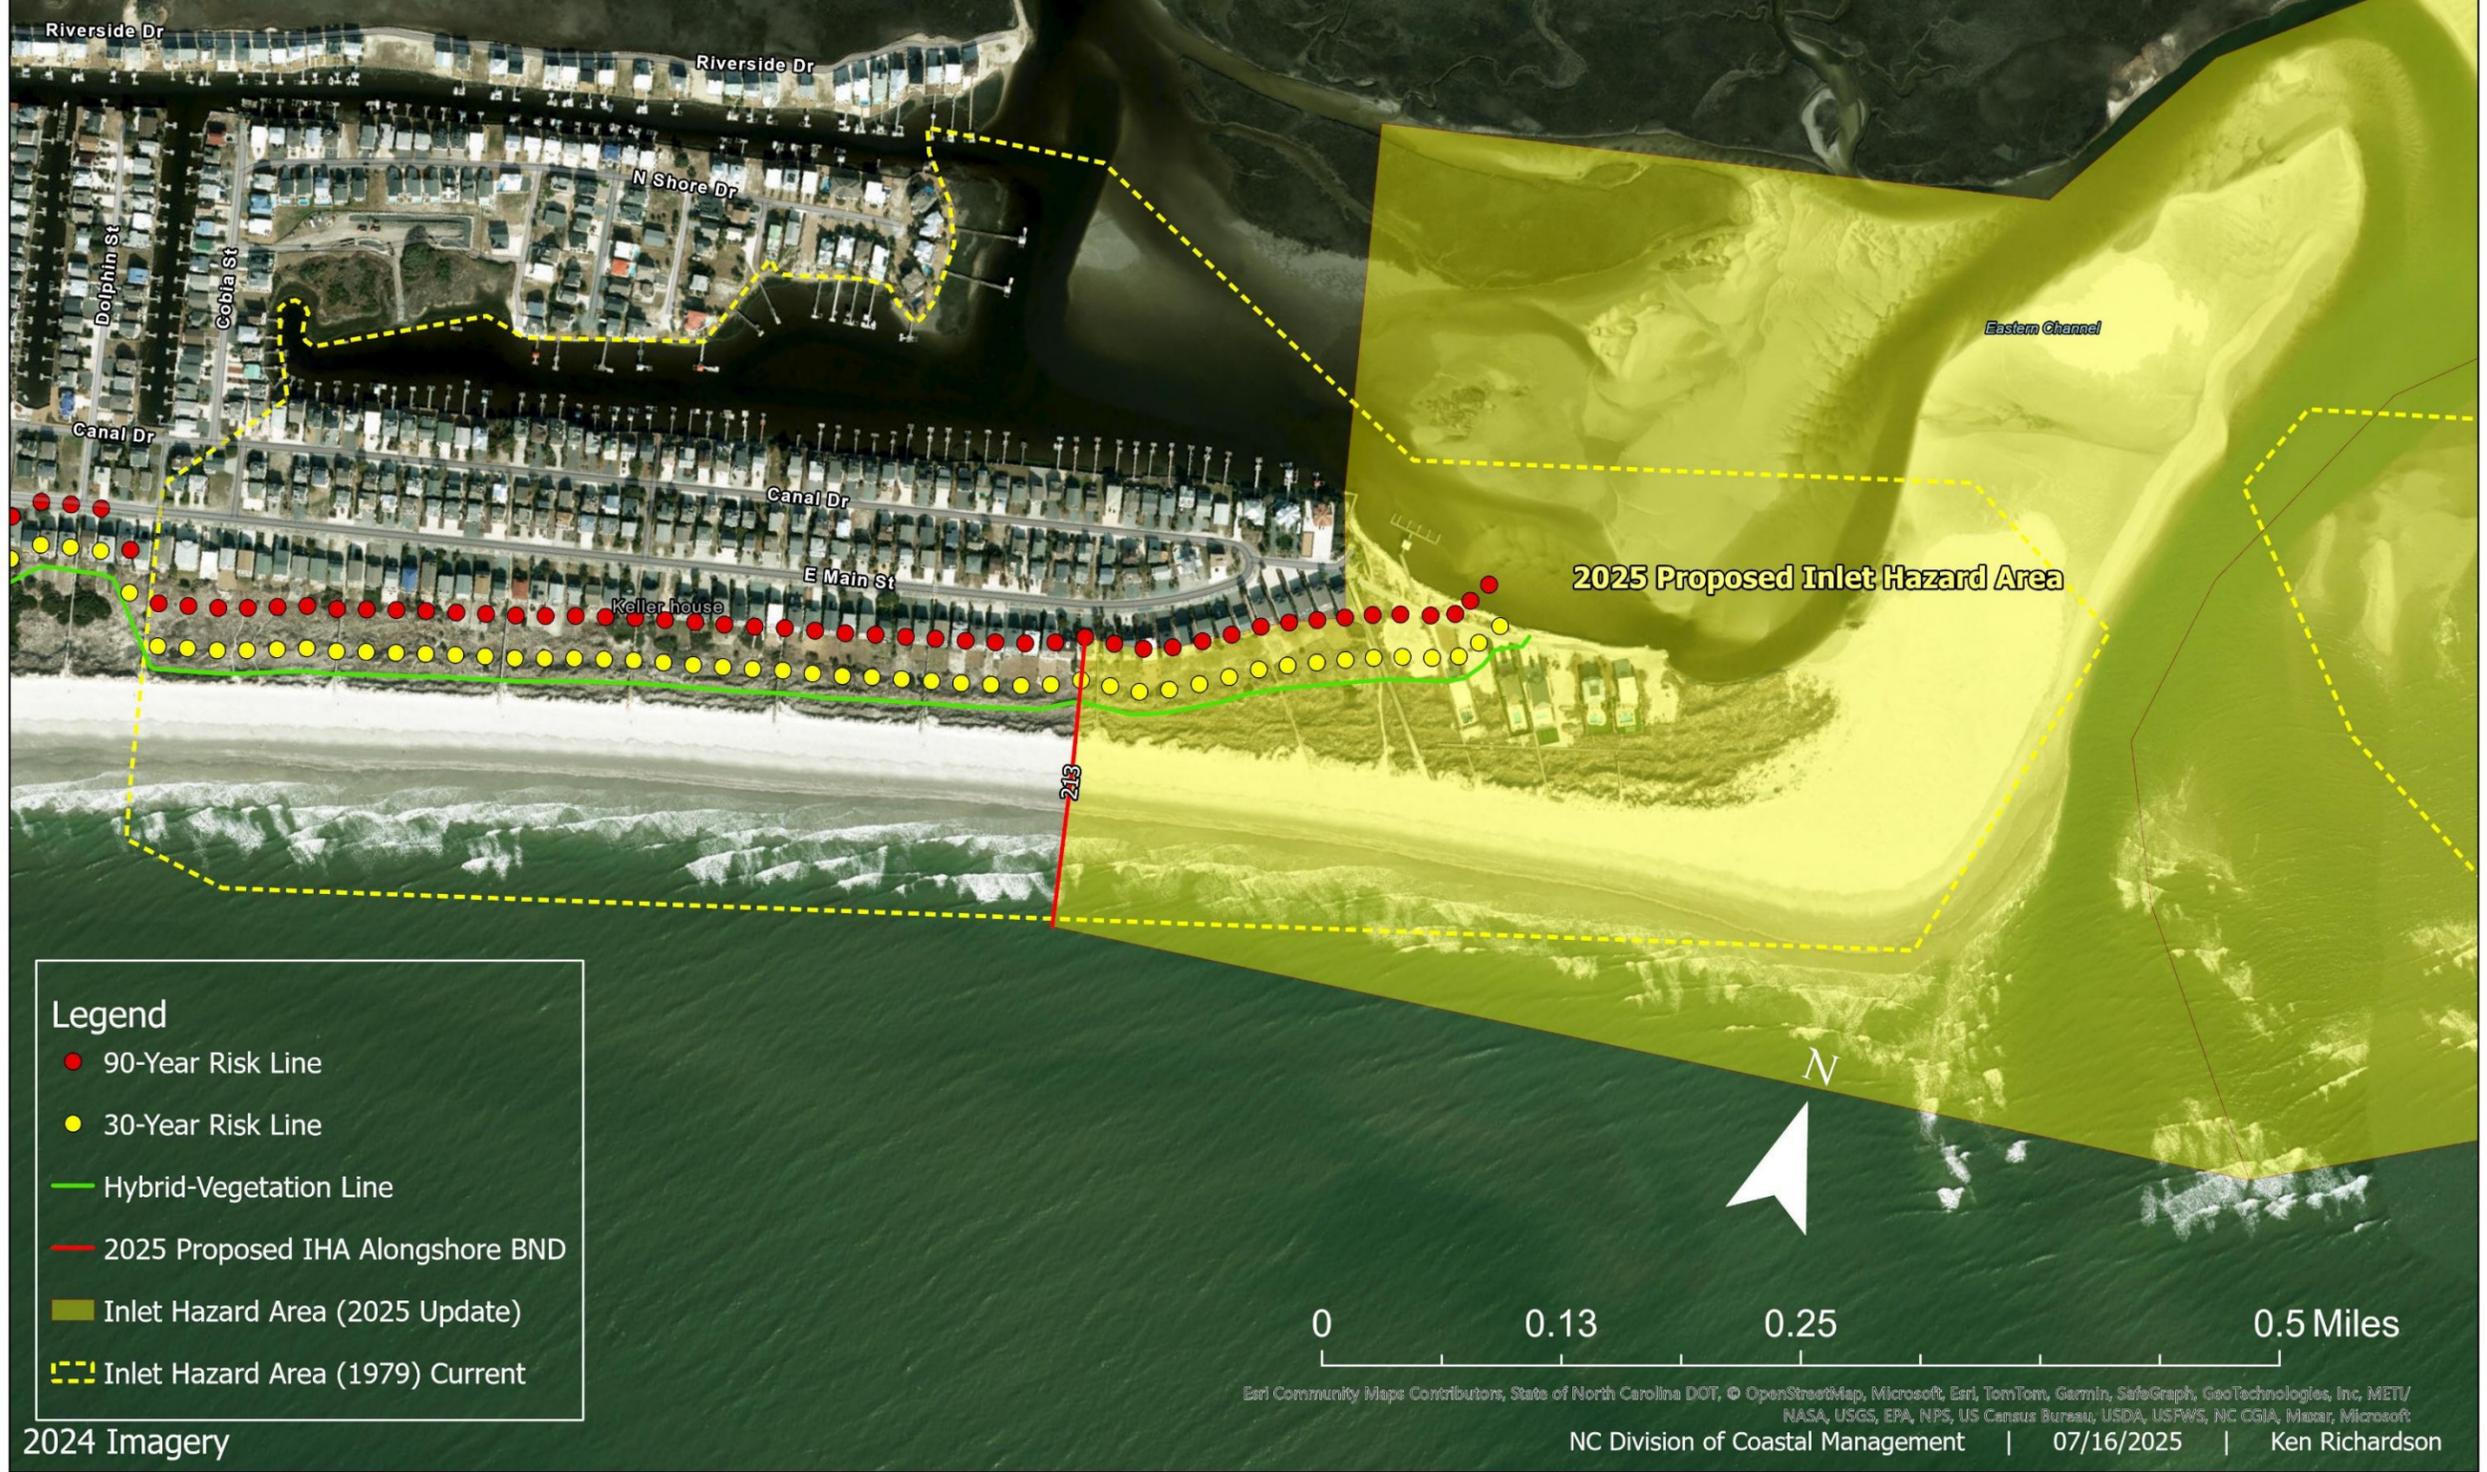
Tubbs Inlet - Sunset Beach

Figure C1. Proposed Inlet Hazard Area at Tubbs Inlet (Sunset Beach).
