Inlet Hazard Area Boundaries, 2025 Update:

Science Panel Recommendations to the
North Carolina Coastal Resources Commission

August 1, 2025

NC Coastal Resources Commission's Science Panel on Coastal Hazards
& NC Division of Coastal Management

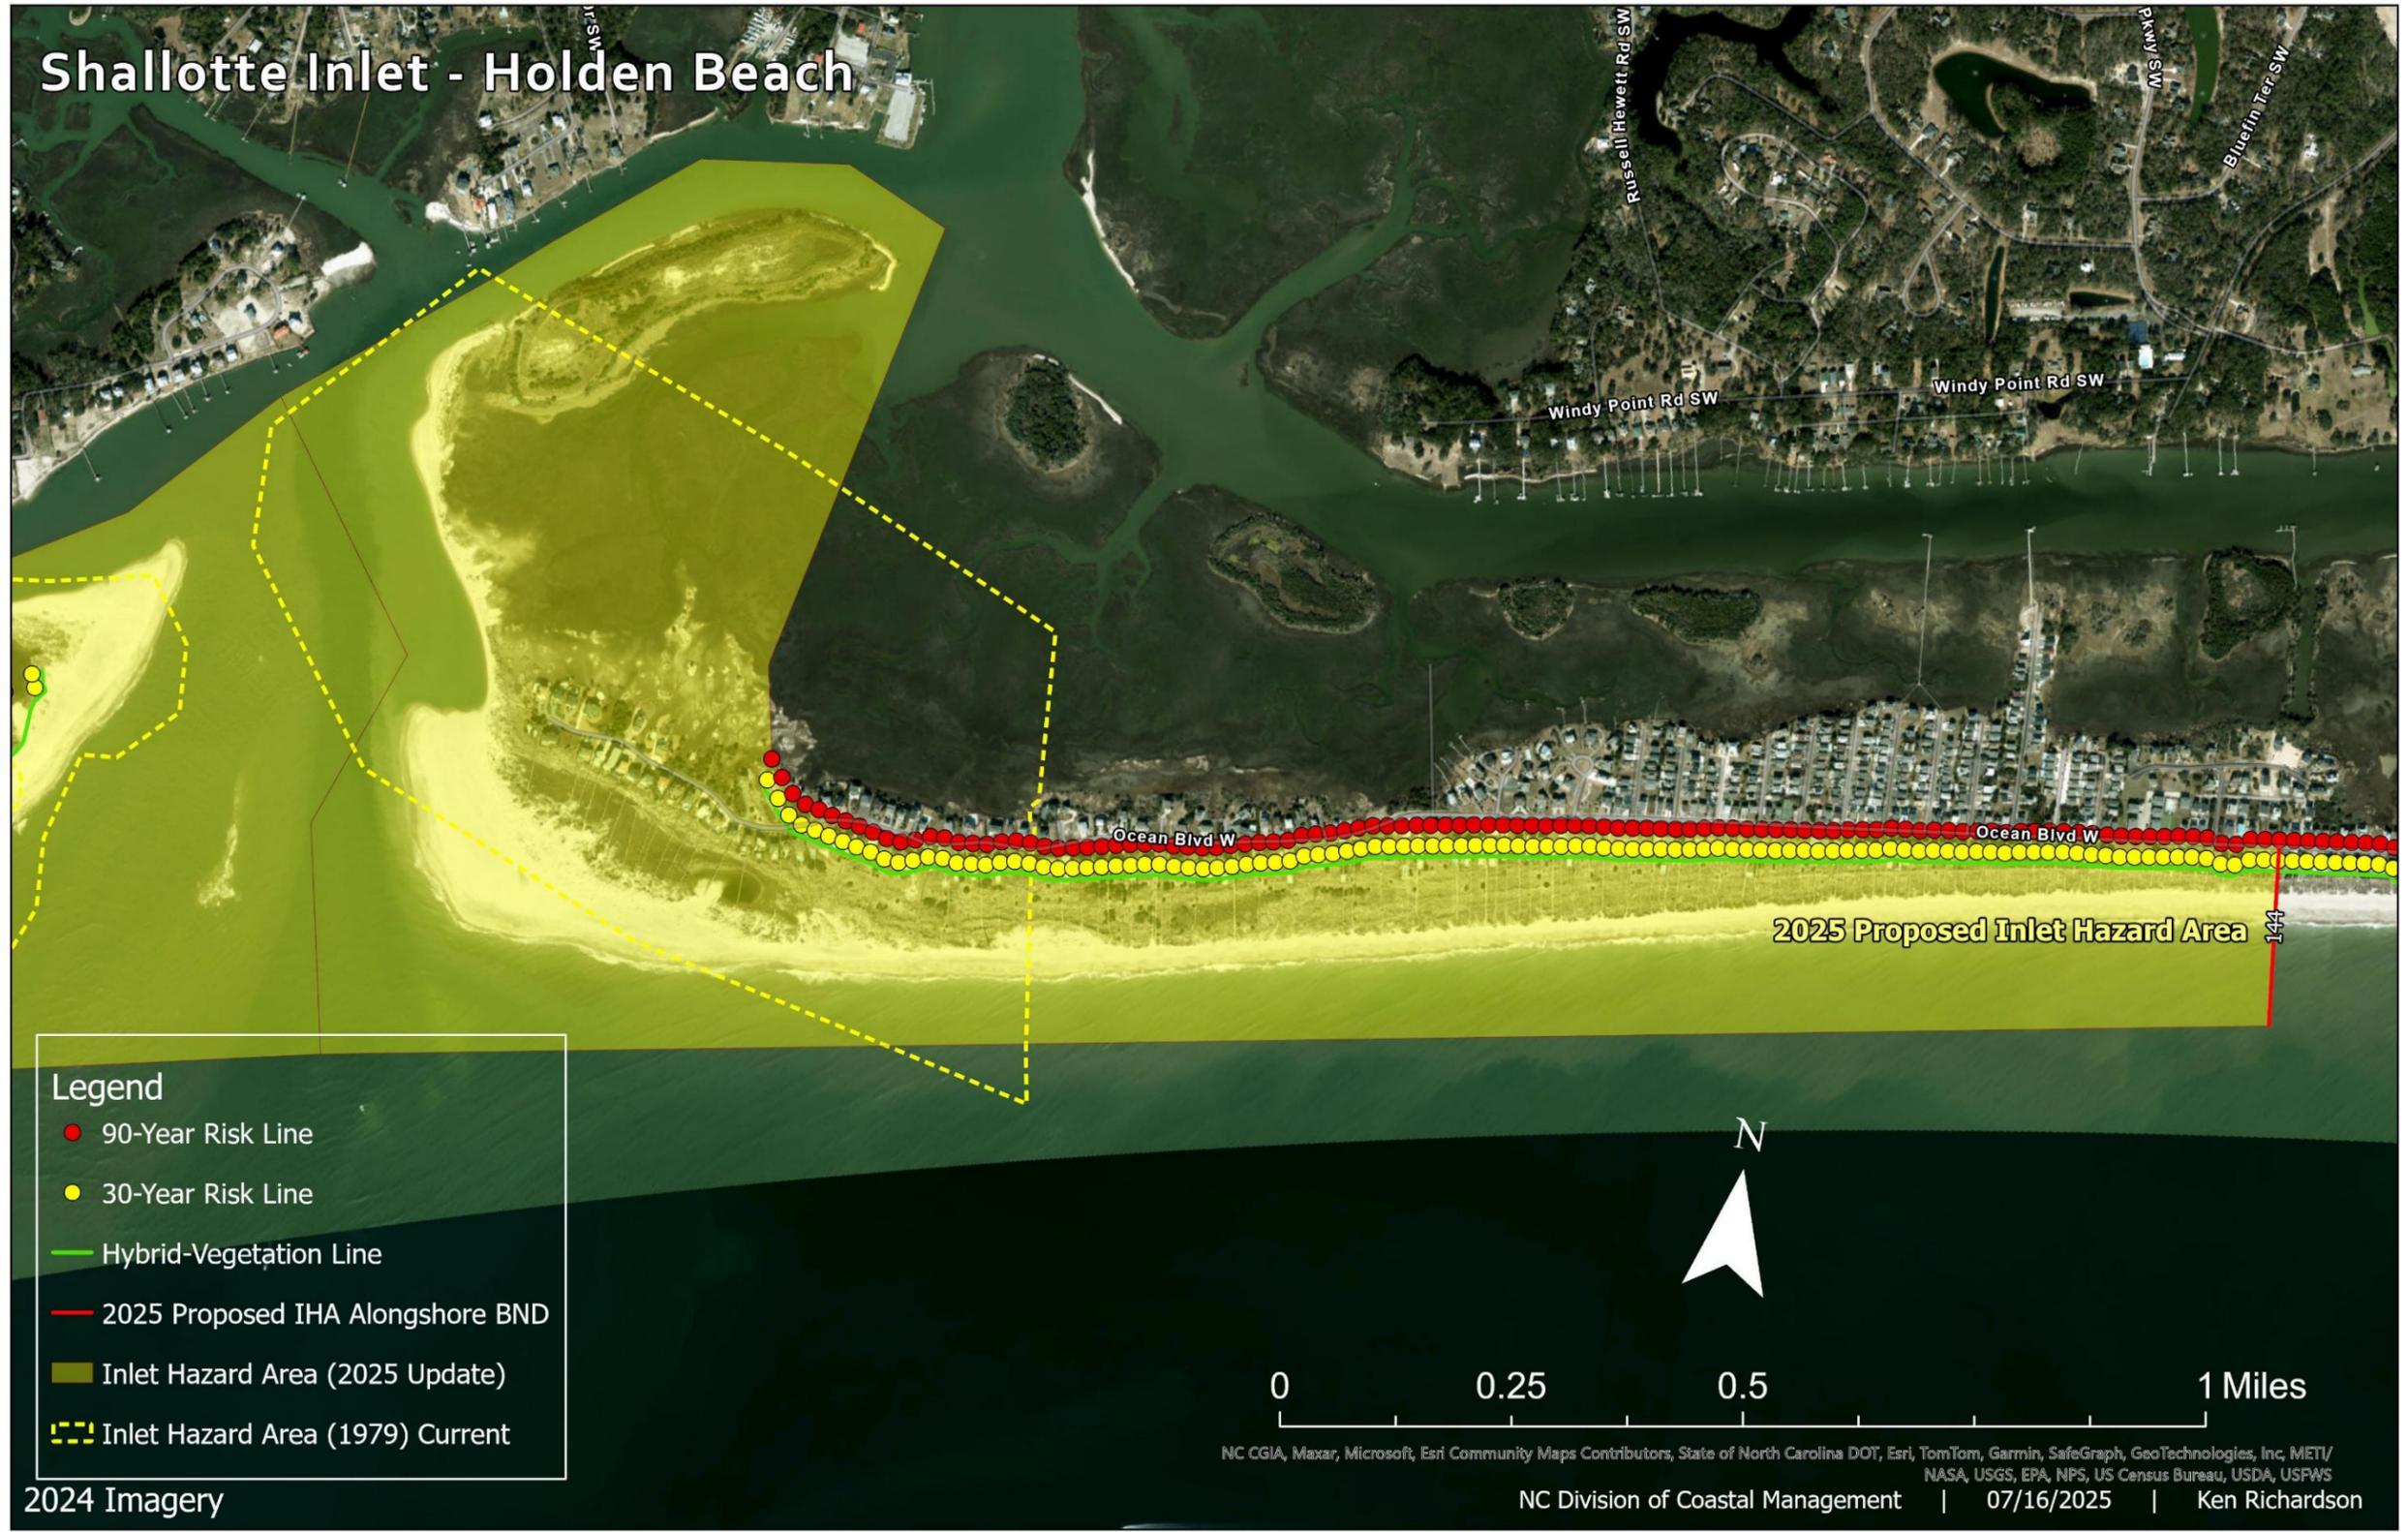
Figure C4. Proposed Inlet Hazard Area at Shallotte Inlet (Holden Beach).

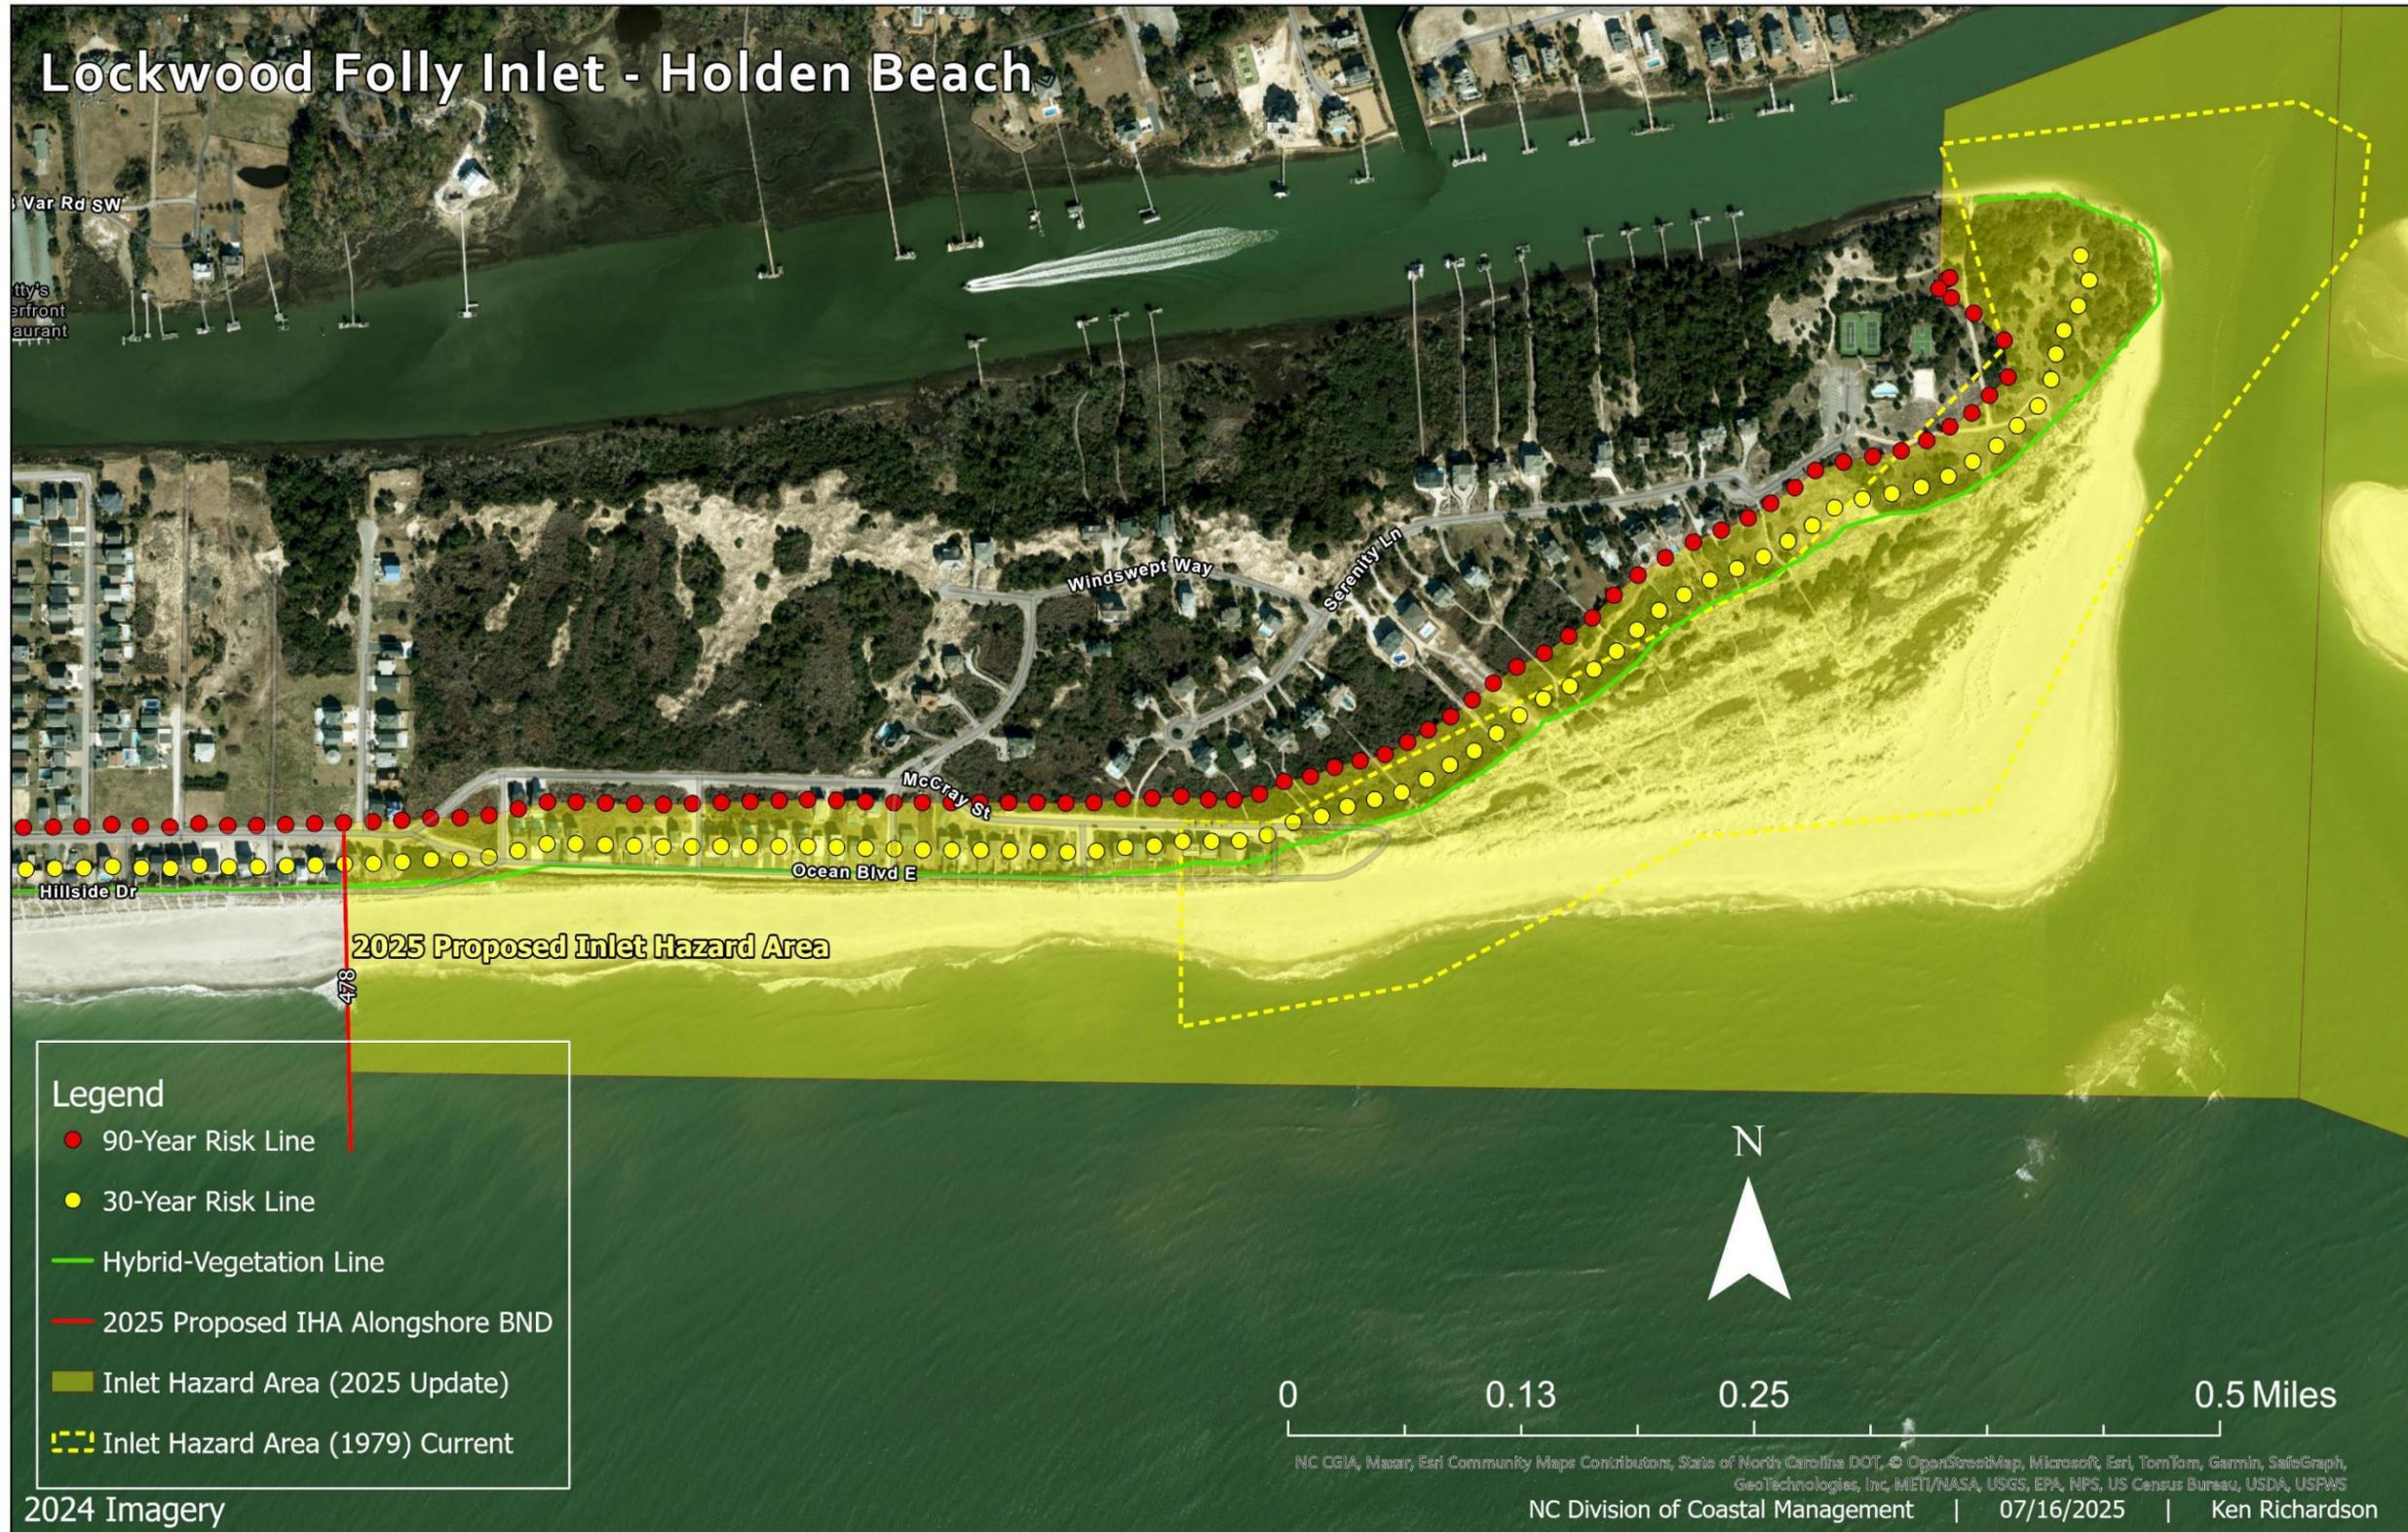
Figure C5. Proposed Inlet Hazard Area at Lockwood Folly Inlet (Holden Beach).

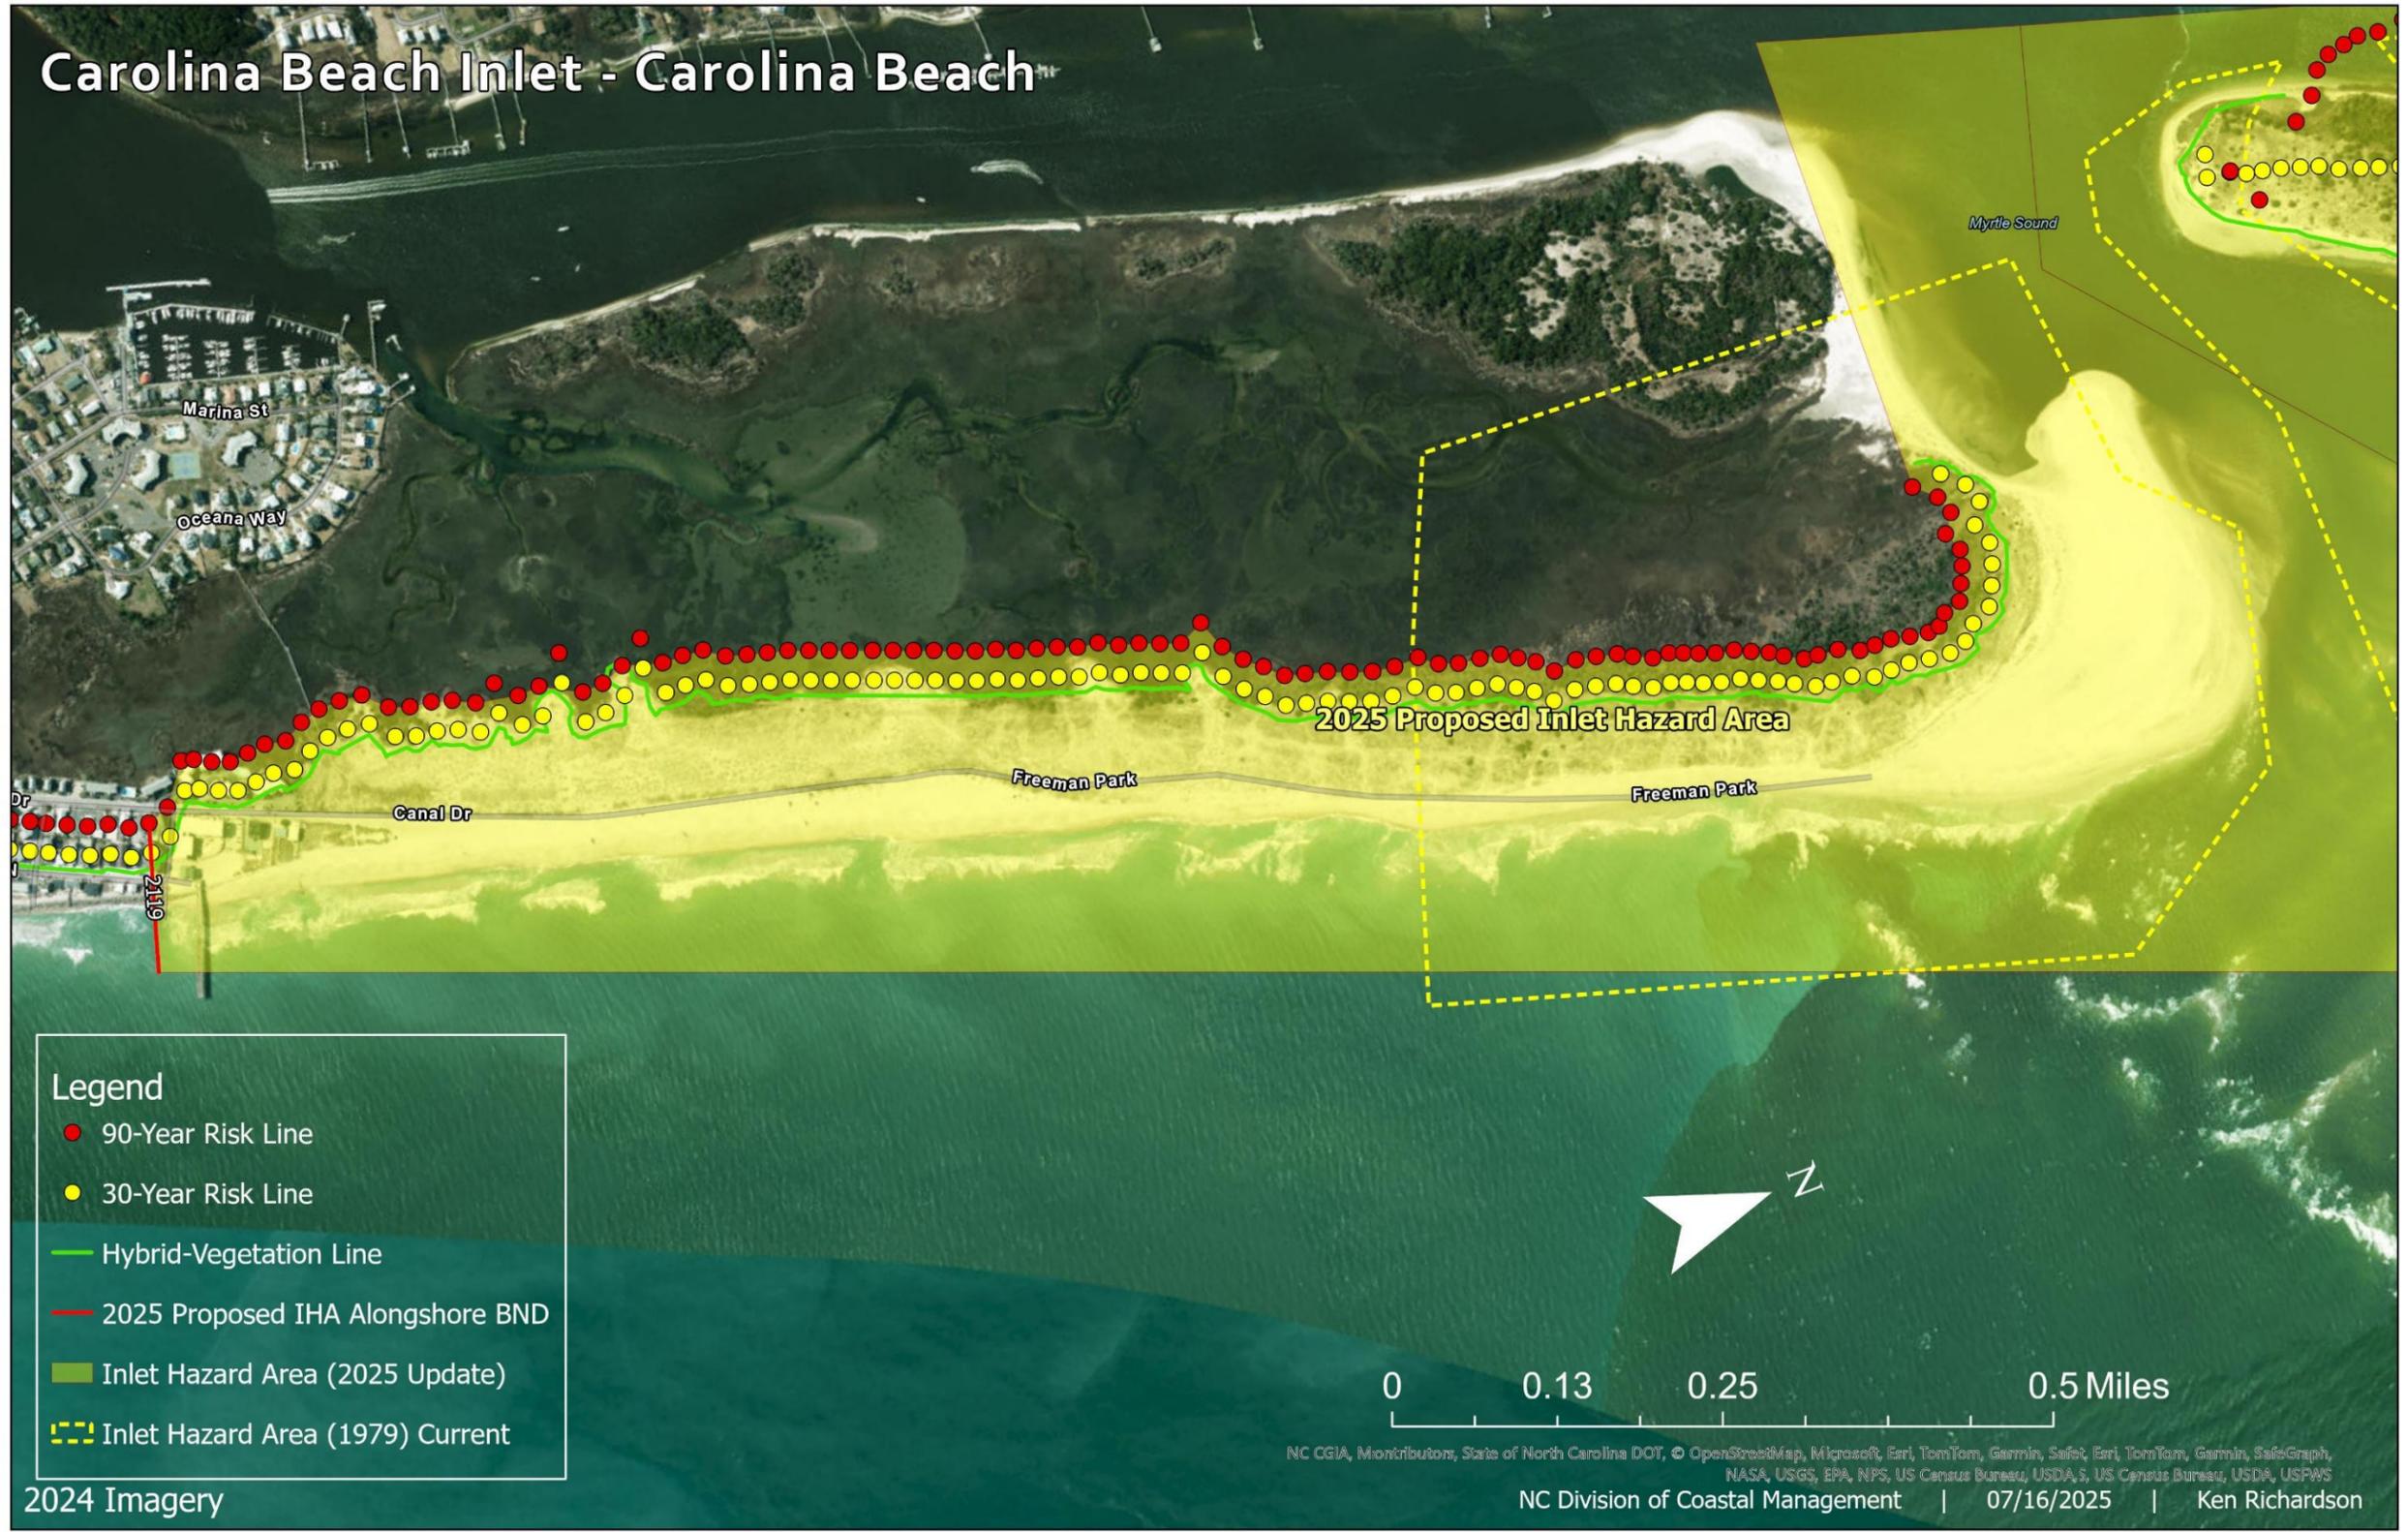
Figure C7. Proposed Inlet Hazard Area at Carolina Beach Inlet (Carolina Beach).

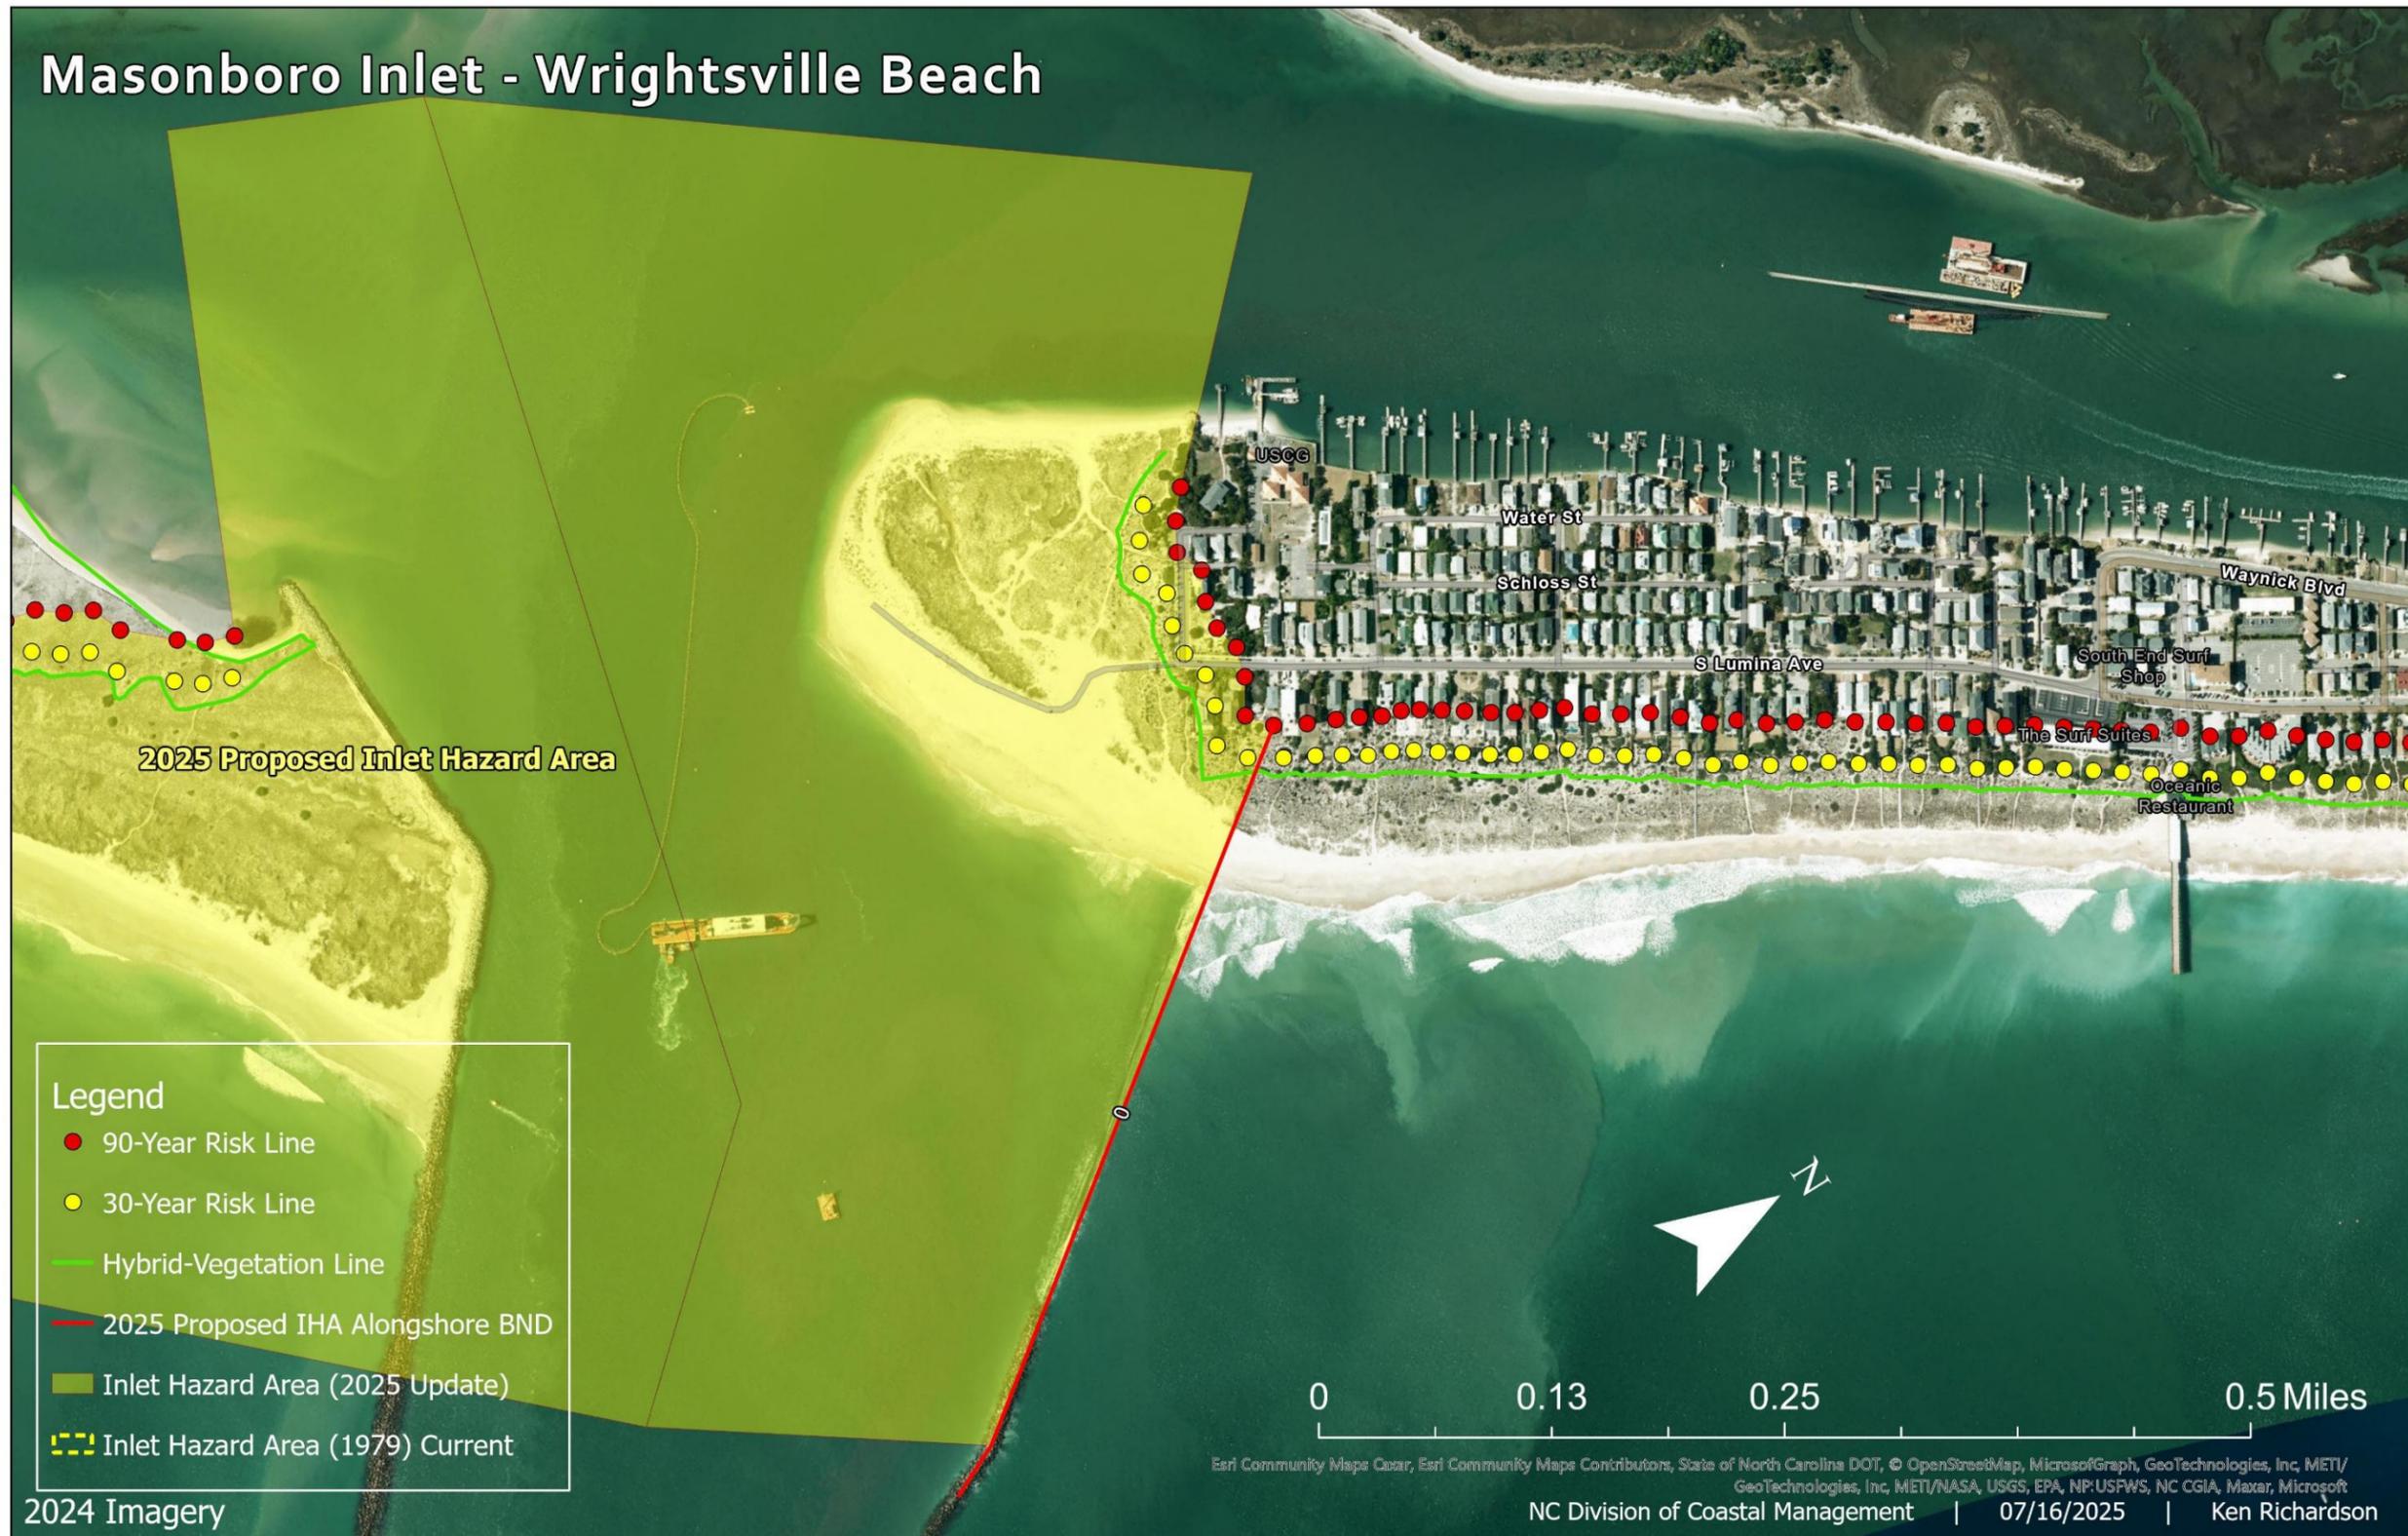
Figure C9. Proposed Inlet Hazard Area at Masonboro Inlet (Wrightsville Beach).

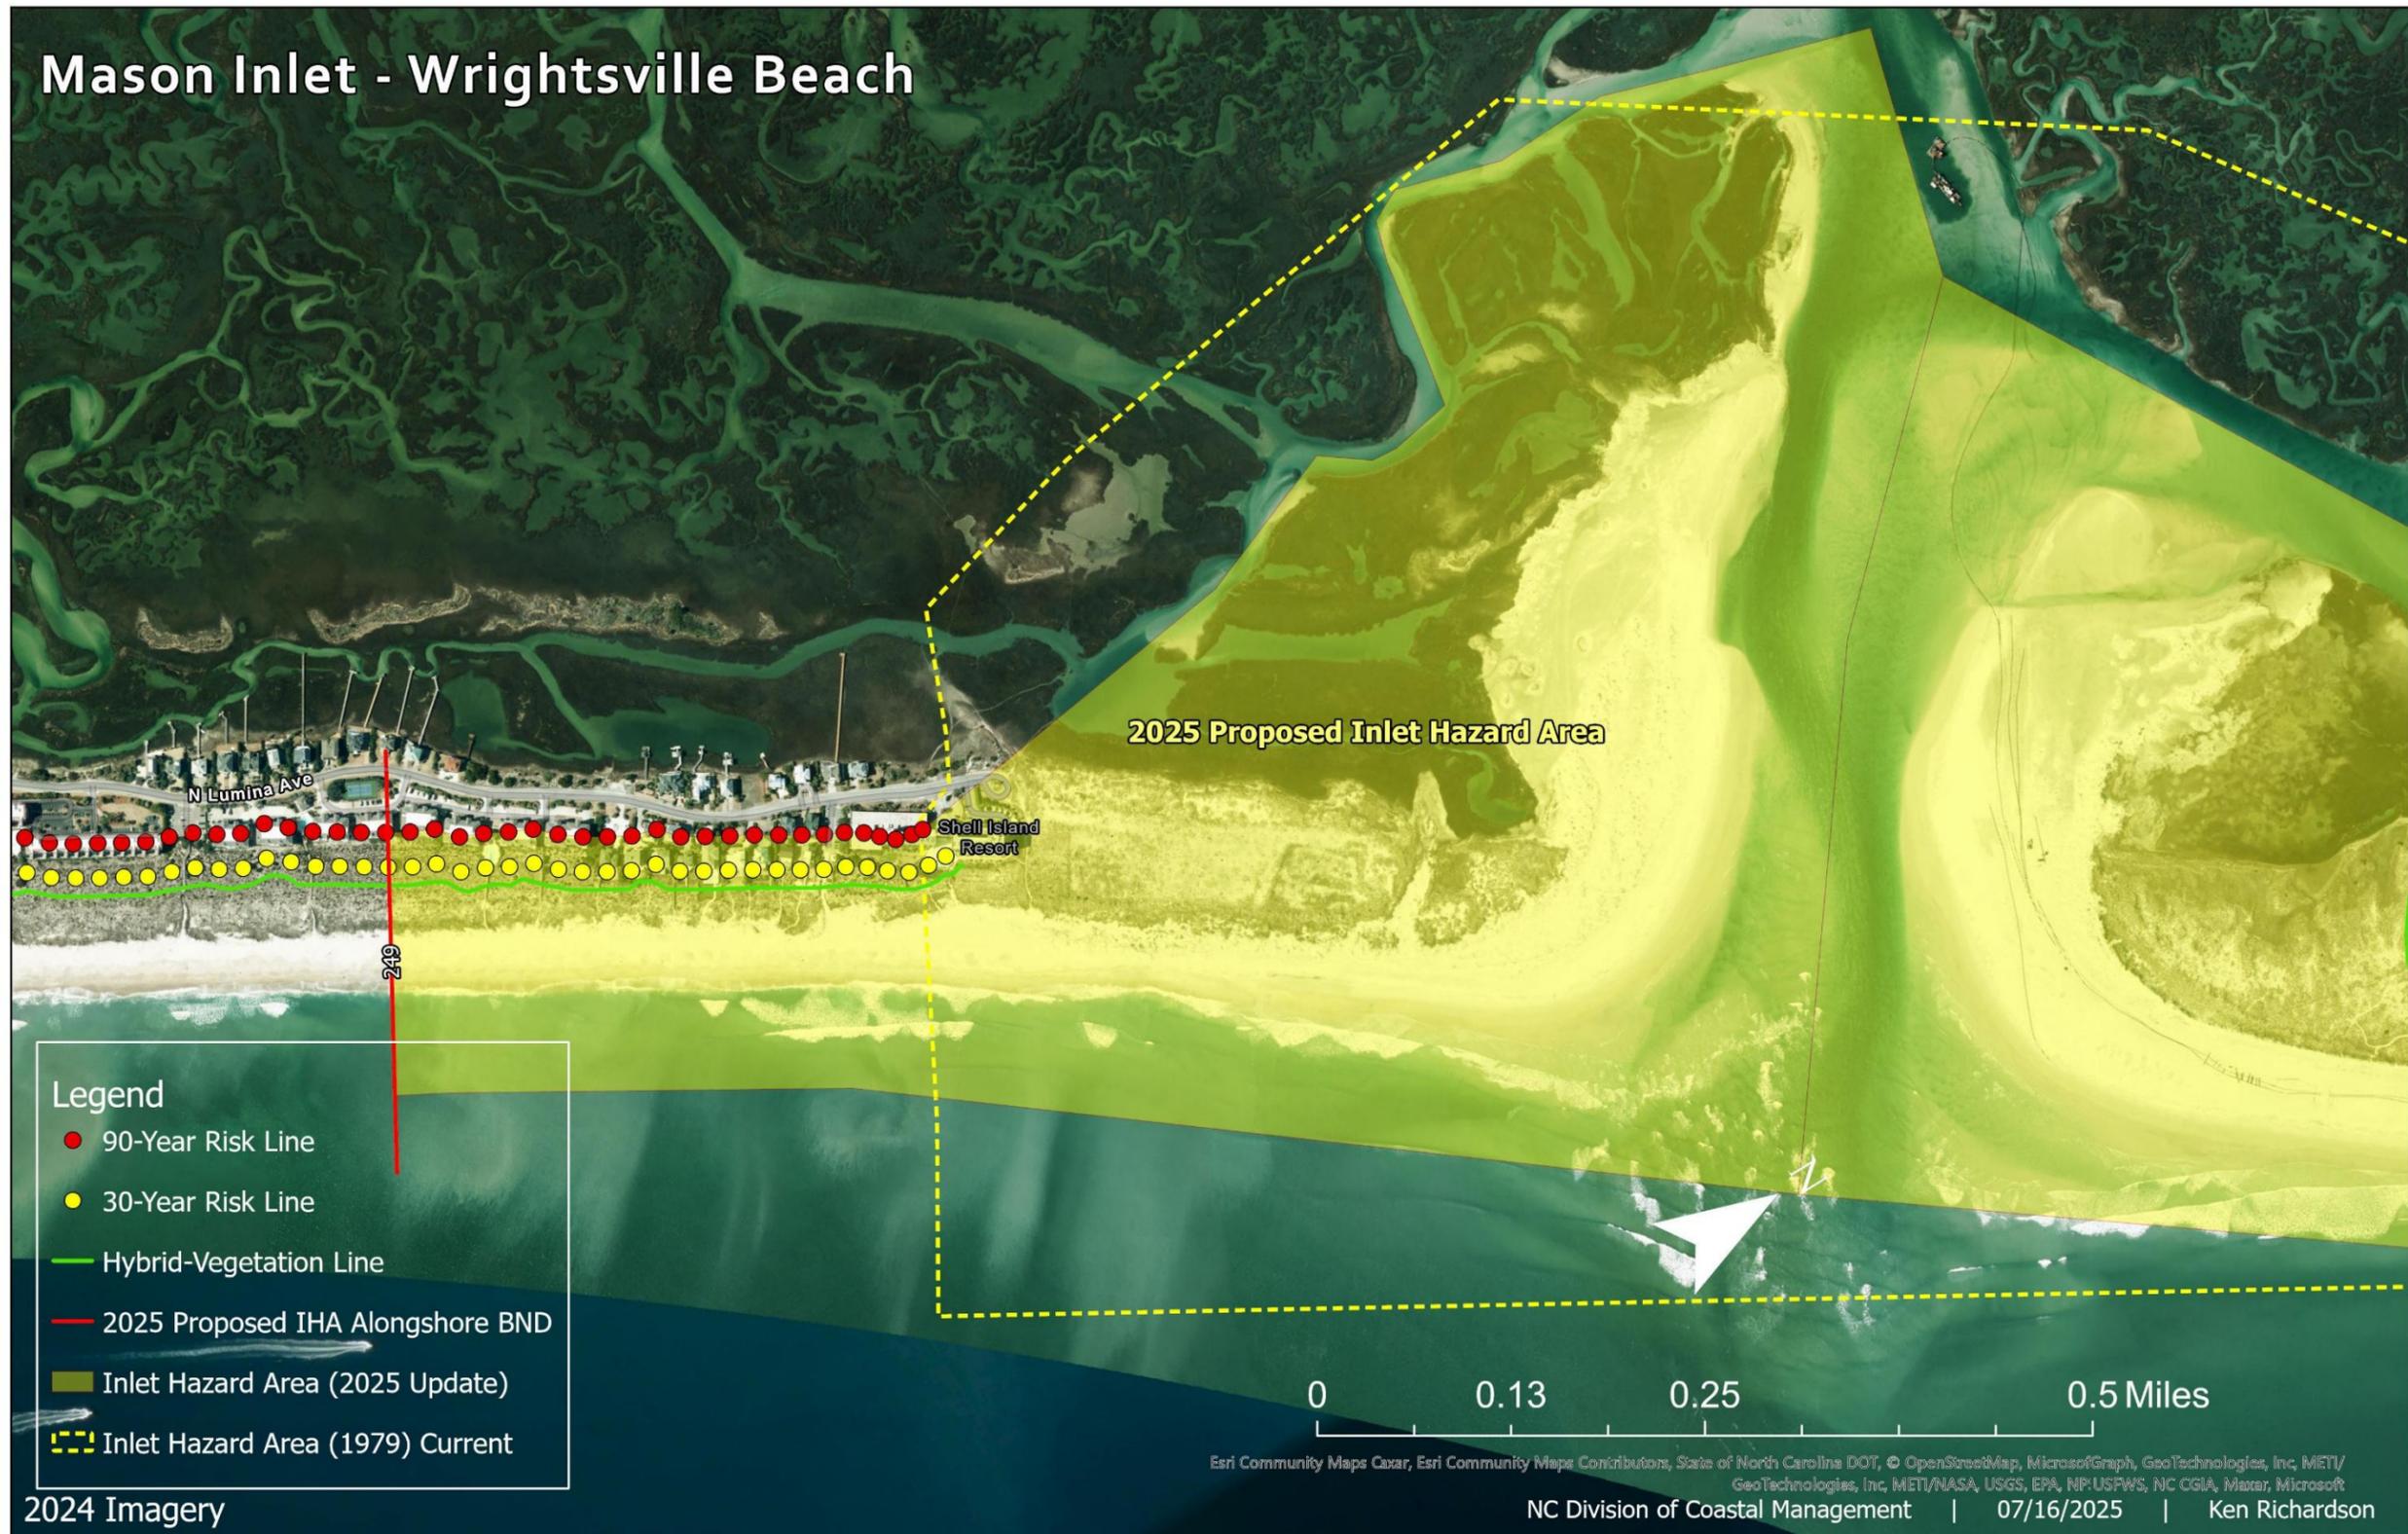
Figure C10. Proposed Inlet Hazard Area at Mason Inlet (Wrightsville Beach).

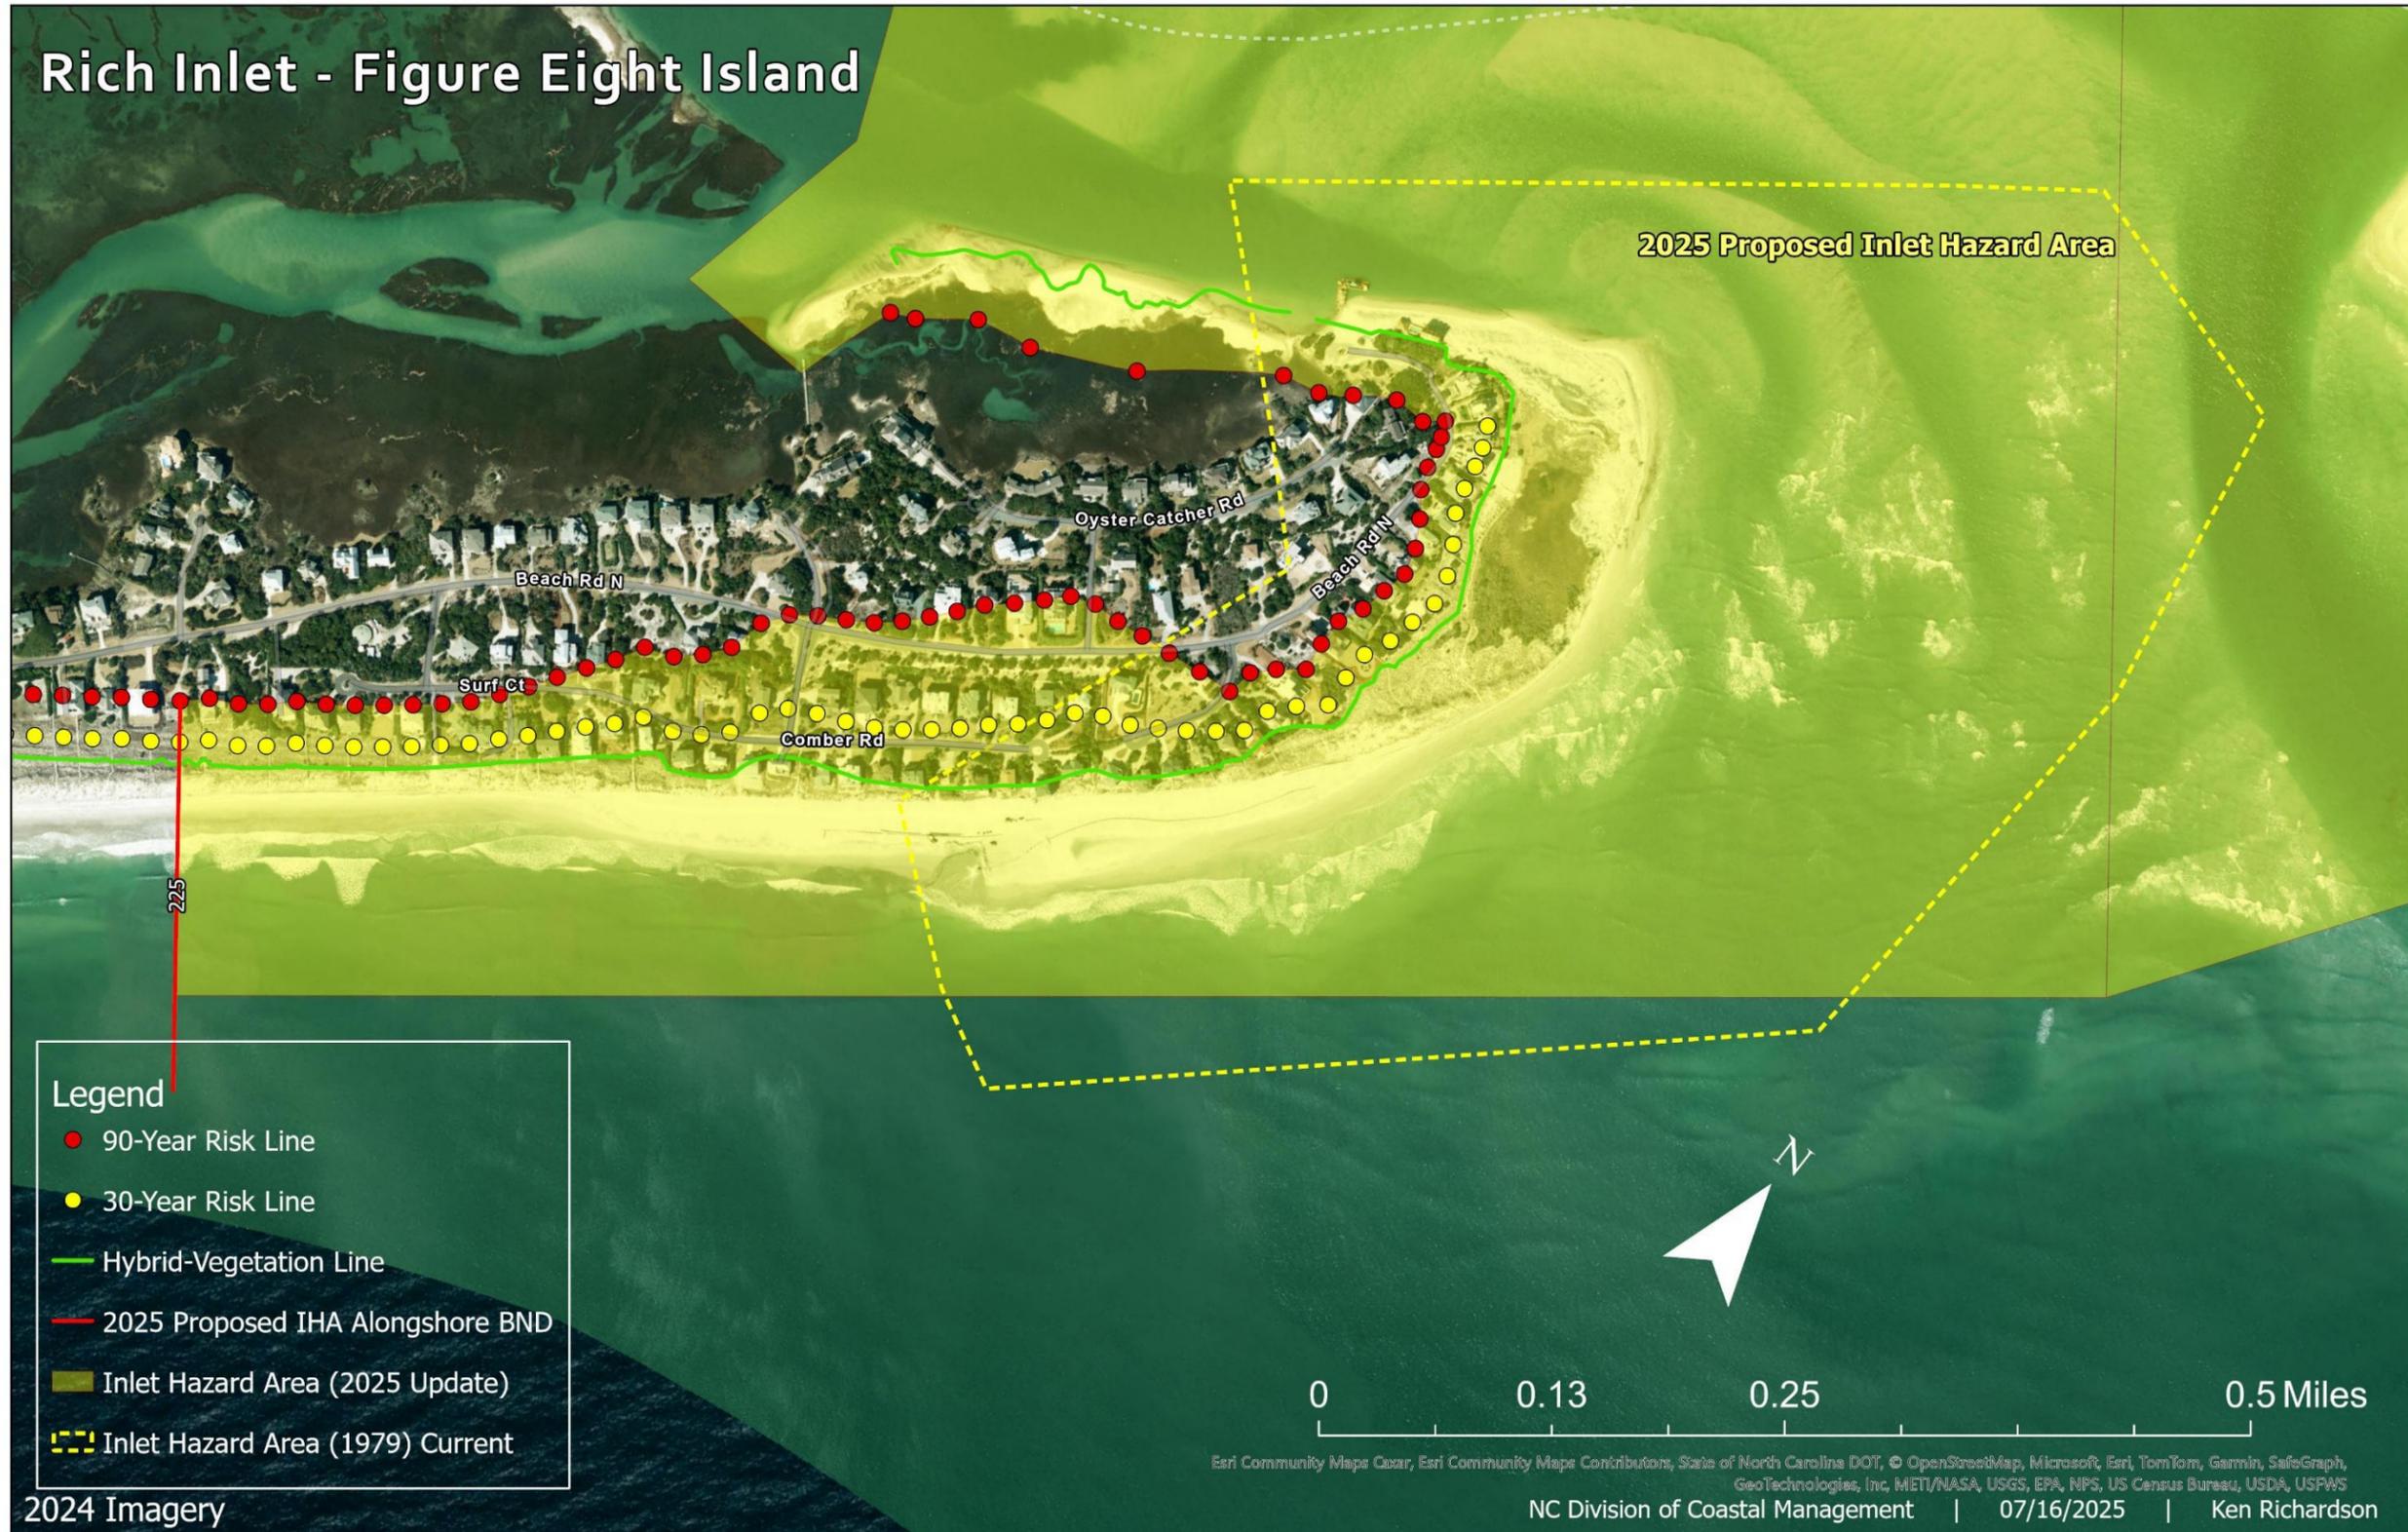
Figure C12. Proposed Inlet Hazard Area at Rich Inlet (Figure Eight Island).
