Inlet Hazard Area Boundaries, 2025 Update:

Science Panel Recommendations to the
North Carolina Coastal Resources Commission

August 1, 2025

NC Coastal Resources Commission's Science Panel on Coastal Hazards
& NC Division of Coastal Management

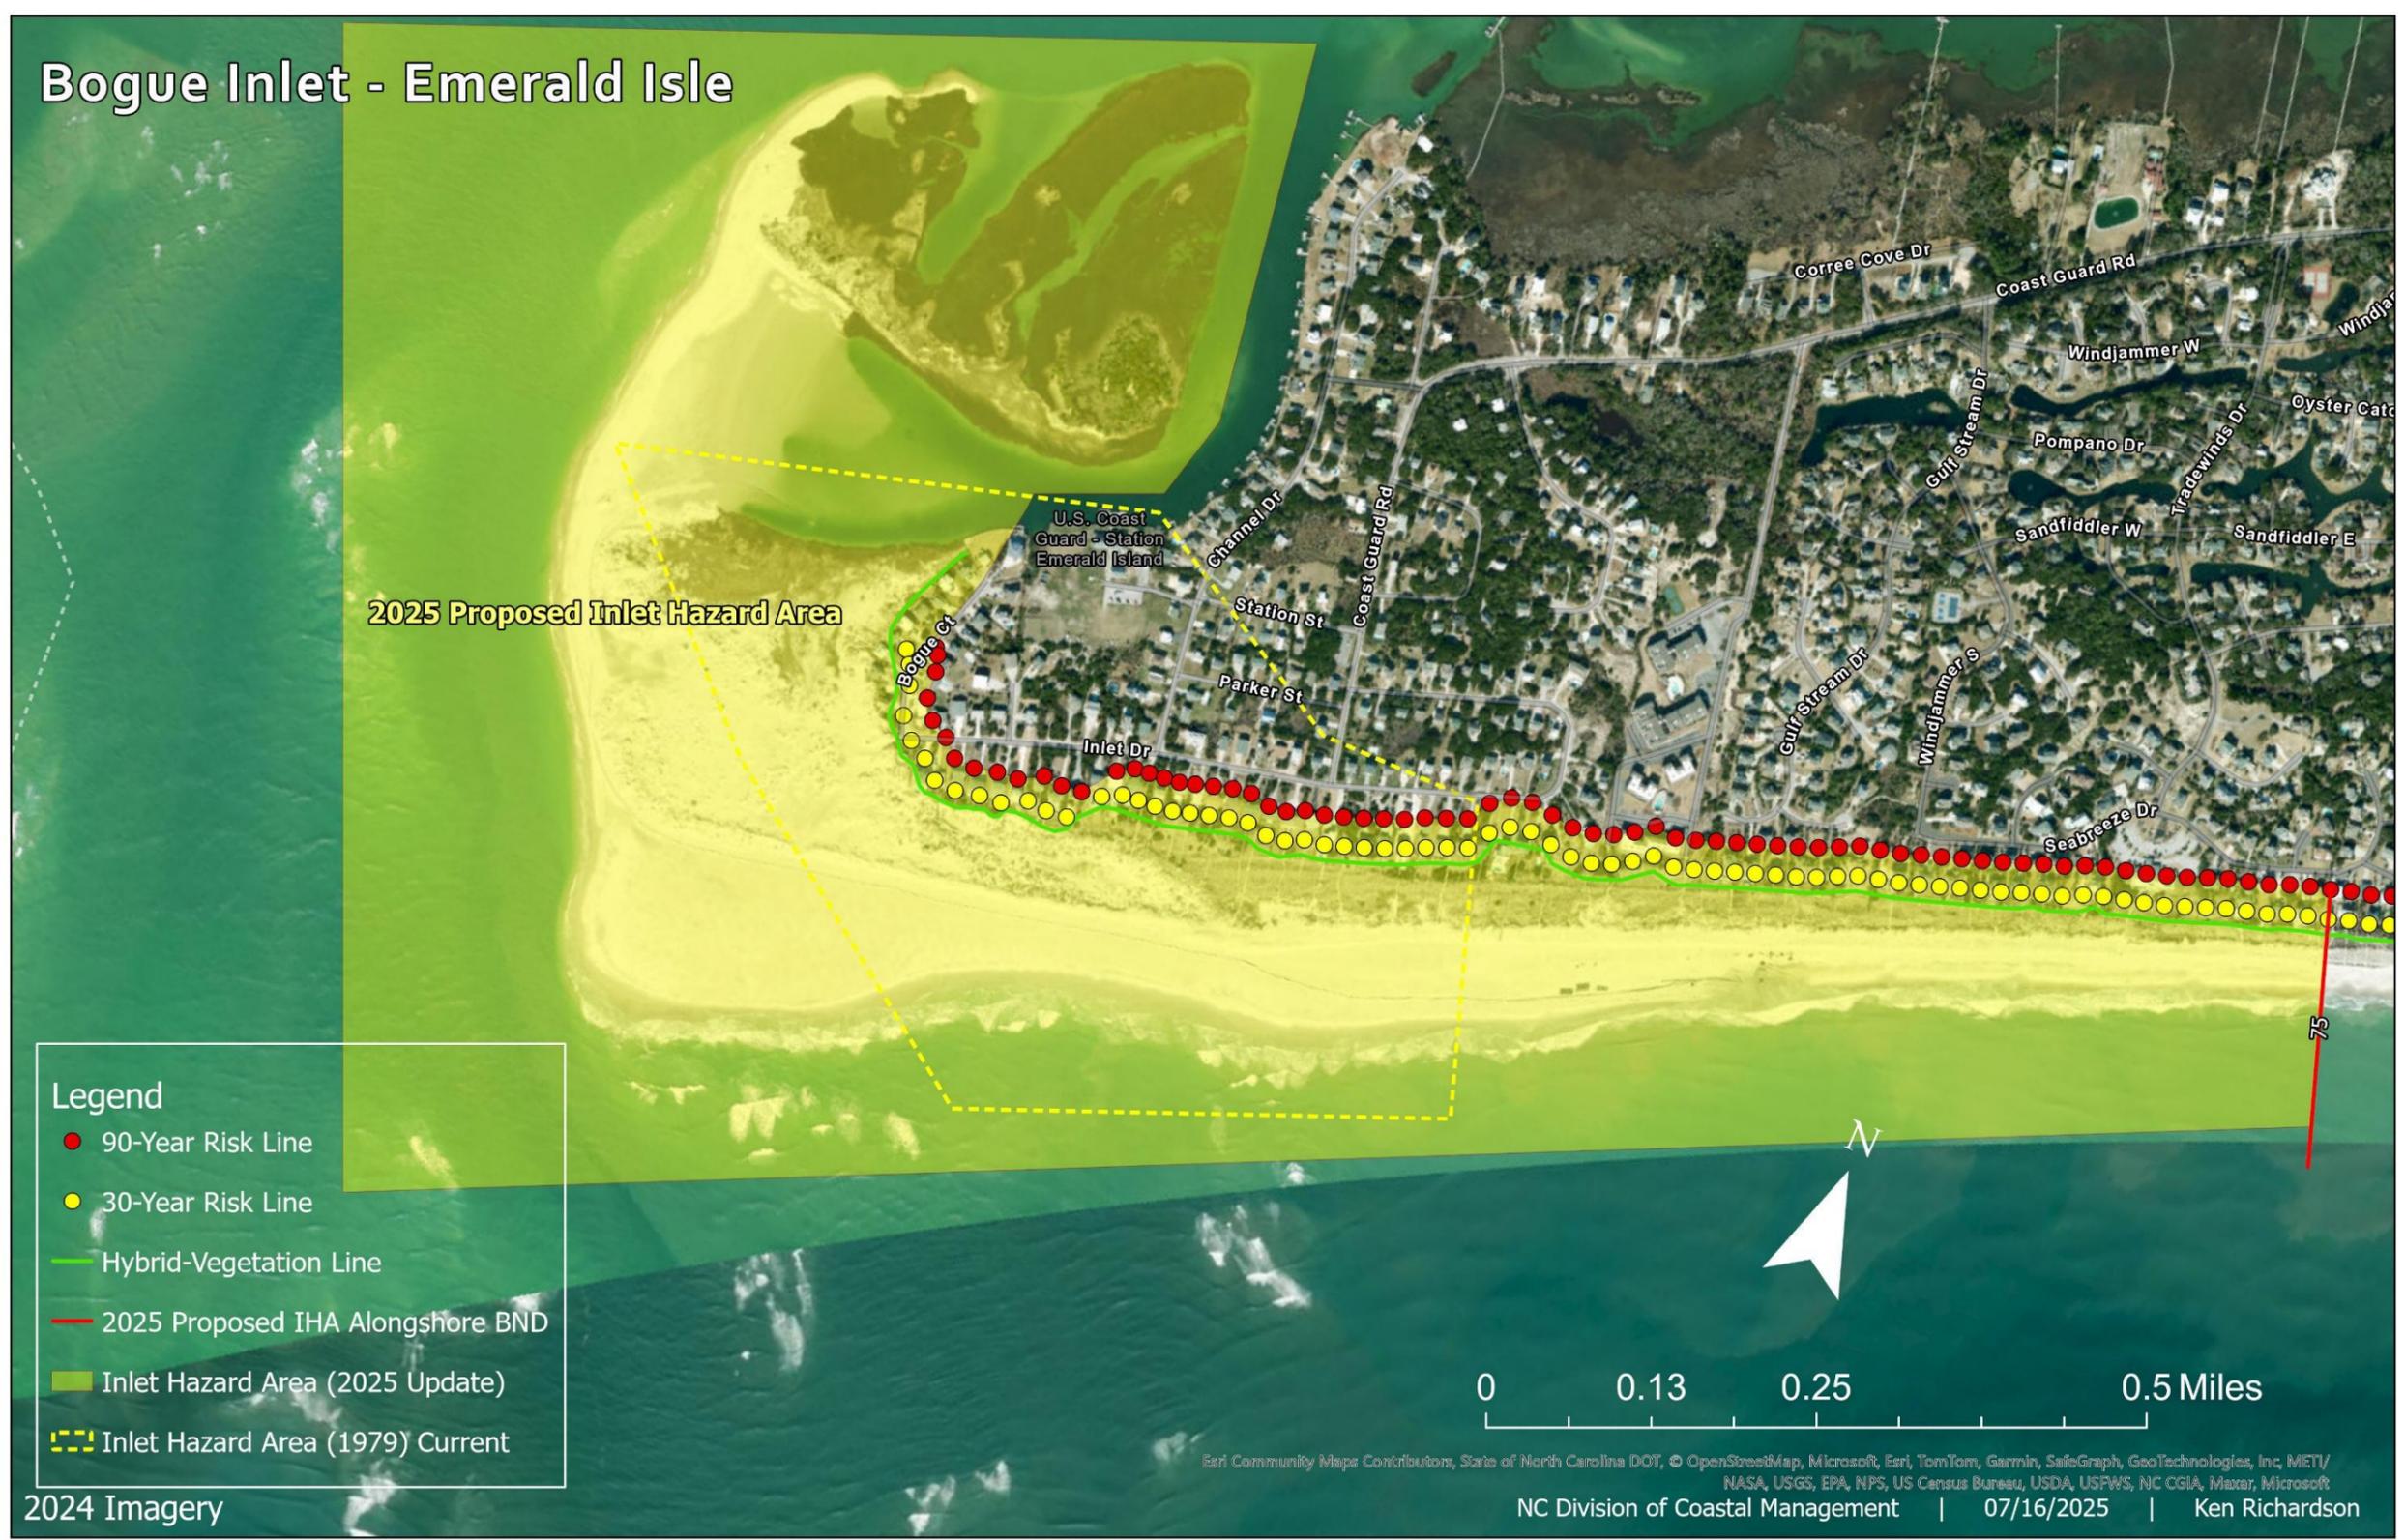
Figure C16. Proposed Inlet Hazard Area at Bogue Inlet (Emerald Isle).

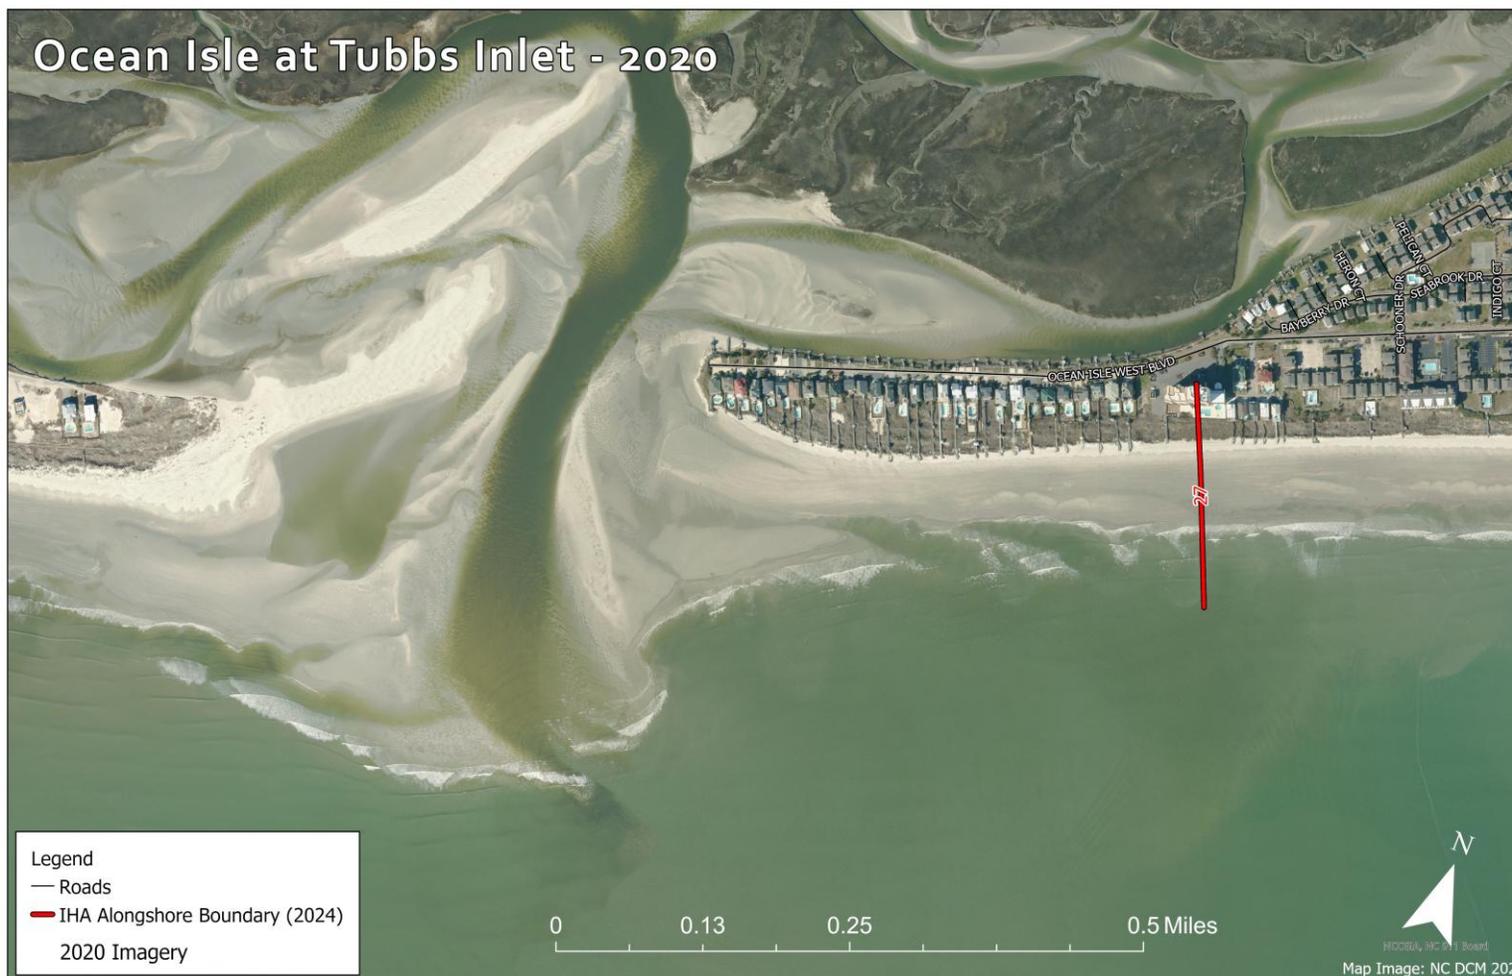
Figure D13. Tubbs Inlet at Ocean Isle in 2023, shown relative to the 2024-2025 alongshore IHA boundary limit at transect 27 (red line).

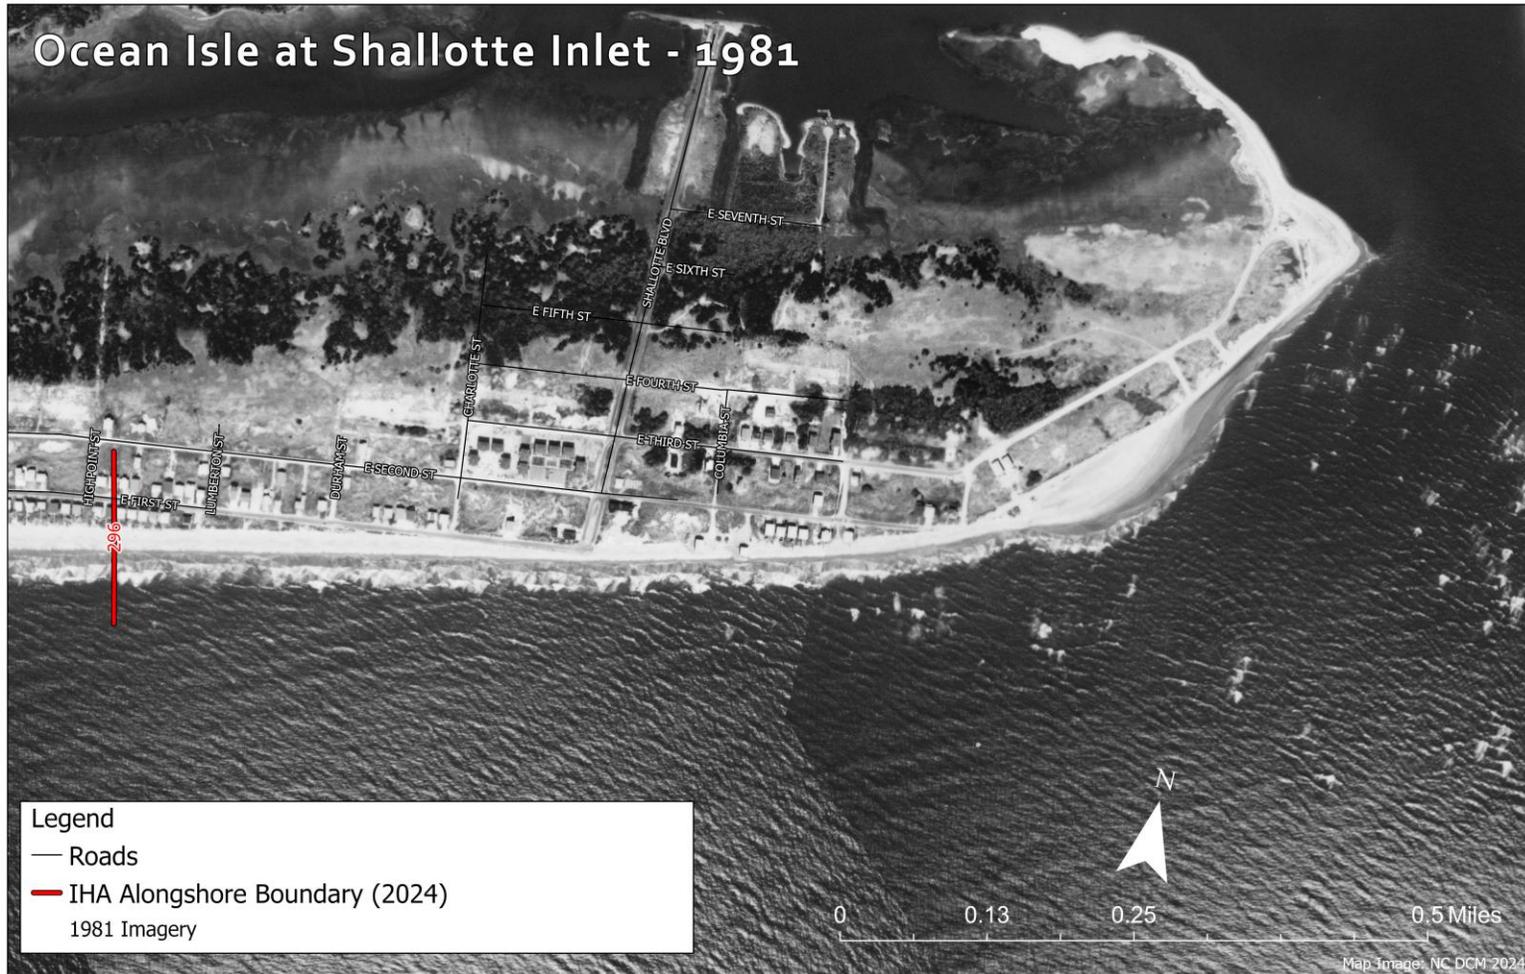
Figure D16. Shallotte Inlet at Ocean Isle in 1992, shown relative to the 2024-2025 alongshore IHA boundary limit at transect 296 (red line).

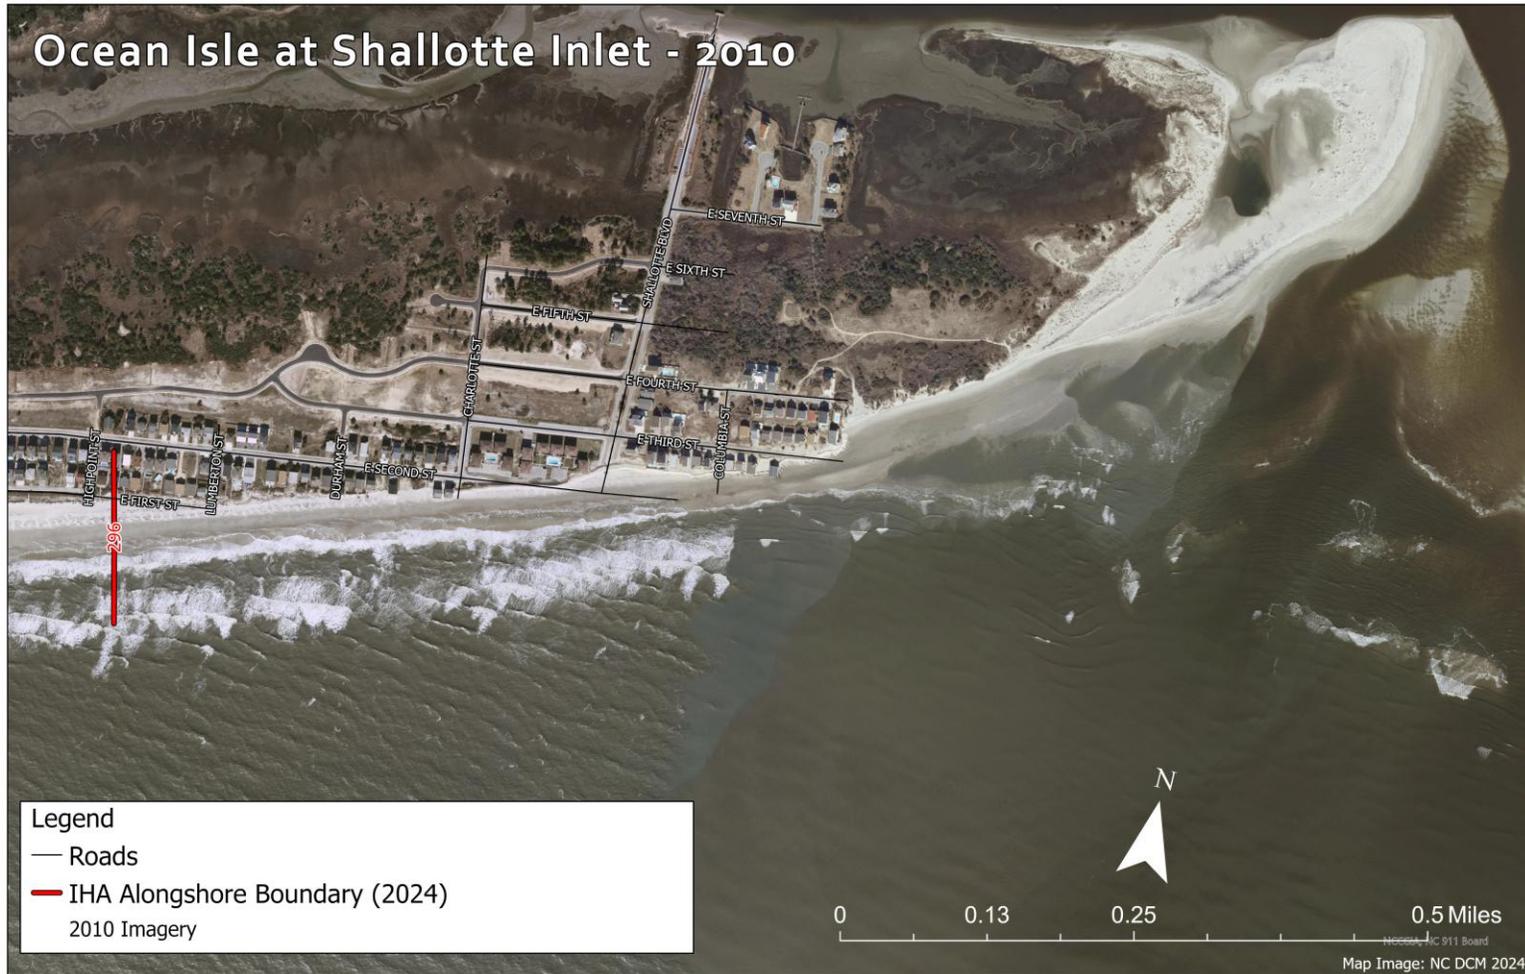
Figure D18. Shallotte Inlet at Ocean Isle in 2016, shown relative to the 2024-2025 alongshore IHA boundary limit at transect 296 (red line).

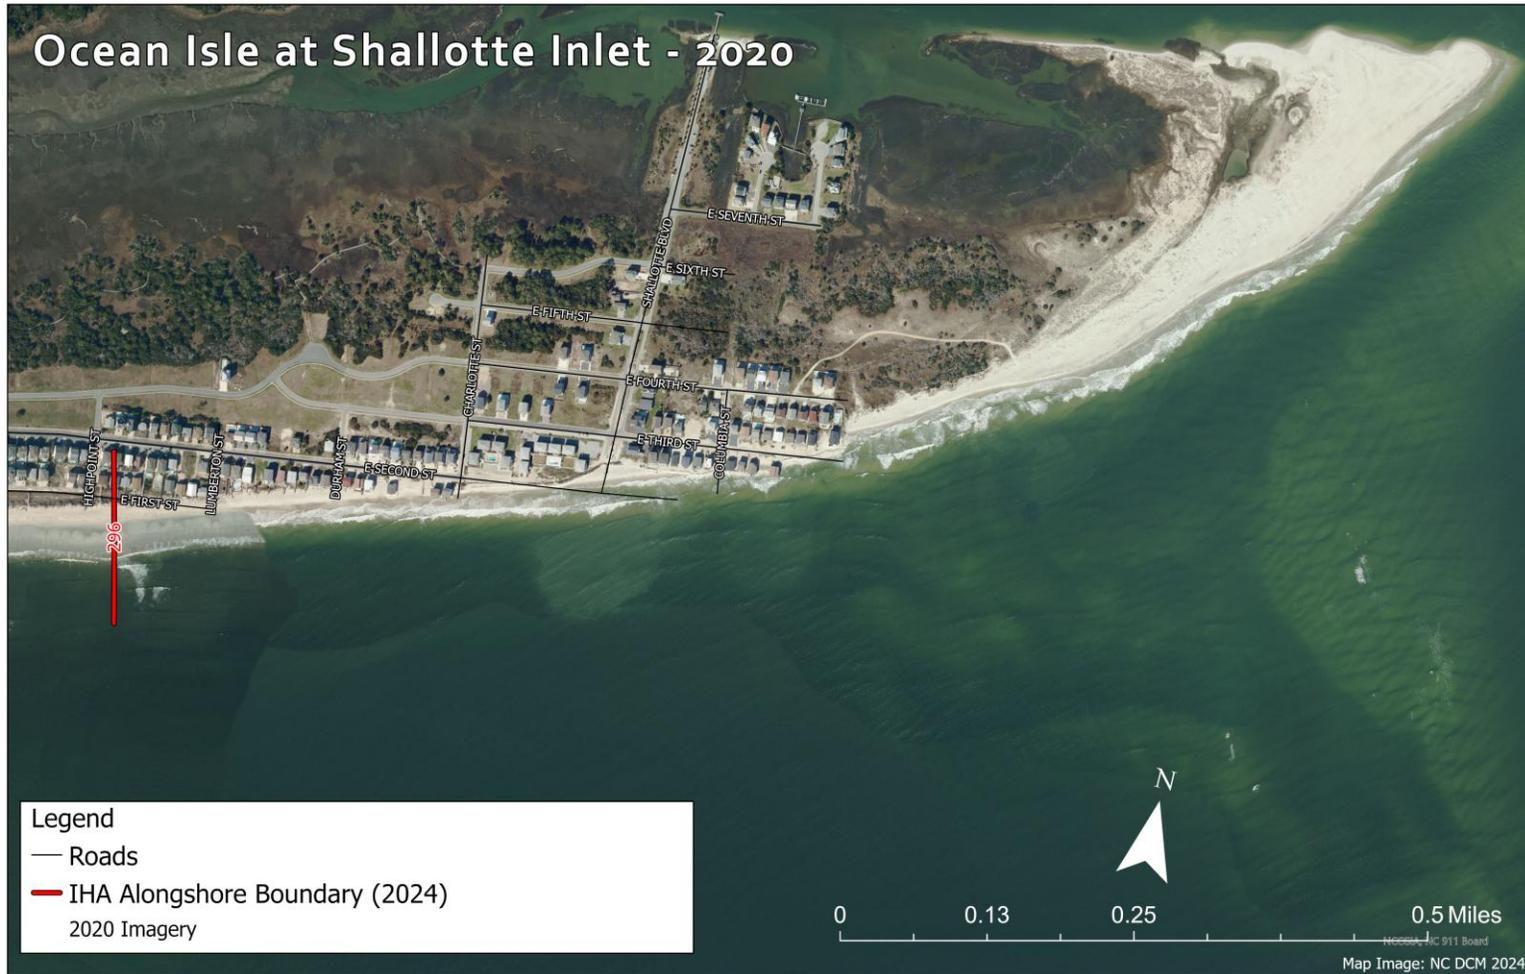
Figure D20. Shallotte Inlet at Ocean Isle in 2023, shown relative to the 2024-2025 alongshore IHA boundary limit at transect 296 (red line).

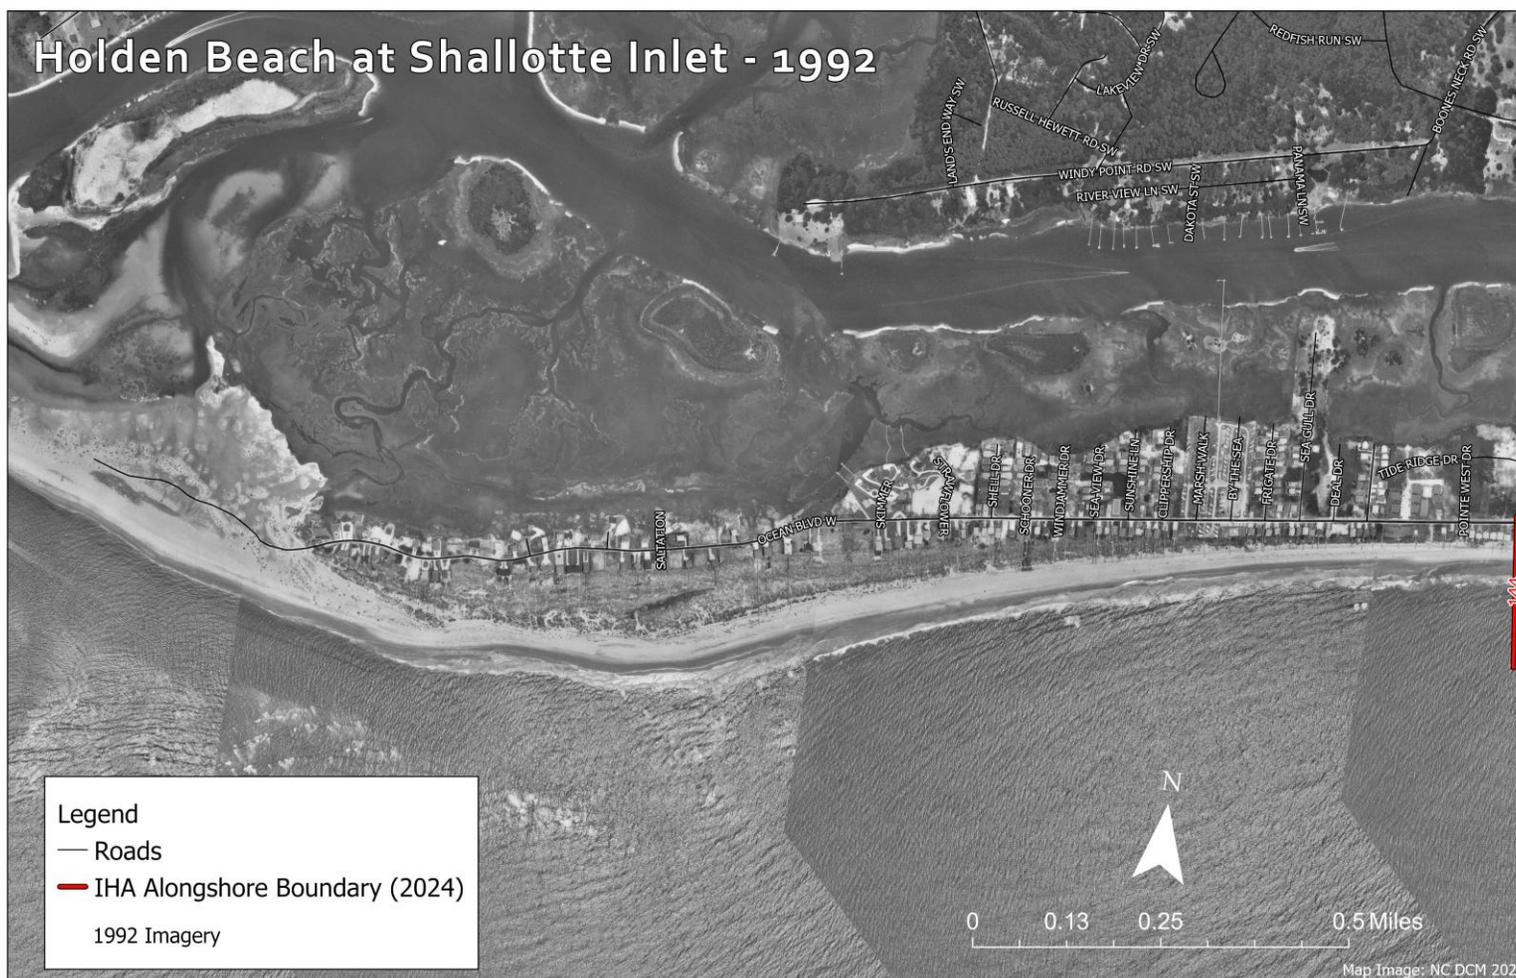
Figure D26. Shallotte Inlet at Holden Beach in 1993, shown relative to the 2024-2025 alongshore IHA boundary limit at transect 144 (marked by the red line on the right edge of the image). Although the prominent accretion area is less noticeable due to short-term erosion and the growth of vegetation, the ebb channel along the shoreline remains visible. Additionally, gradual longshore accretion toward the alongshore IHA boundary is still occurring, indicating ongoing shoreline changes in this dynamic environment.

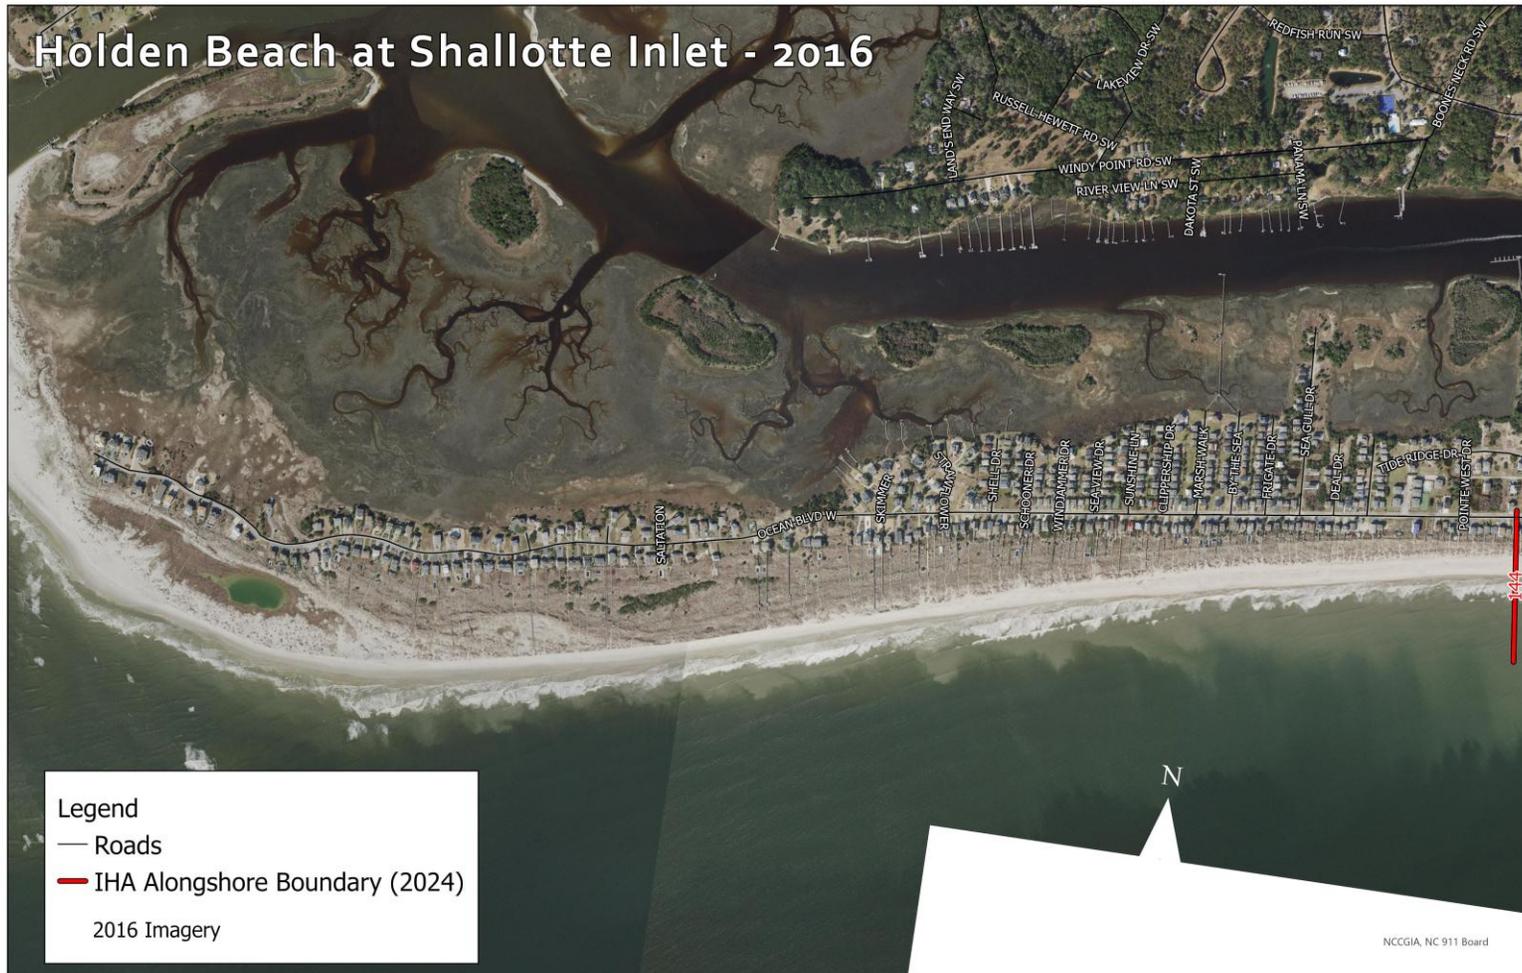
Figure D31. Shallotte Inlet at Holden Beach in 2020, shown relative to the 2024-2025 alongshore IHA boundary limit at transect 144 (marked by the red line on the right edge of the image).

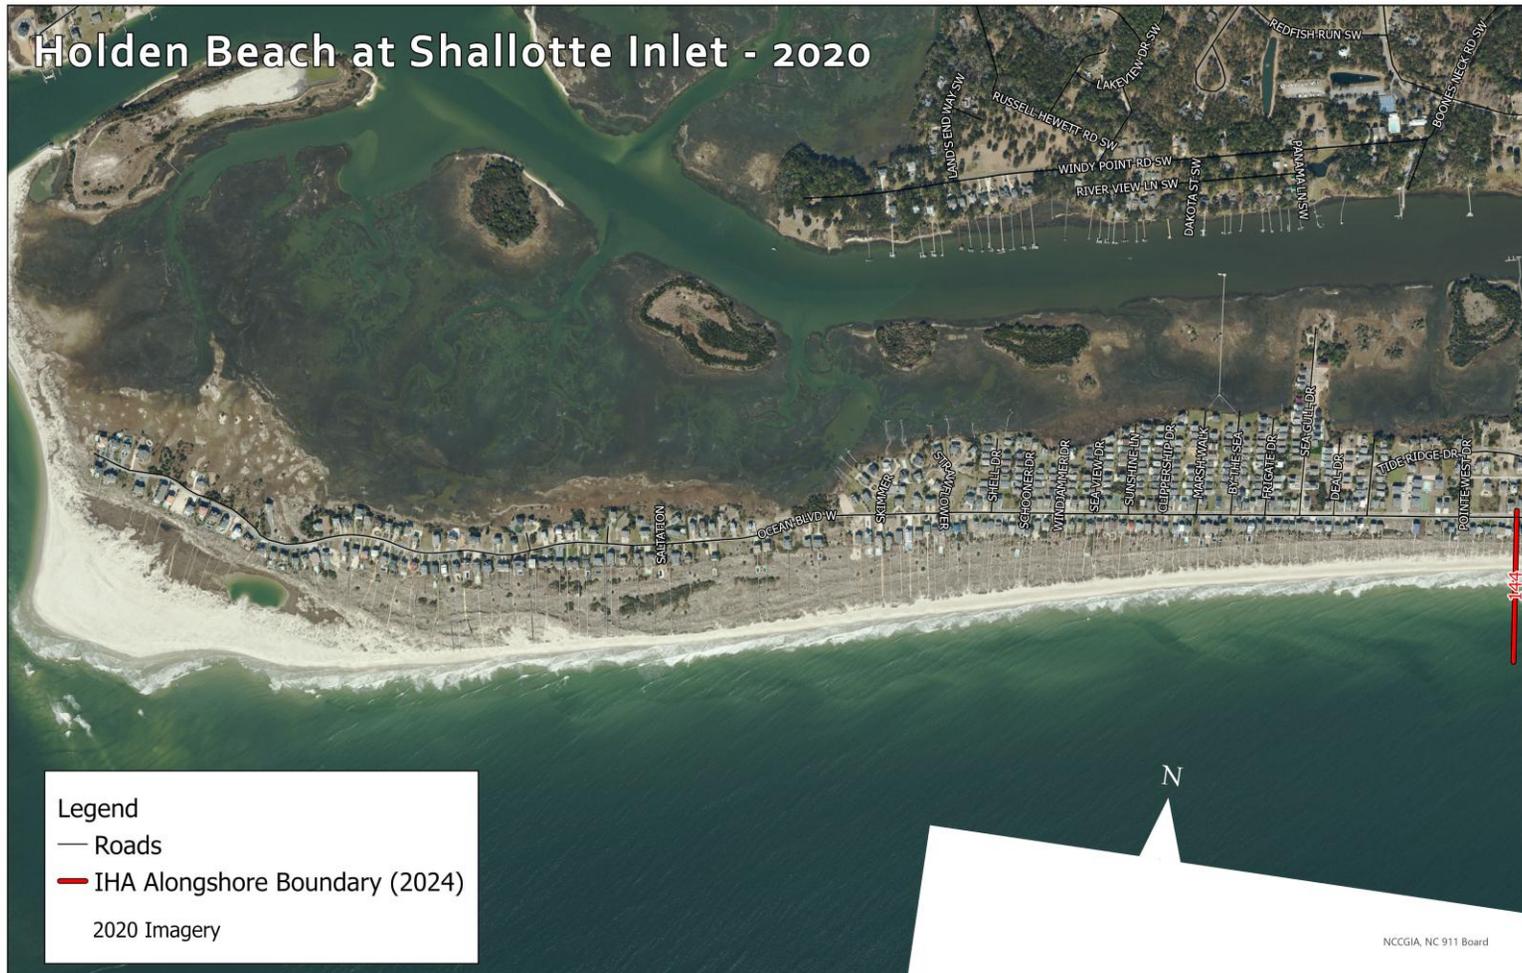
Figure D32. Shallotte Inlet at Holden Beach in 2023, shown relative to the 2024-2025 alongshore IHA boundary limit at transect 144 (marked by the red line on the right edge of the image).

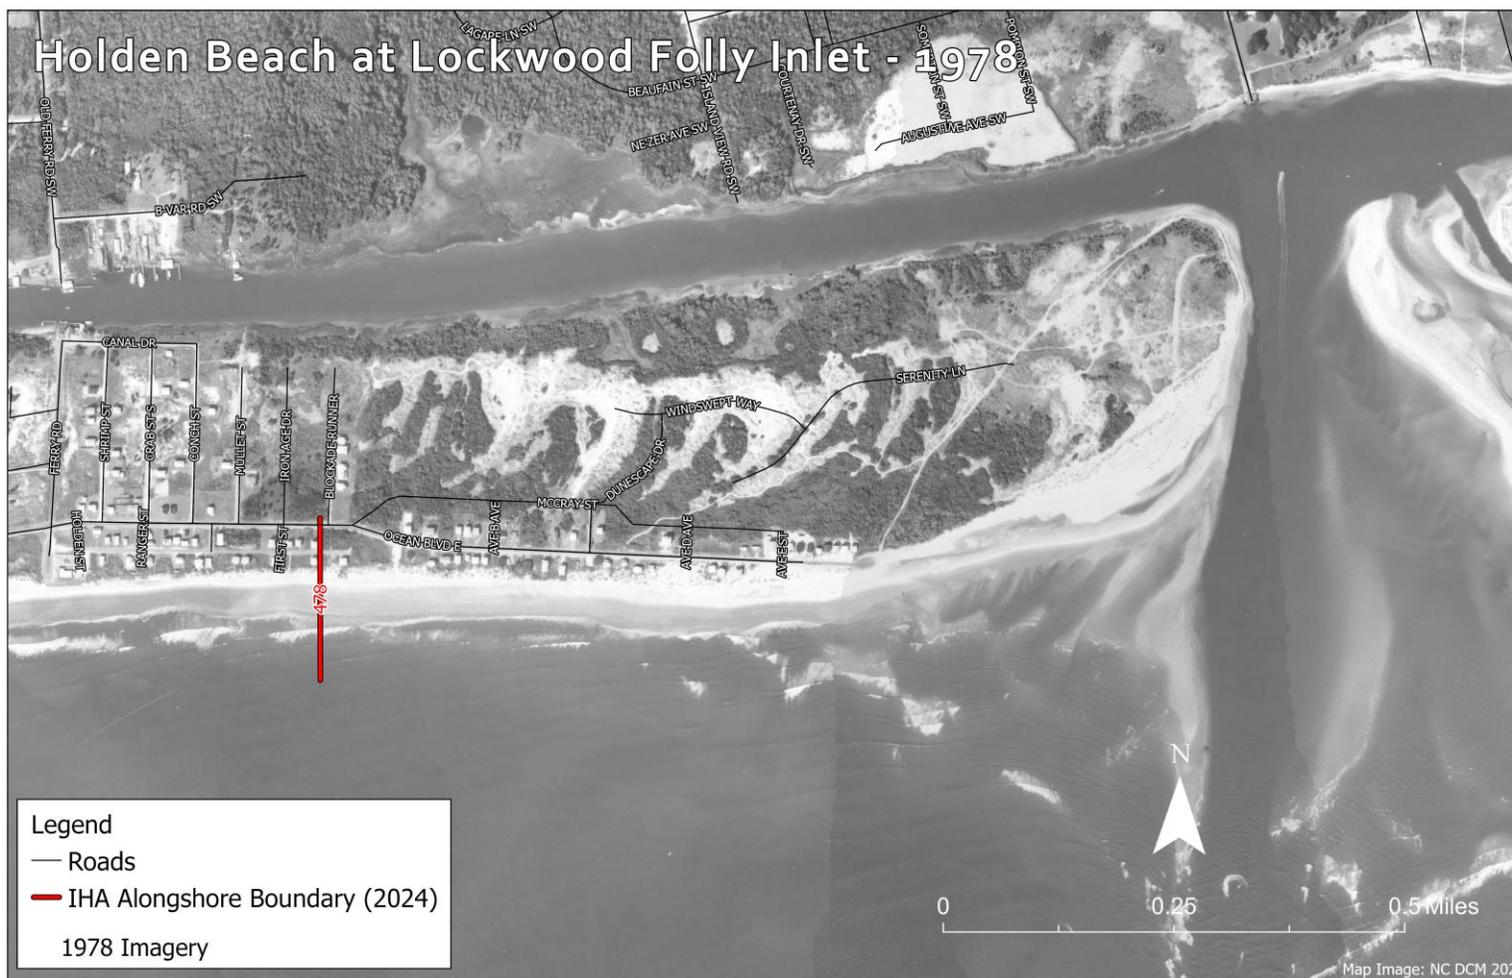
Figure D35. Lockwood Folly Inlet at Holden Beach in 1988, shown relative to the 2024-2025 alongshore IHA boundary limit at transect 478 (red line).

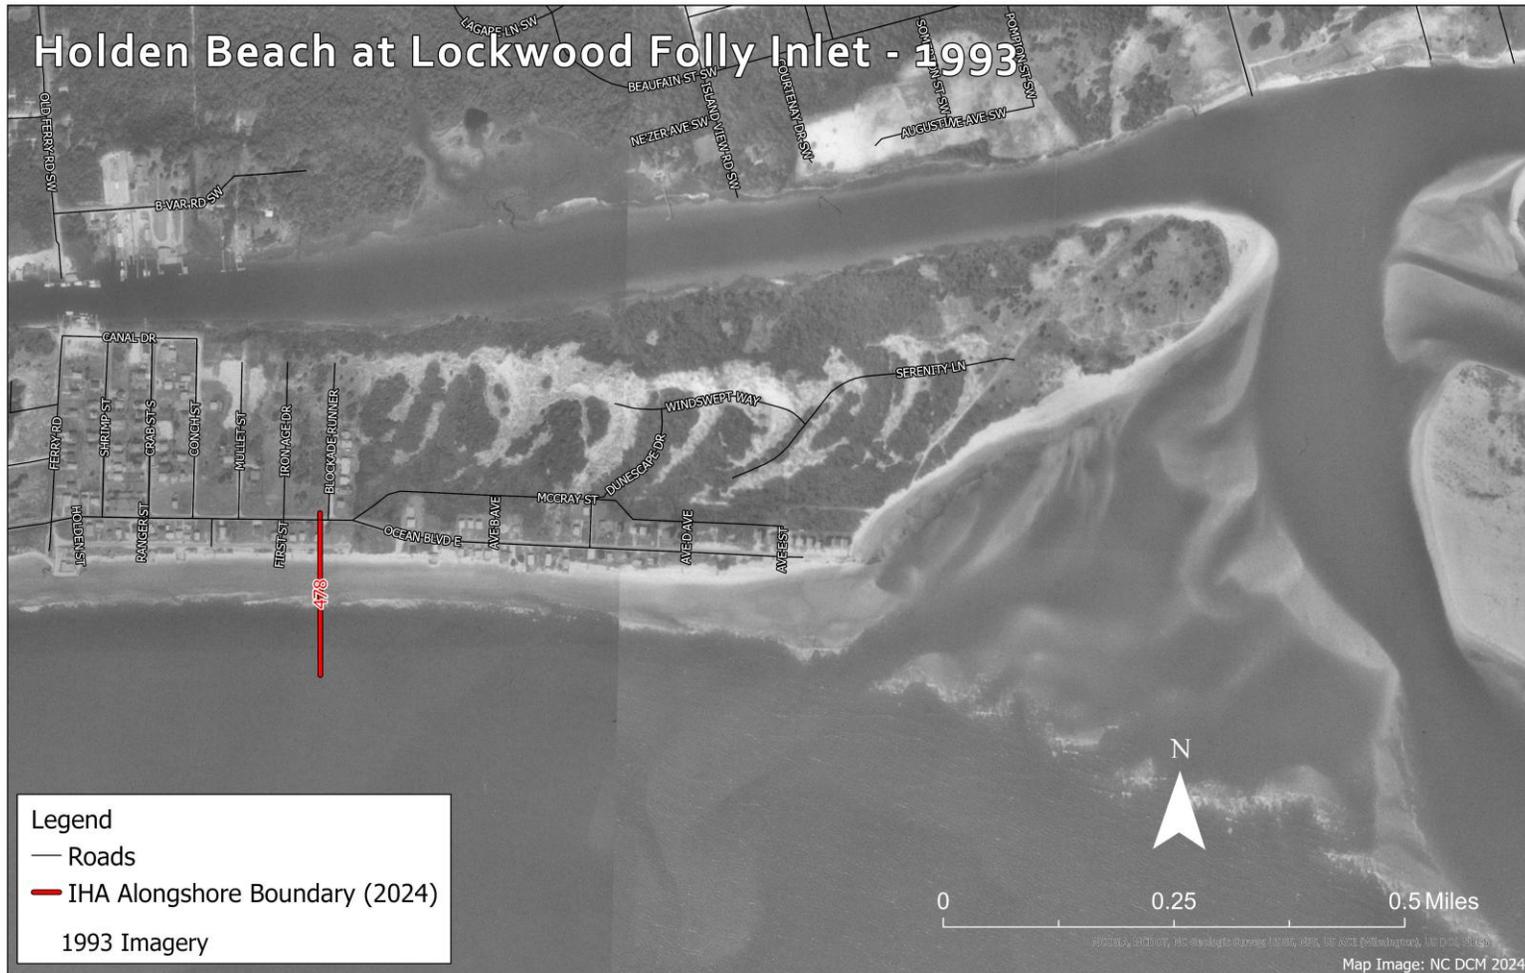
Figure D37. Lockwood Folly Inlet at Holden Beach in 1998, shown relative to the 2024-2025 alongshore IHA boundary limit at transect 478 (red line).

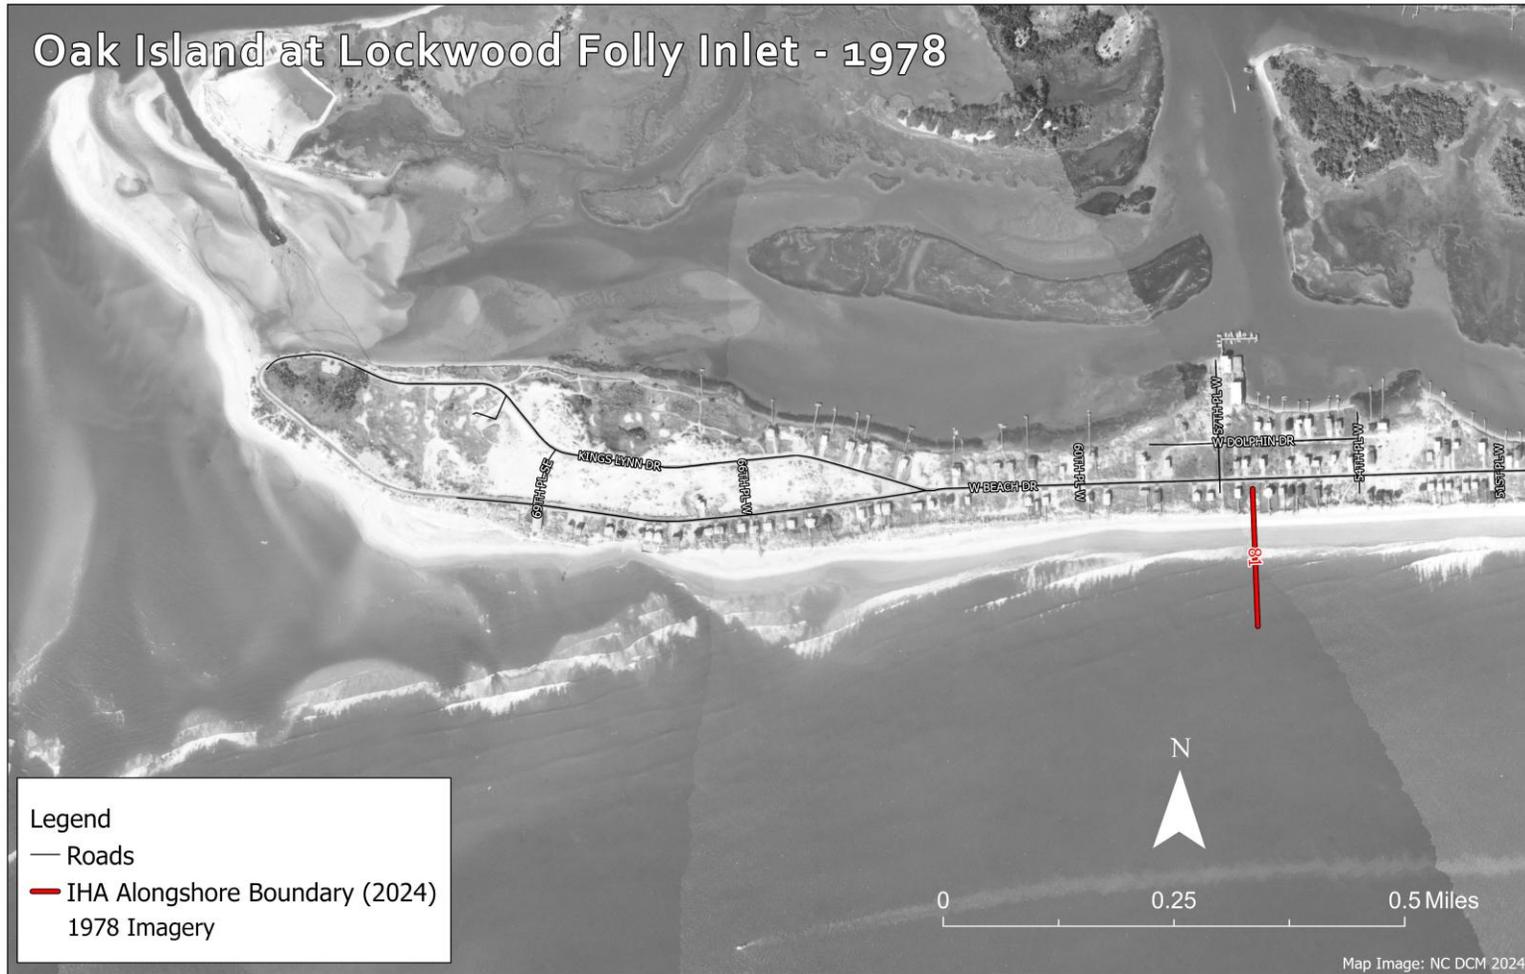
Figure D45. Lockwood Folly Inlet at Oak Island in 1993, shown relative to the 2024-2025 alongshore IHA boundary limit at transect 81 (red line).

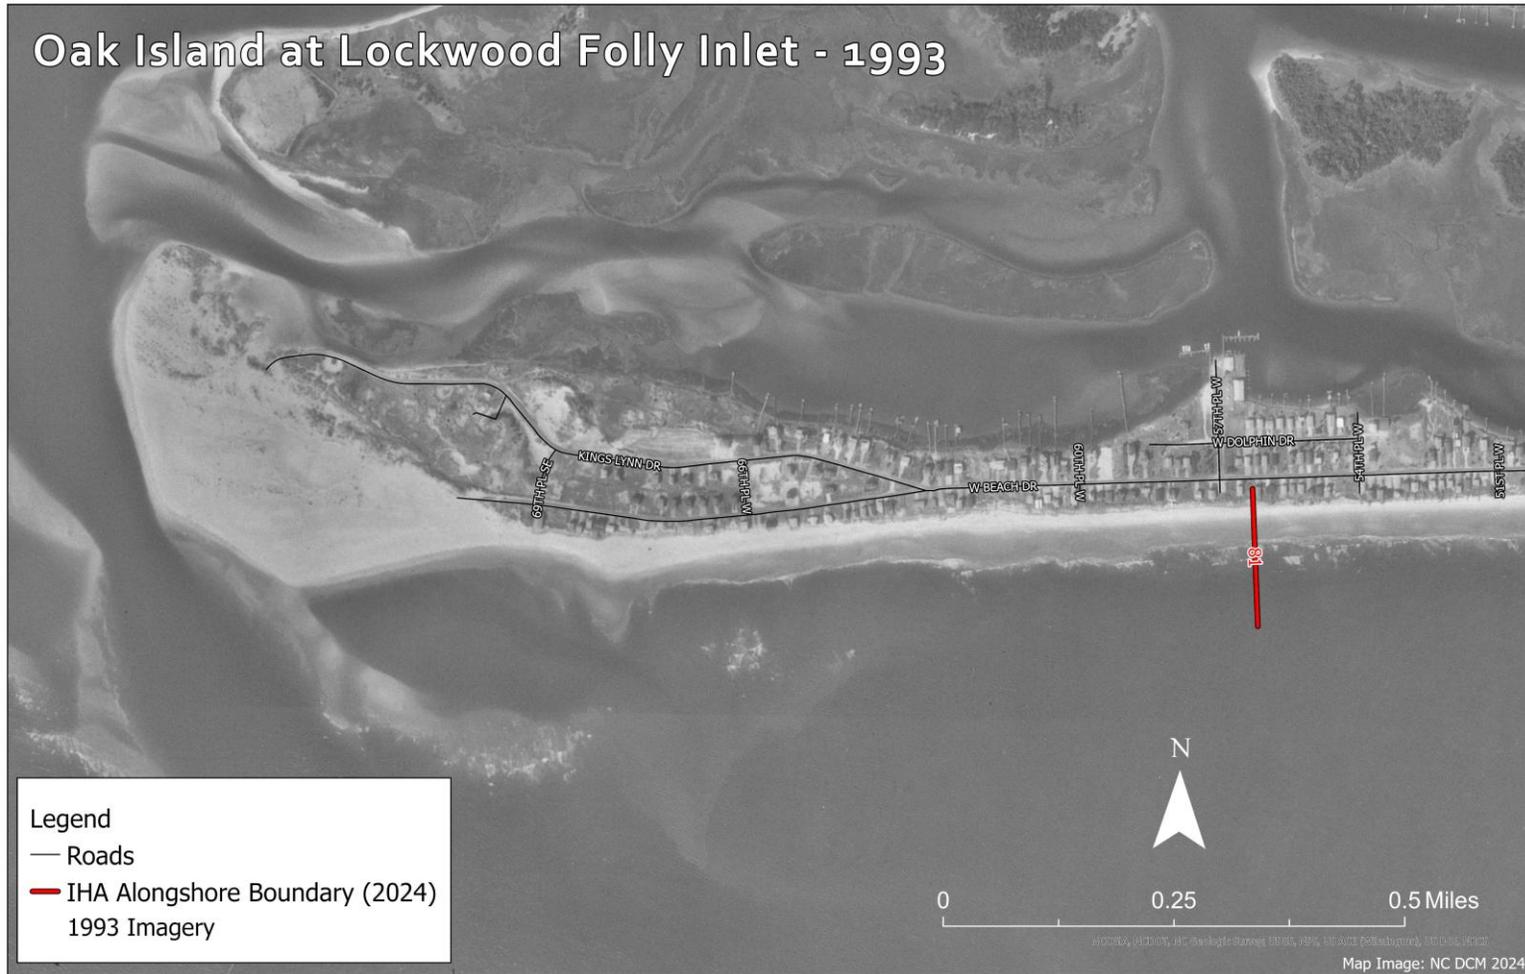
Figure D47. Lockwood Folly Inlet at Oak Island in 2010, shown relative to the 2024-2025 alongshore IHA boundary limit at transect 81 (red line).

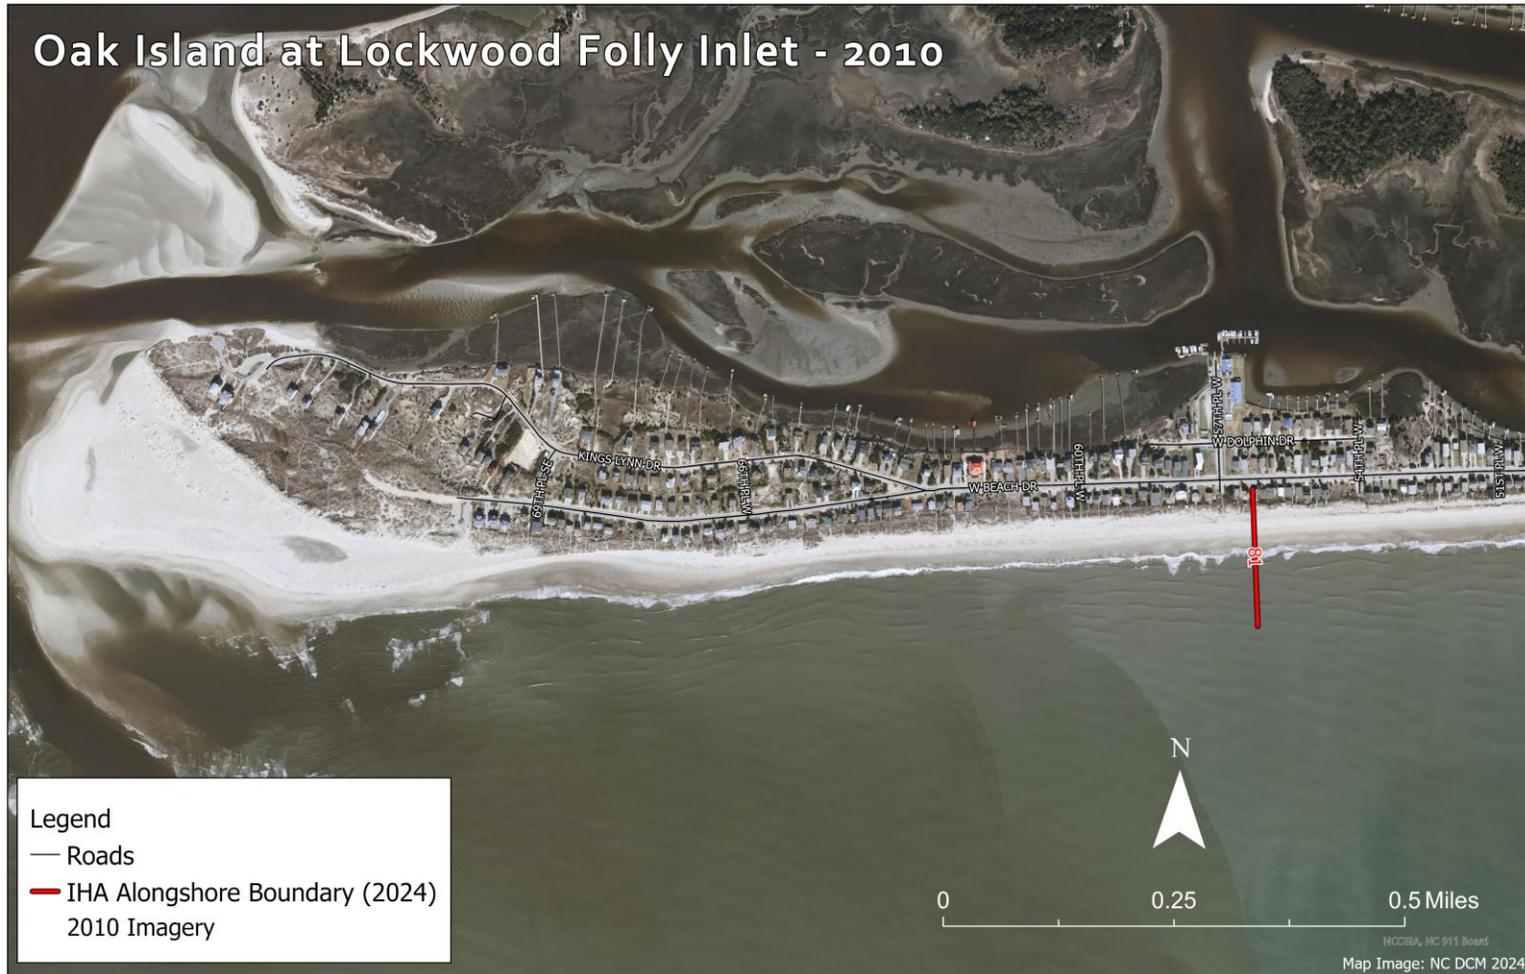
Figure D48. Lockwood Folly Inlet at Oak Island in 2012, shown relative to the 2024-2025 alongshore IHA boundary limit at transect 81 (red line).
