Inlet Hazard Area Boundaries, 2025 Update:

Science Panel Recommendations to the
North Carolina Coastal Resources Commission

August 1, 2025

NC Coastal Resources Commission's Science Panel on Coastal Hazards
& NC Division of Coastal Management

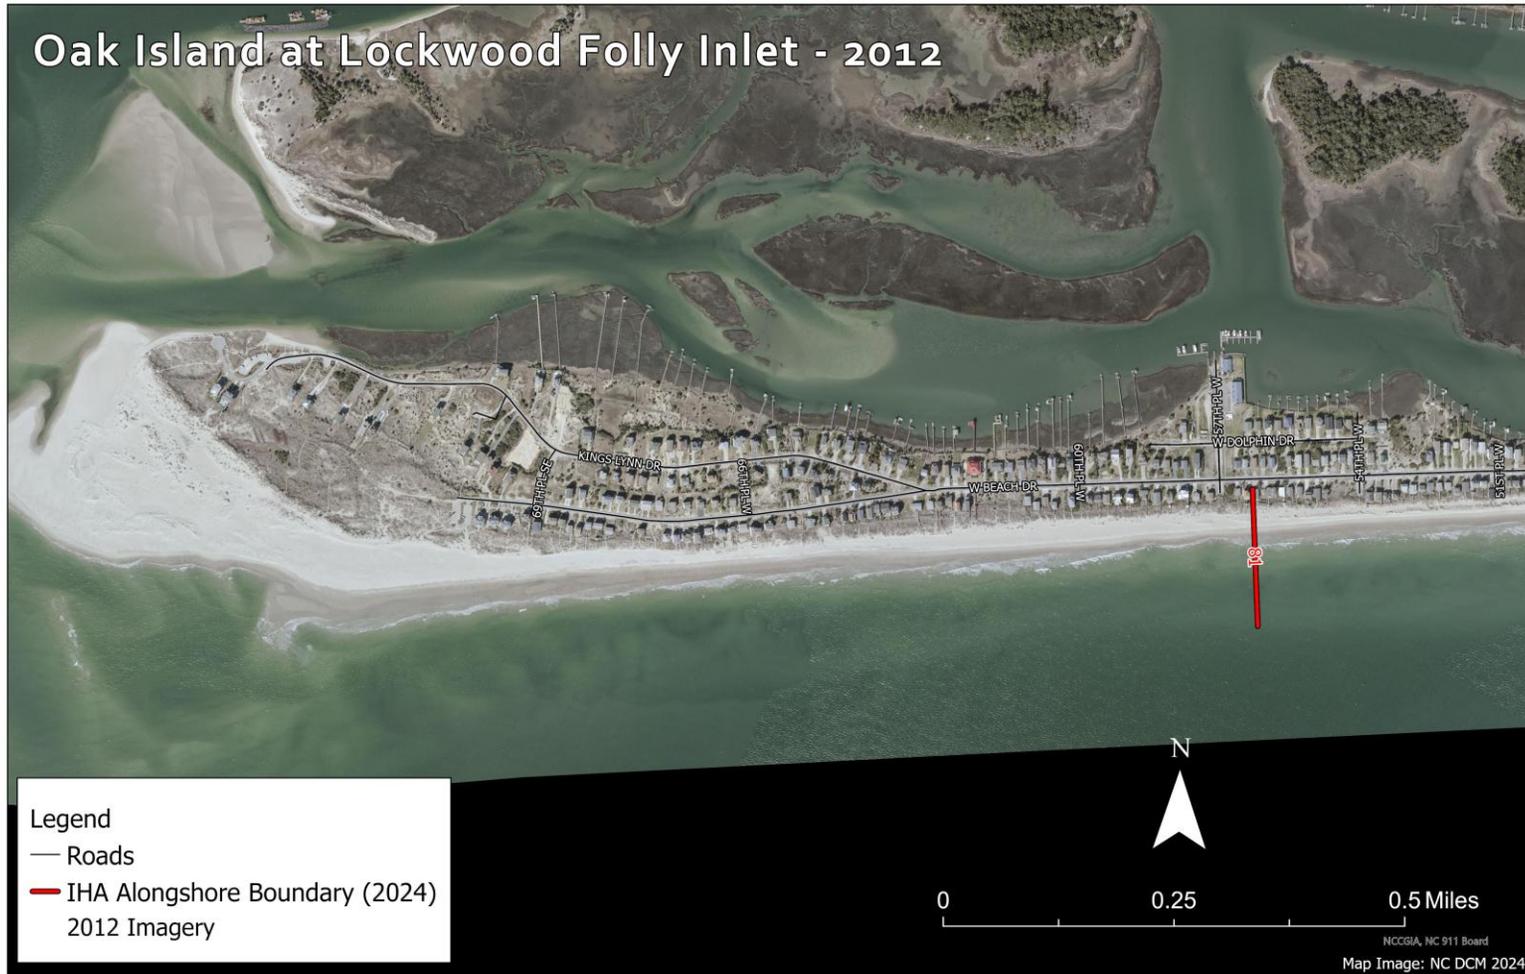
Figure D49. Lockwood Folly Inlet at Oak Island in 2016, shown relative to the 2024-2025 alongshore IHA boundary limit at transect 81 (red line).

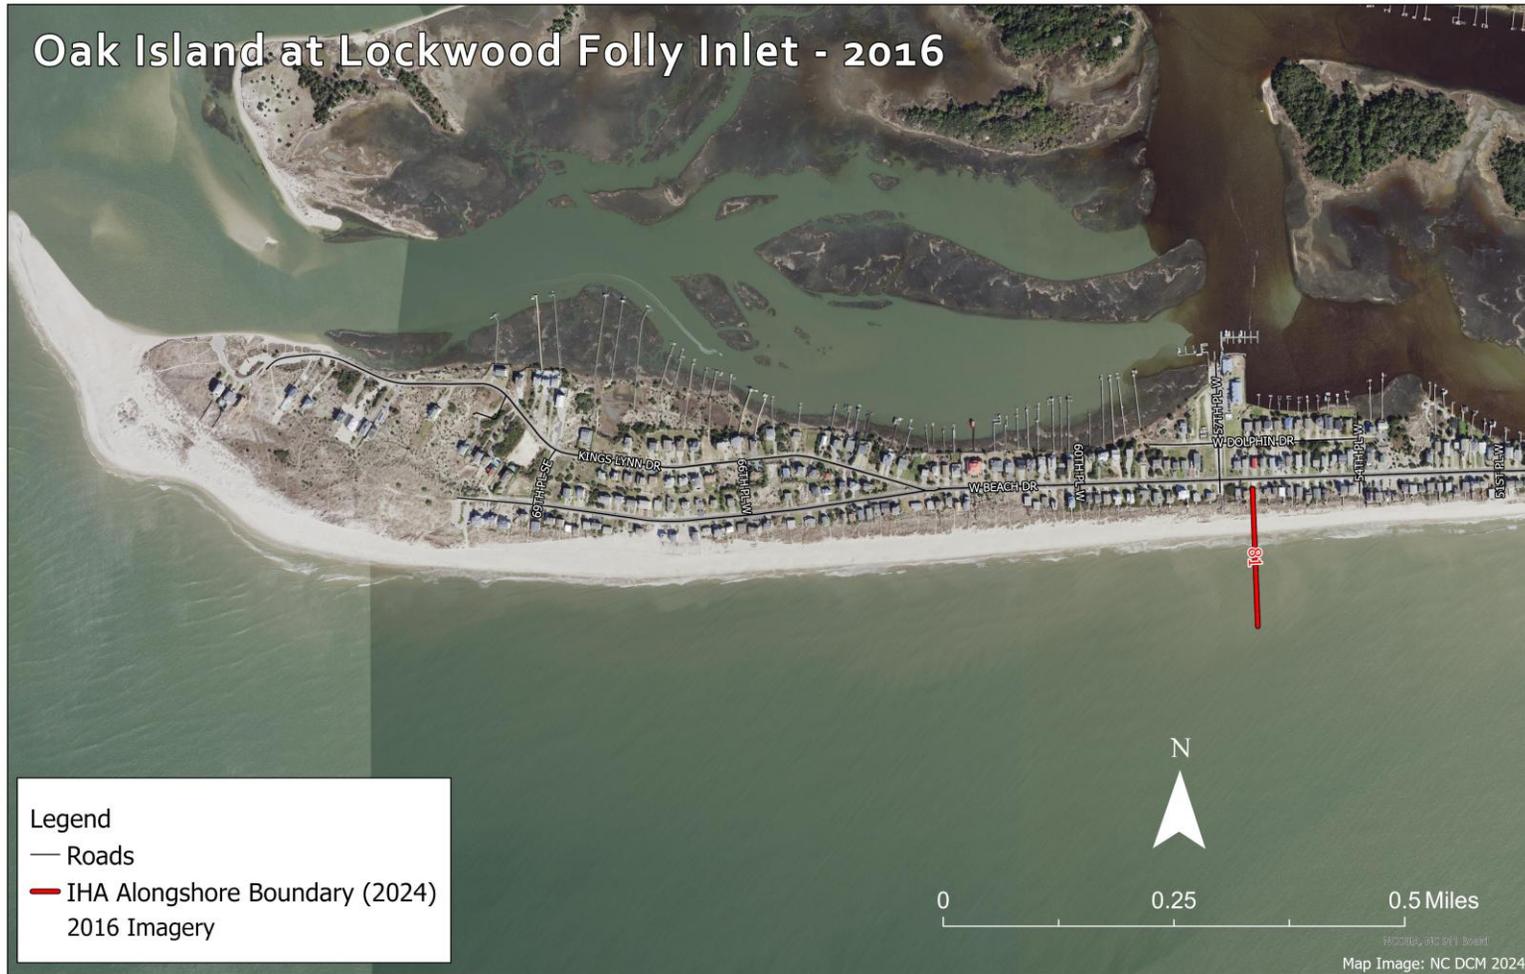
Figure D50. Lockwood Folly Inlet at Oak Island in 2020, shown relative to the 2024-2025 alongshore IHA boundary limit at transect 81 (red line).

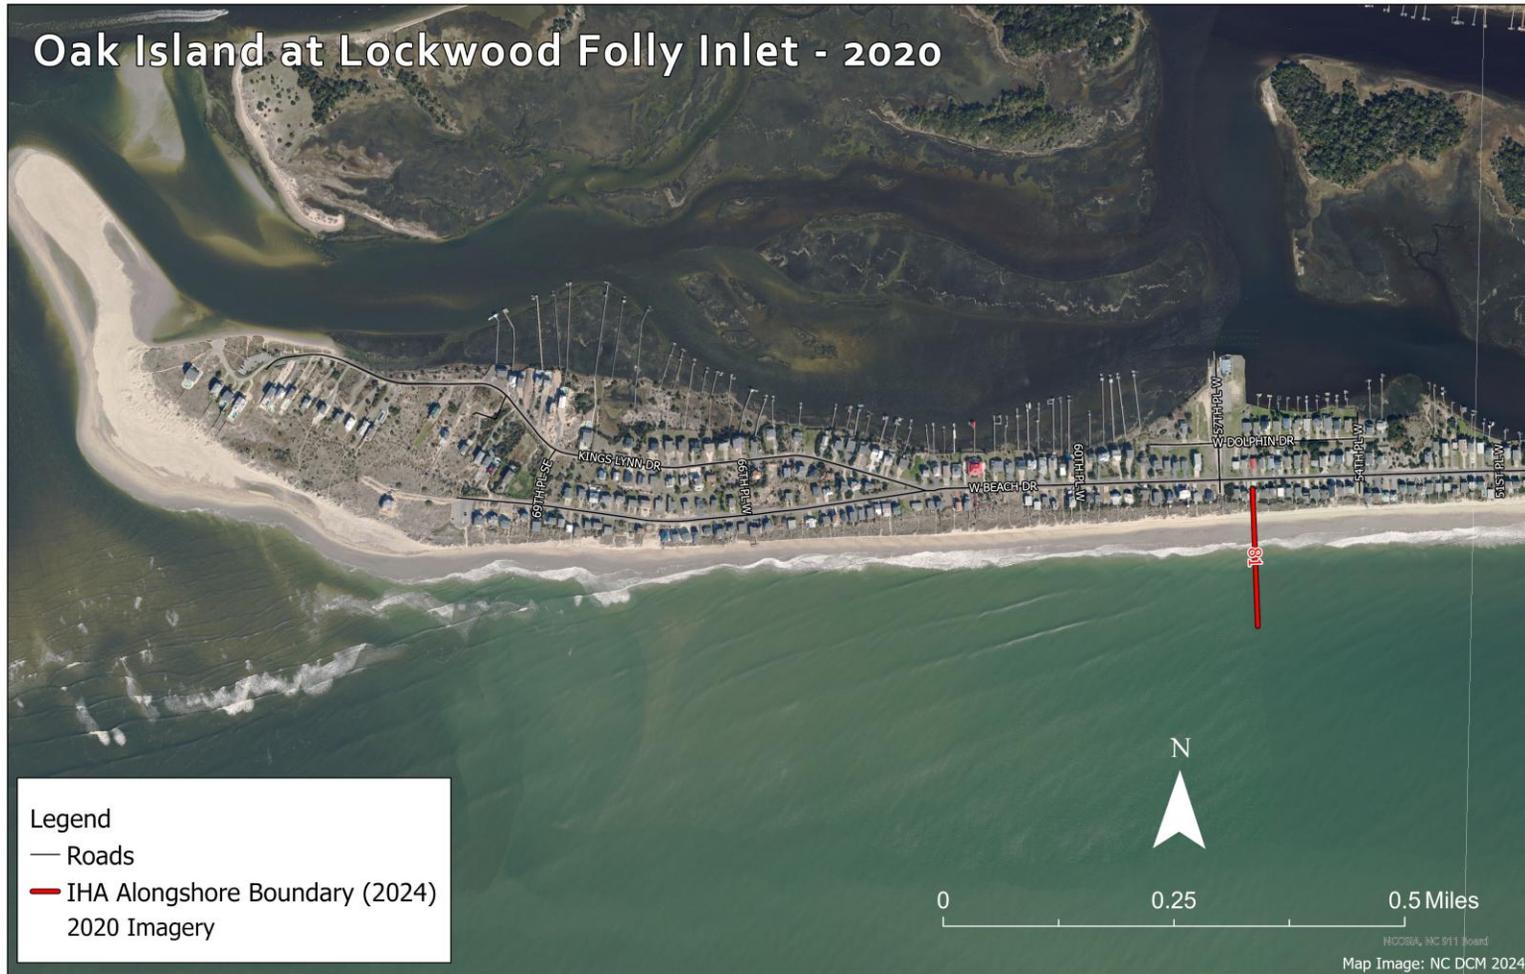
Figure D51. Lockwood Folly Inlet at Oak Island in 2023, shown relative to the 2024-2025 alongshore IHA boundary limit at transect 81 (red line).

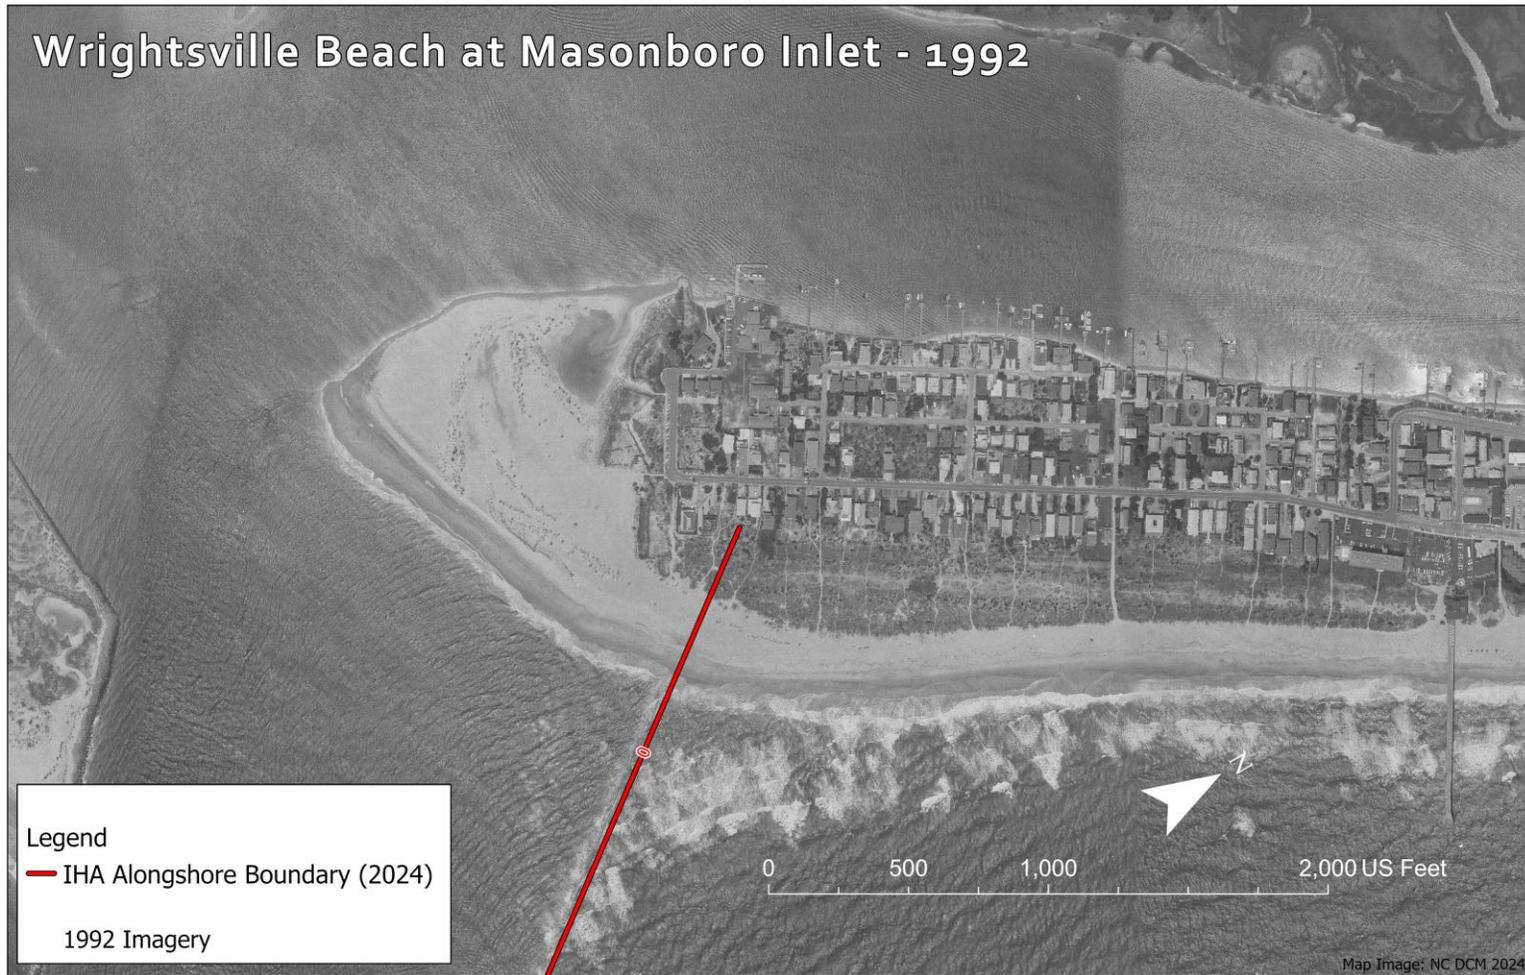
Figure D80. Masonboro Inlet at Wrightsville Beach in 2001, shown relative to the 2024-2025 alongshore IHA boundary limit at the navigation jetty (red line).

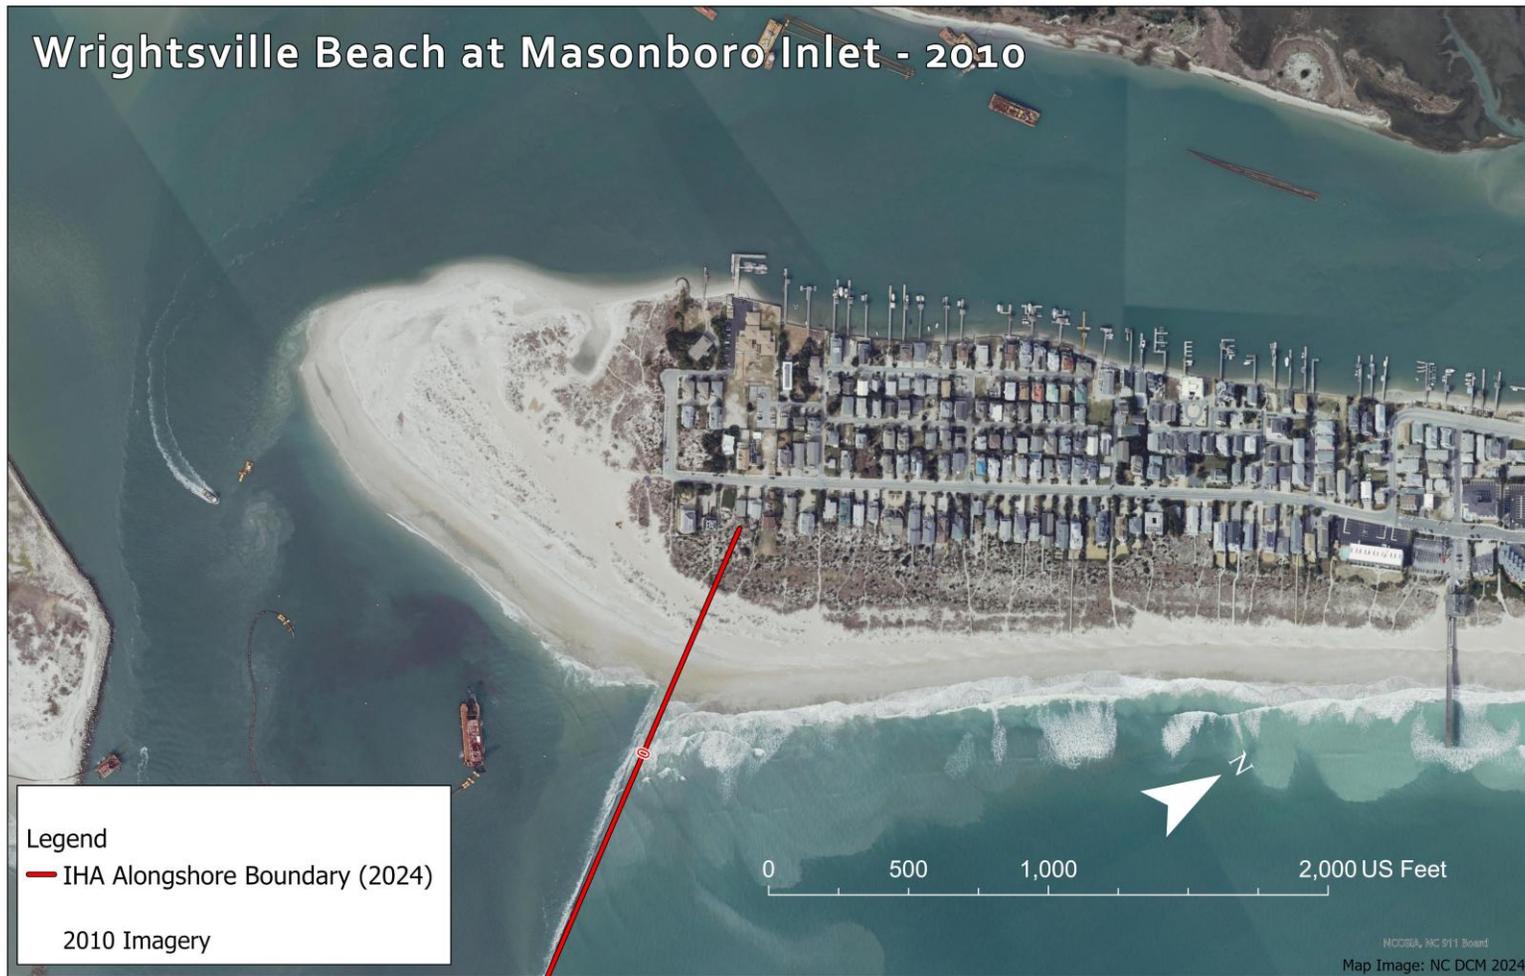
Figure D82. Masonboro Inlet at Wrightsville Beach in 2016, shown relative to the 2024-2025 alongshore IHA boundary limit at the navigation jetty (red line).

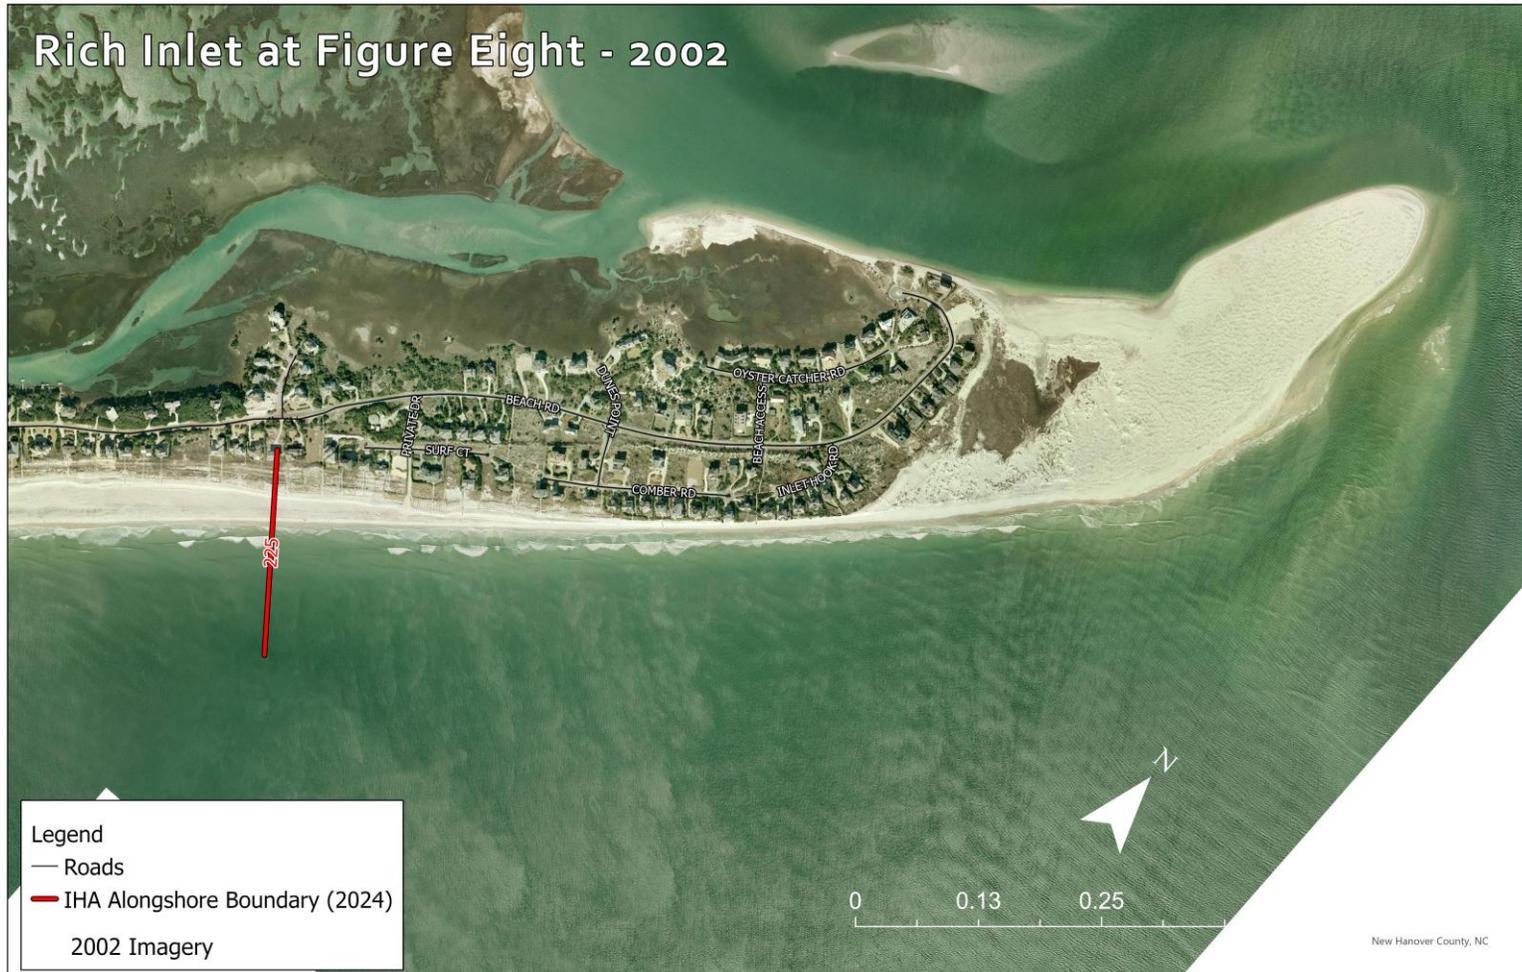
Figure D109. Rich Inlet at Figure Eight Island in 2010, shown relative to the 2024-2025 alongshore IHA boundary limit at transect 225 (red line).

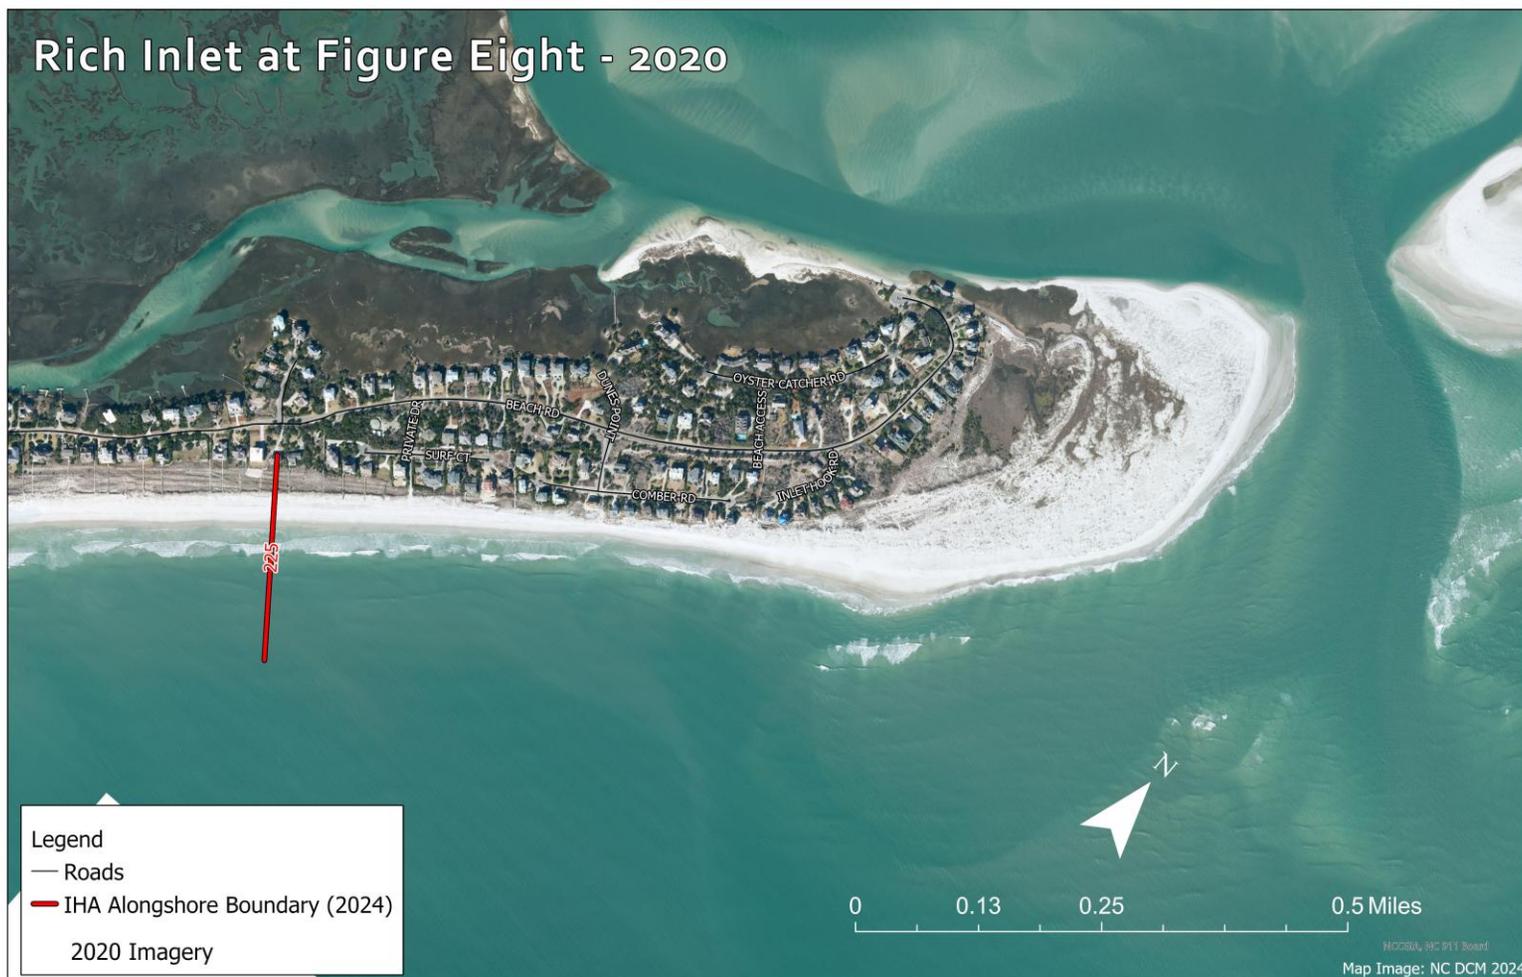
Figure D112. Rich Inlet at Figure Eight Island in 2023, shown relative to the 2024-2025 alongshore IHA boundary limit at transect 225 (red line).

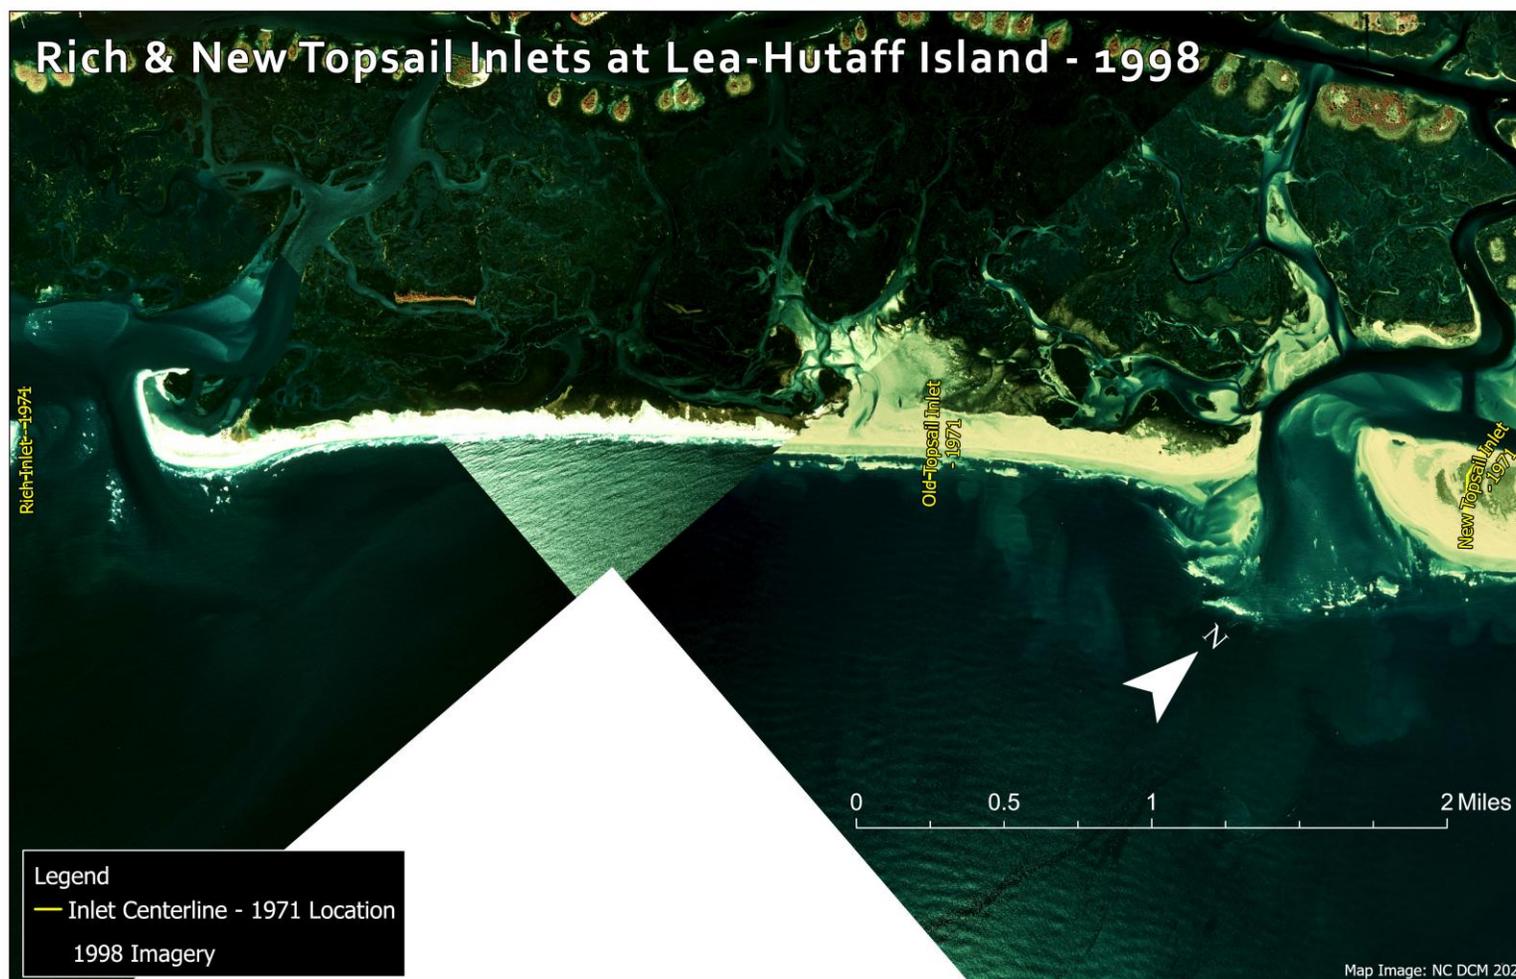
Figure D120. Rich (left) and New Topsail (right) Inlets at Lea-Hutaff Island in 2000, shown relative to 1971 inlet channel centerlines at Rich, Old Topsail (closed in 1998), and New Topsail Inlets.

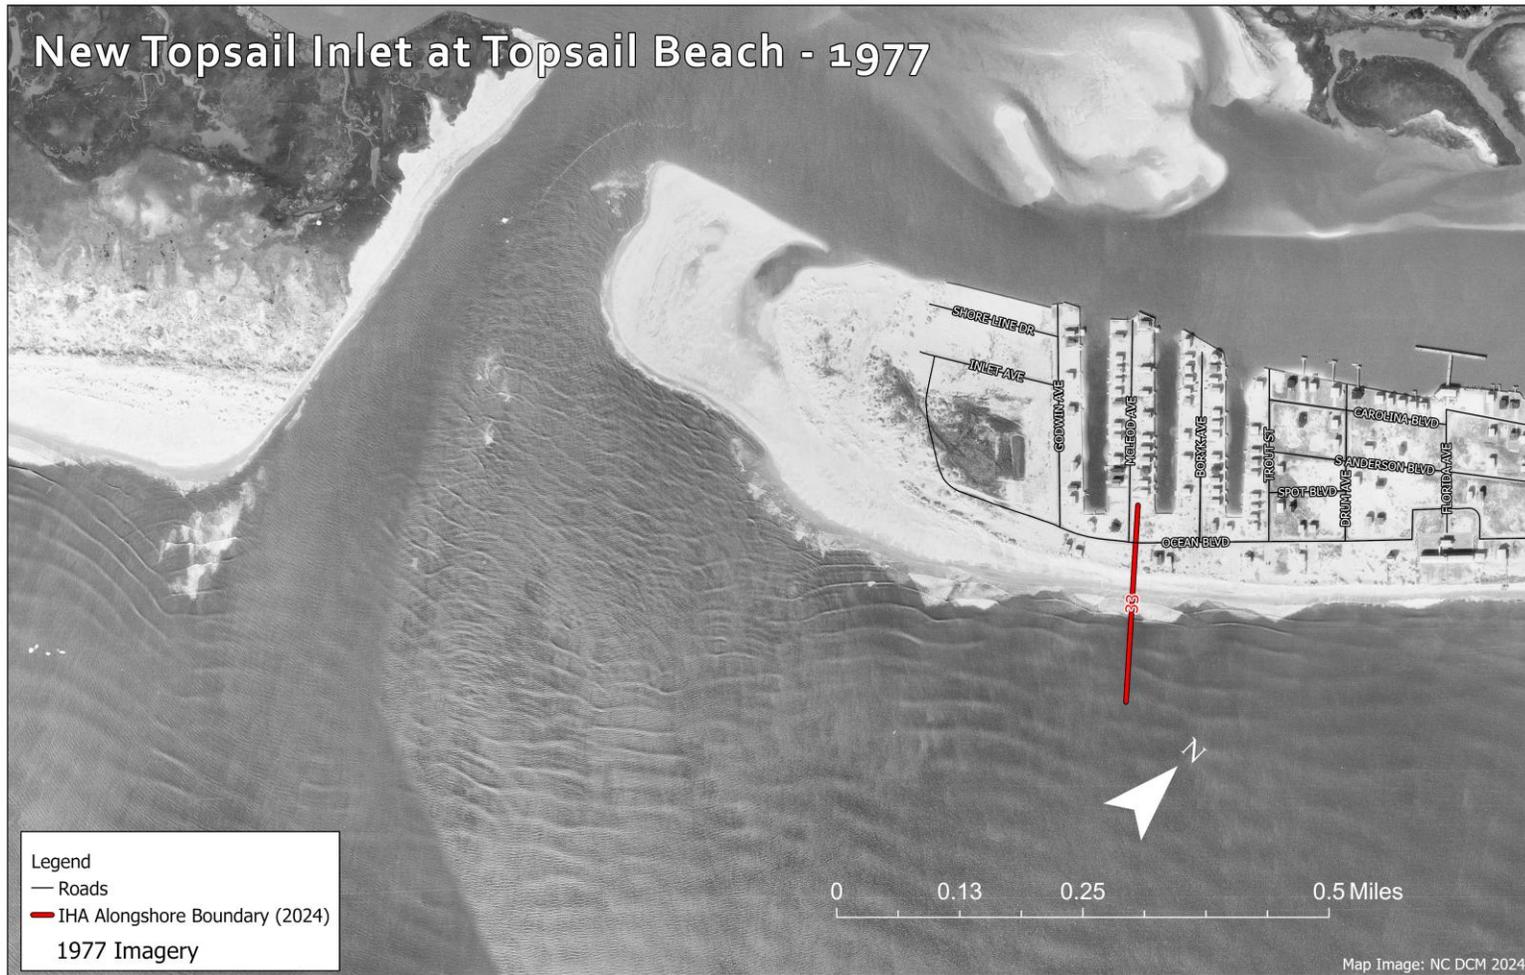
Figure D128. New Topsail Inlet at Topsail Beach in 1984, shown relative to the 2024-2025 alongshore IHA boundary limit at transect 33 (red line).

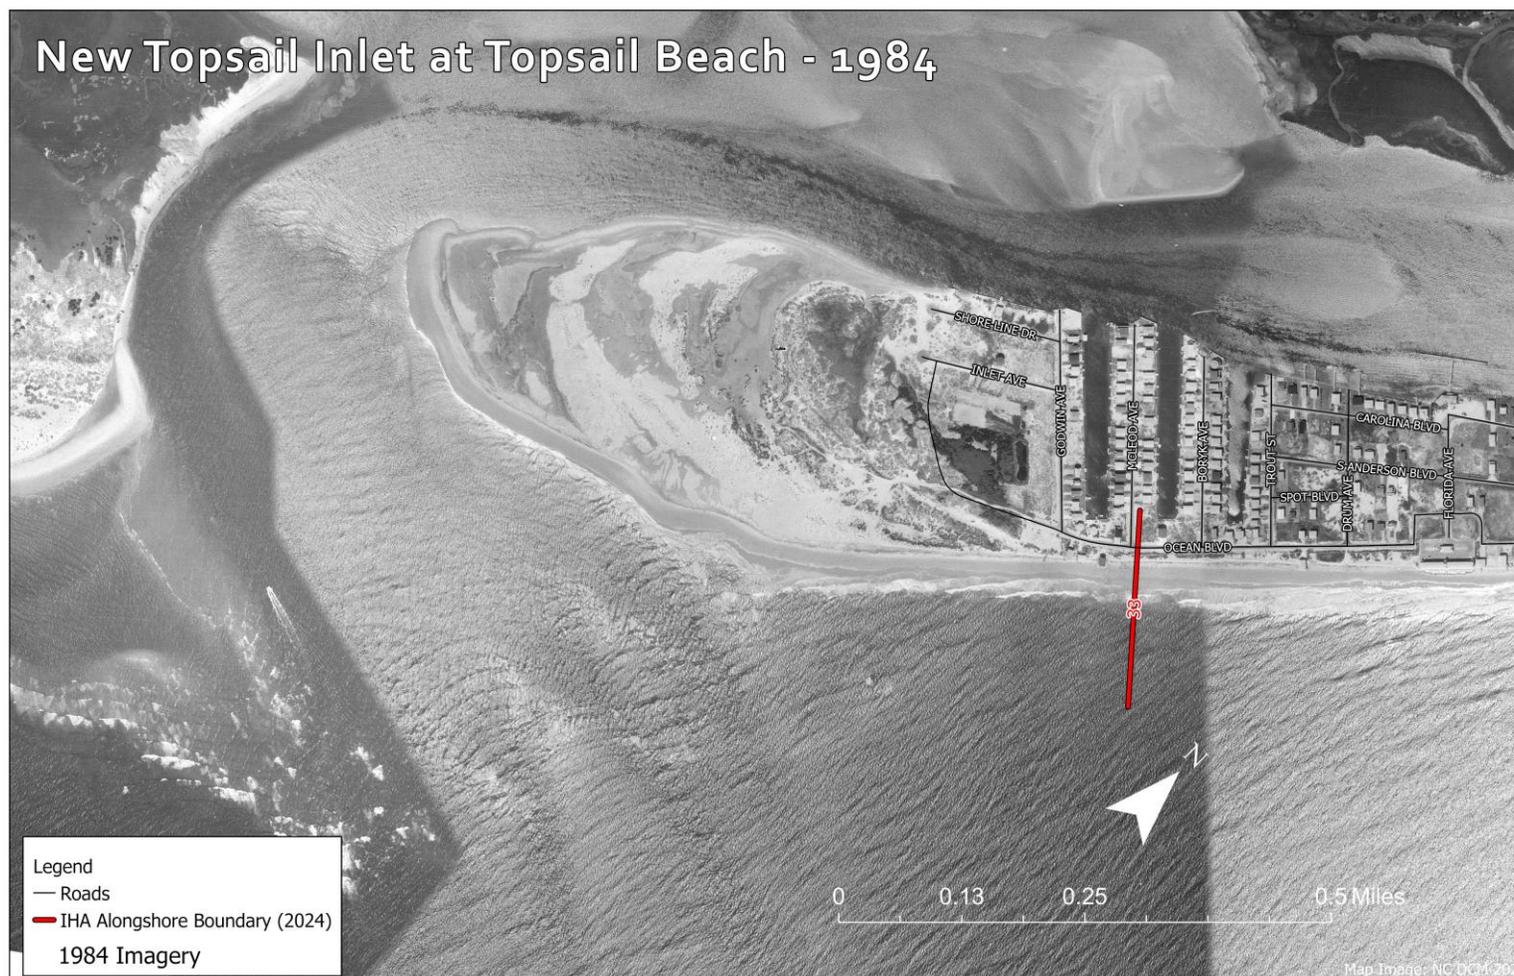
Figure D129. New Topsail Inlet at Topsail Beach in 1992, shown relative to the 2024-2025 alongshore IHA boundary limit at transect 33 (red line).

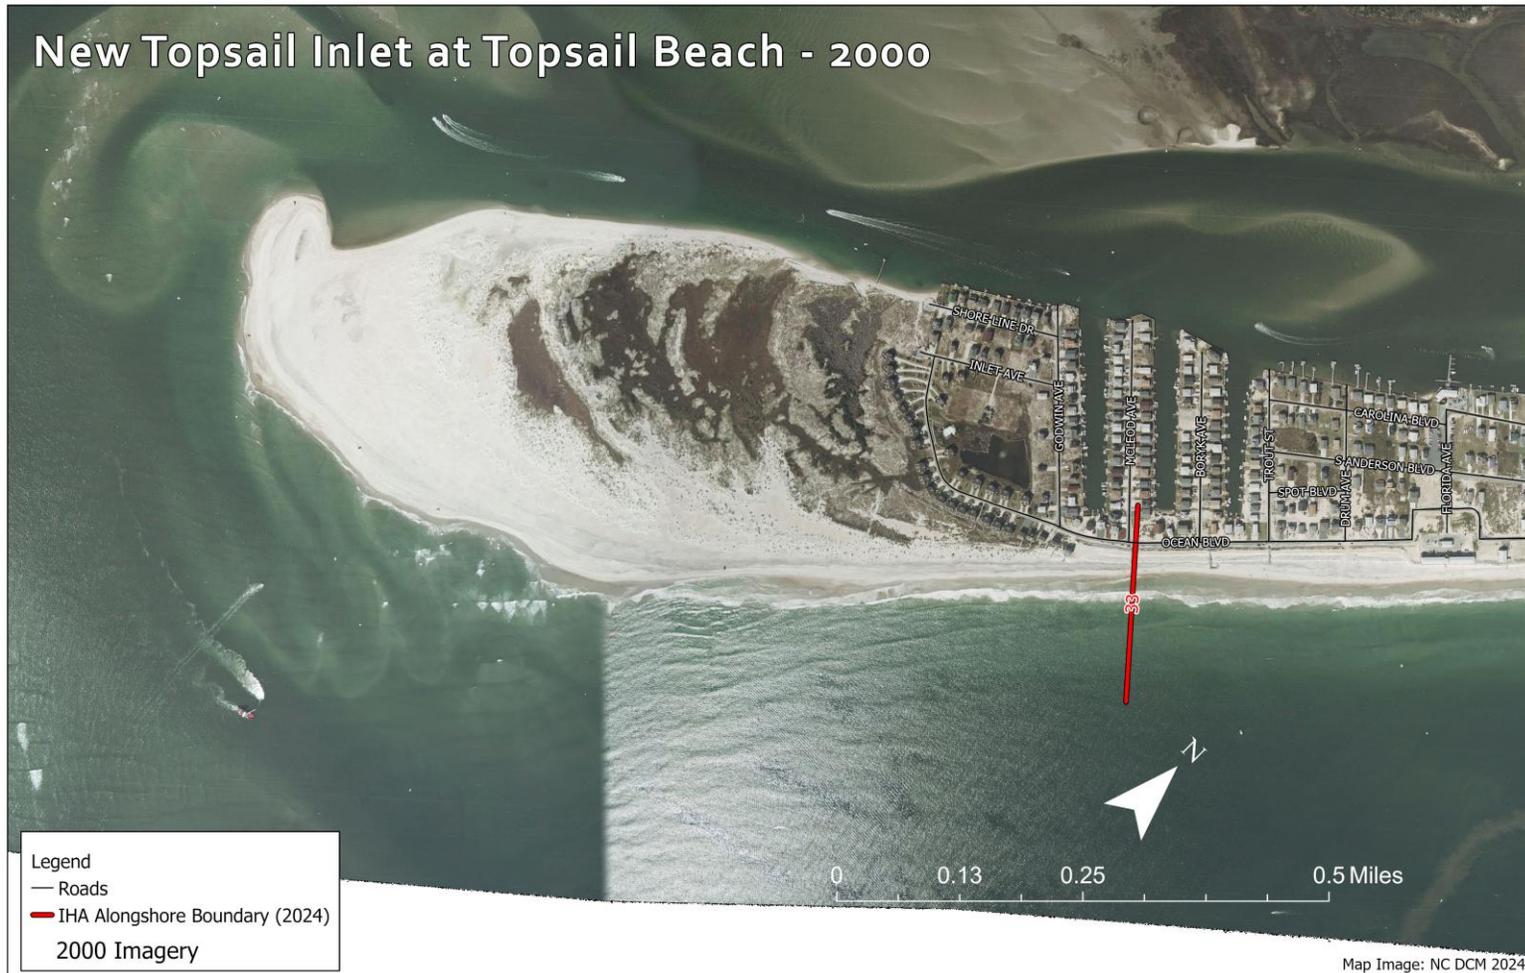
Figure D132. New Topsail Inlet at Topsail Beach in 2010, shown relative to the 2024-2025 alongshore IHA boundary limit at transect 33 (red line).

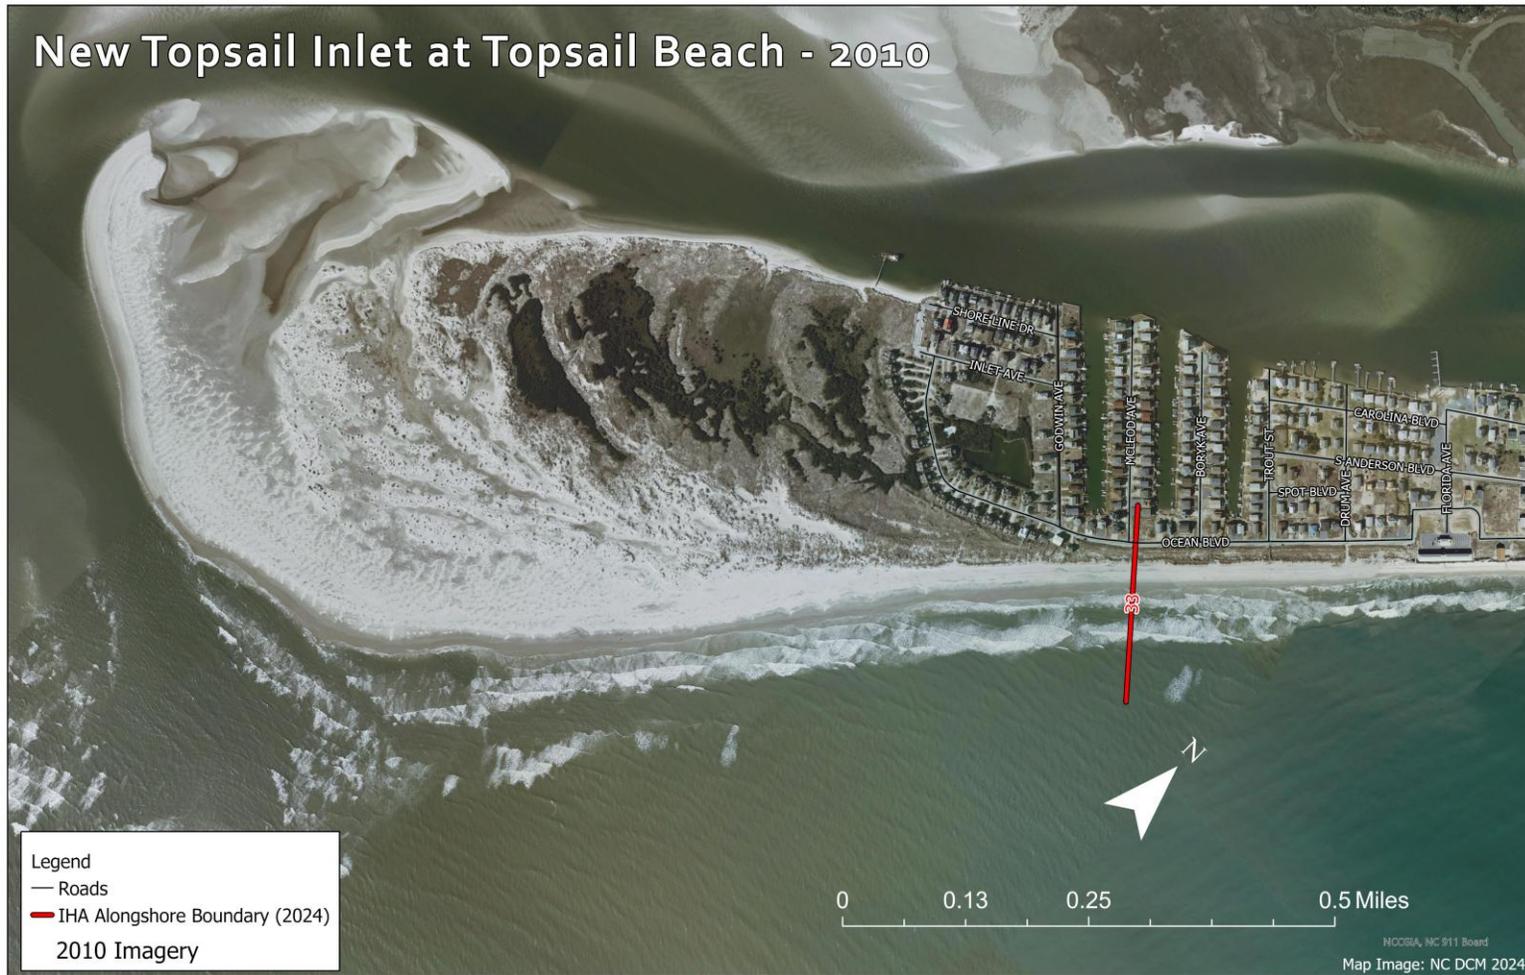
Figure D133. New Topsail Inlet at Topsail Beach in 2016, shown relative to the 2024-2025 alongshore IHA boundary limit at transect 33 (red line).

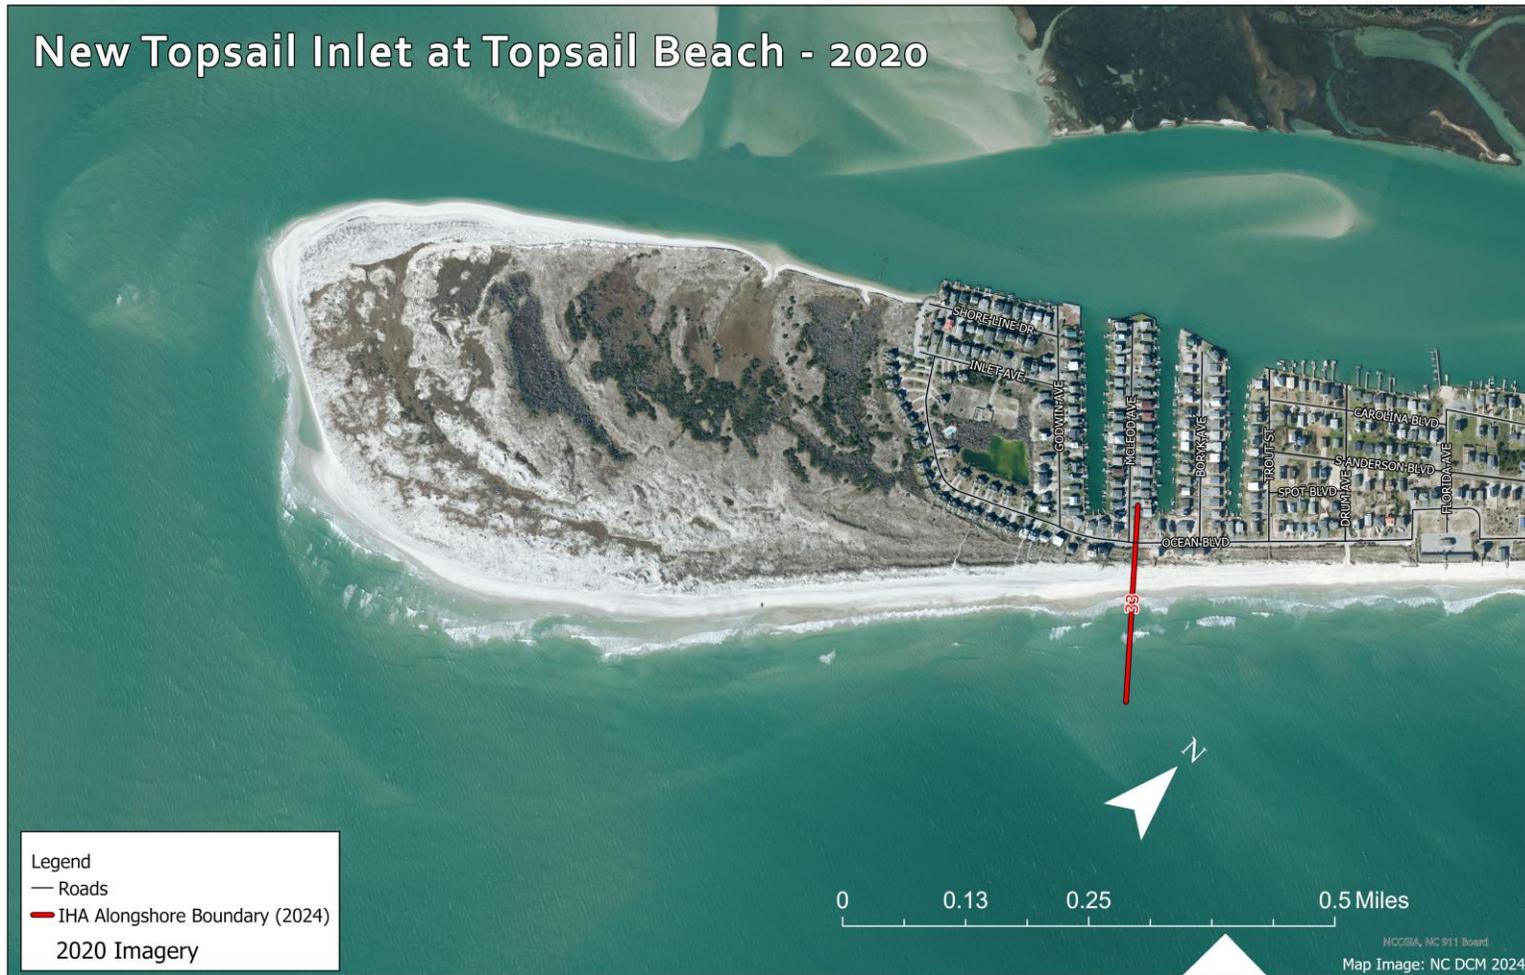
Figure D135. New Topsail Inlet at Topsail Beach in 2023, shown relative to the 2024-2025 alongshore IHA boundary limit at transect 33 (red line).

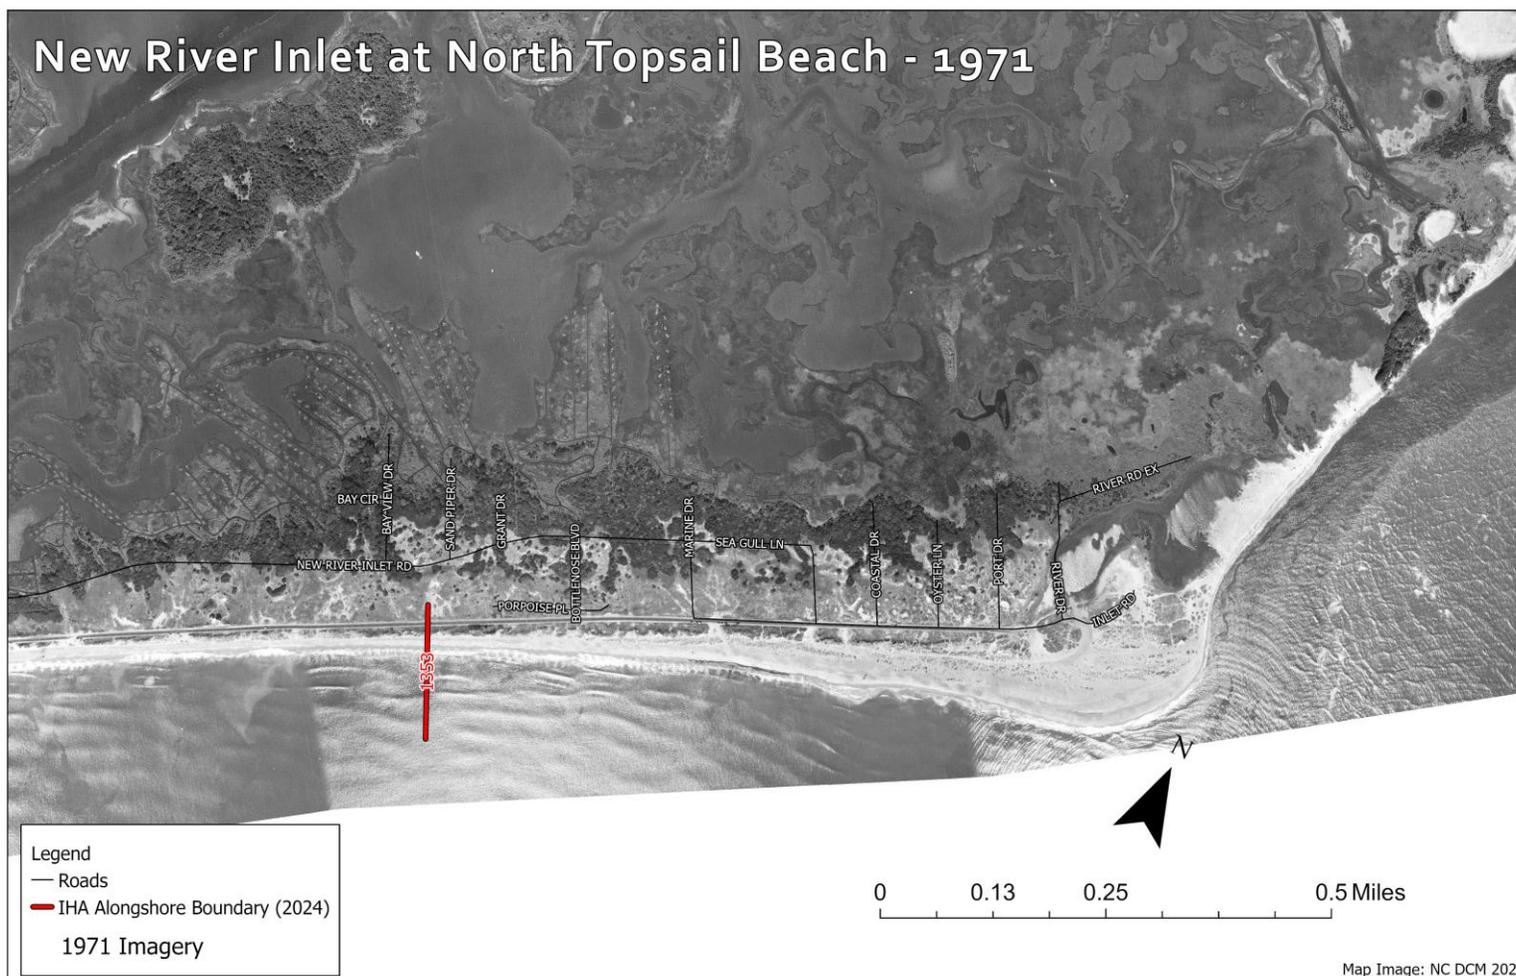
Figure D137. New River Inlet at North Topsail Beach in 1974, shown relative to the 2024-2025 alongshore IHA boundary limit at transect 1353 (red line).

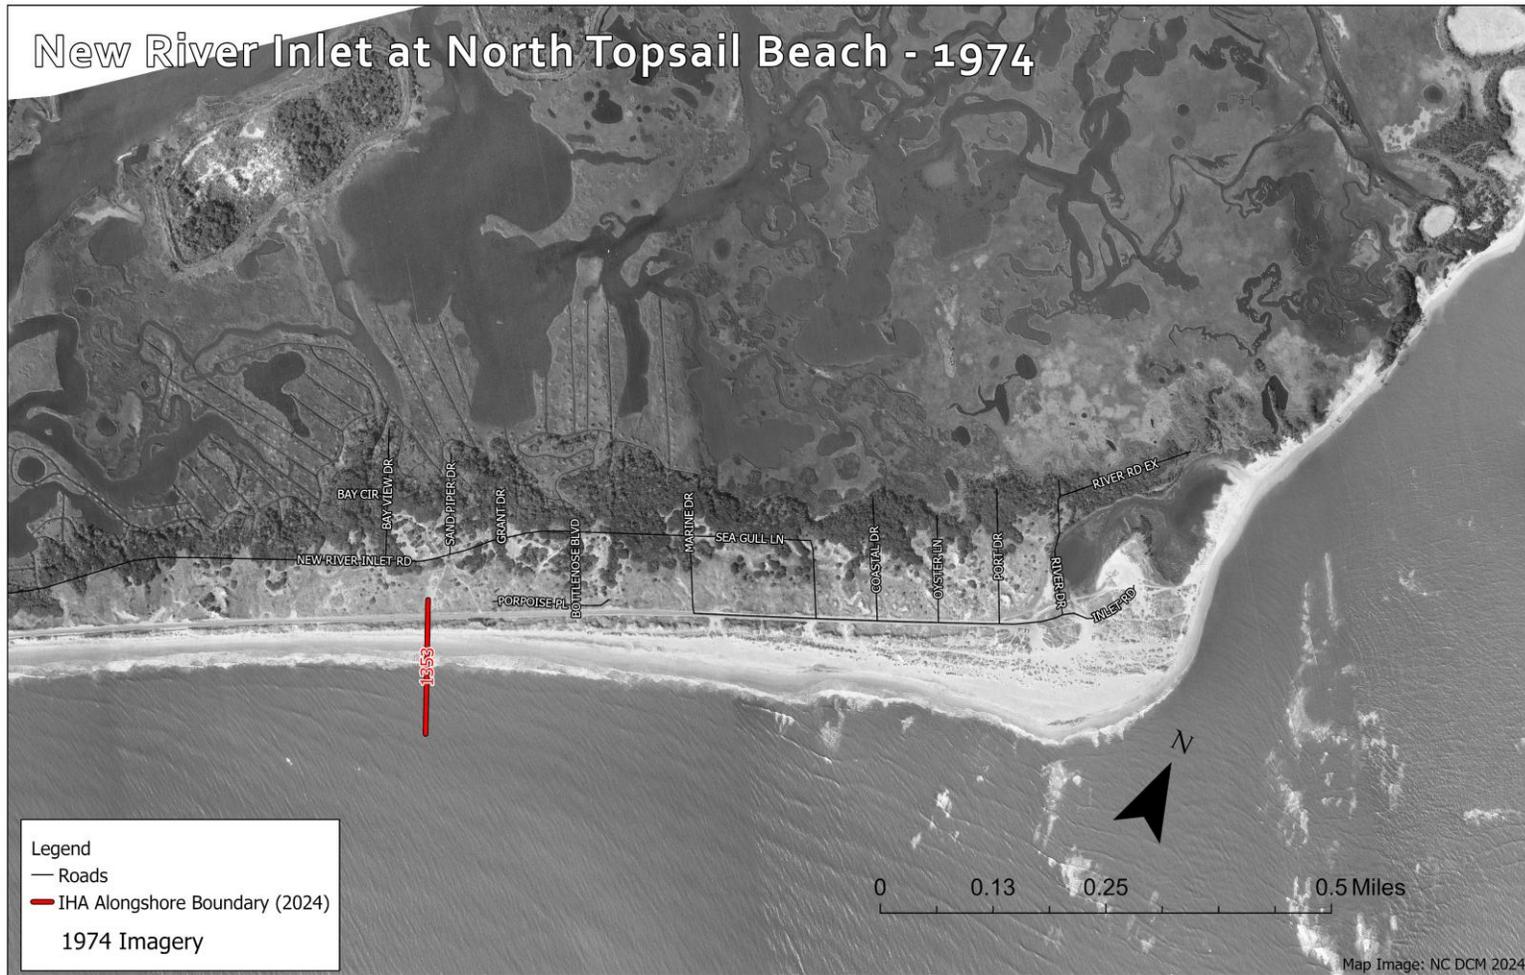
Figure D138. New River Inlet at North Topsail Beach in 1977, shown relative to the 2024-2025 alongshore IHA boundary limit at transect 1353 (red line).
