Inlet Hazard Area Boundaries, 2025 Update:

Science Panel Recommendations to the
North Carolina Coastal Resources Commission

August 1, 2025

NC Coastal Resources Commission's Science Panel on Coastal Hazards
& NC Division of Coastal Management

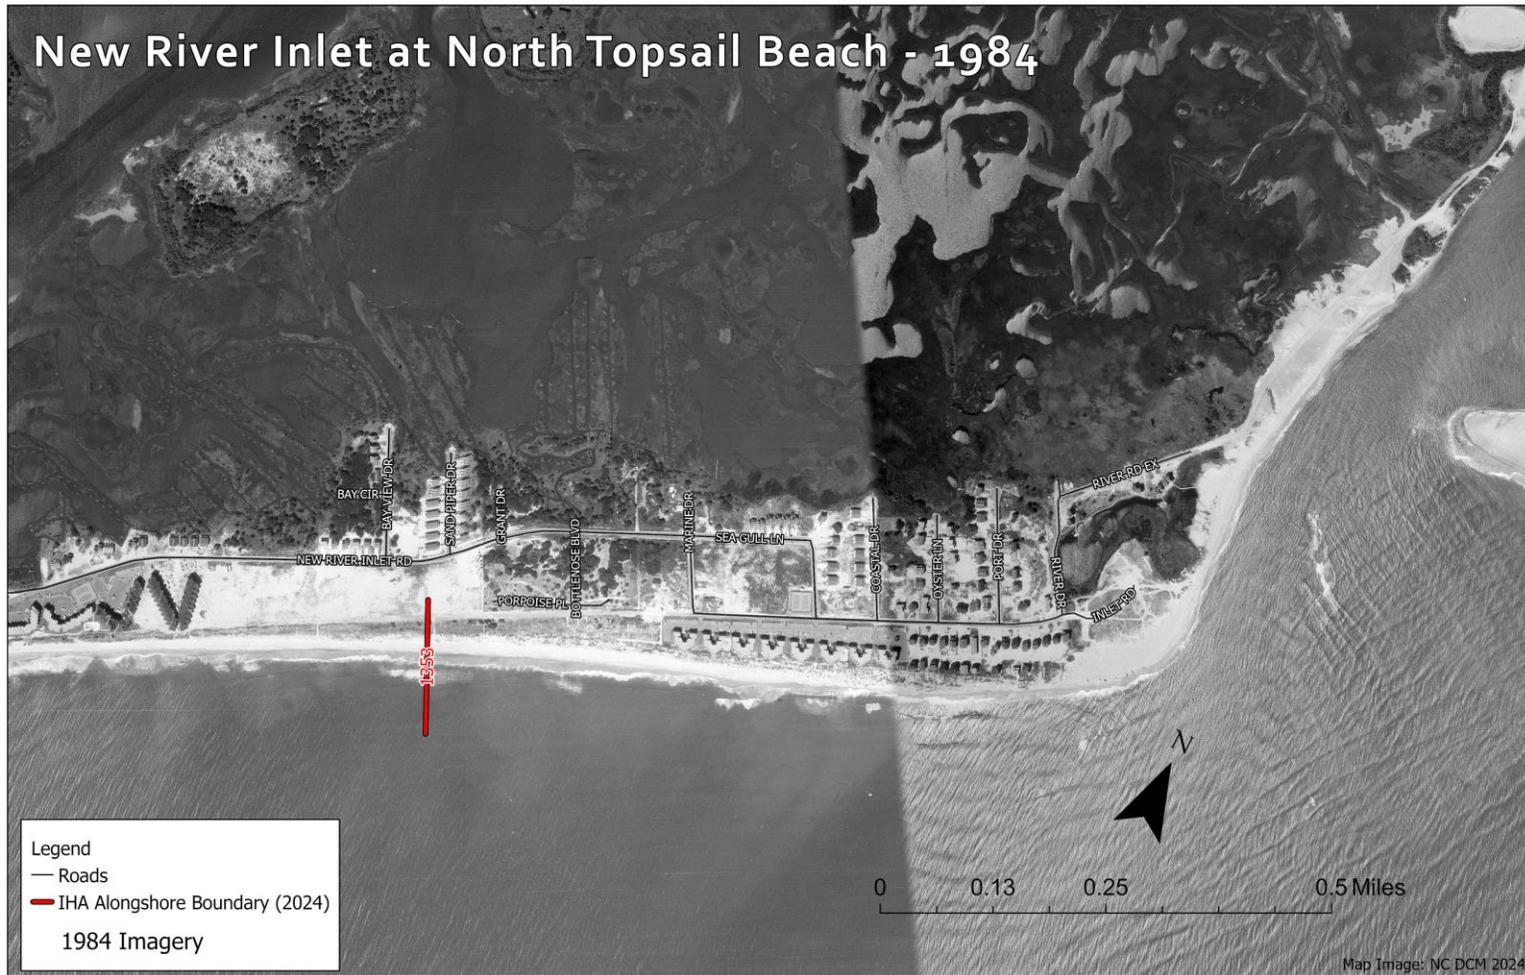
Figure D140. New River Inlet at North Topsail Beach in 1992, shown relative to the 2024-2025 alongshore IHA boundary limit at transect 1353 (red line).

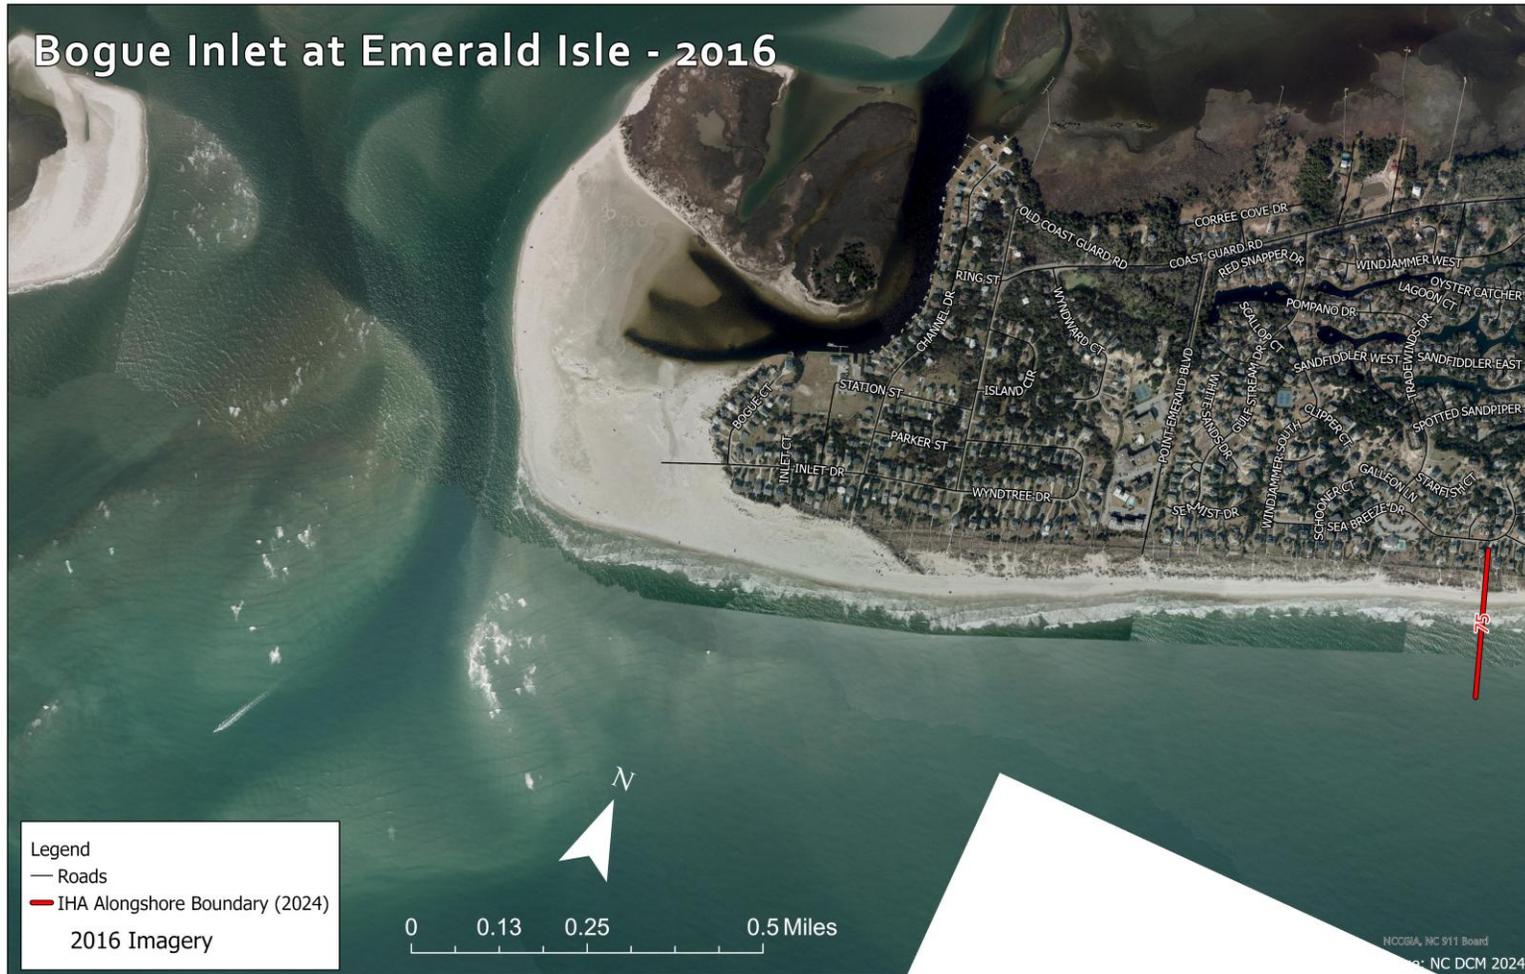
Figure D159. Bogue Inlet at Emerald Isle in 2020, shown relative to the 2024-2025 alongshore IHA boundary limit transect 75 (red line).

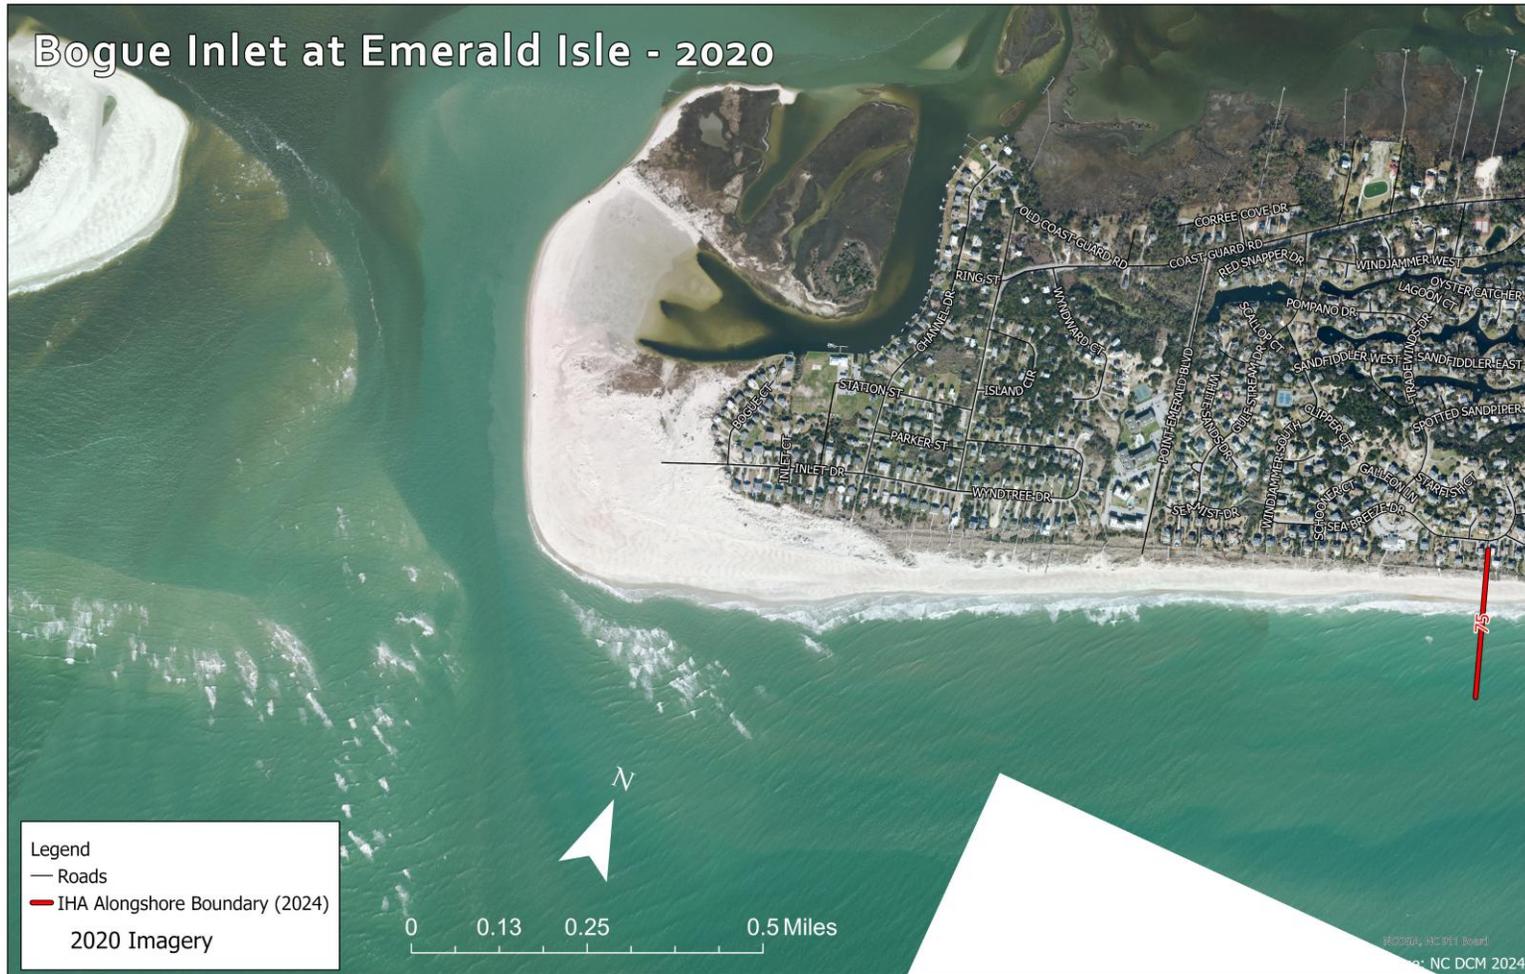
Figure D160. Bogue Inlet at Emerald Isle in 2023, shown relative to the 2024-2025 alongshore IHA boundary limit transect 75 (red line).
