CRC-24-07

TO: Coastal Resources Commission
FROM: Heather Coats, Beach & Inlet Management Project Coordinator
SUBJECT: Addition of Rule Language to Allow the Installation and Maintenance of Straw Bales

ATTACHMENT A: 2022 MEMO TO CRC REGARDING PROPOSED AMENDMENTS TO 15A 7K .0212- INSTALLATION & MAINTENANCE OF SAND FENCING

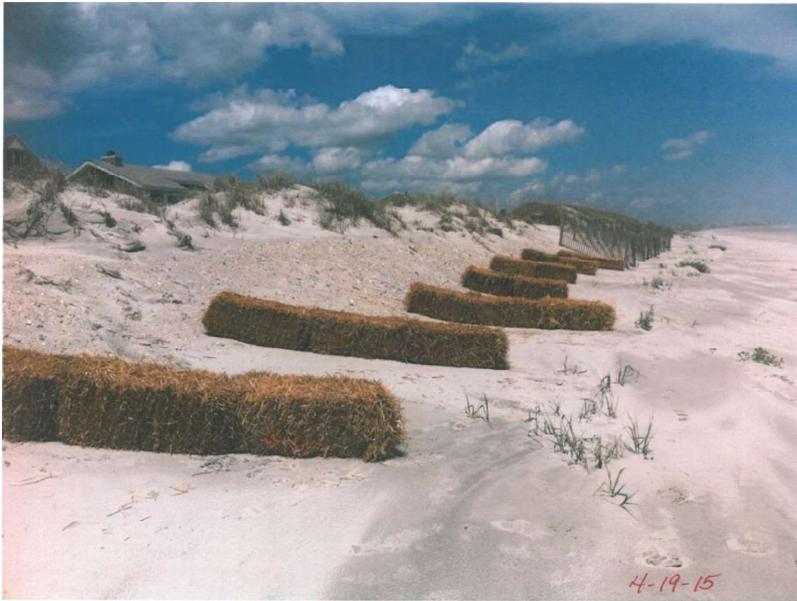
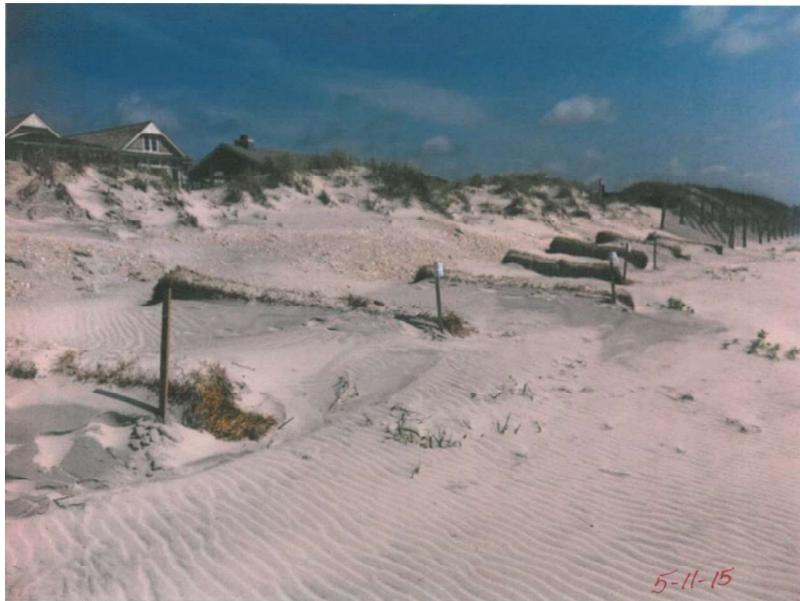
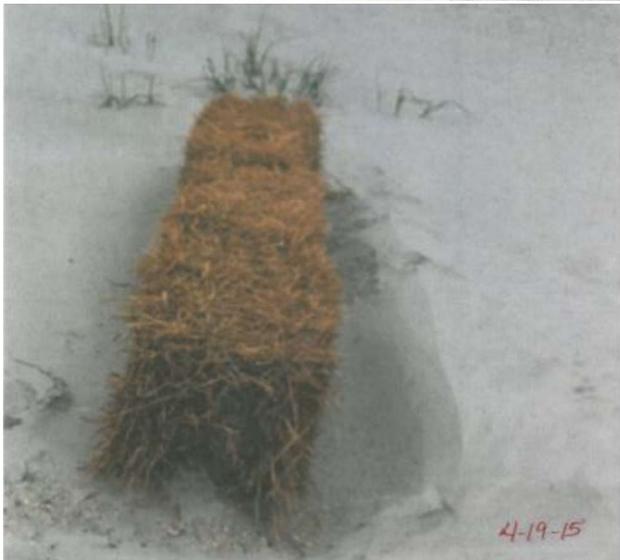
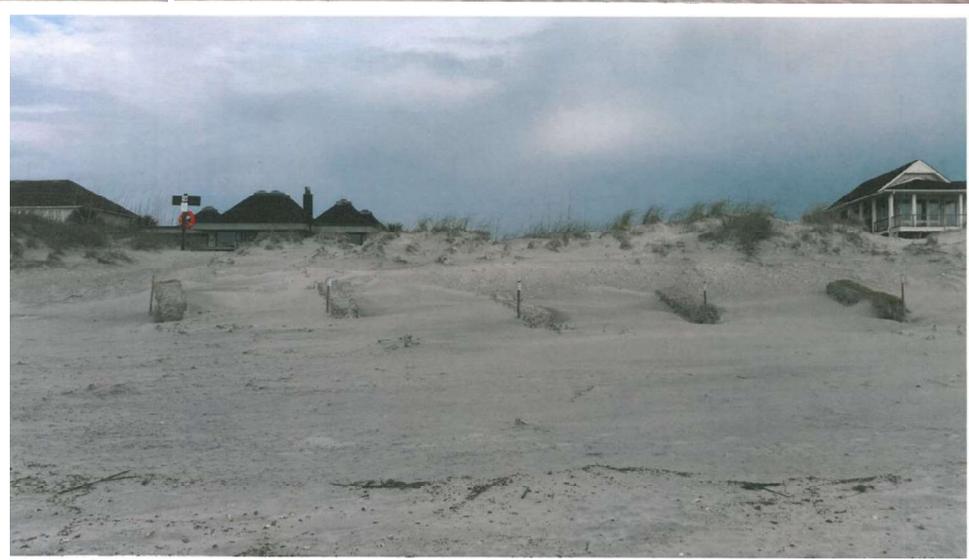
ATTACHM ENT B:

ATTACHMENT B: IMAGES FROM THE EXPERIMENTAL SITE IN FIGURE 8 ISLAND

The experimental Minor Permit issued on Figure 8 Island followed the same criteria listed above, however the permit conditions limited the vertical extent to the height of one bale as per the request of the NC WRC. Recommendations from resource agencies also included removal of all bindings or ties on the bales to prevent entanglement with threatened or endangered species.

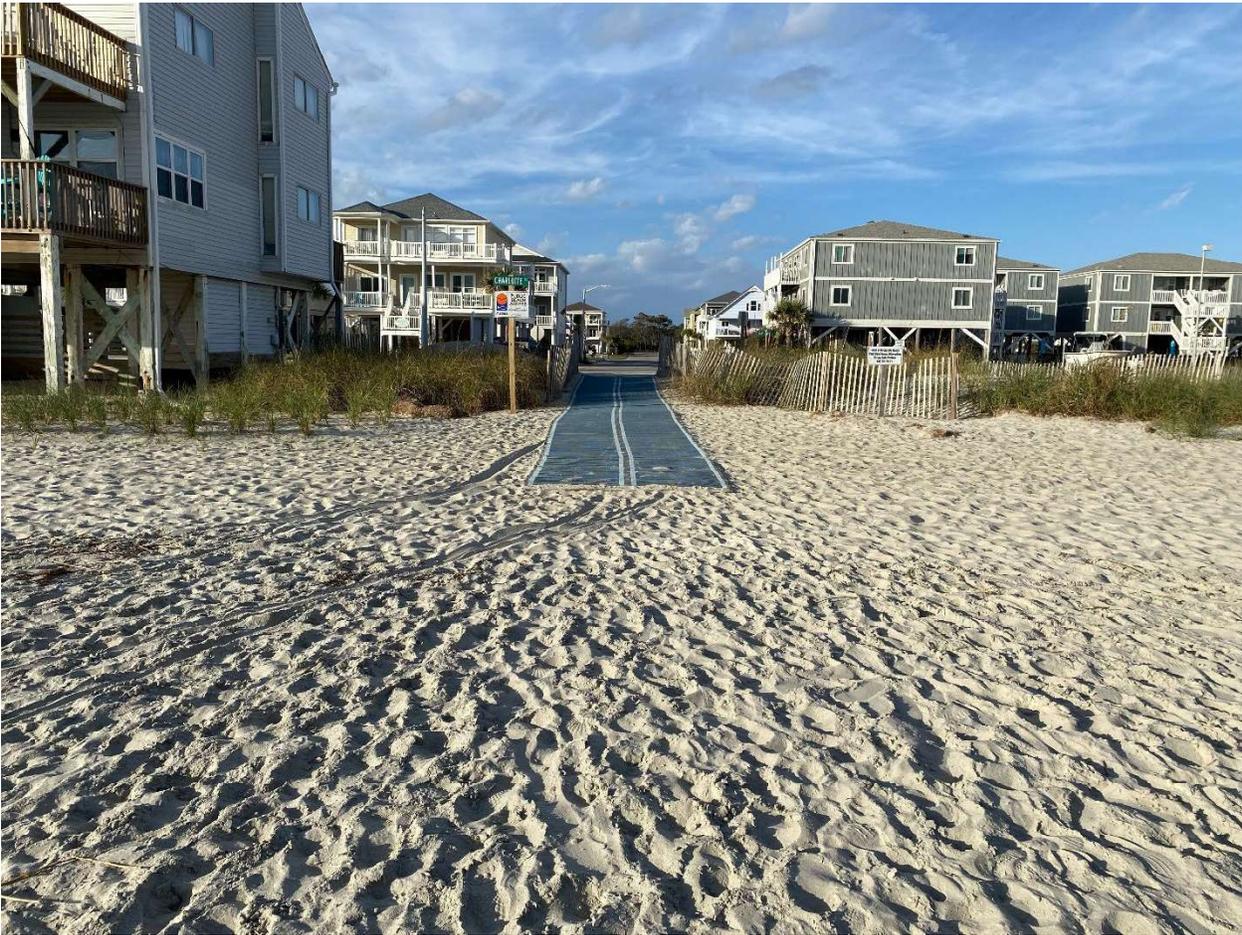
Charlotte St.

Attached is the monthly straw bale photos for November 2023. The photos were taken November 20, 2023. The temperature was 64 degrees and partly cloudy. The bales are all fully intact and most are completely covered.

Thank you for the photos and report. I was onsite November 7, 2023 and have a slightly different interpretation of the bales. Several of the ones I saw had fallen apart somewhat. They were either depressed on the top or just fallen away with the installed wooden stakes more exposed than the bales. Stakes originally were at or below half bale height. This was especially true at Shallotte Street. A casual look may have them appear to be covered but looking at the height of the bale and surrounding conditions, it seems they deteriorated. The area with the best collection was East Third Street. The bales closest to the access really weren't covered at all, but those closer to the groin were – perhaps the difference was due to the groin influence or beach angle difference due to inlet proximity. However, it is hard to compare as those bales did not seem to appear in the May photos I took. There were also random bales placed landward the frontal dune at Charolotte Street. These were not part of the original proposal. We request their removal.

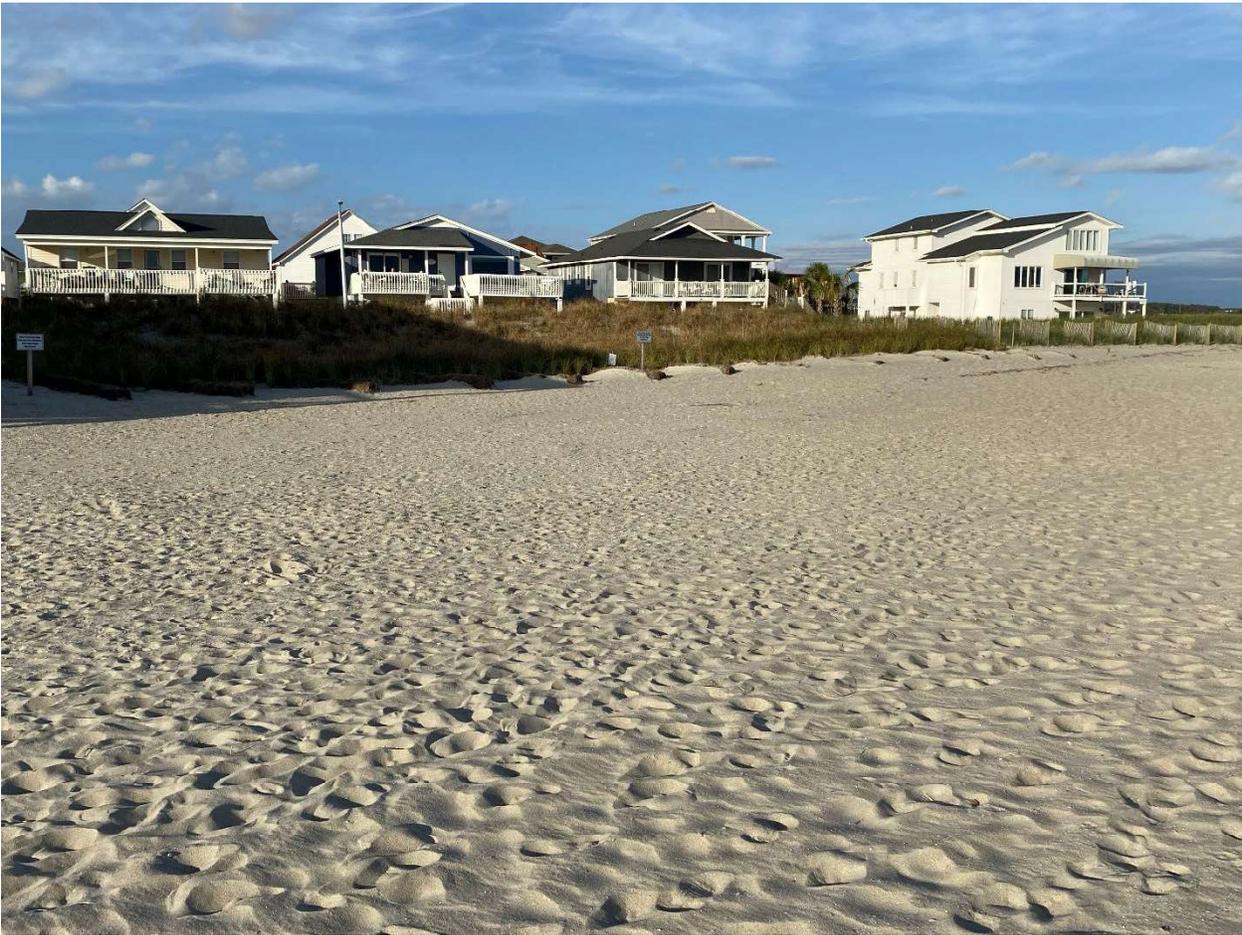
E. Third St.

We believe if the bales were allowed to be placed 2-high (similar height as sandfence), it would have reduced the chances of beachgoers walking over the bales once they became covered. The bales along E. Third Street are not adjacent to a public beach access and are not experiencing the same compression. This indicates that the bales aren't falling away. The bales along E. Third that aren't as covered are being blocked by a home adjacent to their location.

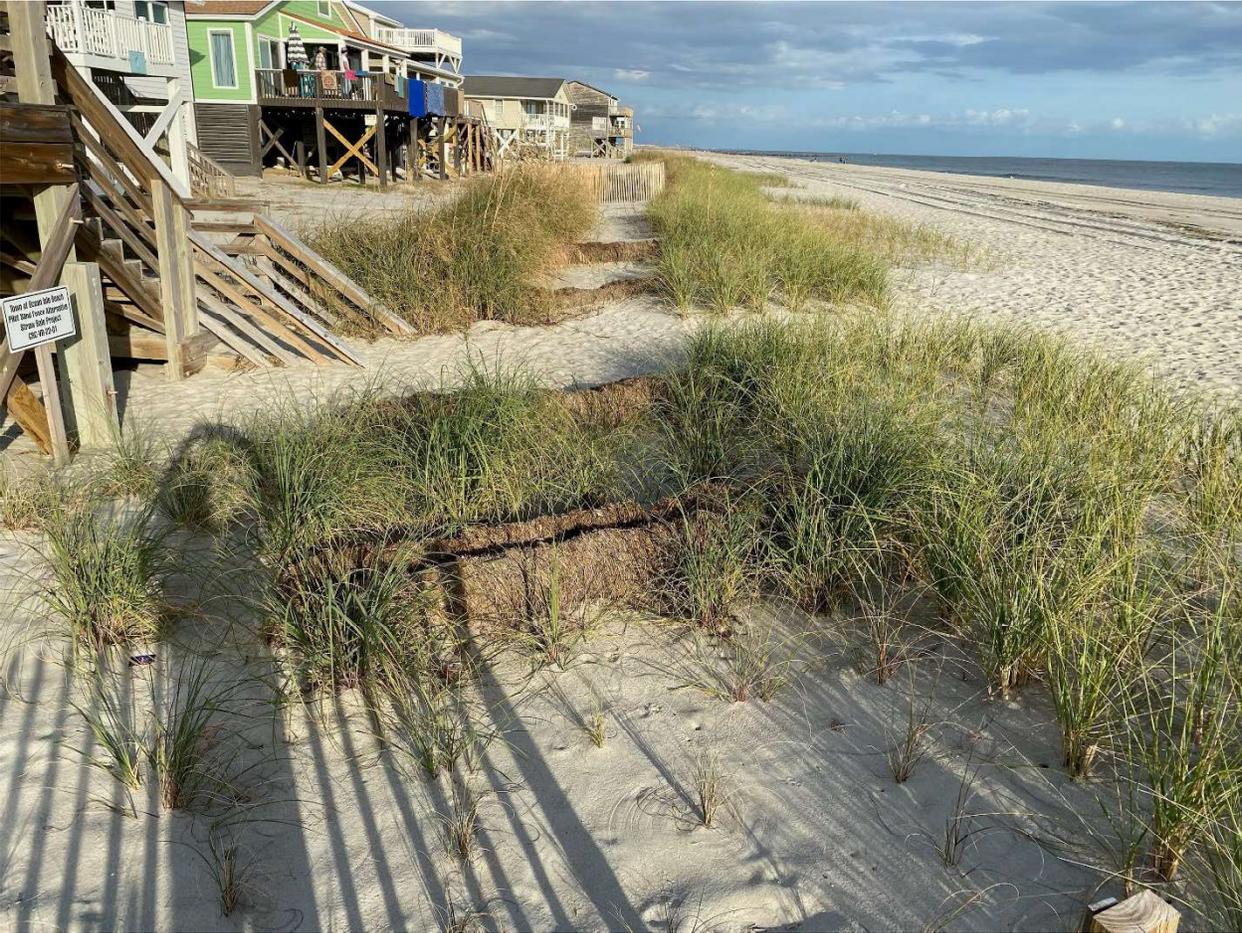
Lumberton St.

After further investigation the depressed bales near Lumberton Street appear to be because of people sitting on the bales since they have taken longer to cover due to their location landward of the vegetation. Those are ones we would like to relocate to the oceanward side of the vegetation so they can trap the blowing sand. The bales you mentioned at Shallotte Blvd. have not fallen away. We dug down and found the bale compressed. We believe that once the bales became covered that beachgoers would walk over the tops of the bales, compressing them into the sand. You can see all the footprints along and on top of the bales in the photos you submitted.

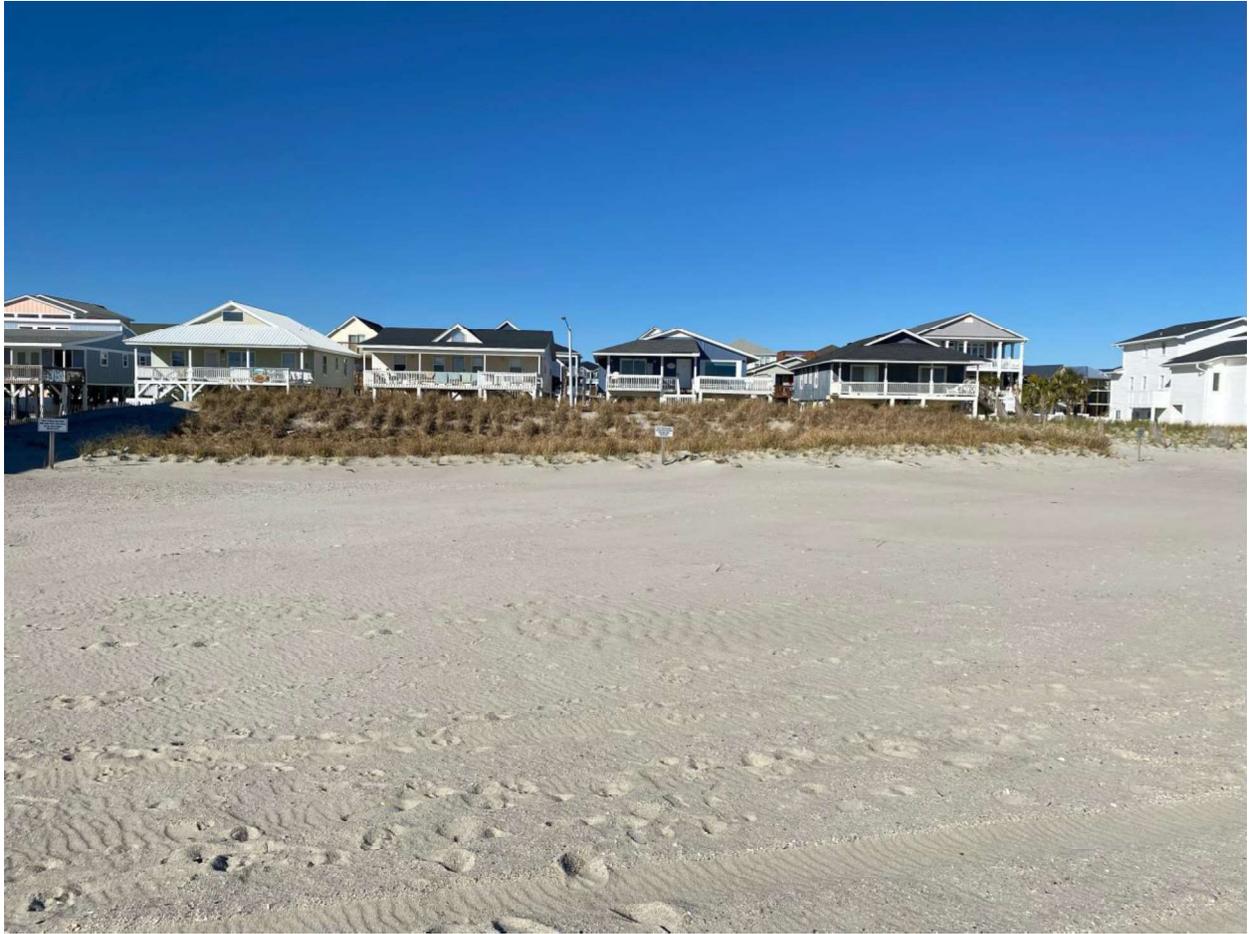
After back to back storm events in December we only have 1 remaining area of straw bales. The attached photo is from the E. Third St. location. The photo was taken January 16, 2024. The weather was clear and approximately 51 degrees.

We would like to have some discussion on replacing the bales. They were working and getting covered with sand prior to the storm events. Even though they washed away, they left no remains or debris on the beach strand.
