Subject: Response to Comments re: Shoals Club Request to Enlarge Their Sandbag Revetment

BALD HEAD ISLAND, N.C.
Beach Monitoring Program
Report No. 21
(May 2022 – May 2023)

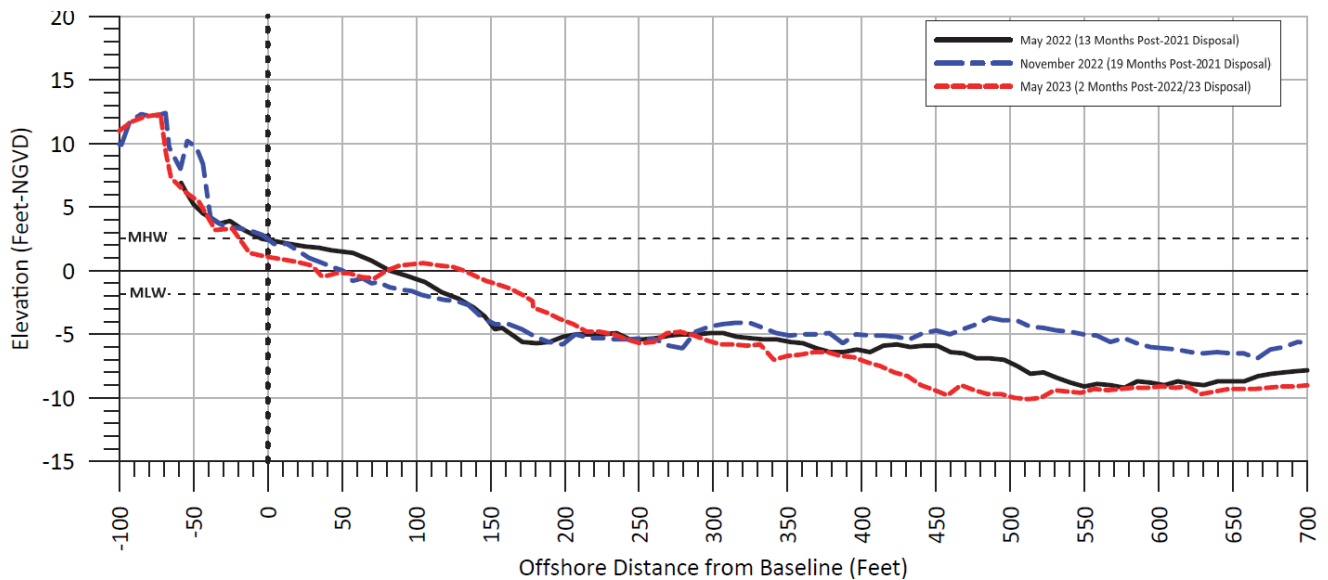
Figure 3: Beach profile B-55 from May 2022 to May 2023. Figure A-72 from Olsen (2023).

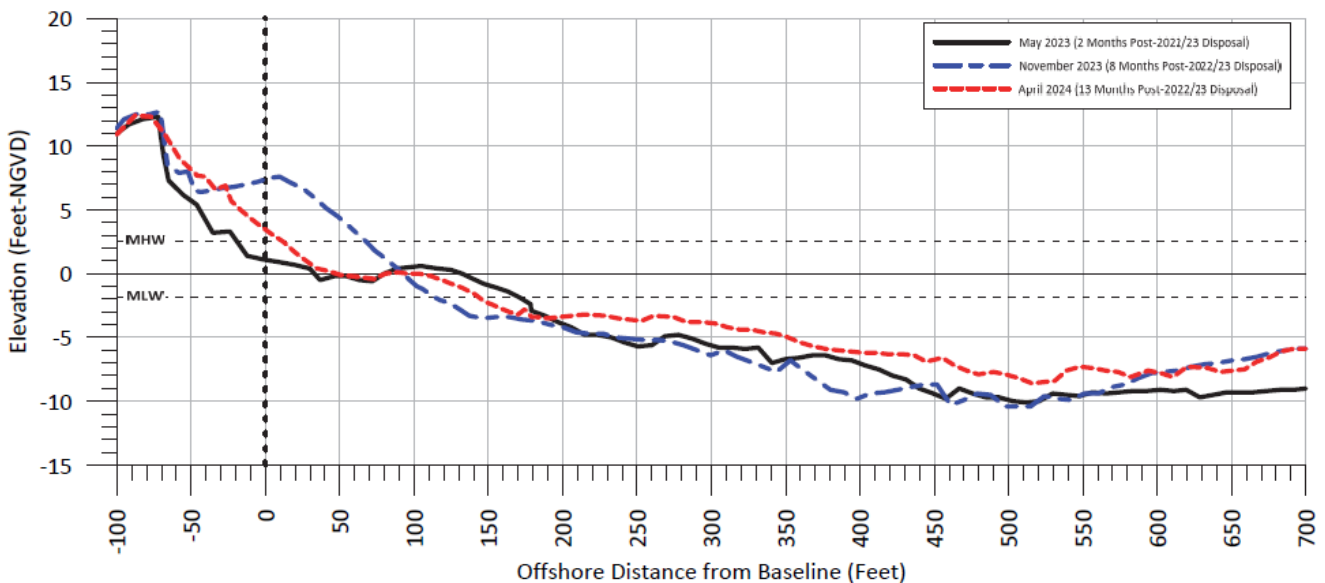
Figure 4: Beach profile B-55 from May 2023 to April 2024. Figure A-72 from Olsen (2024).

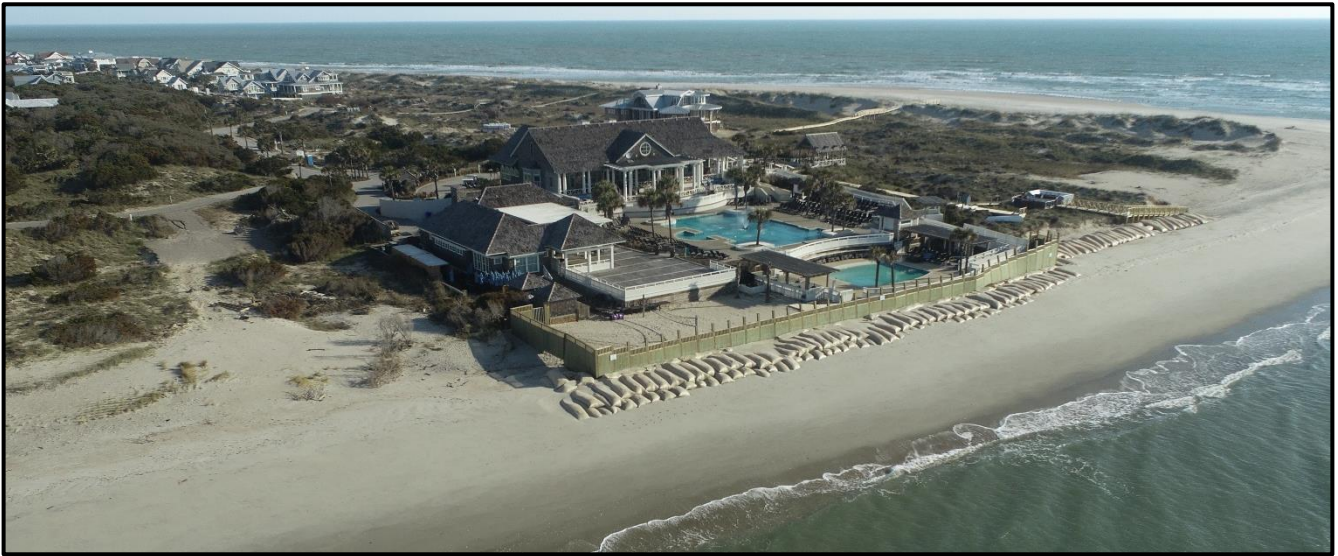
Figure 6: Drone imagery from November 1, 2022, 6-months post-installation of the sandbags. Note the height of the bags relative to the top of the wooden fence. Image courtesy of Olsen Associates, Inc.

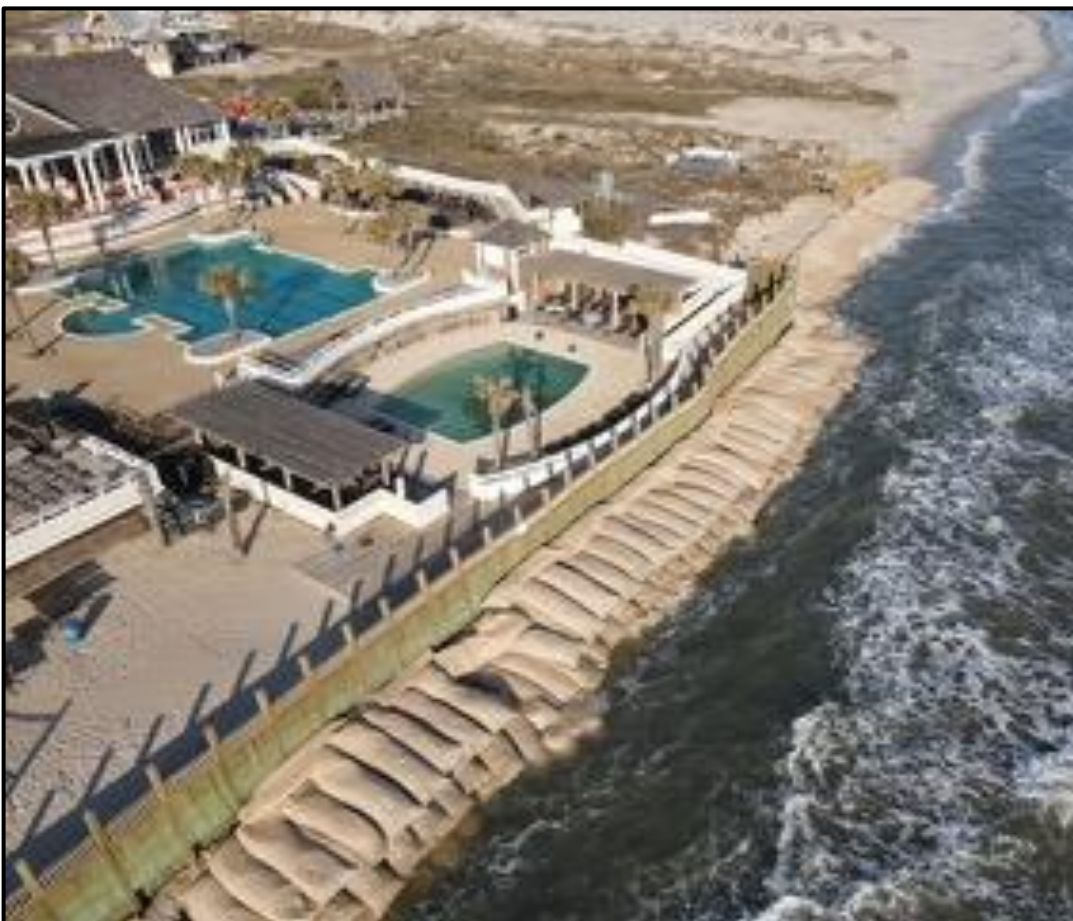
Figure 7: March 2023 drone imagery of a high-water event impacting the sandbags approximately 10-months post-installation. Image courtesy of the Shoals Club.

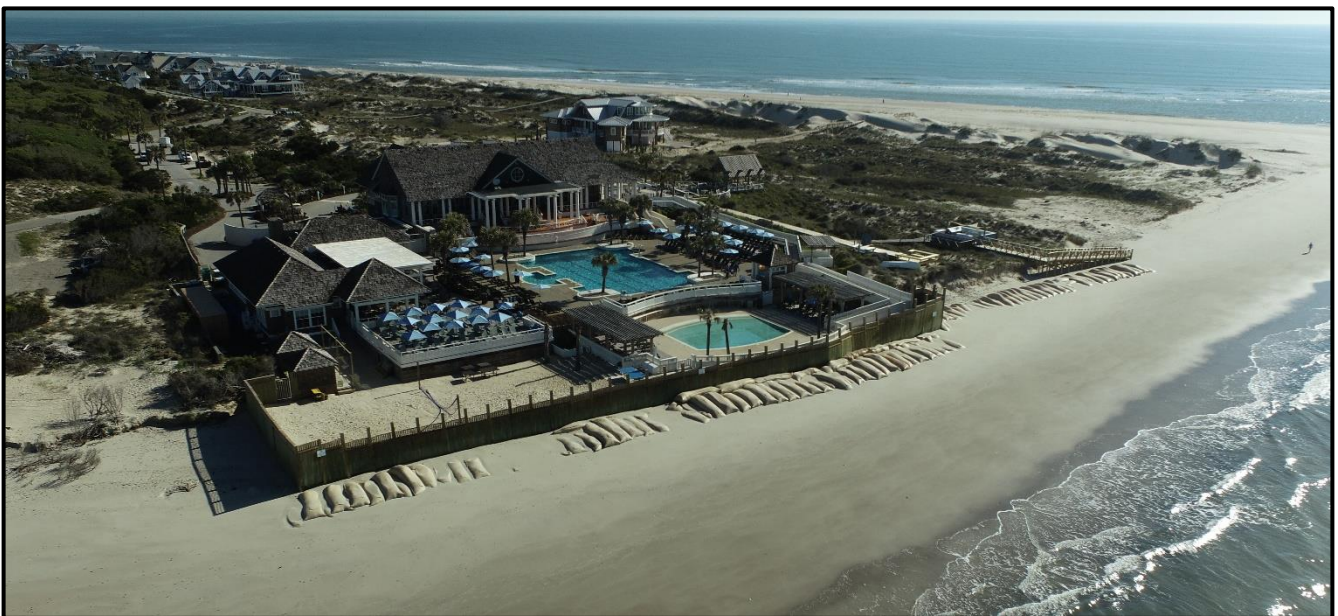
Figure 9: Drone imagery from April 13, 2023, approximately 11-months post-installation of the sandbags. Image courtesy of Olsen Associates, Inc.

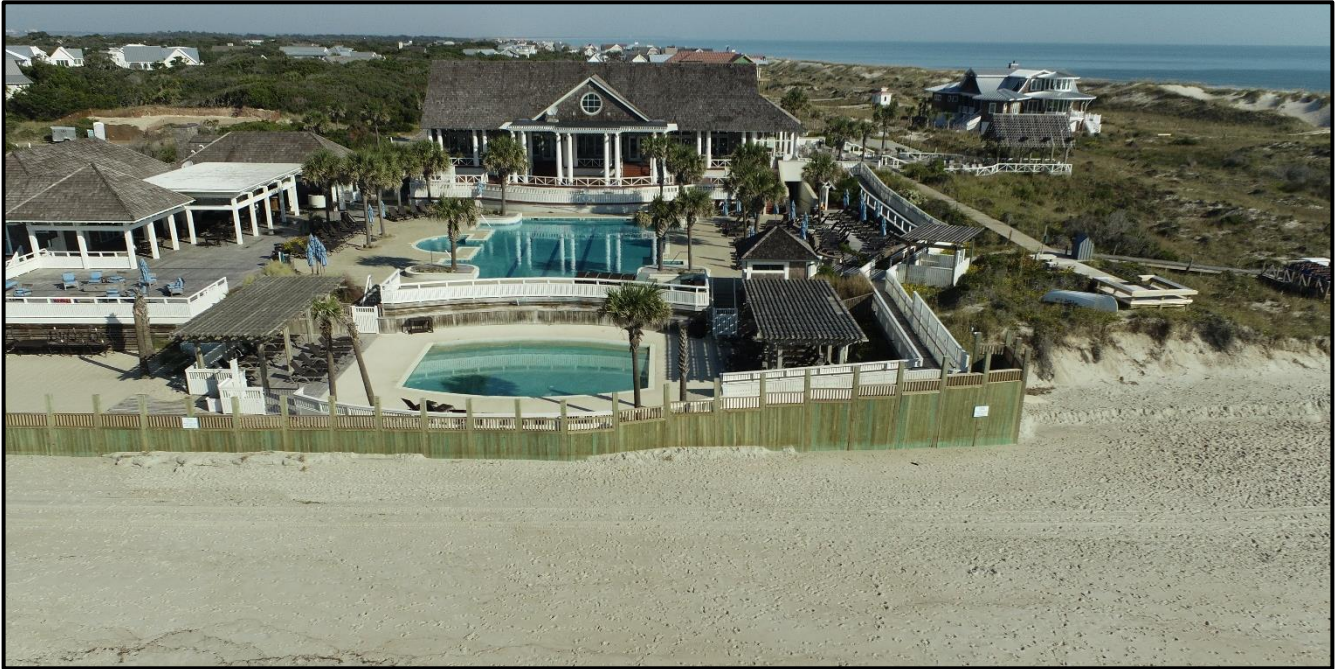
Figure 10: Drone imagery from November 8, 2023, approximately 1.5 years post-installation of the sandbags. Potential settling of the sandbags and an accretional event resulted in temporary covering of the sandbags. Image courtesy of Olsen Associates, Inc.

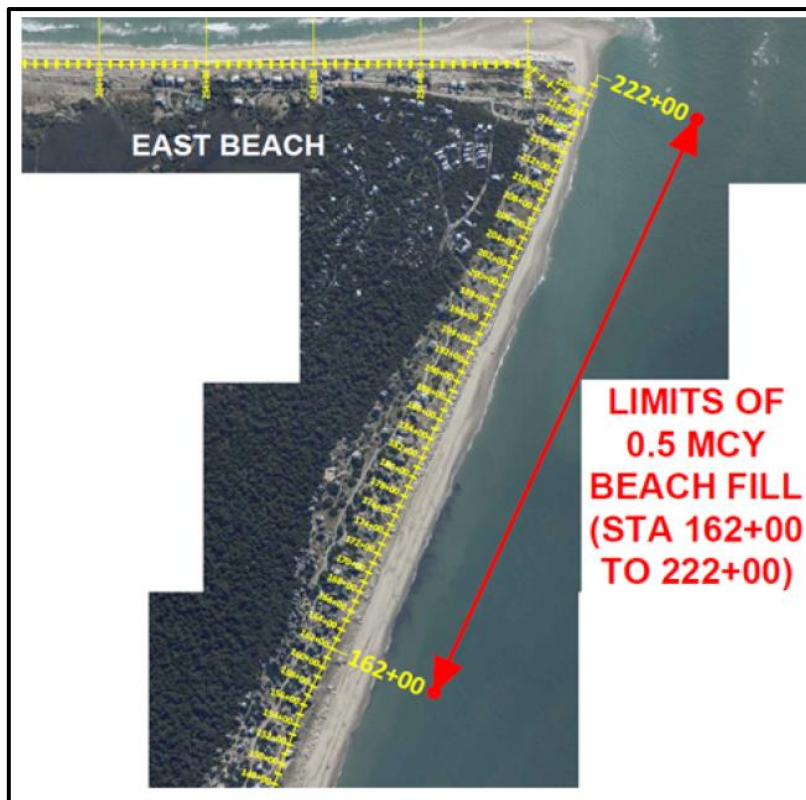
Figure 14: Original placement quantity and extents of ongoing beach renourishment project.
