WILMINGTON TERMINAL TURNING BASIN EXPANSION PROJECT COMPENSATORY WETLAND MITIGATION PLAN

October 26, 2018

Prepared for: North Carolina State Ports Authority PO Box 9002 Wilmington, NC 28402

Prepared by: Dial Cordy and Associates Inc. 201 North Front Street, Suite 307 Wilmington, NC 28401

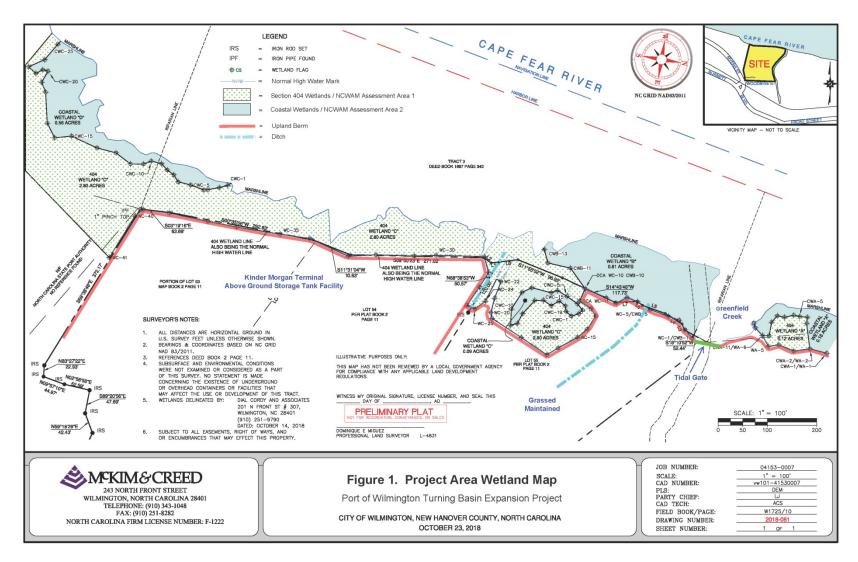
Figure 1. Project Area Wetland Map

The project area encompasses salt and brackish marshes on the contiguous tidal floodplain of the Cape Fear River (CFR) (Figure 1). The tidal marshes form a continuous fringe along the project area river shoreline that is interrupted only by the mouth of Greenfield Creek. The landward boundary of tidal wetlands within the project area is marked by an existing man-made upland berm that extends continuously along the river shoreline and ties to a tidal gate across the mouth of Greenfield Creek. The berm functions as an artificial shoreline that has effectively reduced the width of the tidally influenced floodplain to approximately 100 feet. The normal high water mark and the Section 404 wetland-upland boundary are both located along the waterward toe of the berm. The tidal floodplain encompasses a mix of relatively natural salt/brackish marshes, disturbed brackish marshes consisting of dense common reed (*Phragmites australis*) stands on shallow fill deposits, and unvegetated tidal mud flats in shallow depressional areas. The entire area waterward of the berm toe, including the common reed stands, is inundated at high tide.

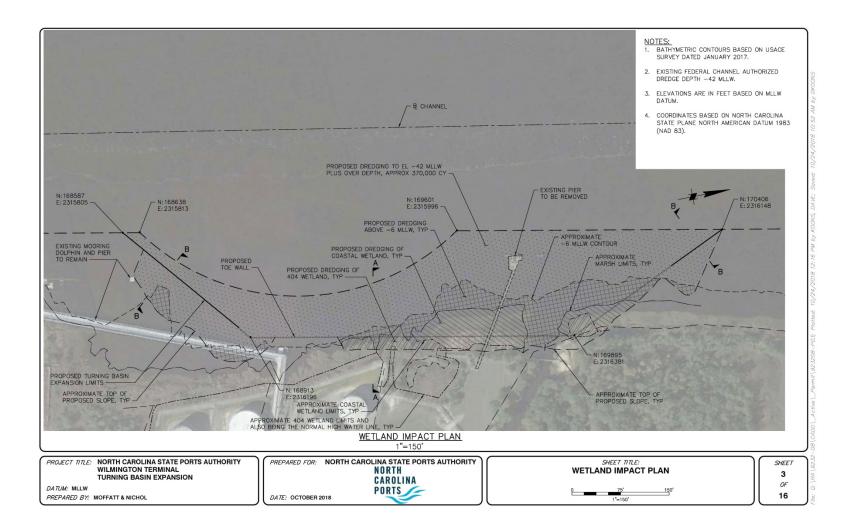
Figure 2. Wetland Impact Plan

The proposed expansion of the existing turning basin via dredging would permanently impact a total of 1.4 acres of Section 404 jurisdictional salt/brackish marsh wetlands on the tidal floodplain of the CFR, including 1.01 acres of CAMA coastal wetlands (smooth cordgrass marsh) and 0.39 acre of non-coastal wetlands (common reed marsh) (Figure 2). The 1.4 acres of wetlands would be excavated and permanently converted to subtidal soft bottom. In order to facilitate the determination of compensatory wetland mitigation requirements, a functional assessment of the affected project area wetlands was performed using the NCWAM (NC Functional Assessment Team 2016). The North Carolina Wetland Assessment Method is a rapid assessment method that is based on the evaluation of field indicators of wetland functions. The NCWAM method ultimately generates an overall wetland rating of High, Medium, or Low. Separate NCWAM evaluations were completed for two assessment areas representing the principal wetland communities and conditions within the project area. Assessment Area 1 encompasses the natural smooth cordgrass marshes on the relatively undisturbed portion of the project area floodplain, and Assessment Area 2 encompasses the disturbed common reed marshes that occur on shallow fill deposits (Figure 1). Dial Cordy and Associates Inc. conducted the field assessment on 15 October 2018 in conjunction with the delineation of project area wetlands. The NCWAM Rating Calculator v5.0 (1) was used to complete the field assessment forms and wetland rating sheets (Appendix A). Assessment Area 1 received an overall wetland rating of "High" and Assessment Area 2 received an overall wetland rating of "Low."

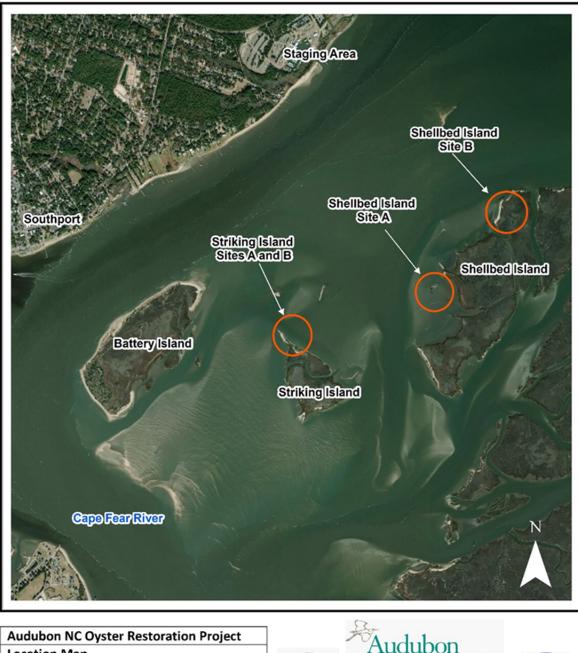
Figure 3. Proposed Location Map for Shellbed Island Site A

Overseen by Audubon staff, Shellbed Island is a natural island with a shoreline made up of oyster shell "rakes" and marsh habitat (Figure 3). Also identified as an important bird area, the island has been used as a study site for American oystercatchers where banding, band resighting, demographic studies, and censuses of oystercatchers have been conducted. American oystercatchers and laughing gulls nest here, as well as clapper rail. Non-nesting
