IV. Engineering Construction Techniques

B. Characteristics of the Five Study Site Structures

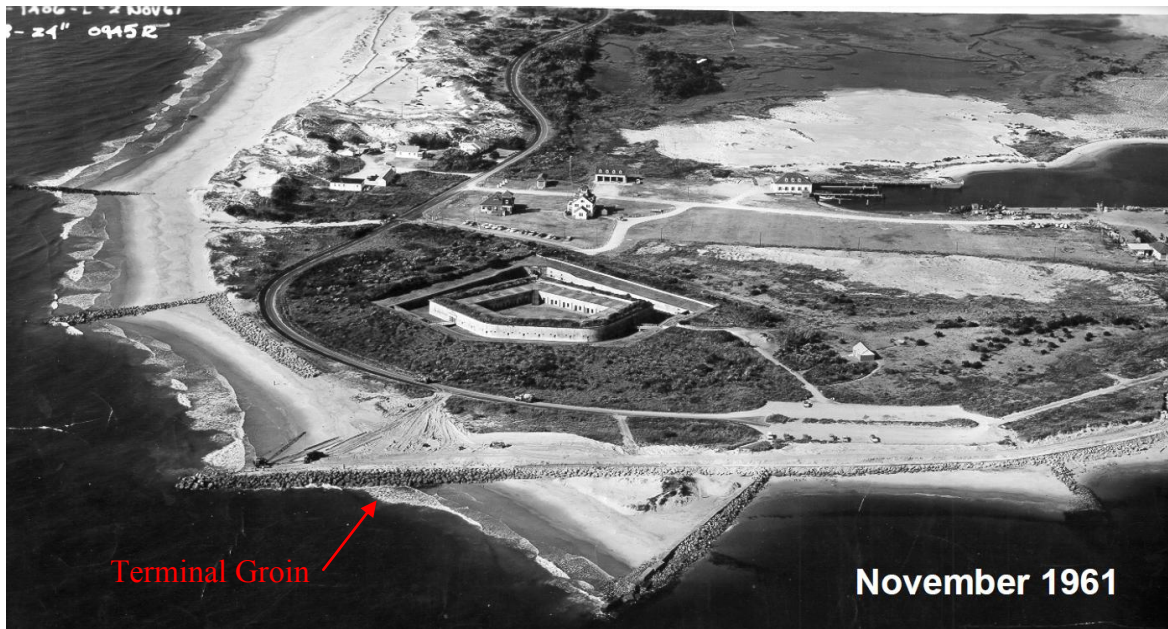
Figure IV-4. Fort Macon Terminal Groin Initial Construction (1961)

Figure IV-4 shows the layout of the Fort Macon terminal groin, revetment, and seawall, where construction was completed in three phases. The first phase began in 1961 with the construction of the seawall, revetment, and a portion of the terminal groin that was built to a length of only 720 feet due to budget constraints. This portion of the groin was built to an elevation of 6 feet and excluded the structure's top armor layer. The revetment (250 feet) and seawall (530 feet) were constructed along the dune bank starting just north of the present-day Fort Macon parking lot in a southeastern direction.

Phase two began in 1965 and extended the groin by an additional 410 feet oceanward. An additional groin was constructed west of the revetment due to extensive erosion on the sound side of the island, which was impacting the US Coast Guard station.

Phase three began in August 1970. It extended the terminal groin by an additional 400 feet to bring the total length to 1,530 feet. A 480-foot long stone groin was built near the bathhouse in an effort to stabilize beach fill placed in the area. The total erosion control measures include a revetment, seawall, a terminal groin, and seven more groins in the vicinity of Fort Macon.

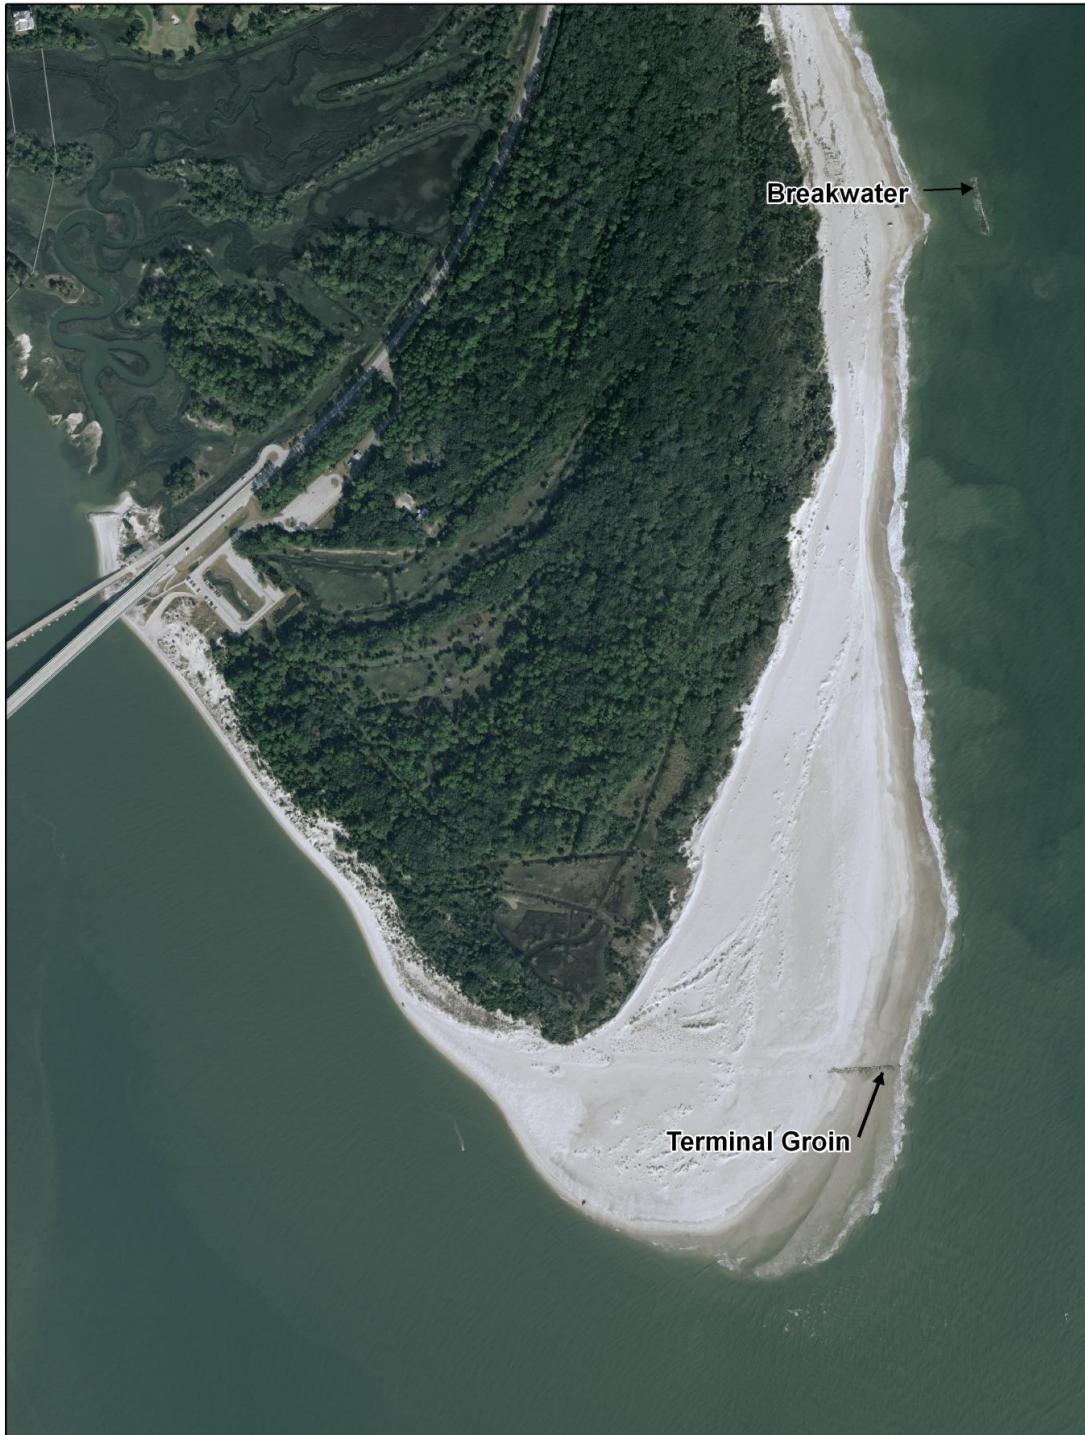
Figure IV-6. Amelia Island Terminal Groin

A unique design feature of the terminal groin was development of a sand spit on the downdrift side. The purpose of this spit is to maintain the natural littoral environment along the sound-side shoreline. The groin structure should ideally provide a template for land formation and updrift stability, while at the same time allow a large percentage of the local inlet-directed littoral transport to pass through the structure (Olsen, 2006). Recent aerial photography indicates that the terminal groin is completely inundated with sand and is essentially non-activated or allows sand to freely bypass the structure (Olsen, 2008). Figure IV-6 shows the Amelia Island terminal groin as of 2008.

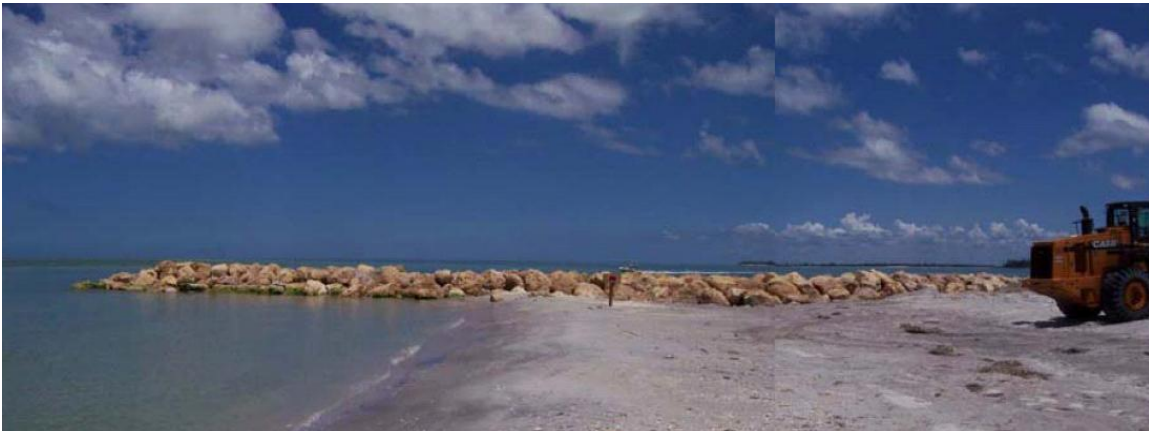
Figure IV-7. 2006 Terminal Groin at Captiva Island

Hurricane Charley, in 2004, severely damaged the groin. Between 2005 and 2006, beach nourishment and groin rehabilitation increased the stability of the beach. The groin reconstruction was completed in 2006 with 9,036 tons of limestone boulders and a total length of 340 feet. The new armor layer unit sizes ranged between 2 to 7 tons (Hagerup, 2006 & Coastal Planning & Engineering, Inc., 2008). Figure IV-7 shows the 2006 reconstructed groin. Figure IV-8 shows the Captiva Island terminal groin in 2008.

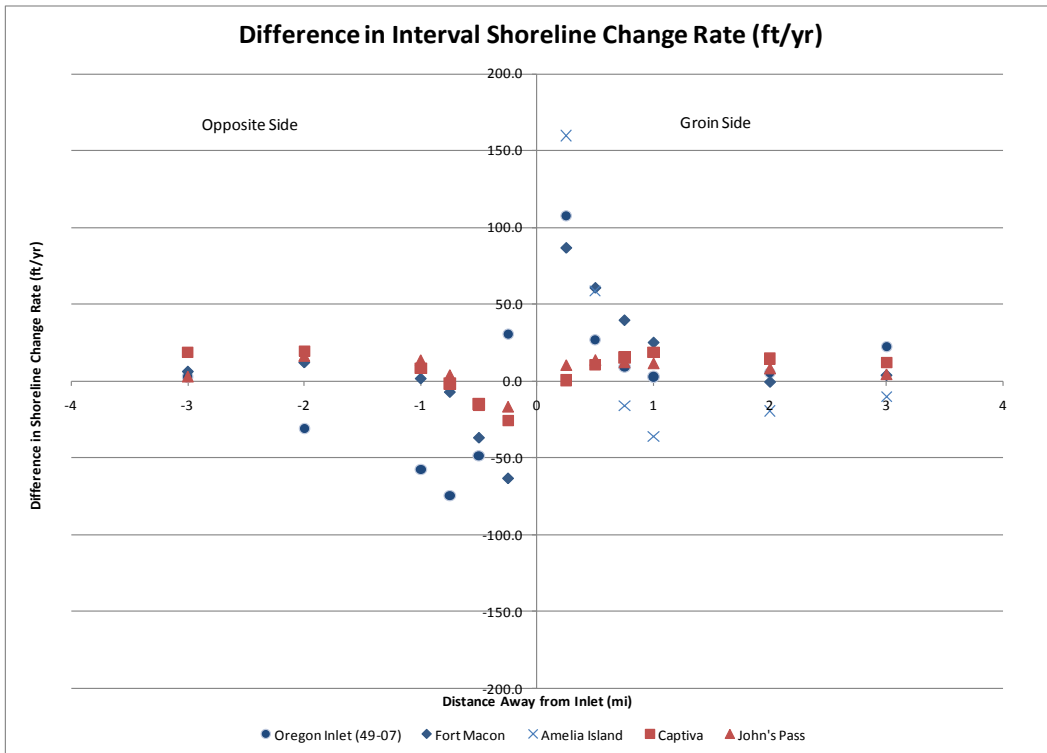
The first factor investigated as part of the study was groin length. For each of the five sites, the difference between pre and post conditions were computed for the following over a distance of 3 miles: the shoreline change, overall volume change, and the volume change with nourishment removed. These factors were then plotted both as a cumulative total and individual intervals for both sides of the inlet. Note that the effective length (perpendicular to shoreline orientation) of the Oregon Inlet terminal groin was estimated to be approximately 1500 ft) and that the time periods of 1949-1980 (pre) and 1997-2007 (post) were used for this analysis of Oregon Inlet. Table IV-5 shows the individual groin lengths calculated. Figure IV-11 through Figure IV-13 show the results for the cumulative totals. Figure IV-14 through Figure IV-16 shows the results on an individual interval basis. Note that the results for the longer groins (~1500 ft) are shown in blue while the results for the shorter groins (~350-460 ft) are shown in red.

As can be seen in the above graphs, on the structure side of the inlet, the shoreline change rate is lessened more over the entire 3 mile length with a longer groin than with a shorter one. It is also apparent that the greater reductions with longer groins are seen immediately adjacent to the structure and that the reductions appear to converge the further away from the structure. When looking at the volume changes, the same behavior can be seen. It is very interesting to note that there appears to be a point of diminishing returns with length especially once the nourishment effects are removed. It is also interesting to note how the “leaky” structure at Amelia Island appears to be allowing a significant portion of sediment to pass through the structure with the majority of the groin’s impacts being felt within the first 0.5 mile from the structure. Also, while the cumulative behavior of the shorelines and volumes follows a distinct pattern, the interval plots do not show as clear of a trend. While still showing mostly positive impacts, there is one data point for Fort Macon and a few for Amelia Island that show a negative impact. However, it is believed that the impacts at Amelia are clouded by the equilibration of the recent large nourishment project that was completed recently. Lastly, it should be noted that the volume change rates listed above do not have the potential effects of dredging included.

Based on the above graphs, the longer structures appear to have a more pronounced effect on the opposite side of the inlet. However, it is important to note that these values were not adjusted for the dredging impacts which could be substantial and explain these apparent effects. The geologic considerations at these inlets could also explain these trends (especially Oregon Inlet). While only a few data points, they reveal the importance of the scale of these structures in relation to the other sediment transport drivers.

As can be seen in the previous figures (Figure IV-11 through Figure IV-16), the trends are very similar on the structure side of the inlet with the shoreline change rate being lessened more over a 3 mile length with a higher groin than with a lower one which makes intuitive sense. When looking at the volume changes, it is very interesting to note that there appears to be a point of diminishing returns with height especially once the nourishment effects are removed.

When investigating the opposite side of the inlet, it appears that trends are again similar with higher groins having the potential for more effects than a lower one. However, it is again important to note that these values were not adjusted for the dredging impacts which are substantial at the higher groin sites (Oregon Inlet, Fort Macon-Beaufort Inlet).

The last factor investigated as part of the study was groin permeability. Since all of the terminal groins (except Amelia) were built with a dense core, the above graphs were also investigated by looking at the results for Amelia. Based on the above graphs, the results for Amelia show almost no effect on shorelines more than 1 mile updrift of the structure. In fact, the volume changes were negative (but likely due to the recent nourishment equilibration) past the 1 mile distance. Only by looking at the detailed results was it determined that the “leaky” structure showed shoreline and volume change benefits within the first 0.5 mile updrift of the terminal groin.

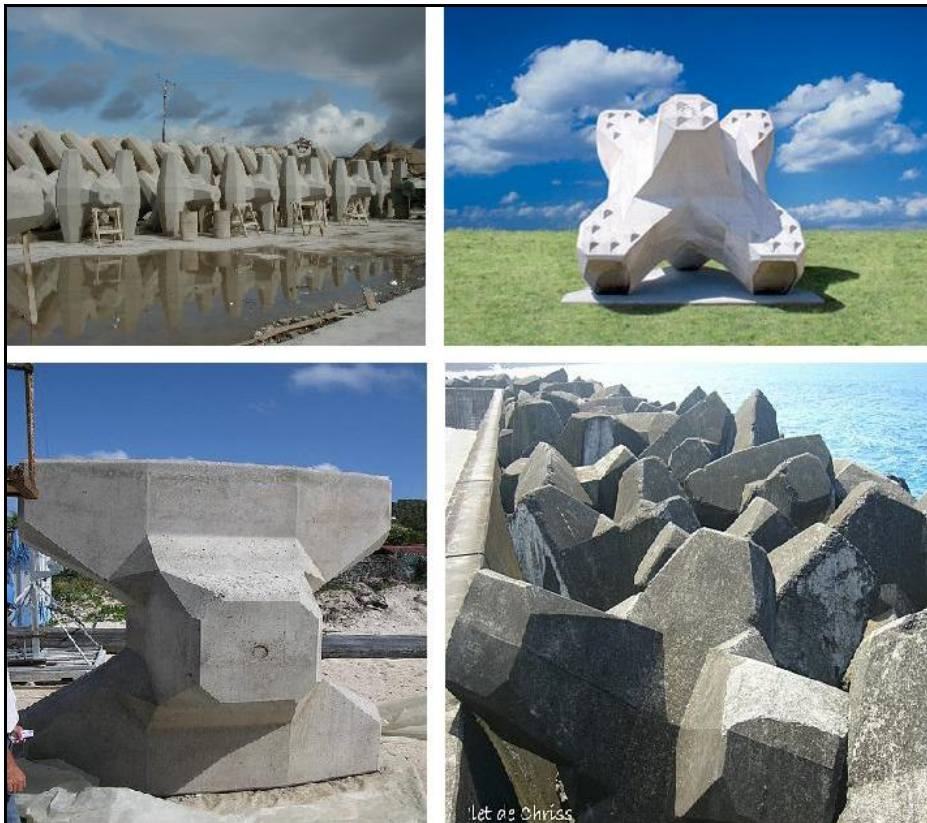
Figure IV-21. Examples of Concrete Armor Units

Concrete armor units are man-made concrete objects designed to resist the action of waves on coastal structures. The armor units are applied in a single layer. The performance of these units greatly depends on accurate positioning of the individual blocks to enable the full interlocking potential. Specific placing must be strictly maintained during construction to ensure stability of the armor layer. Breakage can occur if the units are not installed properly (Boorman, 1996; Bunker, 1996; & USACE, 2002). Figure IV-21 shows some examples of different concrete armor units.

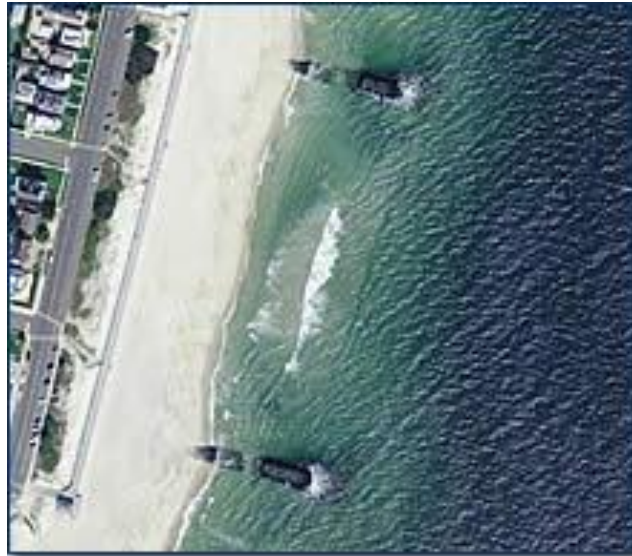
Figure IV-25 Example of Notched Groins (New Jersey DEP Website)

When long groins have detrimental effects on the downdrift beaches, groin notching can be an alternative to removal of the groin. Groin notching, or removal and lowering of a portion of the groin just seaward of the beachfill design template, is designed to help maintain a straighter shoreline and provide the needed littoral transport downdrift of the groin. Another advantage to groin notching over removal is leaving existing marine habitats intact (Bocamazo, 2003).

Notched groins have recently undergone laboratory and field tests conducted by the US Army Corps of Engineers (USACE). Trial notched groins have been implemented by USACE along the southern New Jersey shore (Figure IV-25). Tentative conclusions show that notches in the swash zone are the most efficient. However, notching a groin in the swash zone may not be successful depending on how and at what rate sediment typically moves along the shore. Notches located in the surf zone are less efficient and can create strong rip currents which are hazardous to swimmers. Surf zone notches may actually move sediment further from shore (USACE, 2002).
