North Carolina Coastal Resources Commission

FINAL REPORT TERMINAL GROIN STUDY

March 1, 2010

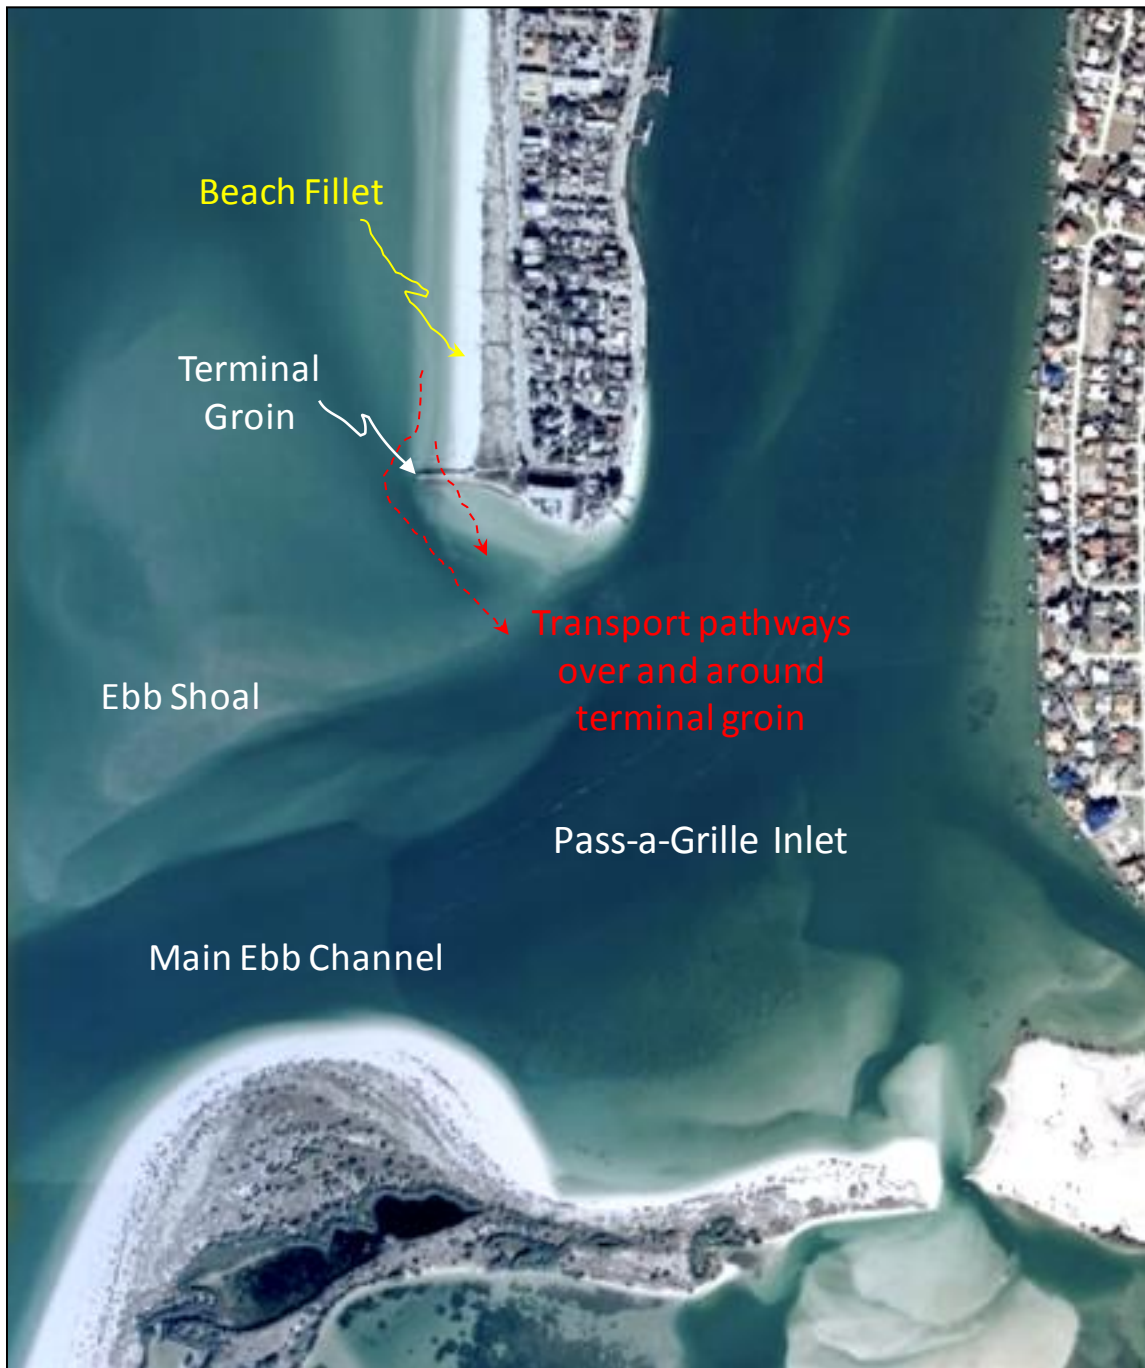
Figure II-1. Terminal Groin at Saint Pete Beach, Florida

Terminal groins are structures built at the end of littoral cells to reduce shoreline erosion and conserve sand along the end of beach or barrier, usually consisting in part of nourishment sand. They extend into the nearshore zone and act as a dam to the longshore transport of sediment and are usually constructed at the downdrift end of a barrier on the updrift side of a tidal inlet. However, due to wave refraction around the ebb tidal delta, which causes sand to enter the channel from both sides of the inlet, terminal groins have been built on both sides of an inlet. Jetties are built to prevent sand in the littoral zone from entering the inlet channel and to help maintain navigation depths of dredged channels. Although terminal groins trap sand, they are dissimilar to a jetty, because once the terminal groin fills with sediment (beach accretes to the end of the groin and is called a *fillet*), additional sand bypasses the structure and enters the nearshore and/or the tidal inlet (Figure II-1). The proper design of a terminal groin permits the longshore transport of sand around and over the structure once the beach has accreted to the end of the groin. Commonly, terminal groin construction is done in combination with beach nourishment so that the groin does not capture existing sand reservoirs. During high wave energy events, the beach along the fillet often erodes and the sand is mobilized. Once depositional wave conditions return and the normal longshore transport system is reestablished, the fillet is reconstructed.

Although most terminal groins are designed primarily to help stabilize a length of oceanfront shoreline, a sometimes overlooked consequence when the structure is built on the downdrift side of the inlet, is the stabilization of the inlet by preventing migration of the inlet channel. The groin inhibits erosion of the side of the channel by tidal currents and thus the inlet is not allowed to migrate.

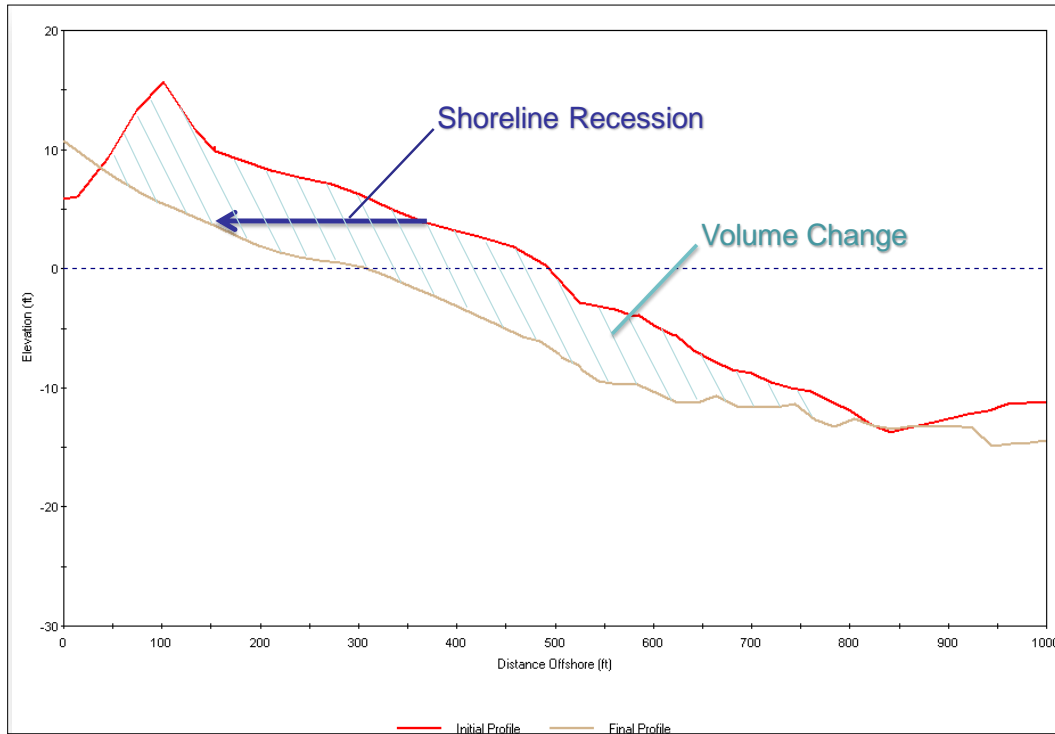
Figure II-3. Shoreline to Beach Volume Change Relationship

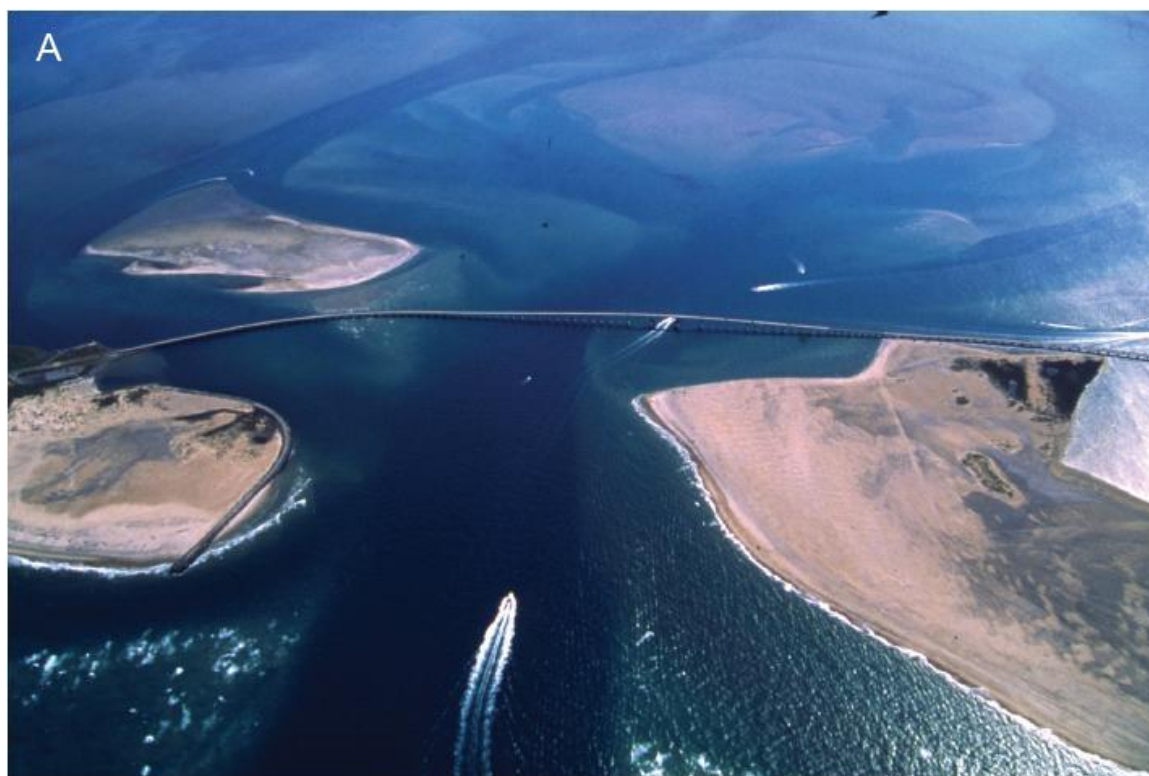
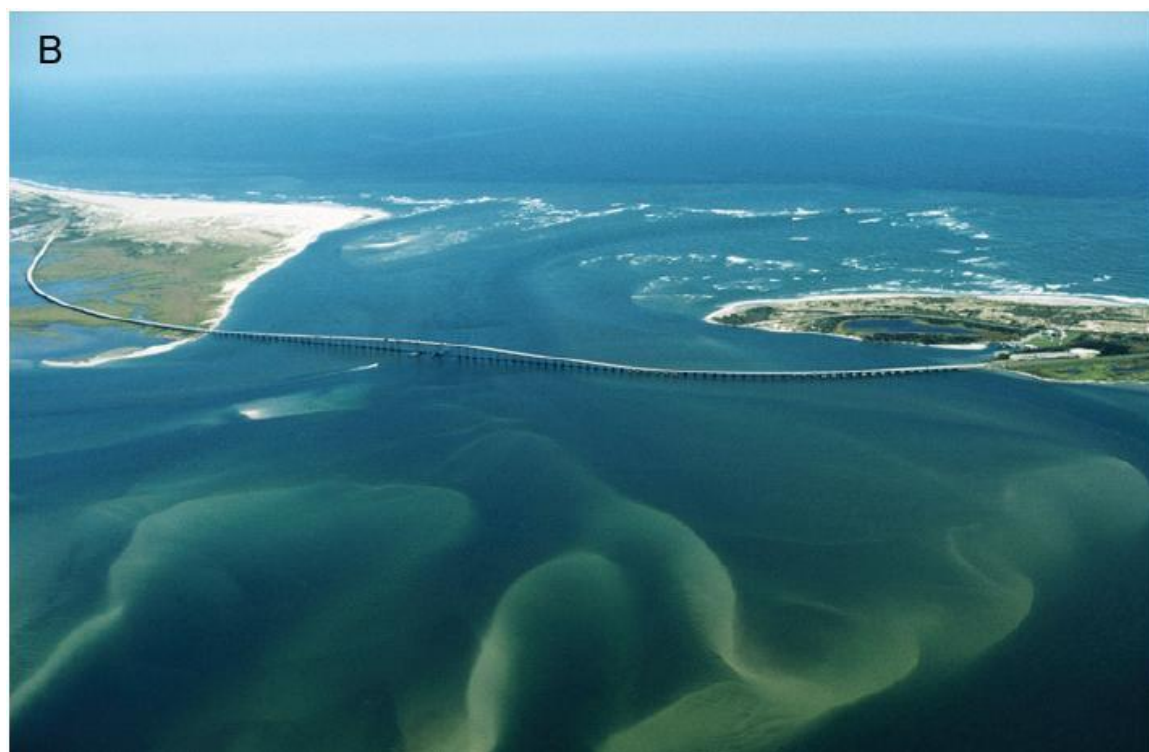
Figure II-5. Aerial Photographs of Oregon Inlet A. Looking Landward (Photograph from Ramanda, Nags Head) and B. Seaward (Photograph by D.A. Harvey)

A 2.4 mile long bridge (Bonner Bridge) connecting Bodie Island to Pea Island was completed in 1963. By the 1980's the southerly migration of Oregon Inlet resulted in a deepening of tidal channels beneath the bridge, which exposed support pilings costing millions of dollars in bridge repairs. Eventually erosion of downdrift Pea Island threatened to separate the end of the bridge from the island, so to prevent this foreseeable disaster, a 3,125-foot long rubble-mound revetment and terminal groin were constructed at the northern end of Pea Island. The revetment wrapped around to the backside of the island and terminated at the Coast Guard facility. The groin projected slightly northward into the inlet and extended seaward to a position parallel to the northern end of Pea Island. The terminal groin was constructed to protect the southern end of the bridge and prevent further southerly migration of the tidal inlet.

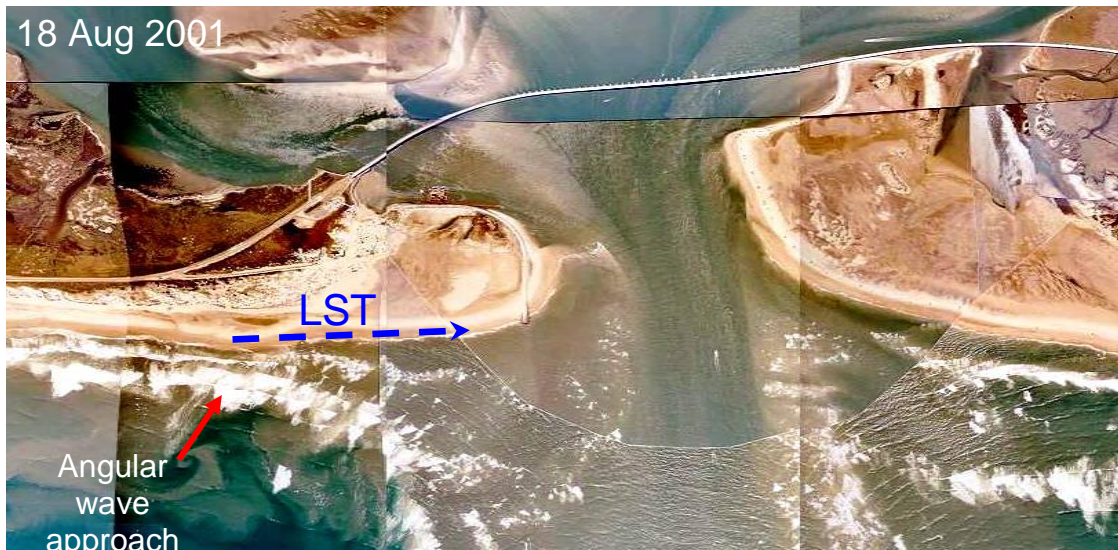
Figure II-12. 2001 Aerial Photograph of Oregon Inlet Showing Wave Refraction Around Ebb Delta Producing Northerly Transport Along Pea Island Feed Sand to the Fillet Region. Note the sand that has moved past the groin and constructed a beach along the inlet shore

This same morphology is observed in a 2001 photograph of the region (Figure II-12). This photograph demonstrates that after the beach accretes to the end of the groin, additional longshore transport of sand toward the inlet moves around the groin (as well as over and through the groin during elevated tides and high wave energy events) and is deposited along the inlet shoreline. It should also be noted that sand is also sequestered at the northern end of Pea Island as a consequence of storm overwash into the fillet region. Beach sand blown into the back dunal area also adds to the sand reservoir in this region.

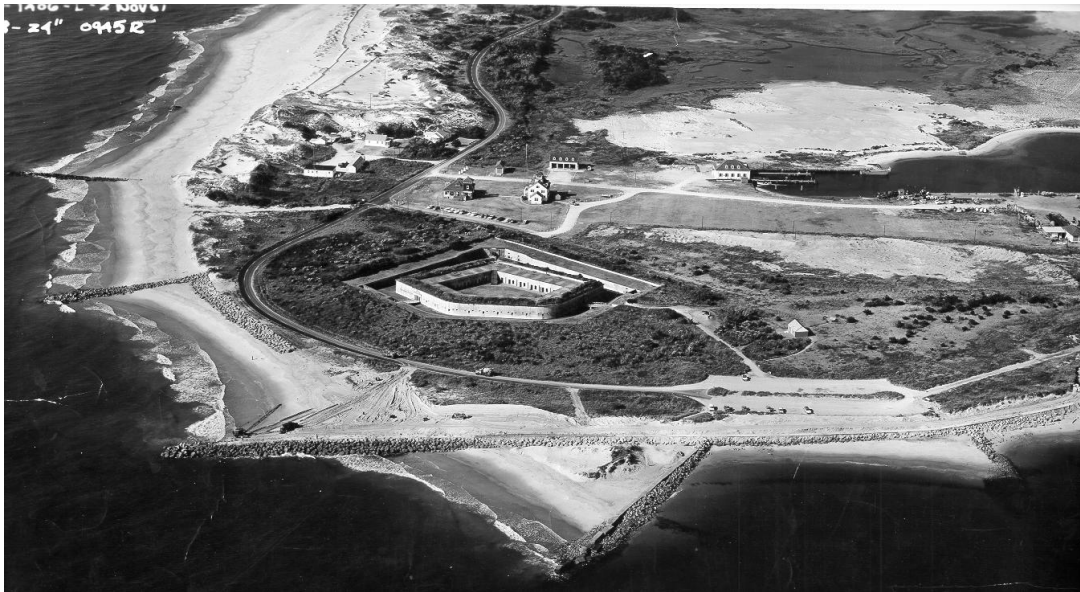
Figure II-24. Fort Macon Revetment-Groin Protection (1961)

Macon. He recommended that stone groins be constructed. By 1845 a total of six stone groins were built around the fort which protected the shore for almost 40 years (Paul Branch, <http://www.clis.com/friends/default.htm>). In 1906-11, the Army Corps of Engineers dredged the channel through Beaufort Inlet to a 20-foot depth, which today is dredged to 47-feet for navigation into Morehead City Harbor. Hurricane Hazel in October 1954 did considerable damage to the beach around the fort and erosion problems worsened. In 1961, a stone seawall and groin system was begun (Figure II-24). Later in 1968 the terminal groin was constructed by extending one of the existing groins. It was further extended in 1970 to its present size.

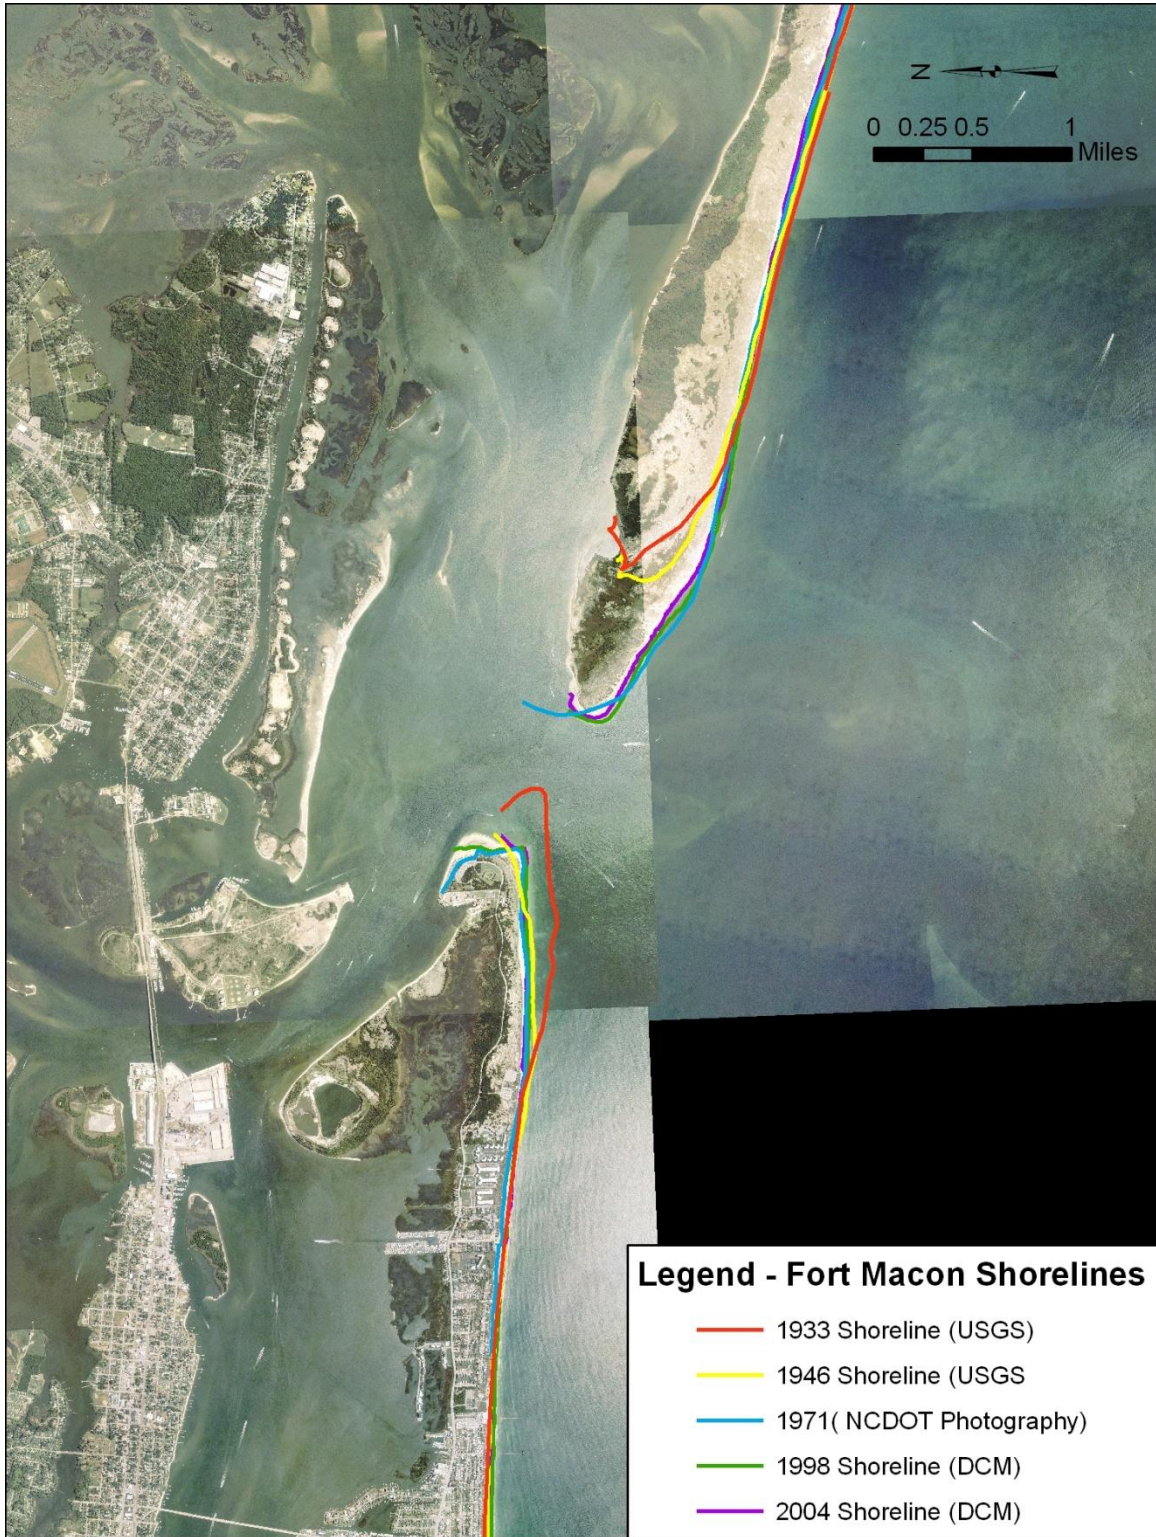
Figure II-32. Historic Shorelines – Fort Macon (Beaufort Inlet)

The shoreline impacts of the terminal groin at Fort Macon on the western side of Beaufort Inlet are assessed by examining the shoreline change prior to, and after, construction of the structure. Historical shoreline data was obtained from the NC Division of Coastal Management (DCM). The differences in shoreline position were calculated at 50 m (164 ft) transects along the shore for a distance of three miles to either side of the inlet. Shoreline data sets selected were chosen which extended three miles to either side of the inlet and to cover the pre-structure and post-structure time periods. Figure II-32 illustrates the shoreline data used in the analysis.

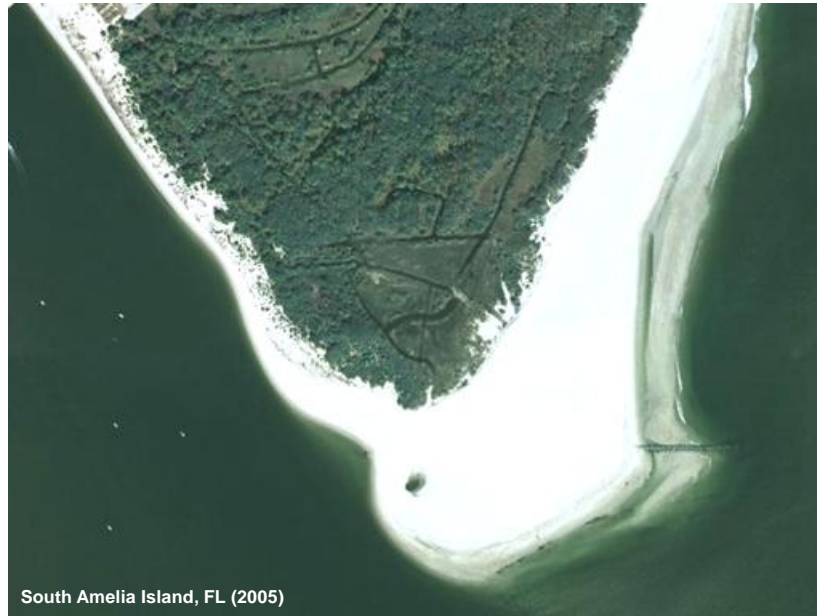
Figure II-40. Amelia Island Terminal Groin

During the summer of 2006, additional sand was placed between the breakwater and terminal groin by the USACE (Jacksonville District). The sand was sourced from maintenance dredging in the nearby Nassau Sound segment of the Intracoastal Waterway west of the bridge.

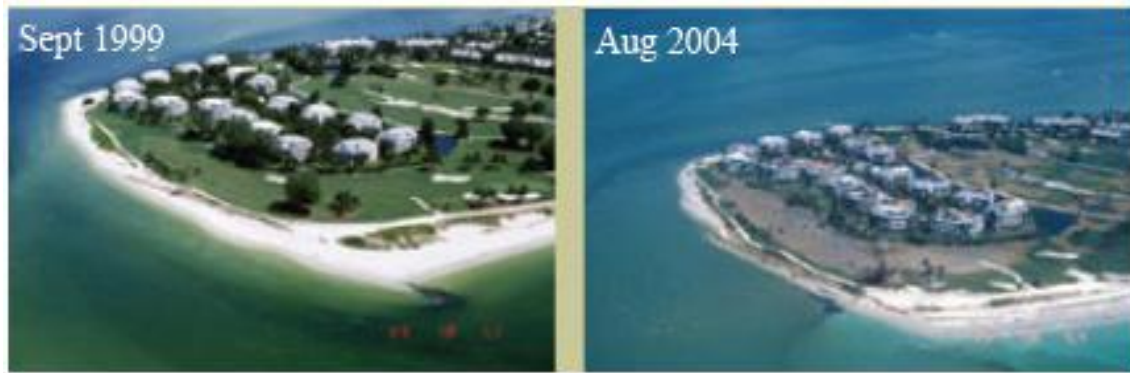
Figure II-59. Comparison of Photographs Taken Before and Immediately After the Passage of Hurricane Charley Showing Beach Erosion Inside the Inlet

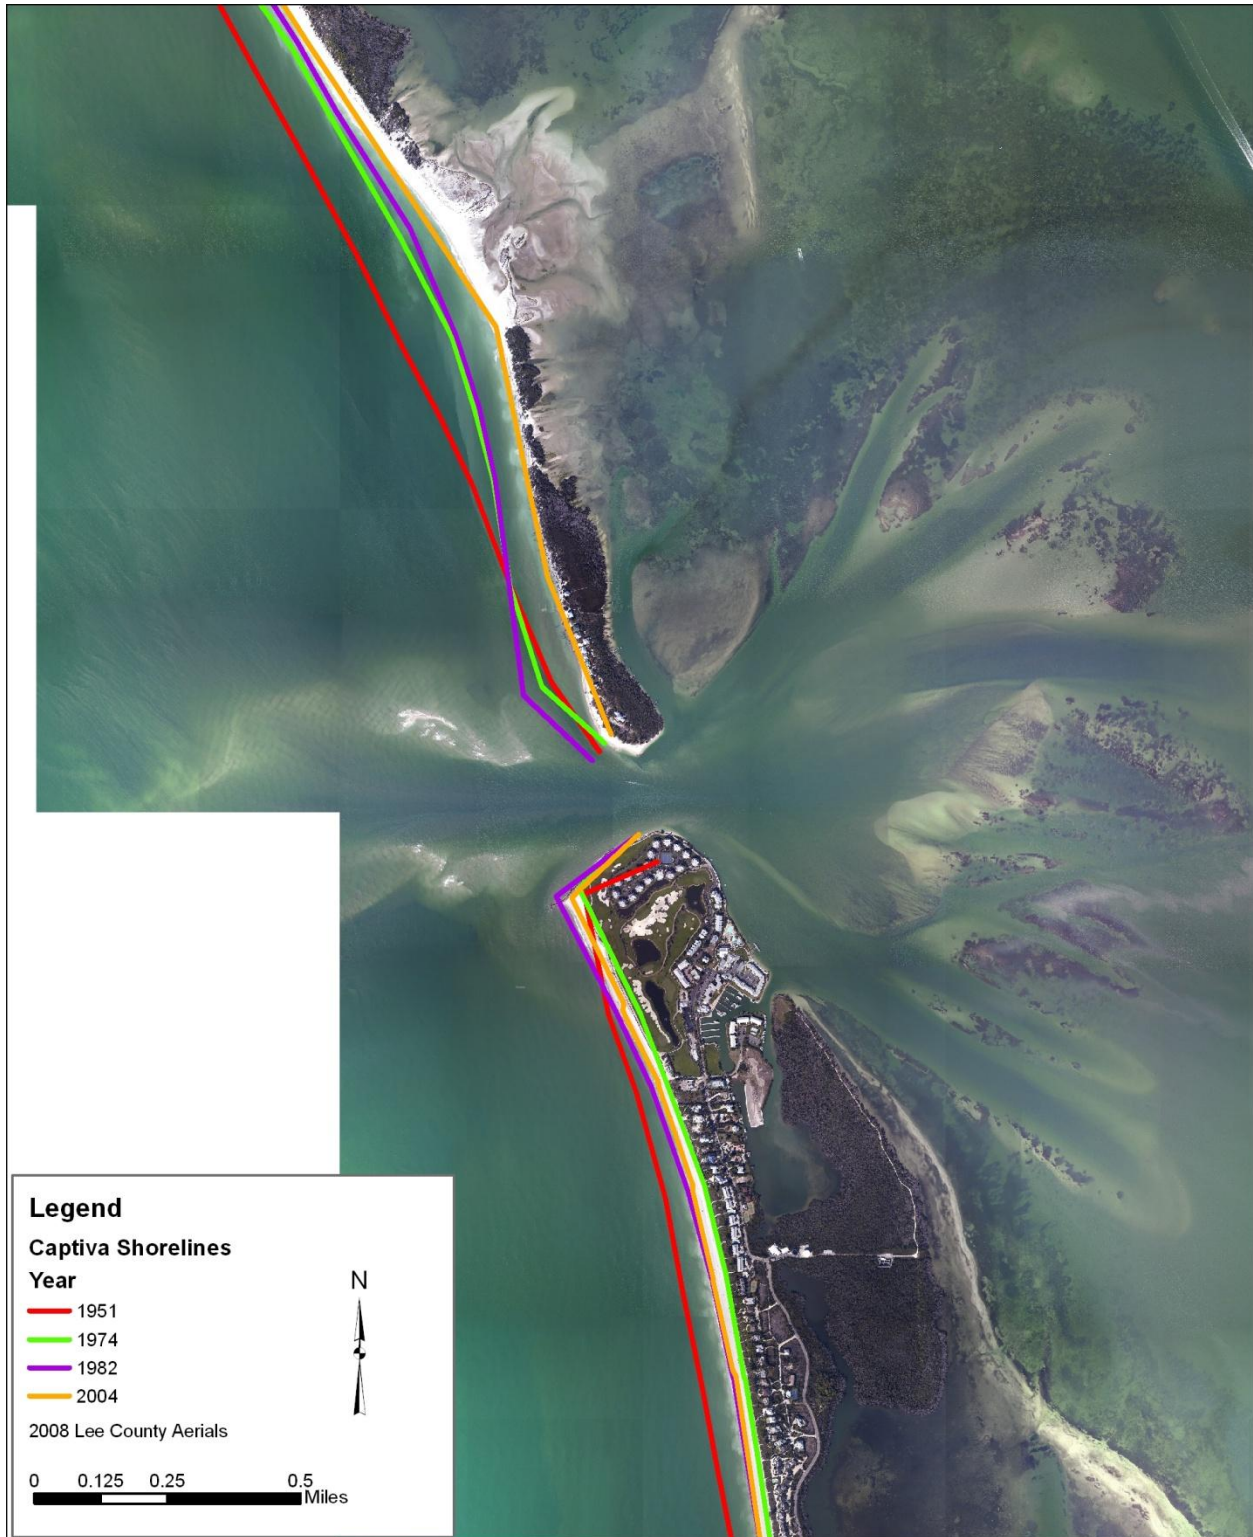
Figure II-60. Historic Shorelines – Captiva Island

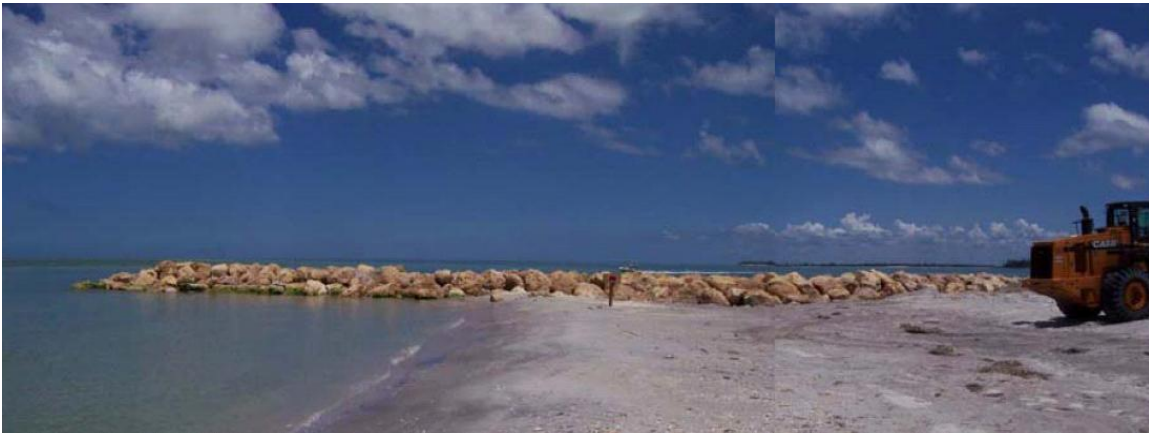
Figure IV-7. 2006 Terminal Groin at Captiva Island

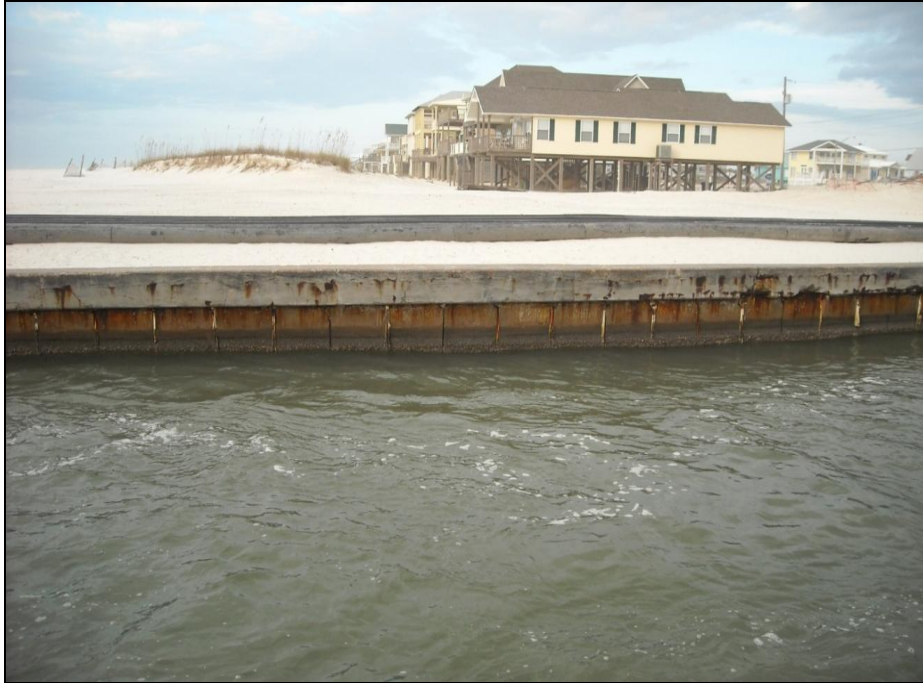
Figure IV-20. Example of Concrete Sheet Piles

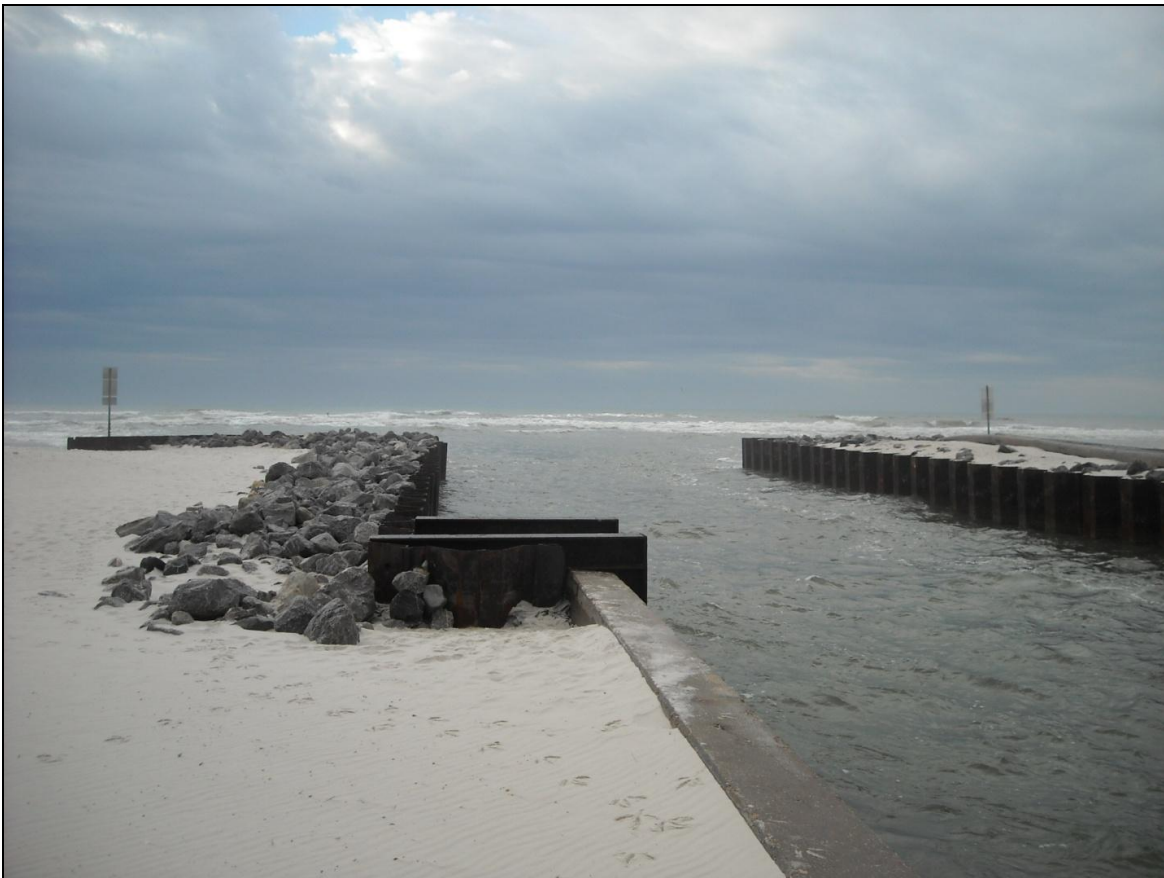
Figure IV-22. Example of Steel Sheet Pile Terminal Groin

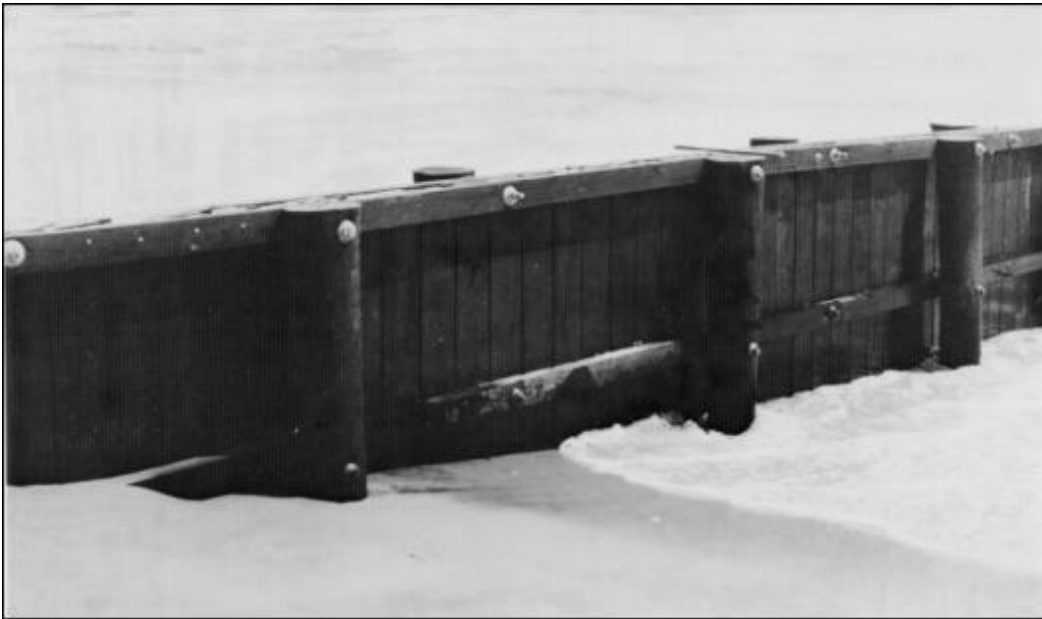
Figure IV-23. Example of a Timber Groin

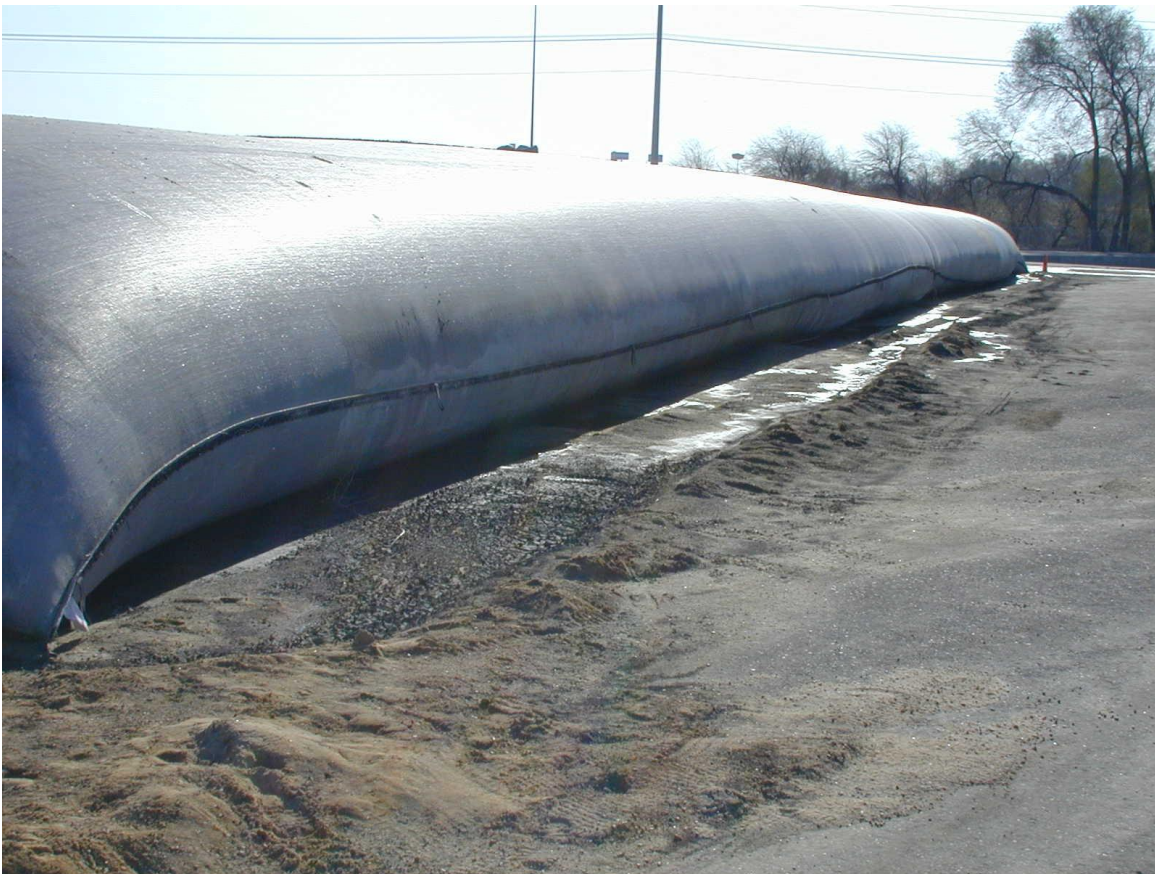
Figure IV-24. Example of a Geotextile Tube

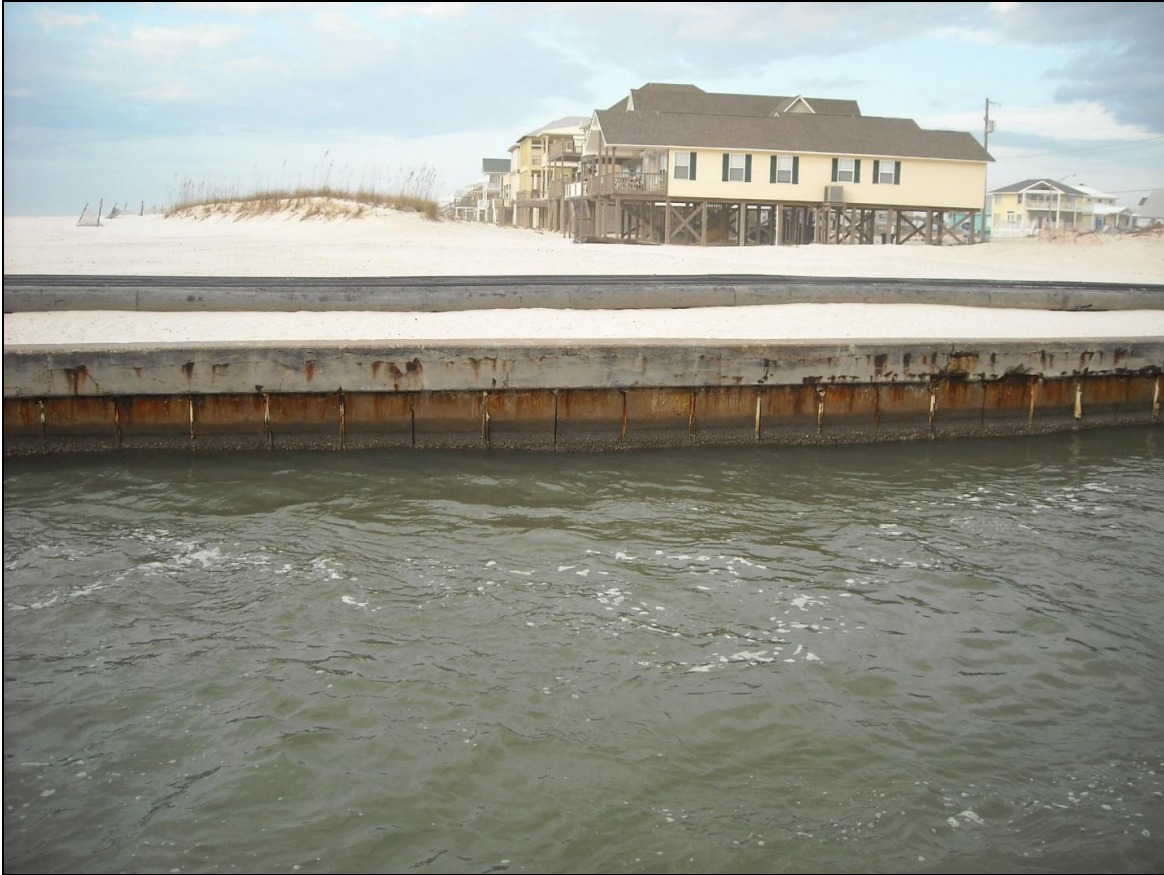
Figure VI-4. Example of Concrete Sheet Piles

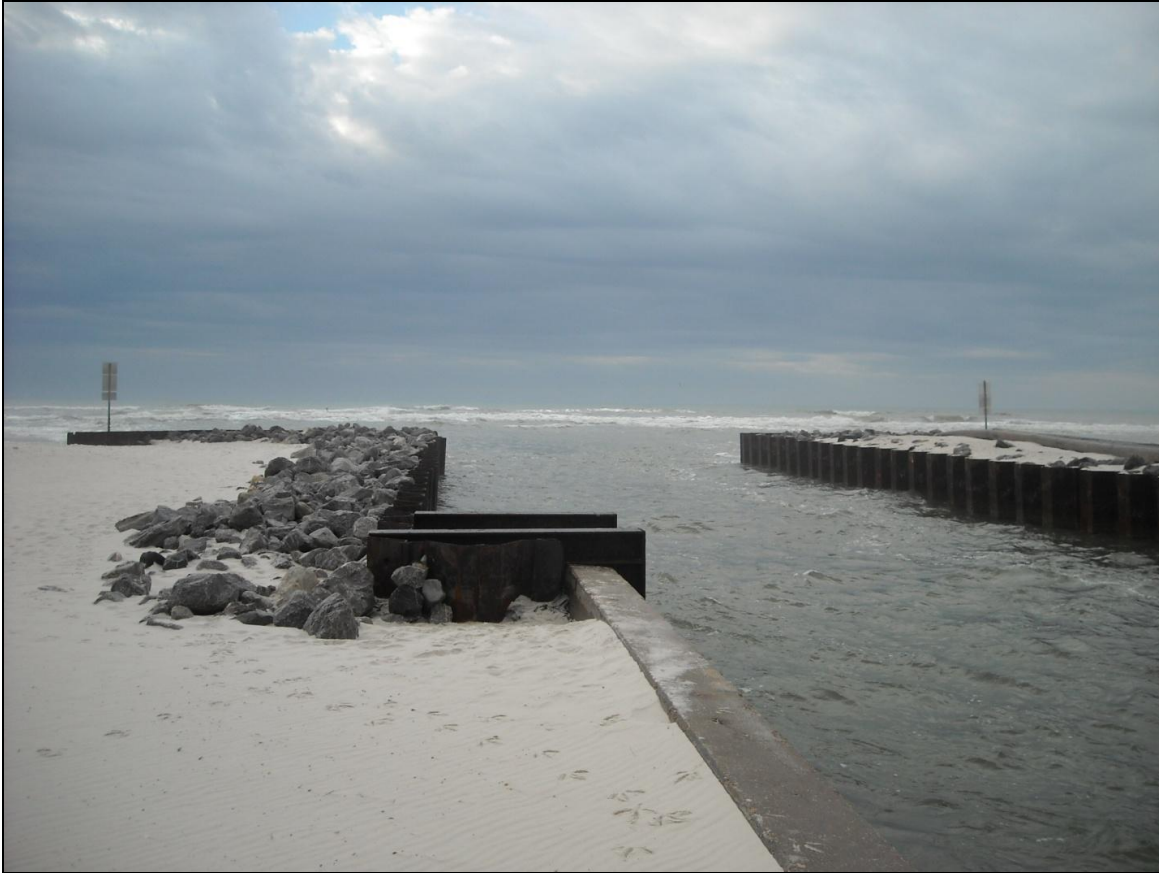
Figure VI-5. Example of Steel Sheet Pile Terminal Groins
