**SUPERCONDUCTING SUPER COLLIDER:
APPENDIX: PETROGRAPHY AND
PHOTOMICROGRAPHS**

**NORTH CAROLINA GEOLOGICAL SURVEY
OPEN-FILE REPORT 97-3**

Appendix: Petrography and photomicrographs

Age and Status of Faults Observed in Bedrock
at the
Proposed North Carolina Site for the Superconducting Super Collider

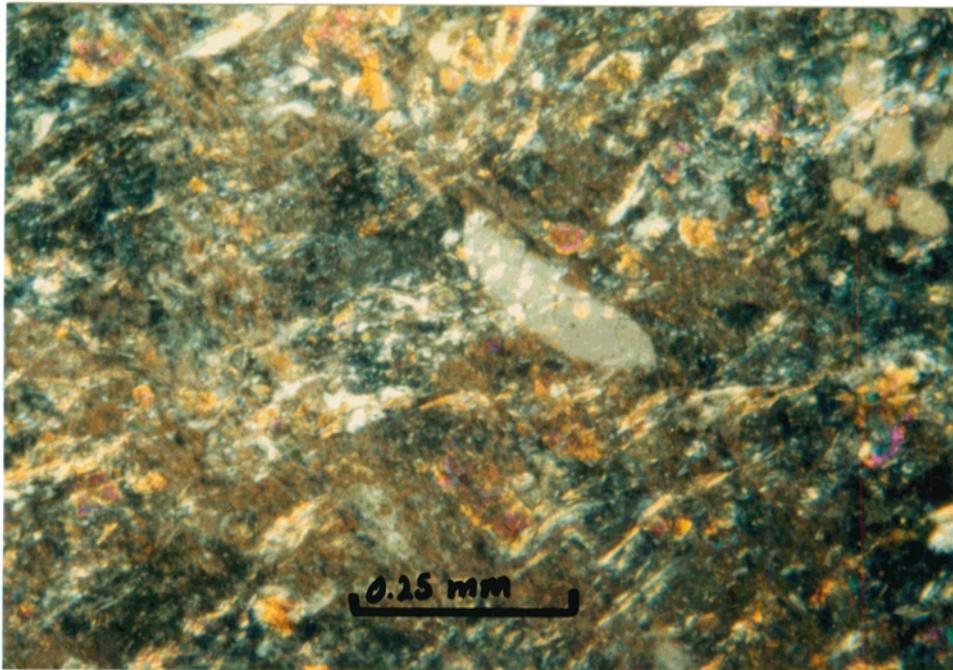
Core from schistose crystal metatuff (SC-9, 188.5')
(crossed nicols)

Extensive development of epidote and micaceous minerals (that impart directional fabric) in an intermediate composition crystal (vitric?) metatuff.

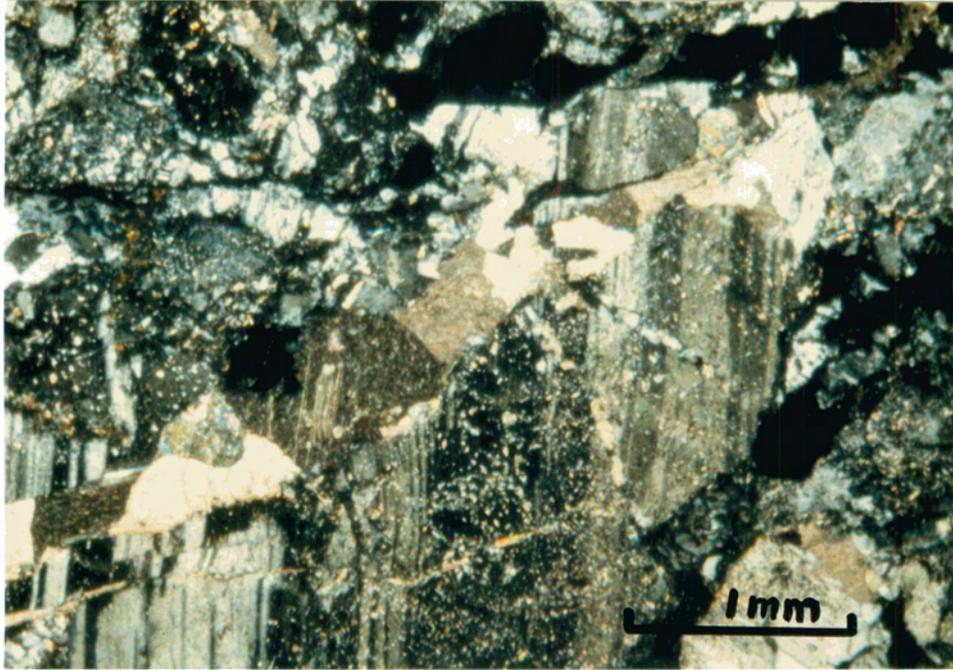
Core from disturbed rock in Moriah pluton (SC-12, 143.6')
(crossed nicols)

This section shows an irregular calcite vein cutting across an old breccia zone. No faulting or fracturing has affected this rock subsequent to development of the calcite vein.

The oldest faults are ductile shears. Literature indicates that such faulting accompanied creation of the Virgilina synclinorium and occurs primarily along its axis. Shearing was observed in core from one drill hole (SC-12) in the Moriah pluton. This shear is a minor component of a "badly broken zone". Faulting in this plutonic body is located primarily in its border zone and has been described as autoclastic - probably associated with intrusive activity.¹ No other shear zones have been documented in the proposed SSC site. Ductile shear zones have been noted at widely spaced localities throughout the southeastern Piedmont crystalline terrane and have been studied intensely in nuclear power plant site investigations.² They have been interpreted to have formed under high confining pressure and/or at elevated temperatures. Brittle deformation exemplified by breccia and microbreccia zones followed ductile shearing and suggests deformation under lowered pressure and/or temperature conditions. The third type of faulting observed in bedrock at the North Carolina proposed SSC site is simple fracturing with relatively minor offsetting of earlier shear and breccia zones. For example, an epidotized breccia zone offset by simple faulting is shown in photomicrograph SC-12, 106.7'. Finally, fracturing that is simple dilation, perhaps more properly identified as jointing, cuts all 3 earlier fault types described above. (e.g., photomicrographs, SC-12, 118.5', SC-12, 143.6' and SC-18A, 178.3').

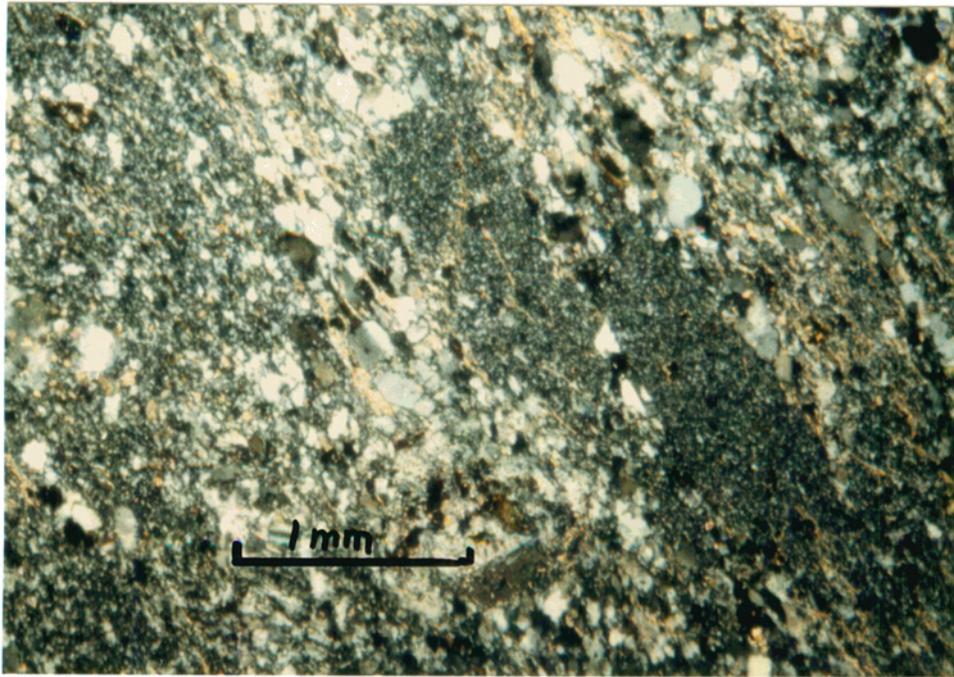
Core is from crystal-lithic-vitric ? metatuff (SC-20, 54.6')
(crossed nicols)

This rock appears to be mostly quartz and devitrified glass (gray, diffuse patches). Oriented secondary micas impart a weak schistosity to the rock.
