FINAL MY1 MONITORING REPORT

MILLSTONE CREEK MITIGATION SITE

Randolph County, North Carolina

DMS Project No. 204

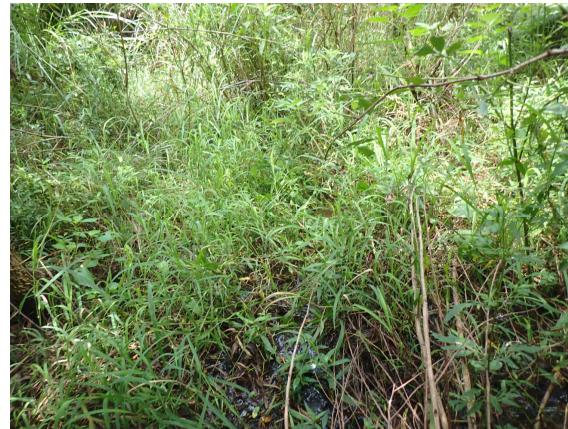
SUMMARY DATA	
Bankfull Elevation:	450.5
Bank Height Ratio:	0.96
Thalweg Elevation:	448.8
LTOB Elevation:	450.4
LTOB Max Depth:	1.6
LTOB Cross Sectional Area:	5.2

Stream Type	B 5

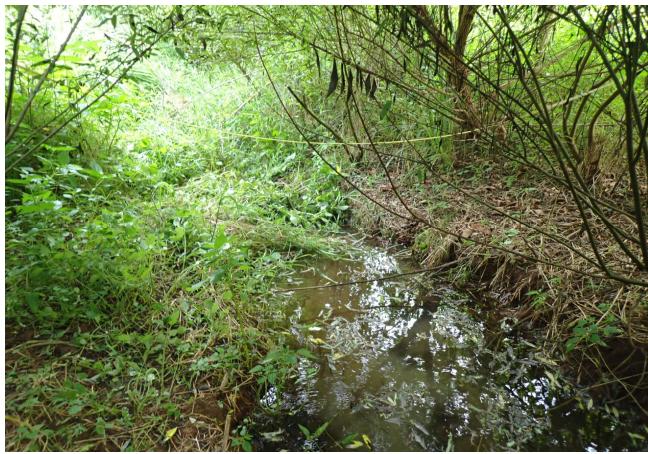
SUMMARY DATA	
Bankfull Elevation:	440.8
Bank Height Ratio:	1.01
Thalweg Elevation:	439.7
LTOB Elevation:	440.8
LTOB Max Depth:	1.1
LTOB Cross Sectional Area:	7.2

Stream Type E 5

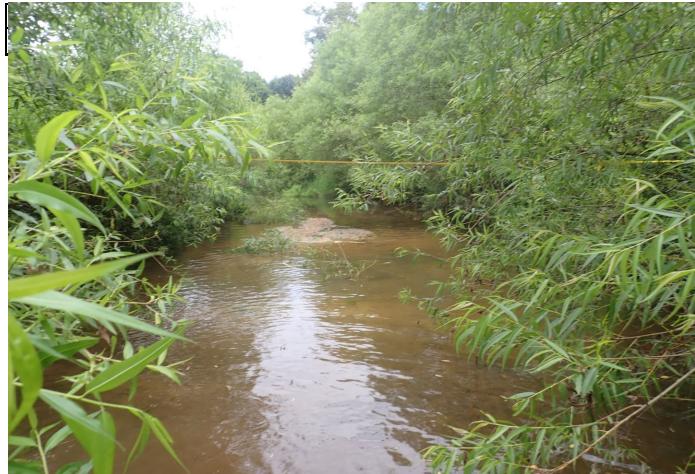
SUMMARY DATA	
Bankfull Elevation:	436.4
Bank Height Ratio:	0.96
Thalweg Elevation:	433.3
LTOB Elevation:	436.3
LTOB Max Depth:	2.9
LTOB Cross Sectional Area:	14.5

Stream Type	E 5
-------------	-----

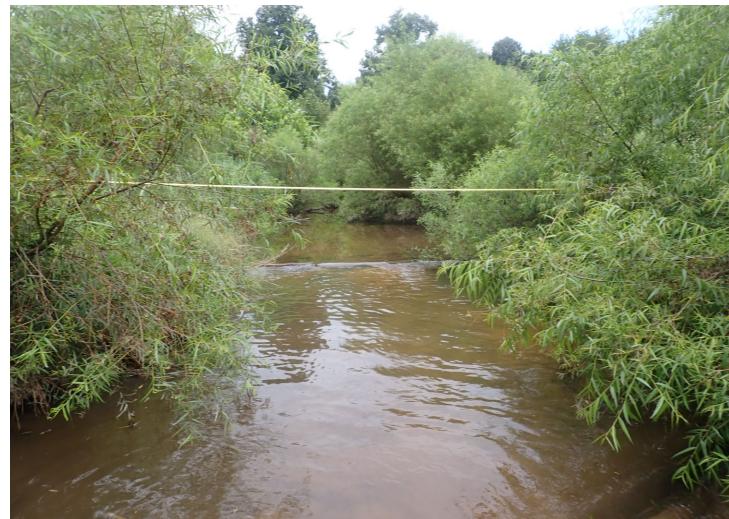
Site	Millstone Creek
Watershed:	Cape Fear River Basin, 03030003
XS ID	Millstone Creek, XS - 4, Riffle
Feature	Riffle
Date:	4/16/2025
Field Crew:	Perkinson, Heider-Metour

SUMMARY DATA	
Bankfull Elevation:	433.4
Bank Height Ratio:	1.07
Thalweg Elevation:	427.3
LTOB Elevation:	433.8
LTOB Max Depth:	6.5
LTOB Cross Sectional Area:	174.2

Stream Type C 5

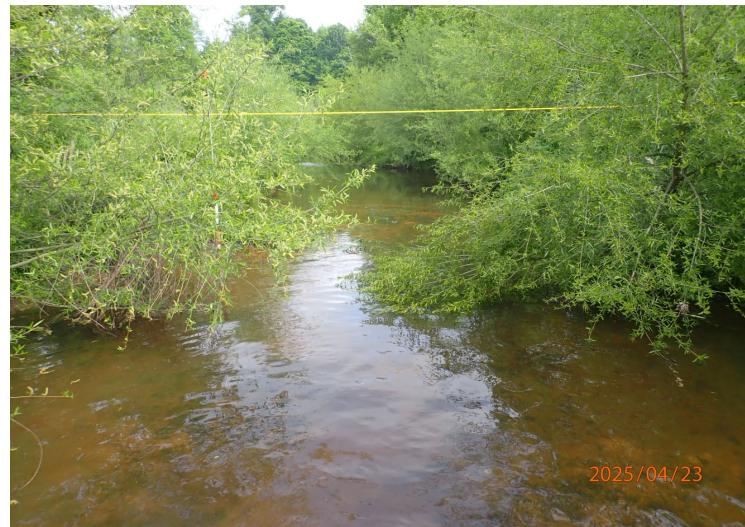
SUMMARY DATA	
Bankfull Elevation:	432.7
Bank Height Ratio:	1.00
Thalweg Elevation:	427.3
LTOB Elevation:	432.8
LTOB Max Depth:	5.5
LTOB Cross Sectional Area:	155.7

Stream Type C 5

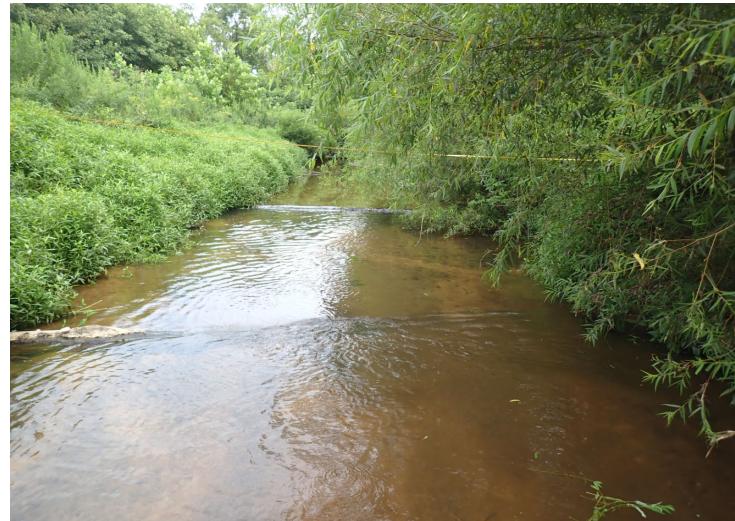
SUMMARY DATA	
Bankfull Elevation:	431.8
Bank Height Ratio:	0.99
Thalweg Elevation:	426.9
LTOB Elevation:	431.8
LTOB Max Depth:	4.9
LTOB Cross Sectional Area:	129.6

Stream Type C 5

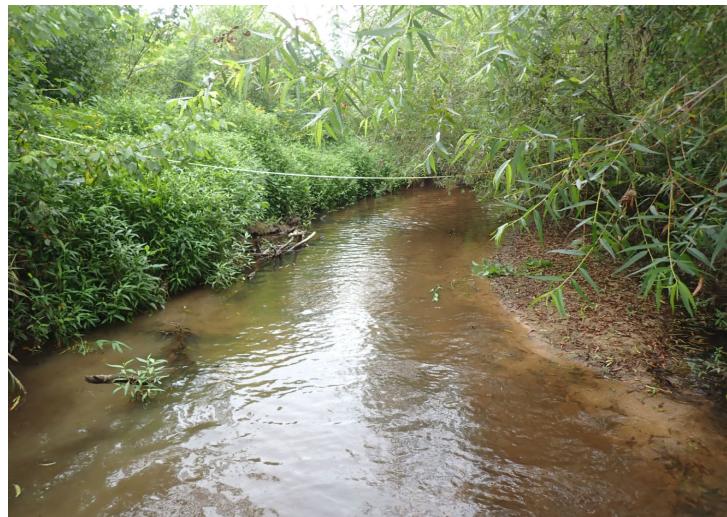
SUMMARY DATA	
Bankfull Elevation:	430.7
Bank Height Ratio:	0.85
Thalweg Elevation:	425.1
LTOB Elevation:	429.9
LTOB Max Depth:	4.8
LTOB Cross Sectional Area:	102.0

Stream Type C 5

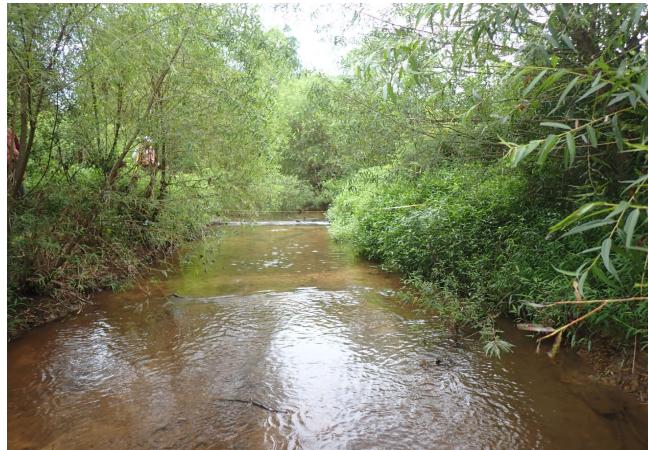
SUMMARY DATA	
Bankfull Elevation:	429.8
Bank Height Ratio:	1.03
Thalweg Elevation:	425.1
LTOB Elevation:	429.9
LTOB Max Depth:	4.8
LTOB Cross Sectional Area:	94.4

Stream Type C 5

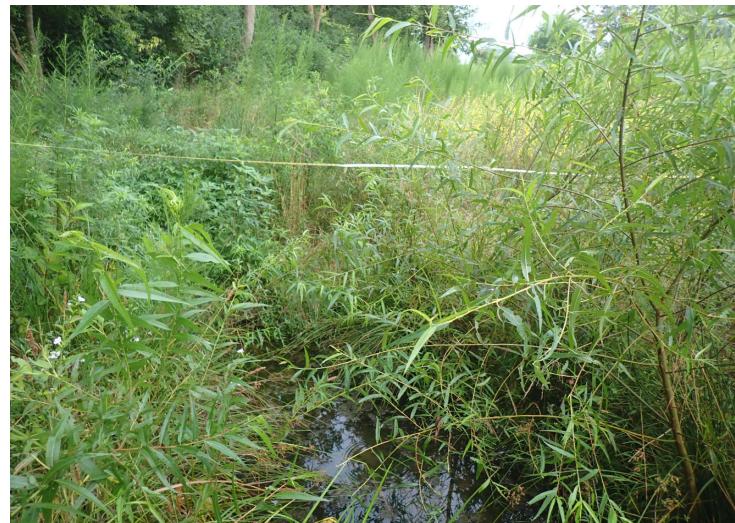
SUMMARY DATA	
Bankfull Elevation:	445.9
Bank Height Ratio:	0.93
Thalweg Elevation:	443.8
LTOB Elevation:	445.7
LTOB Max Depth:	2.0
LTOB Cross Sectional Area:	15.0

Stream Type B 5

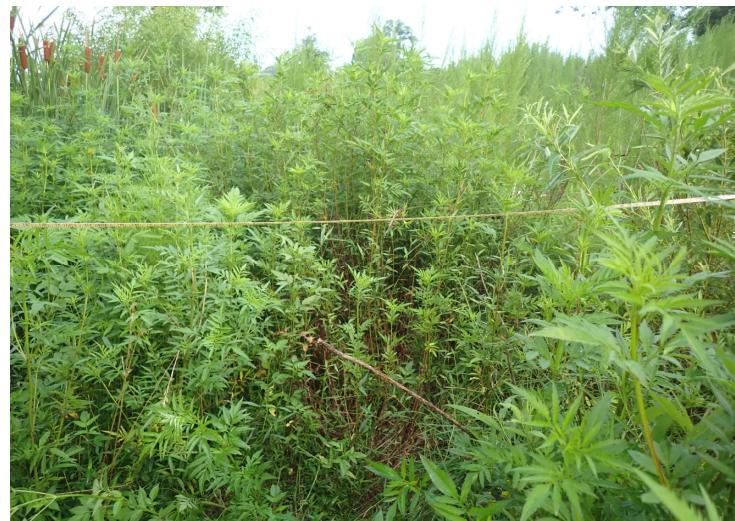
SUMMARY DATA	
Bankfull Elevation:	461.4
Bank Height Ratio:	0.95
Thalweg Elevation:	460.8
LTOB Elevation:	461.4
LTOB Max Depth:	0.5
LTOB Cross Sectional Area:	3.4

Stream Type B 5

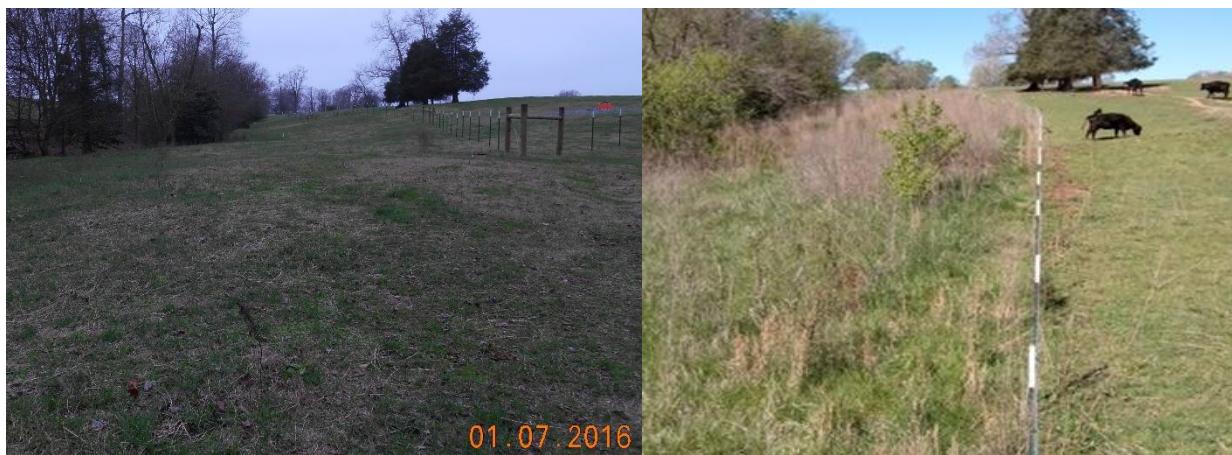
Figure 1. Typical riparian corridor before (left) and after (right) livestock exclusion fencing.

In October and November of 2015 prior to the restoration work, livestock exclusion fencing (LEF) was installed around an 18.8-acre conservation easement that included the entire mitigation project area. The fencing excluded cattle from the riparian corridor nominally 50-100 ft from the banks of all the stream reaches (Line and Doll, 2023). An alternate livestock watering system outside of the fenced area was installed shortly after the fence. Vegetation in the excluded riparian corridor grew rapidly during the spring and summer of 2016, such that the riparian corridors (Figure 1) including stream channels (Figure 2) that were not shaded by trees stabilized quickly. Because there were more trees along the UTA stream, vegetation in and on the banks of that stream channel took more time than the NT stream to become established.

Exclusion fencing (see Figure 1) has been shown to be effective in cases where it was implemented 10 ft from the top of the streambank (Line et al. 2016; Meals and Hopkins 2002; Galeone et al. 2006) to 100 ft (Line and Doll 2023; Line et al. 2000). The width, or distance from one side of the stream of the exclusion corridor, depends on the slope of the land, the type and density of the vegetation next to the stream (in the exclusion corridor), the slope and length of the area that drains to the stream, and the amount or intensity of the source of nutrients. In general, the steeper the slope (toward the stream), the less dense the ground vegetation in the exclusion corridor, and the longer and steeper the upslope contributing area, the wider the exclusion corridor must be to maximize the runoff treatment.

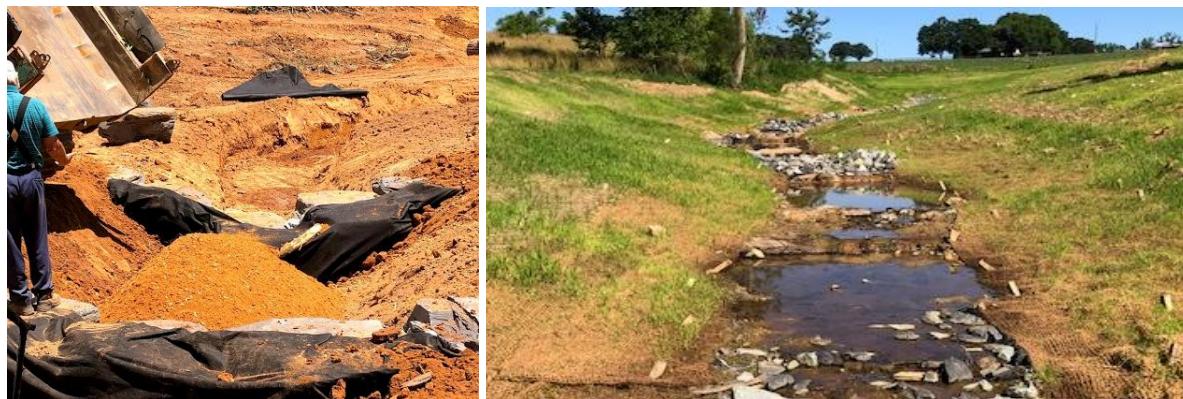
Figure 3. Section of NT stream RSC during construction (left) and after completion (right)

Construction for Phase I of the restoration effort was completed in September of 2021 with planting of vegetation completed in December. Phase I included the restoration and enhancement of Millstone Creek (MC), the installation of a media-based regenerative stormwater conveyance (RSC) system (Figure 3) and enhancement along the NT Stream, restoration of the Unnamed Tributary Reach B (UTB) and hydrologic enhancement of an existing jurisdictional wetland (Table 1). The RSC (Figure 3) consisted of an open surface channel with a series of riffle and step pools constructed over a carbon-rich, porous media bed. The riffle/pool geometry was designed to retain water in shallow pools and dissipate energy as water flowed downstream in rock-lined steps and riffles. Similar to other media-based BMPs, the media had a high hydraulic conductivity to promote infiltration and movement of water in the bed, where filtration, sorption, and enhanced biotransformations were expected to occur. Further, the media contained 15%–20% by volume of shredded wood chip mulch to serve as a carbon source for microbial biotransformation of inorganic (NO_x) nitrogen to nitrogen gas (N₂). Native vegetation was planted in and along the channel to increase both water quality and hydrologic benefits through uptake of nutrients and evapotranspiration. An existing wetland near the downstream end of UTB was enhanced prior to the RSC1 period (Figure 4, right). A log structure was installed at the outlet of the wetland to stabilize the transition zone between the wetland and the off-site ditch. Natural volunteer vegetation proliferated during the project, most of which did not appear to be traditional wetland vegetation.

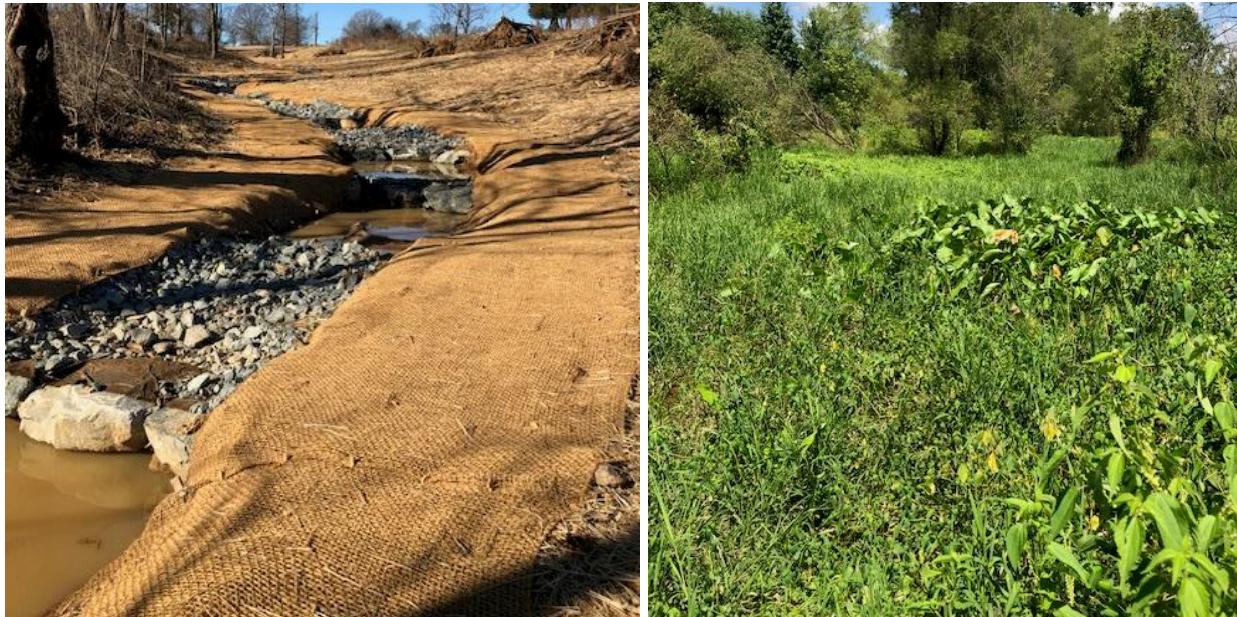
Figure 4. A section of the RSC on UTA (left) and the wetland on UTB (right).

Phase II construction included the construction of an RSC and enhancement work along reach A of the Unnamed Tributary (UTA). It finished in January of 2024 with the planting being completed immediately following the construction. This RSC was constructed using the same design principles as the RSC on the NT stream (Figure 4, left). However, for UTA the elevation of the stream channel was not raised and there was considerably less soil material spread across the upland areas of the riparian corridor.

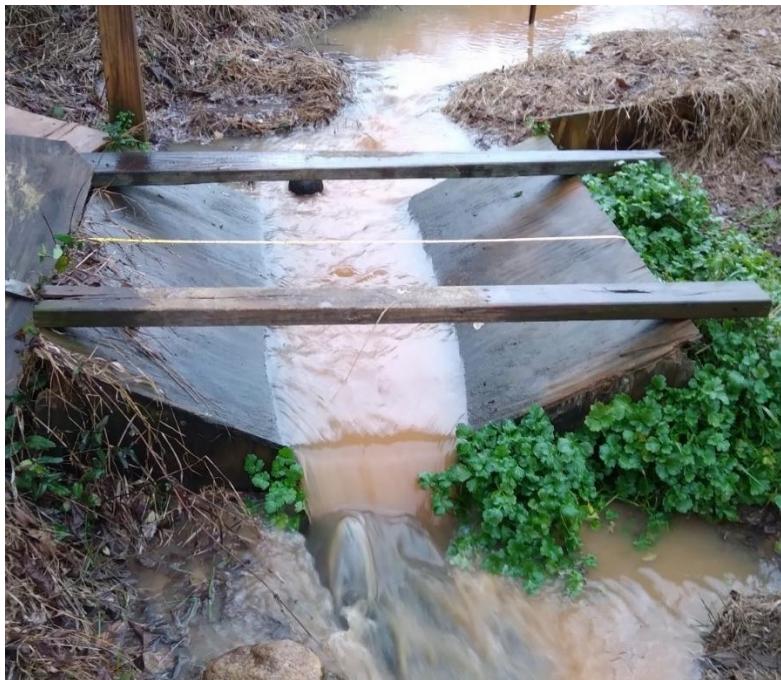
Figure 9. Trapezoidal flume for NT monitoring station.

North, and WET stations also had a trapezoidal flume installed to facilitate measurement of the range of discharges/flows expected (Figure 9). The trapezoidal flume was chosen as a discharge monitoring device because it provided a stable cross-section that could pass the vegetative and other debris that was expected from the pasture and wooded stream banks in addition to facilitating discharge measurements at low and medium to high discharges. At each station, an automated sampler was installed with an integrated flowmeter that measured water depth/stage continuously. The stream stations (UTA, NT) and the wetland station (WET) also employed a Doppler-based velocity measuring sensor/probe for several months to monitor water depth and velocity continuously from which discharge was computed for a range of stages. In addition, manual measurements of discharge were conducted using a graduated bucket and stopwatch (for low discharge) and a stream pygmy meter (for high discharge) to validate the measurements made by the automated Doppler-based sensors. All the discharge and associated depth/stage measurements were used to develop and update a stage-discharge relationship for each monitoring station. This relationship was entered into the sampler and used to estimate discharge from continuous measurements of stage. For each station/flume, the stage-discharge relationship was updated as new measurements were made, but for the most part the relationship stayed relatively consistent during each phase of the project as long as the flume was maintained. Maintenance involved constant cleaning of the flume to maintain the same roughness, which also meant covering the flume to prevent algae from growing on the flume surface (which changed the roughness also). Also, plugging leaks to prevent bypass flow was accomplished on several occasions.

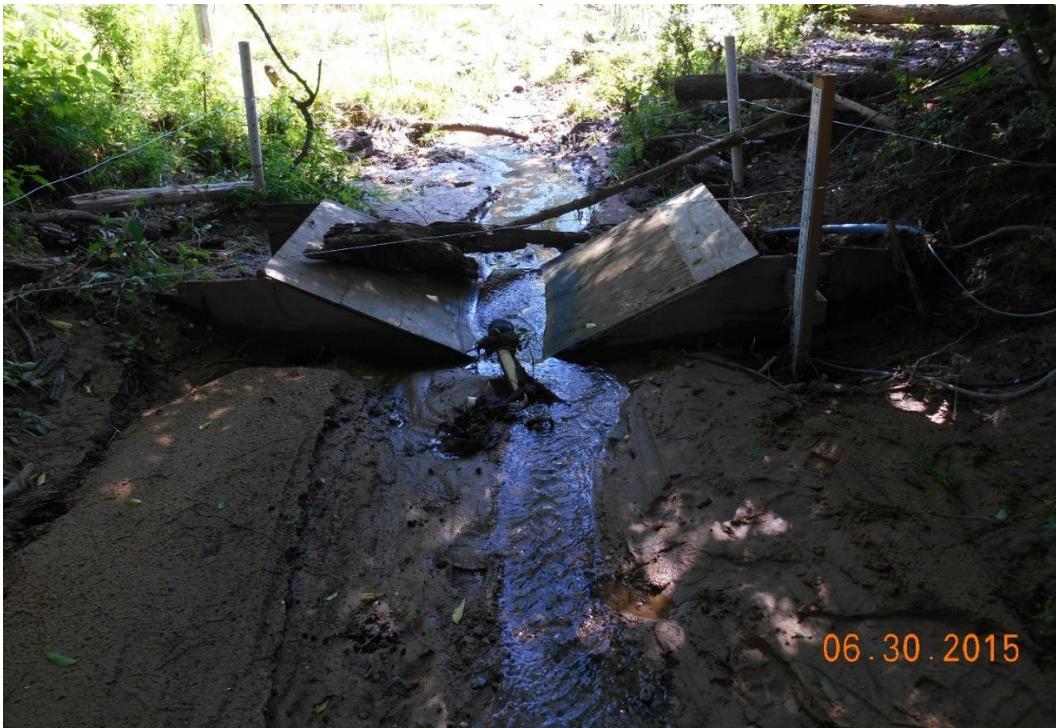
Figure 17. Picture of UTA stream flume and sediment deposition on 6/30/15.

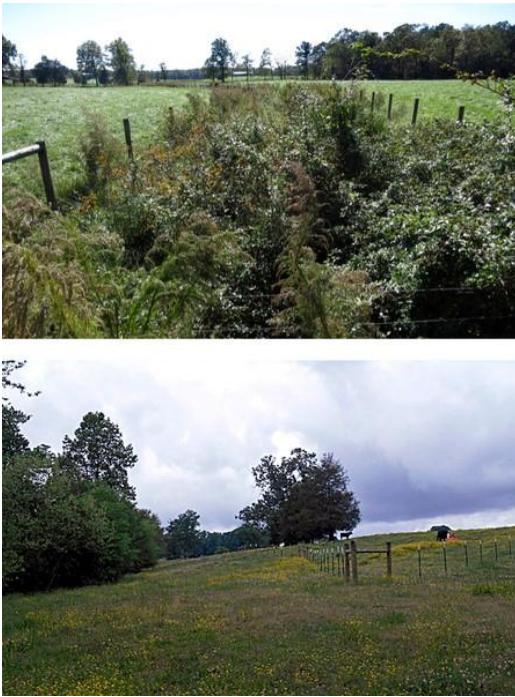
Figure 1. Exclusion fence 10 ft (top) and 50 to 90 ft (bottom) from streambank.
