Annual Monitoring Report (MY4)

BOSEMAN BUFFER MITIGATION SITE

Edgecombe County, NC
NCDEQ Contract No. 7872
DMS ID No. 100119
DWR Project No. 2019-0800
RFP No. 16-007711

December 2023

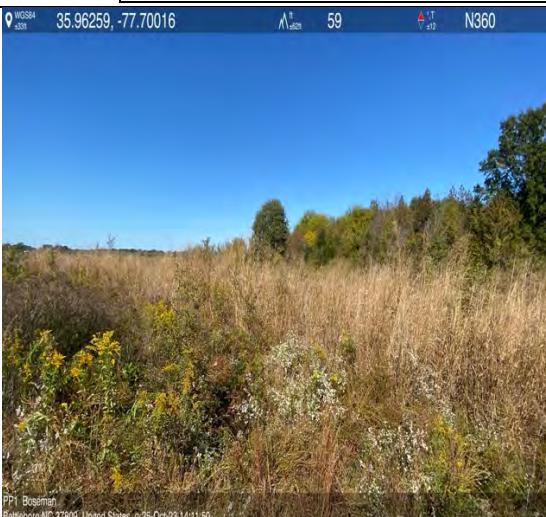
MY4 10/2023	MY3 10/2022
Photo #1	<p>Date: 10/23/2023 Feature: Photo Station 1 Direction: Northeast</p>

<p>PP1_Boseman Battleground NC 27809, United States 0 25-Oct-23 14:11:50</p>	<p>WGS84 35.96259, -77.70016 N 59 E 1° N360</p>

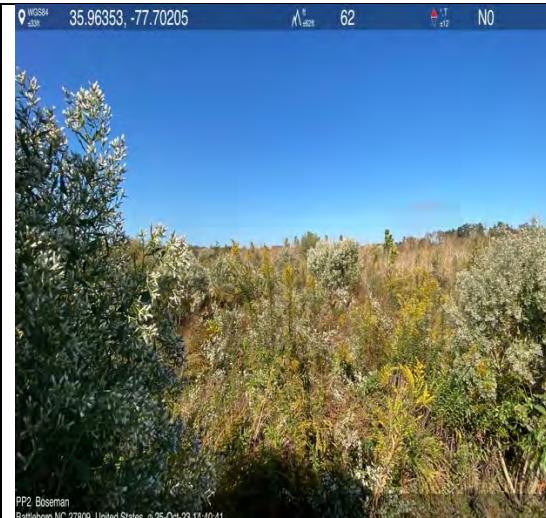
<p>16°N (T) 35.962677°, -77.700402° ±13ft ▲ 71ft PP1_E Boseman 10-04-2022, 12:10:56</p>
Photo #2	<p>Date: 10/23/2023 Feature: Photo Station 2 Direction: North</p>

<p>PP2_Boseman Battleground NC 27809, United States 0 25-Oct-23 14:40:41</p>	<p>WGS84 35.96353, -77.70205 N 62 E 1° N0</p>

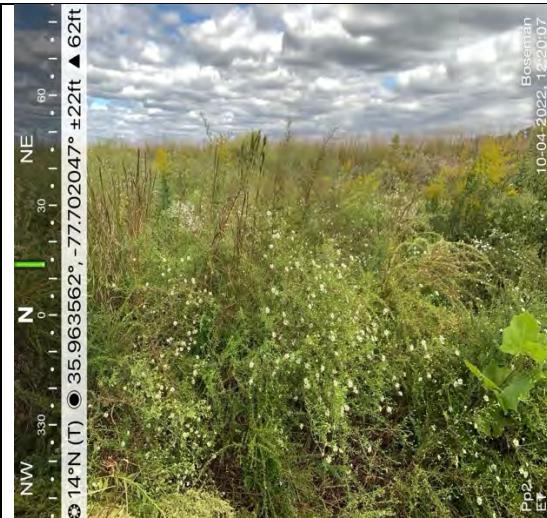
<p>14°N (T) 35.963562°, -77.702047° ±22ft ▲ 62ft PP2_E Boseman 10-04-2022, 14:20:07</p>
Photo #3	<p>Date: 10/23/2023 Feature: Photo Station 3 Direction: North</p>

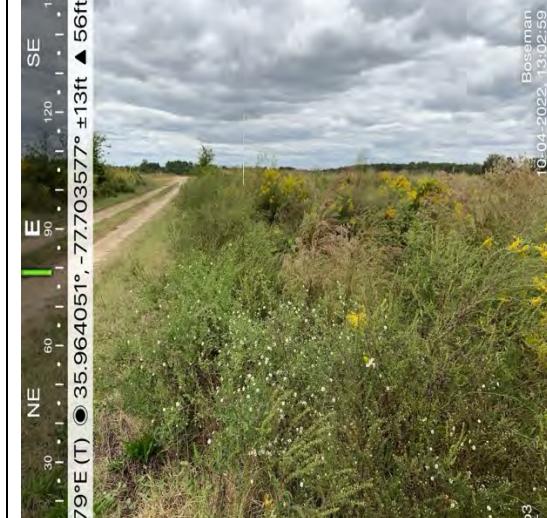
<p>PP3_Boseman Battleground NC 27809, United States 0 25-Oct-23 13:09:34</p>	<p>WGS84 35.96404, -77.70358 N 47 E 1° NE70</p>

<p>79°E (T) 35.964051°, -77.703577° ±13ft ▲ 56ft PP3_E Boseman 10-04-2022, 13:02:59</p>

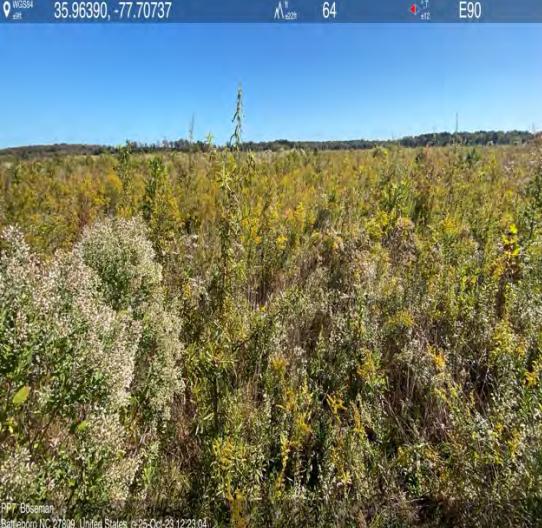
MY4 10/2023	MY3 10/2022
Photo #7	<p>Date: 10/23/2023 Feature: Photo Station 7 Direction: East</p>

<p>PP7 Boseman Battleboro NC 27809, United States e 25-Oct-23 12:23:04</p> <p>WGS84 35.96390, -77.70737 N 64 E 90</p>	<p>PP7 Boseman Battleboro NC 27809, United States e 25-Oct-23 12:23:04</p> <p>WGS84 35.96390, -77.70737 N 64 E 90</p> <p>87°E (T) ● 35.963867°, -77.707334° ±16ft ▲ 62ft</p> <p>SE 150 120 90 60 30 NE E SW 120 150 180 210 240 S 120 150 180 210 240 174°S (T) ● 35.964989°, -77.705727° ±26ft ▲ 65ft</p> <p>Pp7 ET 10-04-2022, 14:29:58</p>
Photo #8	<p>Date: 10/23/2023 Feature: Photo Station 8 Direction: Southeast</p>

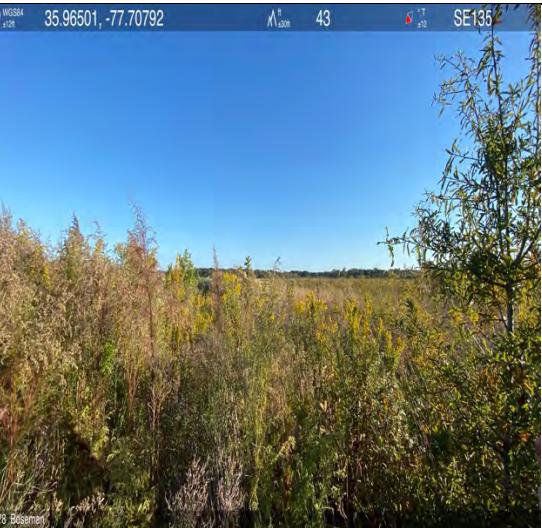
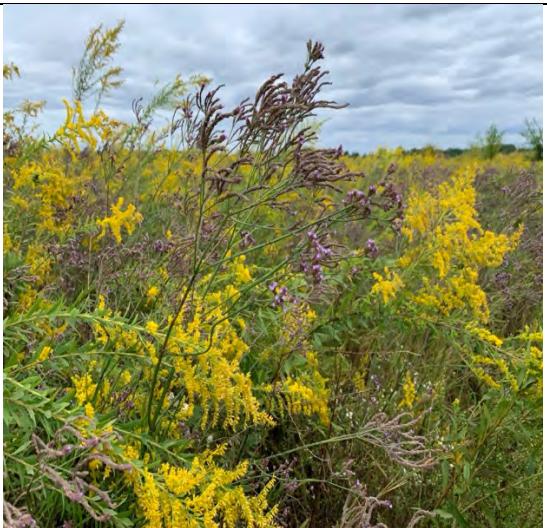
<p>PP8 Boseman Battleboro NC 27809, United States e 25-Oct-23 16:48:37</p> <p>WGS84 35.96501, -77.70792 N 43 SE 135</p>

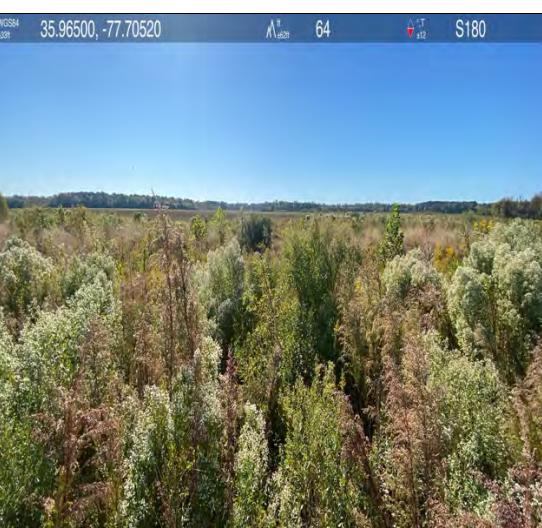
Photo #9	<p>Date: 10/23/2023 Feature: Photo Station 9 Direction: South</p>

<p>PP9 Boseman Battleboro NC 27809, United States e 25-Oct-23 11:26:09</p> <p>WGS84 35.96500, -77.70520 N 64 S 180</p>

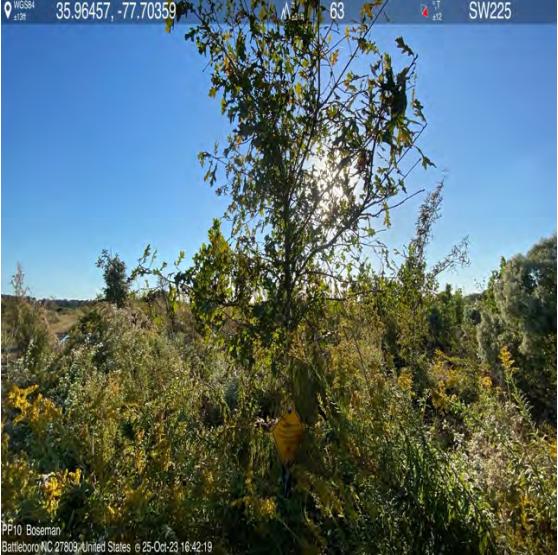
MY4 10/2023	MY3 10/2022
Photo #12	<p>Date: 10/23/2023 Feature: Photo Station 10 Direction: Southwest</p>

<p>PP10 Bosman Battleground NC 27809, United States © 25-Oct-23 16:42:19</p>	<p>NGS84 35.96457, -77.70359 N 63 SW225</p>

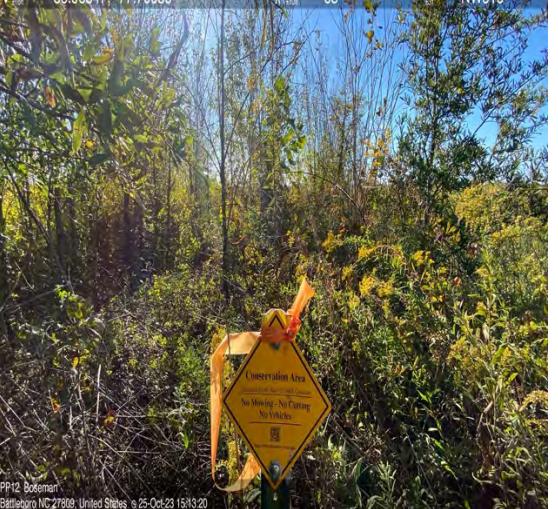
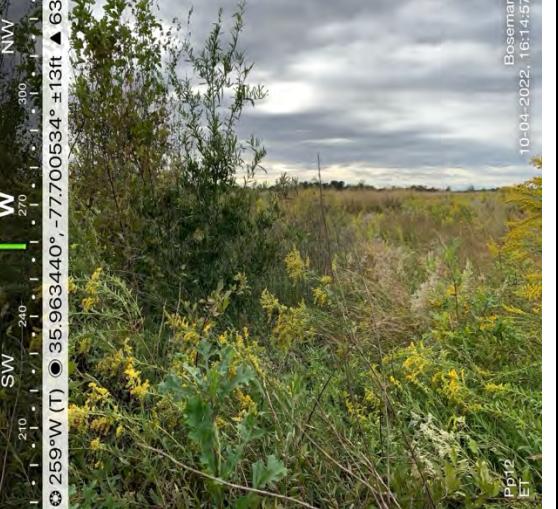
<p>198°S (T) ● 35.964376°, -77.701867° ±16ft ▲ 64ft SE SW 180 150 120 90 60 30 S 180 150 120 90 60 30 N 180 150 120 90 60 30 E 198°S (T) ● 35.964376°, -77.701867° ±16ft ▲ 64ft 10-04-2022, 16:21:18 Bosman PP11 ET</p>
Photo #12	<p>Date: 10/23/2023 Feature: Photo Station 12 Direction: Northwest</p>

<p>PP12 Bosman Battleground NC 27809, United States © 25-Oct-23 15:32:20</p>	<p>NGS84 35.96347, -77.70055 N 63 NW315</p>

<p>259°W (T) ● 35.963440°, -77.700534° ±13ft ▲ 63ft NW SW 180 150 120 90 60 30 W 180 150 120 90 60 30 N 180 150 120 90 60 30 E 259°W (T) ● 35.963440°, -77.700534° ±13ft ▲ 63ft 10-04-2022, 16:14:57 Bosman PP12 ET</p>

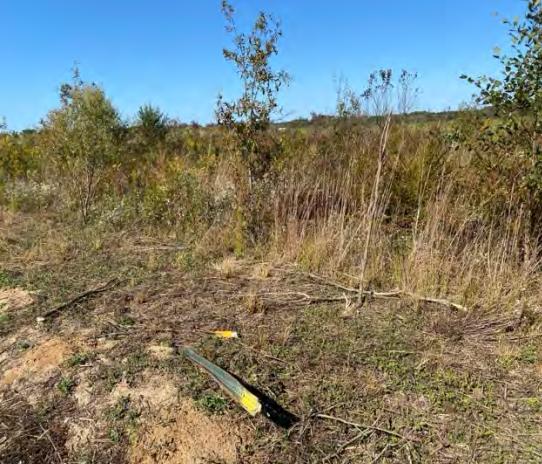
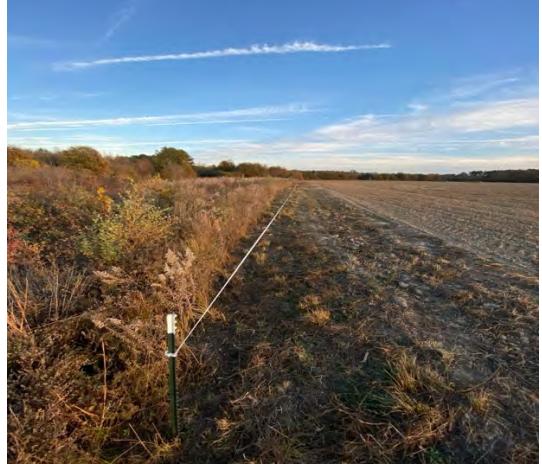
MY4 Encroachment	MY4 Updated Marking
Photo #1 Date: 10/27/2023 Feature: Near PP 1 Direction: North, East

The landowner mowed into the conservation area immediately prior to the vegetation monitoring. The incursion is noted in the Appendix 2; Site Photos. Additional t-posts and conservation markers were placed along the perimeter at the three areas noted. In addition, the landowner was notified verbally of his incursion. No trees were mowed or otherwise injured by this incursion.

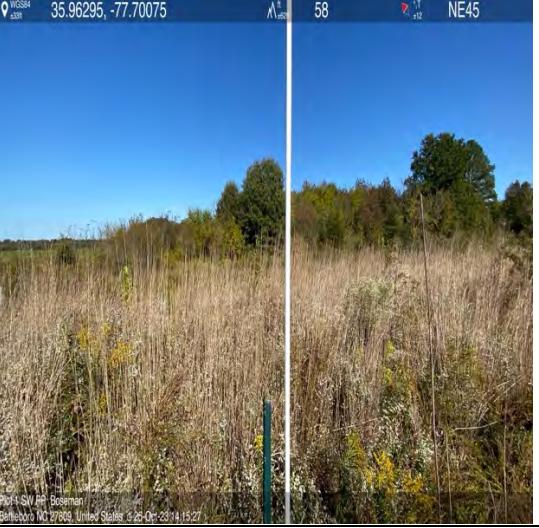
MY4 10/2023	MY3 10/2022
Photo #1	<p>WGS84 NAD83 35.96295, -77.70075 A_{12ft} 58 N_{12ft} E_{12ft} NE45</p>

<p>Plot 4 SW PR Boseman Bettendorf NC 27009, United States 3-25-Oct-23 14:52:27</p>	<p>WGS84 NAD83 35.96295, -77.70075 A_{12ft} 58 N_{12ft} E_{12ft} NE45</p>

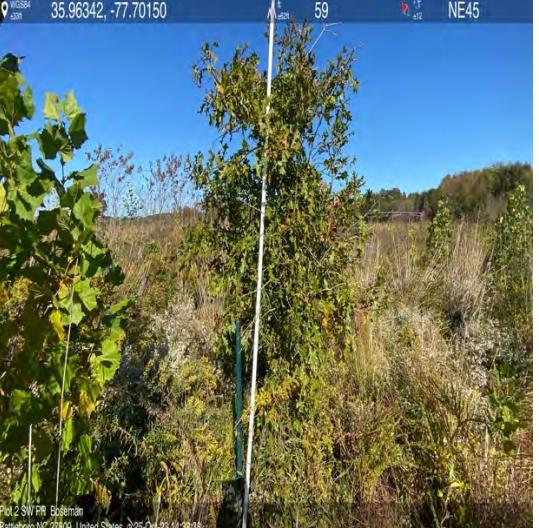
<p>Plot 1 SW PR Boseman Bettendorf NC 27009, United States 10-04-2022 12:14:44</p>
Photo #2	<p>WGS84 NAD83 35.96342, -77.70150 A_{12ft} 59 N_{12ft} E_{12ft} NE45</p>

<p>Plot 2 SW PR Boseman Bettendorf NC 27009, United States 3-25-Oct-23 14:38:38</p>	<p>WGS84 NAD83 35.96342, -77.70150 A_{12ft} 59 N_{12ft} E_{12ft} NE45</p>

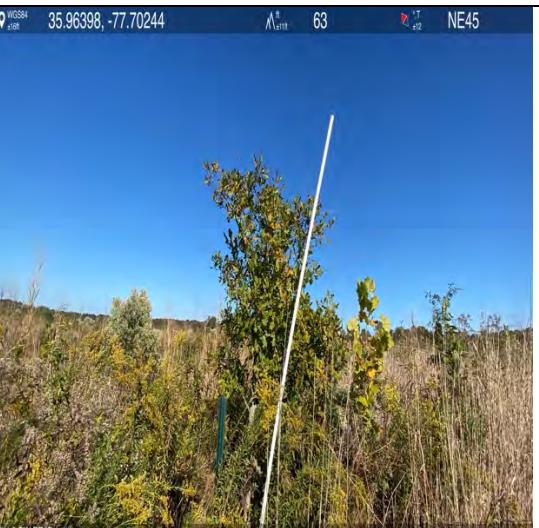
<p>Plot 2 SW PR Boseman Bettendorf NC 27009, United States 10-04-2022 12:21:45</p>
Photo #3	<p>WGS84 NAD83 35.96398, -77.70244 A_{12ft} 63 N_{12ft} E_{12ft} NE45</p>

<p>Plot 3 SW PR Boseman Bettendorf NC 27009, United States 3-25-Oct-23 15:02:46</p>	<p>WGS84 NAD83 35.96398, -77.70244 A_{12ft} 63 N_{12ft} E_{12ft} NE45</p>
