Bowl Basin Restoration Site Monitoring Report MY06 DMS Project # 95721 DMS Contract # 005012

Onslow County, NC CU# 03020106 DWR# 2013-0864 SAW# 2013-00393

Construction Completed: February 2015
Data Collection: 2020
Submitted: December 2020

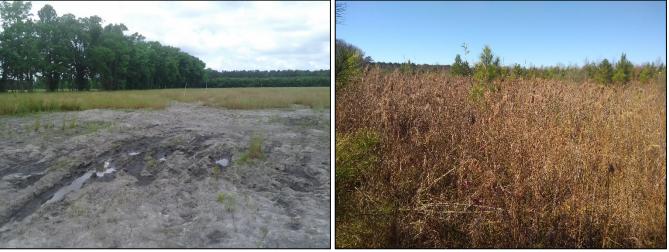
PP5 - MY-00 - 5/20/15

PP5 – MY-06 – 12/8/20

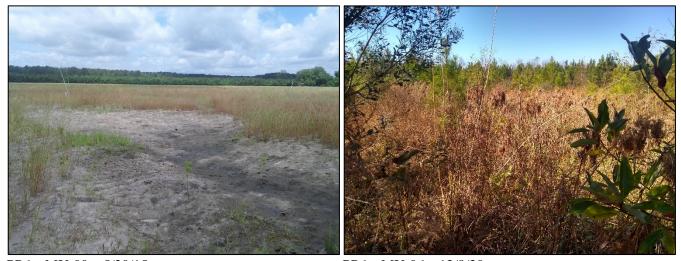
PP6 - MY-00 - 5/20/15

PP6 - MY-06 - 12/8/20

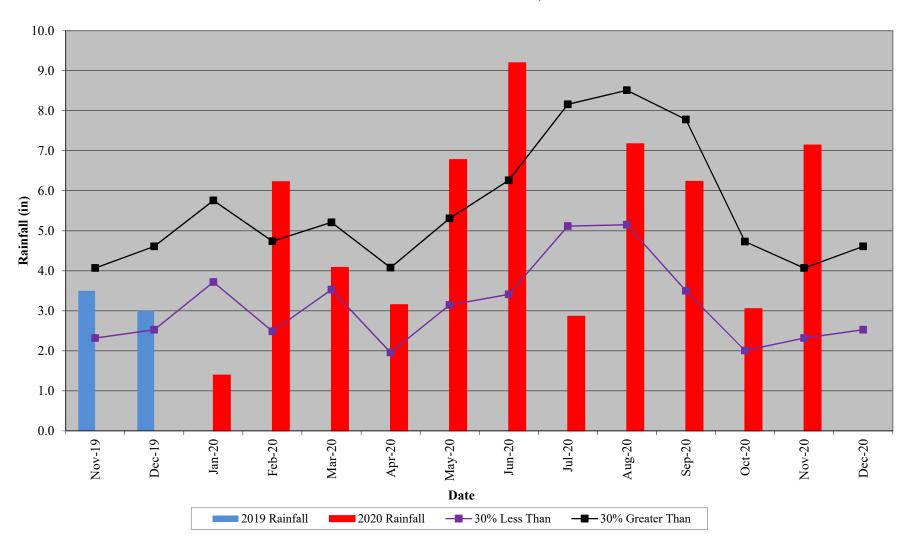
Bowl Basin Wetland Restoration Site 30-70 Percentile Graph WETS Station Name: NHOF, Hoffman Forest

The daily rainfall data was obtained from a local weather station in Jacksonville, NC; provided by the NC State Climate Office. For the 2020 year, the months of March, April, August, September, and October experienced average rainfall, while January, and July experienced below average rainfall. February, May, June, and November experienced above average rainfall in 2020. Although the overall rainfall total for the site was average for the year. After receiving a total of 6 inches of rain during the first 2 months of the growing season (3/18-5/16), the site then received 5.7 inches of rain in 5 days (5/17-5/21). This was followed by approximately three weeks with only 0.5 inches of rain (5/22-6/11) and then another 5.7 inches of rain in 5 days (6/12-6/16). This pattern continued throughout the growing season with long periods of relatively little rain followed by short periods of heavy rain. This inconsistent rain fall caused many of the gauges to have short dry periods during what would normally be jurisdictional hydrology.

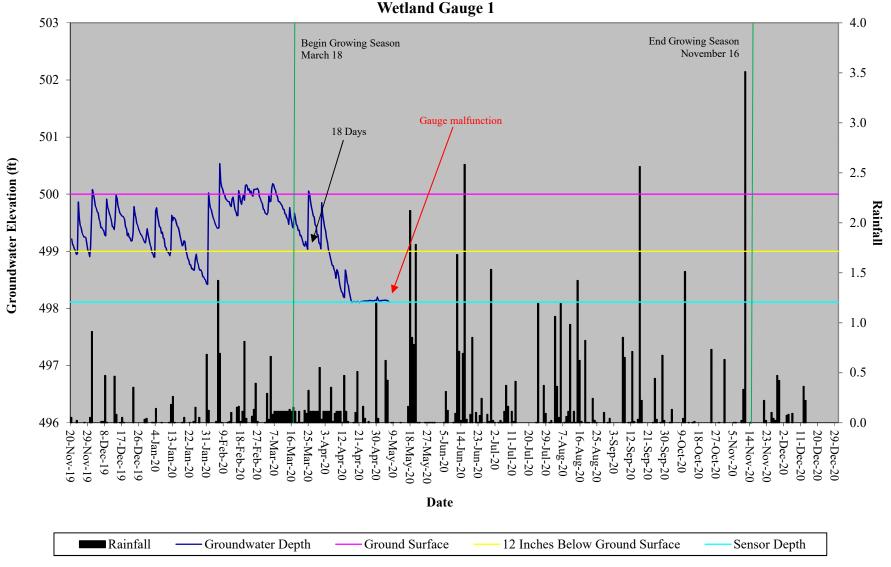
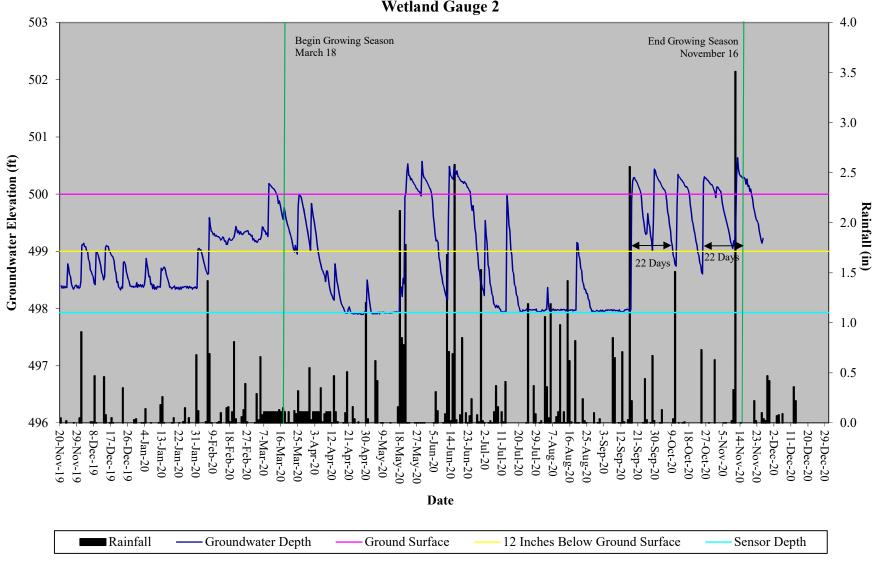
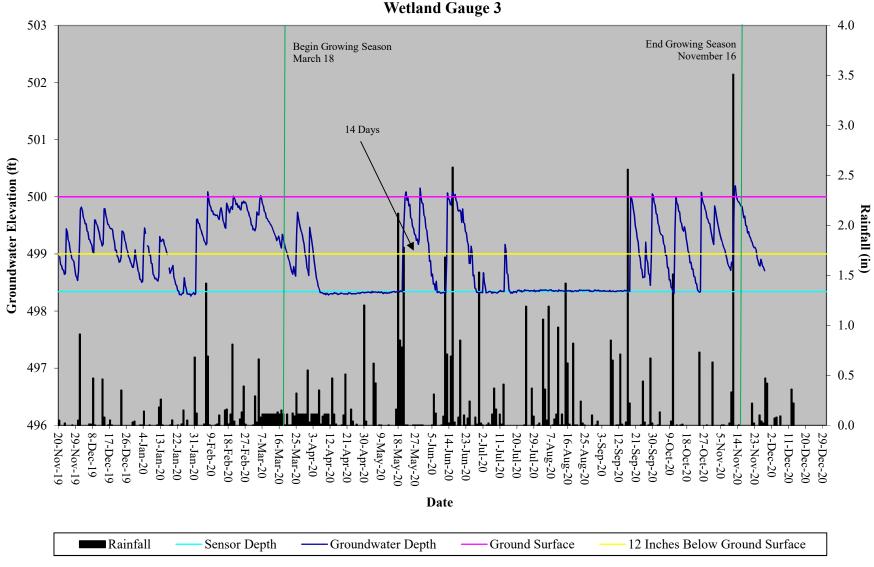
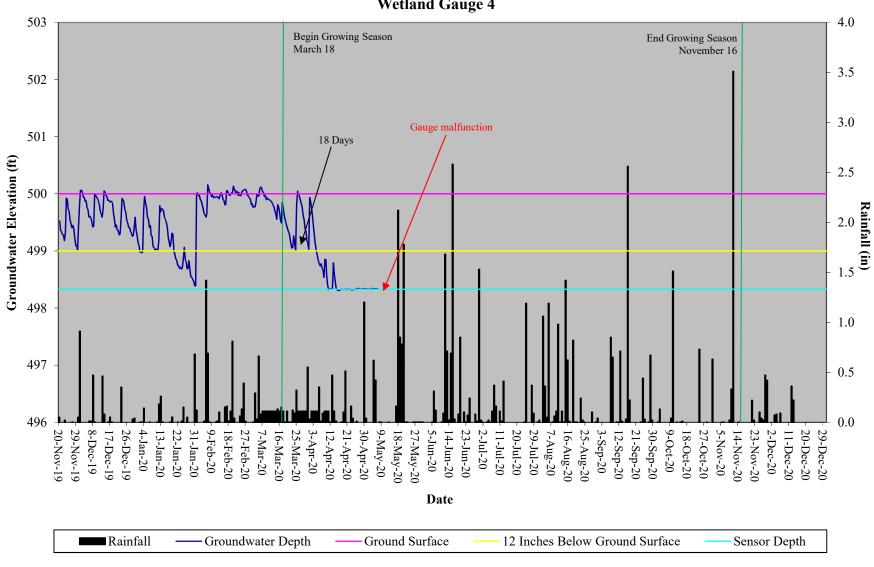
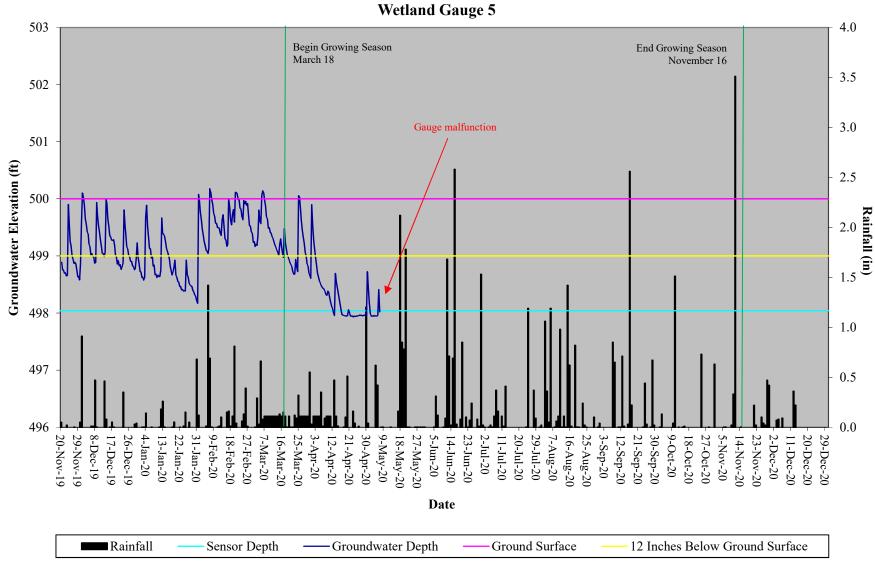
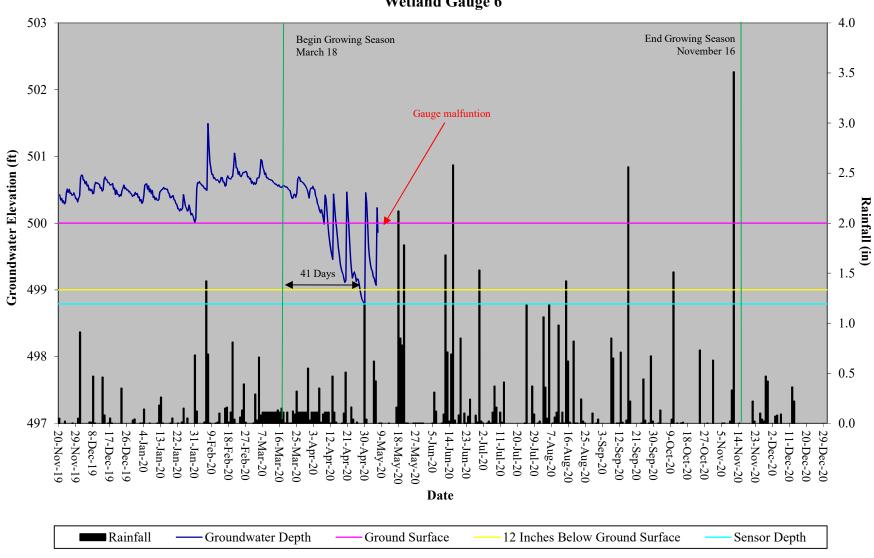
During the site's sixth growing season, only 6 of the 10 gauges had continuous saturation within 12 inches of the ground surface for 9% (22 days) of the 243 day growing season (March 18 to November 16). Overall the gauges on site averaged 32 days (13.4%) of continuous saturation. Three of the four gauges that did not meet the success criteria malfunctioned early in the growing season. It is believed that, since most of the rain fell during the end of the growing season, that these gauges would have met the success criteria had they recorded for the whole year. KCI is currently working with the gauges' manufacturer to try and recover this data and will update the report if it becomes available.

KCI Response: Gauge 3 has been over 5% in every monitoring year but has only achieved the success criteria in 2 of the 6 monitoring years. All of the other gauges have achieved the success criteria for at least 4 of the 6 monitoring years. Additionally, all of the gauges that failed to meet the success criteria failed to meet it in 2019, which was a historically dry year for the site. Because of this, KCI does not believe that any of the gauges besides Gauge 3 represent a risk to the site's success. We are working with the gauge manufacturer to obtain the data off of the three malfunctioning gauges and will add this data to the report once it is available.
