**ANNUAL MONITORING REPORT
YEAR 3 (2008)
BROGDEN ROAD BUFFER RESTORATION SITE
JOHNSTON COUNTY, NORTH CAROLINA
(Contract Number D05015-3)**

**BROGDEN ROAD BUFFER RESTORATION SITE
ANNUAL MONITORING REPORT
YEAR 3 (2008)
JOHNSTON COUNTY, NORTH CAROLINA**

**Brogden Road Buffer Restoration Site
Year 3 (2008) Annual Monitoring
Vegetation Plot Pictures Taken June 2008**

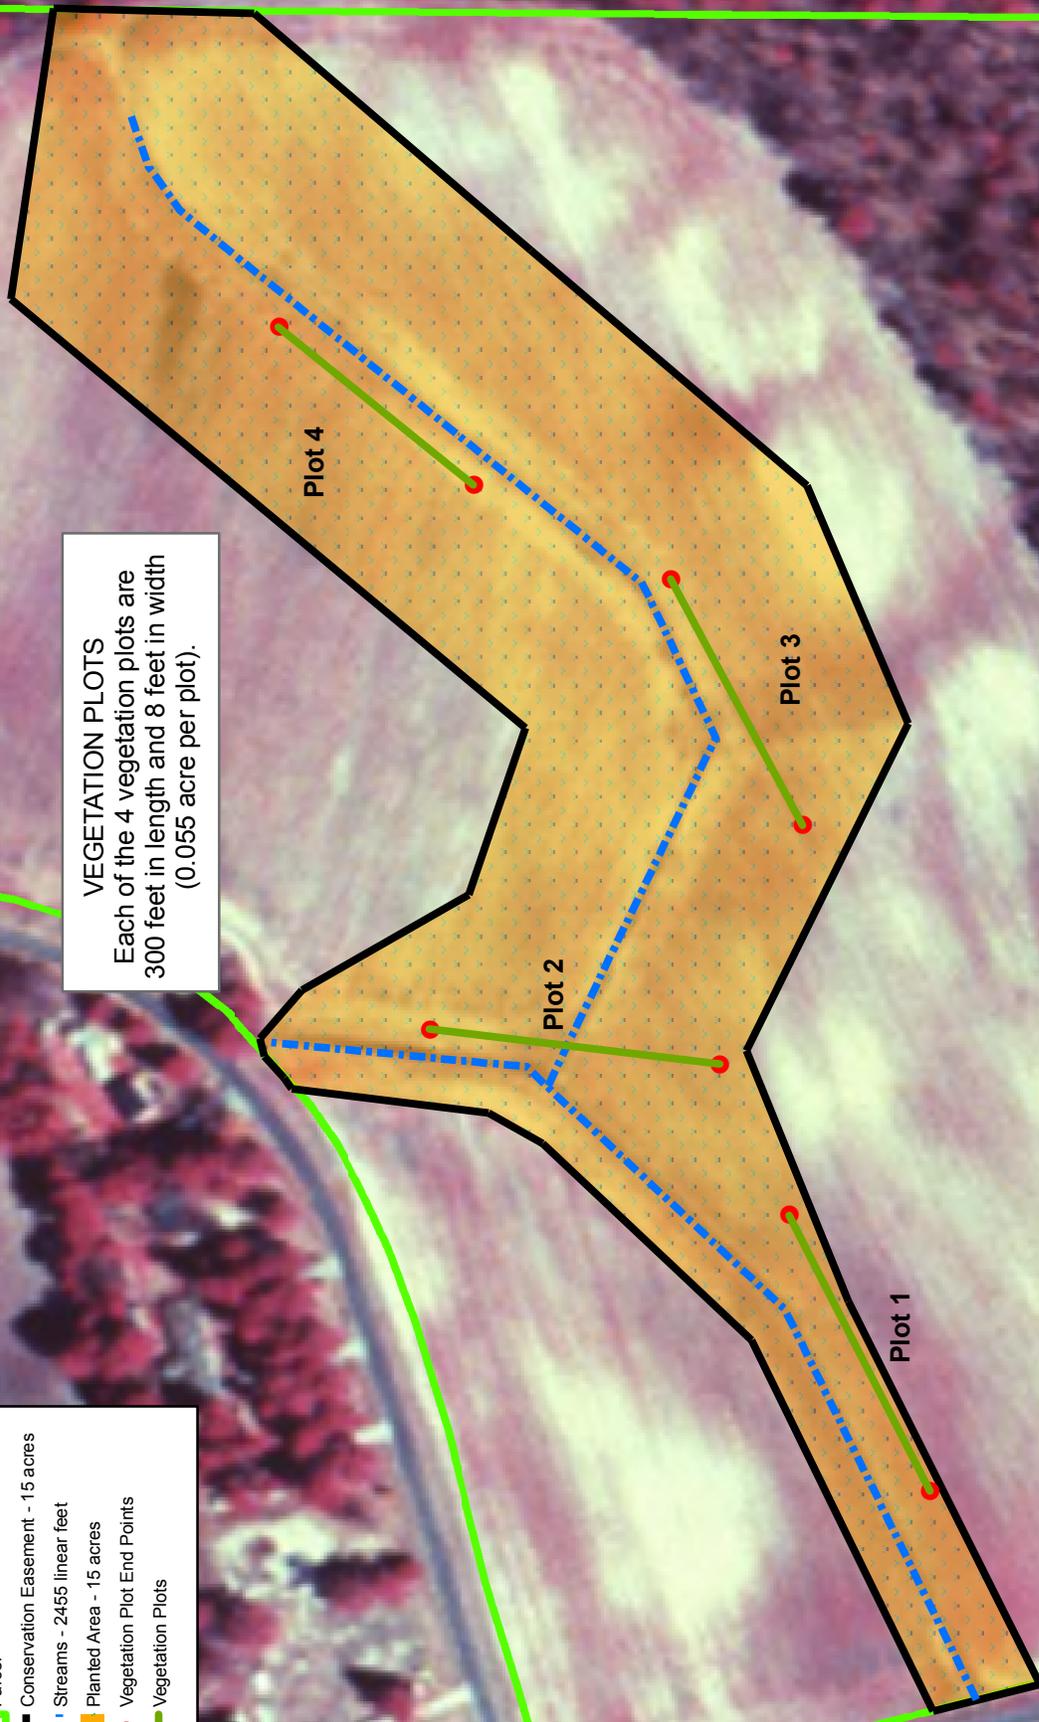
MONITORING PLAN
BROGDEN ROAD BUFFER RESTORATION SITE
 Johnston County, North Carolina

VEGETATION PLOTS
 Each of the 4 vegetation plots are
 300 feet in length and 8 feet in width
 (0.055 acre per plot).

Four sample transects were installed within planted areas of the Site shortly after replanting to equally represent the Site (Figure 2). Each transect is 300 feet in length and 8 feet in width (0.055 acre). In each sample plot, vegetation parameters monitored include species composition and species density. Visual observations of the percent cover of shrub and herbaceous species were also noted. Photographs of the 4 vegetation plots are included in Appendix A.

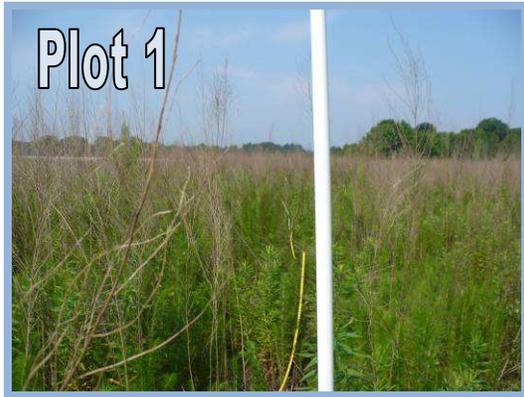
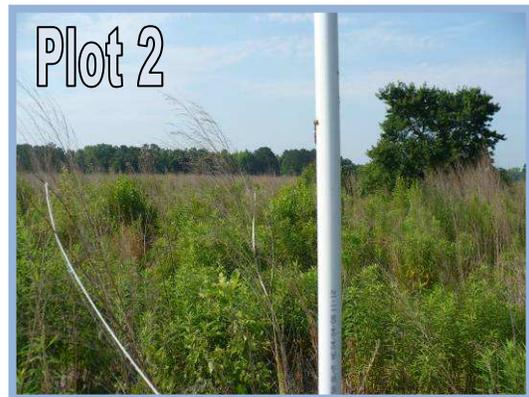
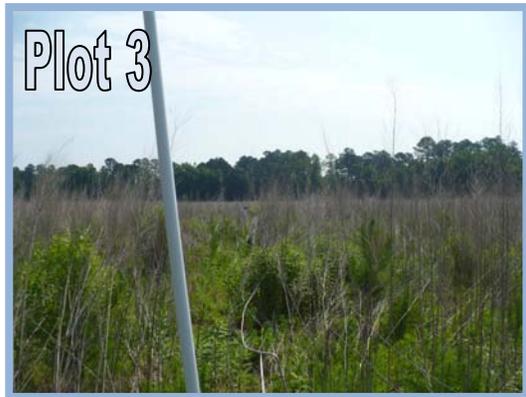
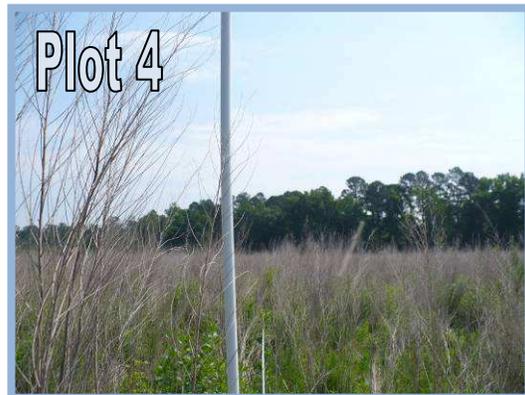
Quantitative sampling of vegetation was conducted in June 2008. Results are provided in Table 2. Vegetation success criteria for year 3 (320 stems per acre) were exceeded for the 2008 annual monitoring year with 695 tree stems per acre across the Site. All individual vegetation plots met success criteria and had good species diversity with 7 to 13 Character Tree Species present within each plot.
