**Brown Bark Park
Stream Restoration Monitoring Report
EEP Project # 52
Monitoring Year – 05
2009**

December 2009

The stream assessment completed during the fifth year of monitoring found the stream to be functioning for the majority of the project. Longitudinal profile and channel dimensions have changed minimally from the as-built conditions. The majority of the in-stream structures are functioning and some previously documented areas of erosion have stabilized with vegetation.

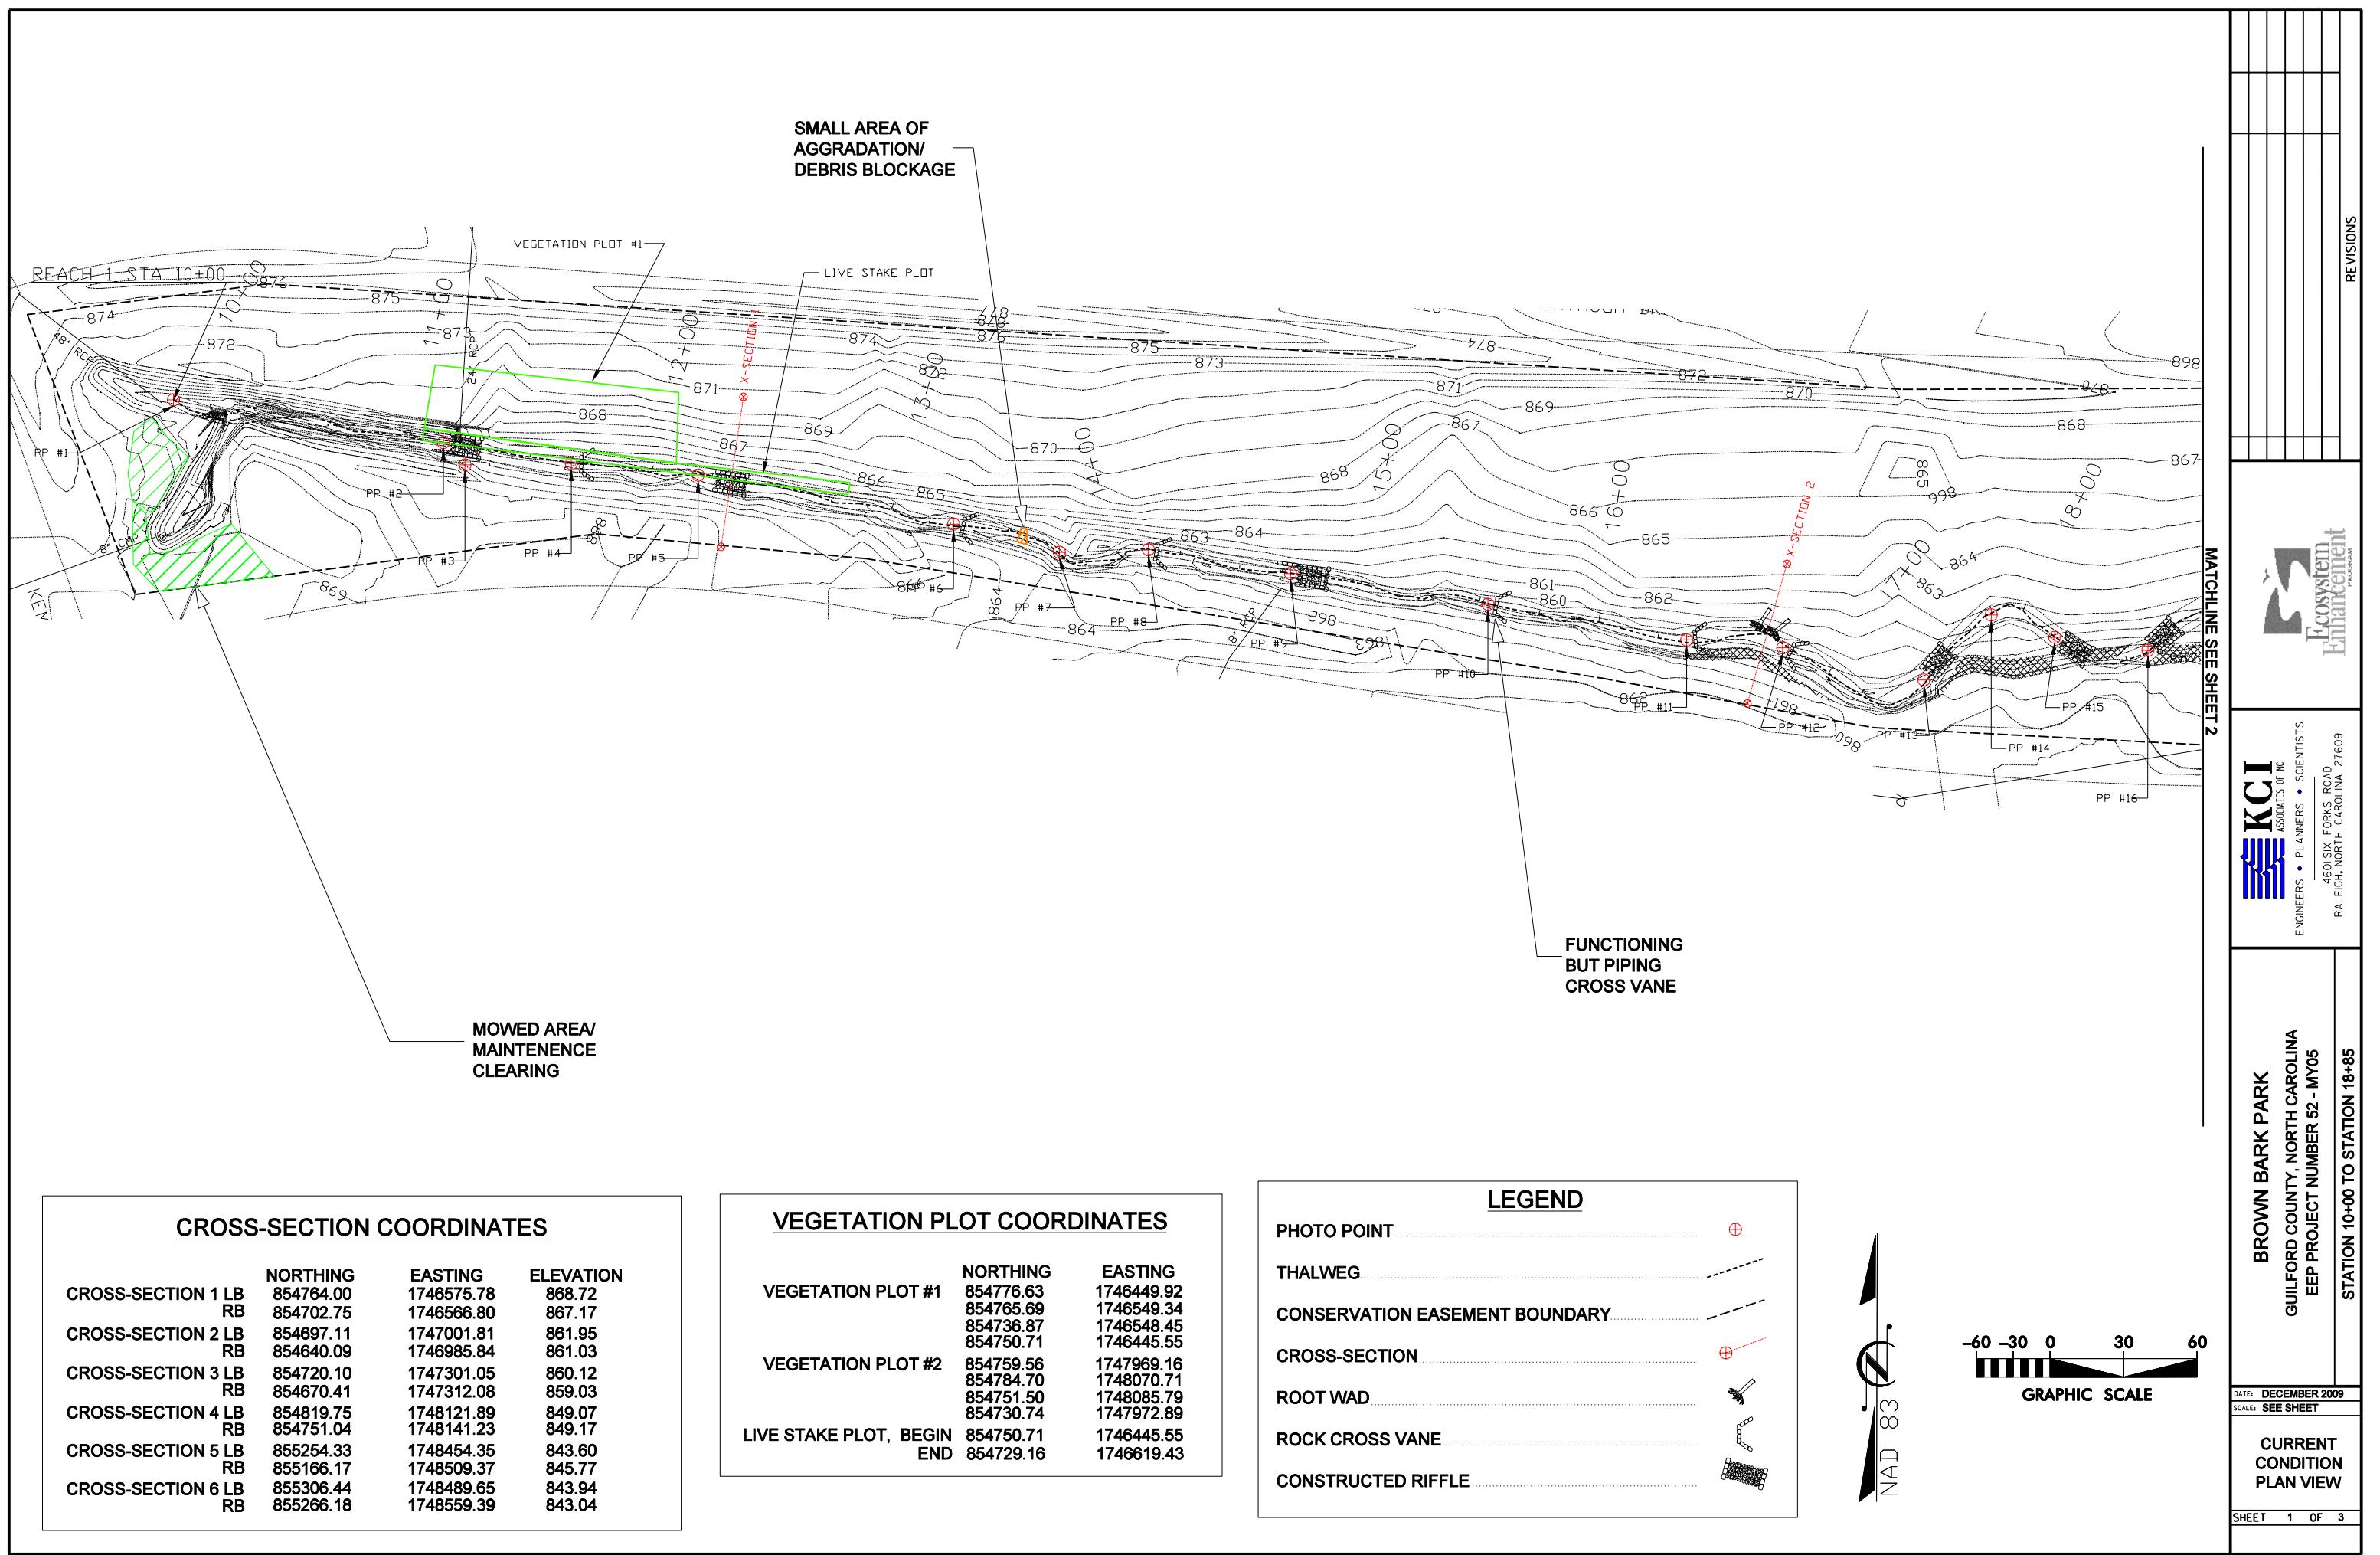
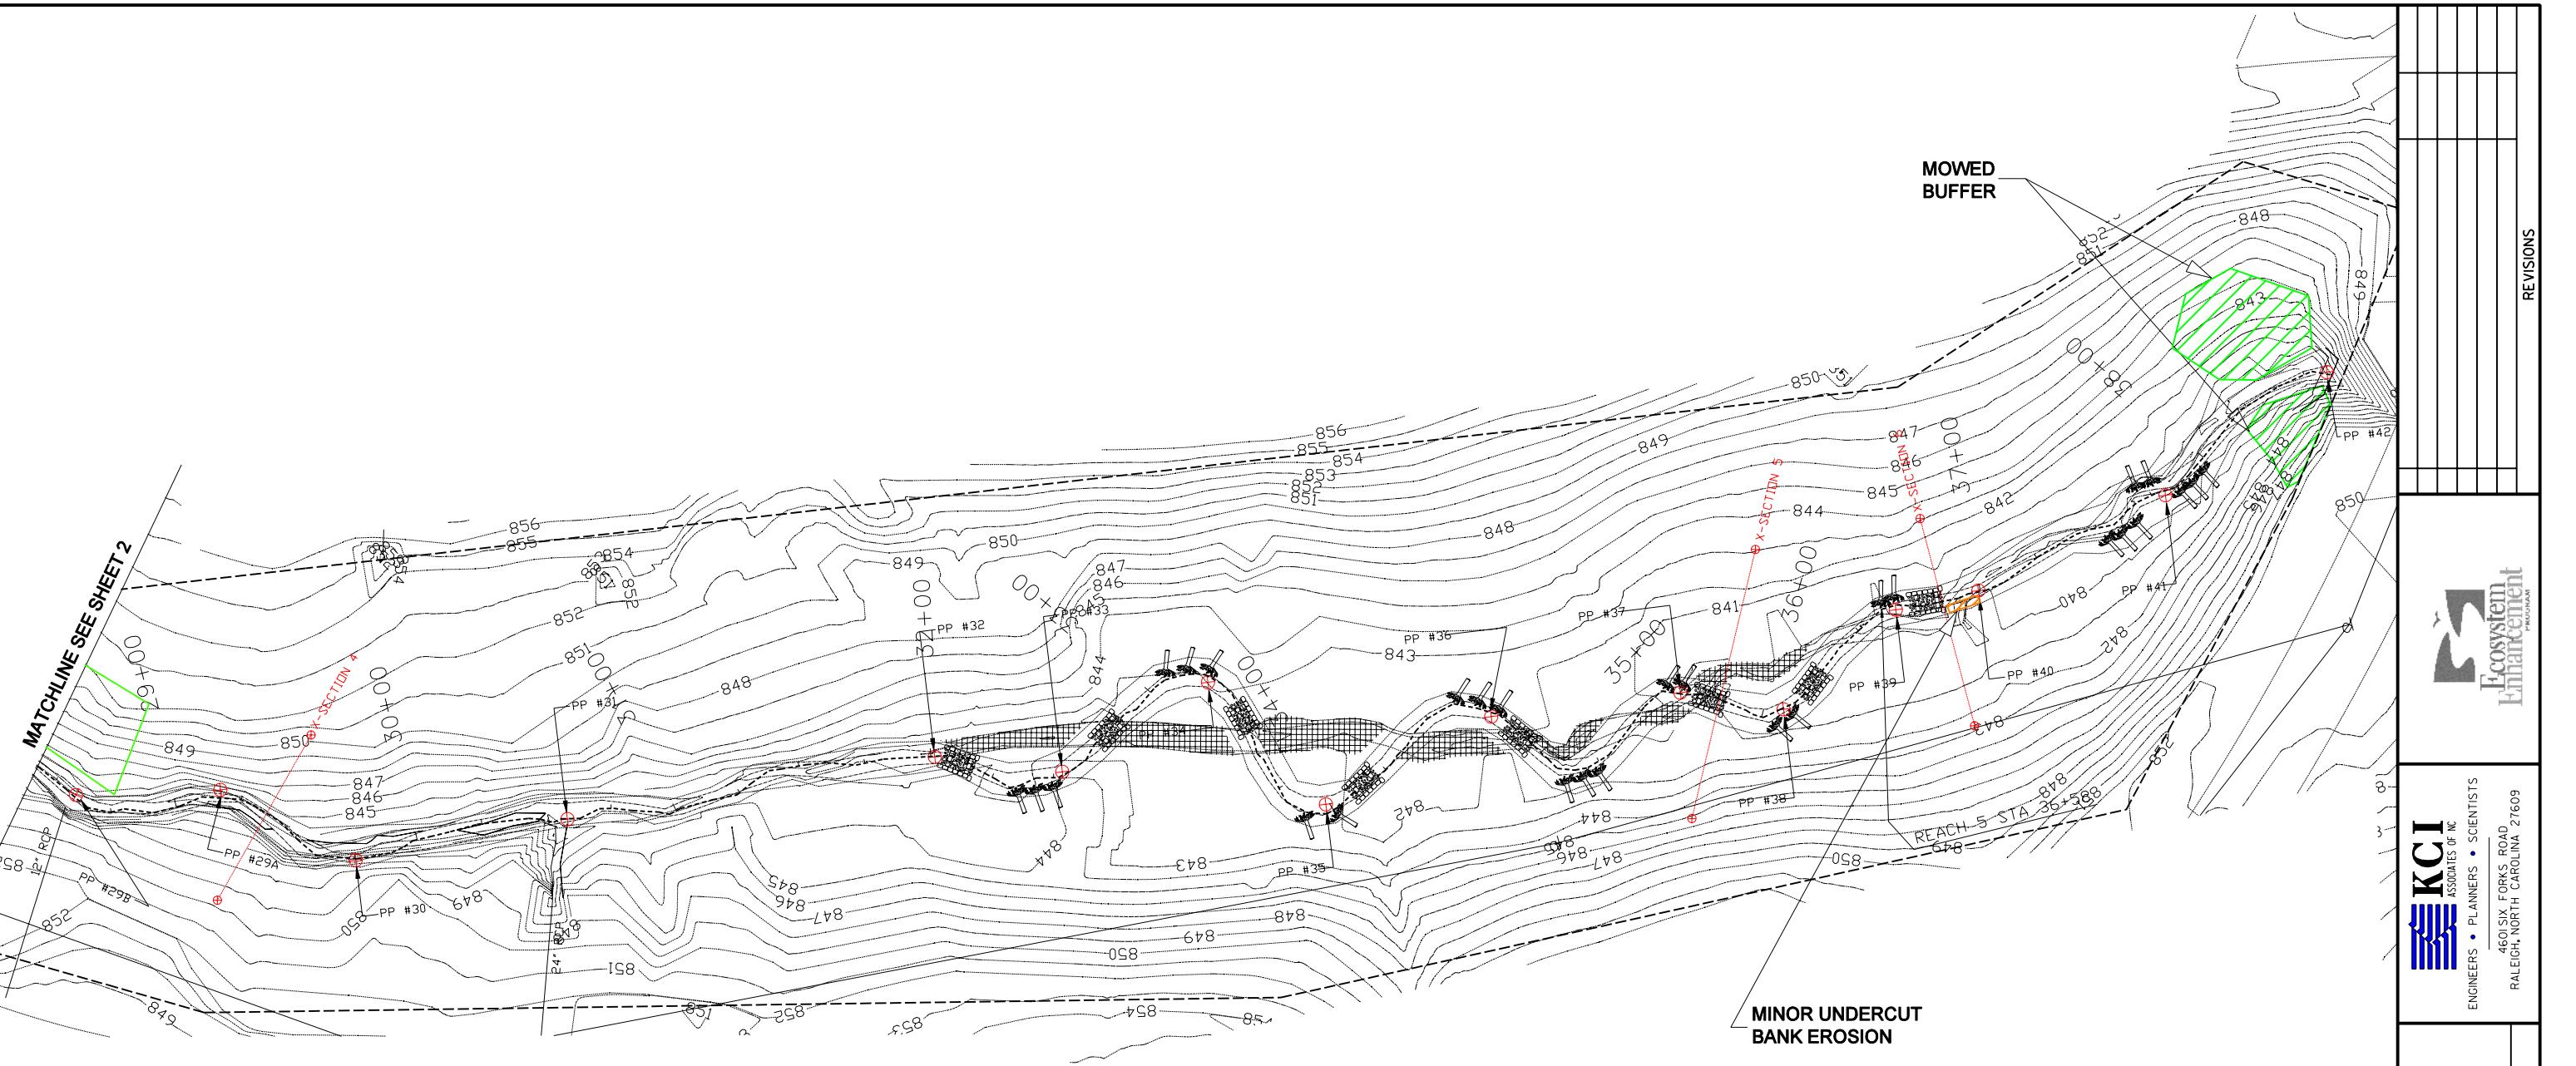
**CURRENT
CONDITION
PLAN VIEW**

BROWN BARK PARK
GUILFORD COUNTY, NORTH CAROLINA
EEP PROJECT NUMBER 52 -MY05
STATION 28+40 TO STATION 38+

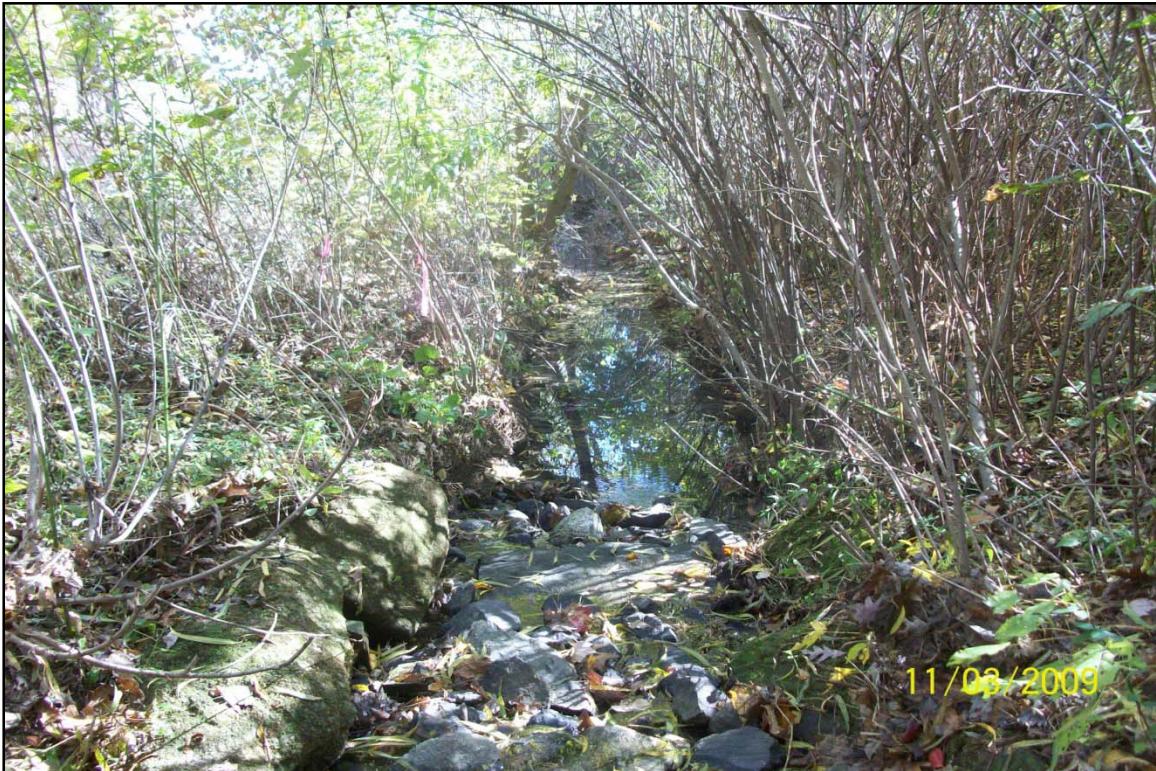
Plot 1 Photo – Taken from Photo Point #3 Buffer Plot #1 and the Live Stake Plot are on the left side of the stream. 11/3/09 - MY 05

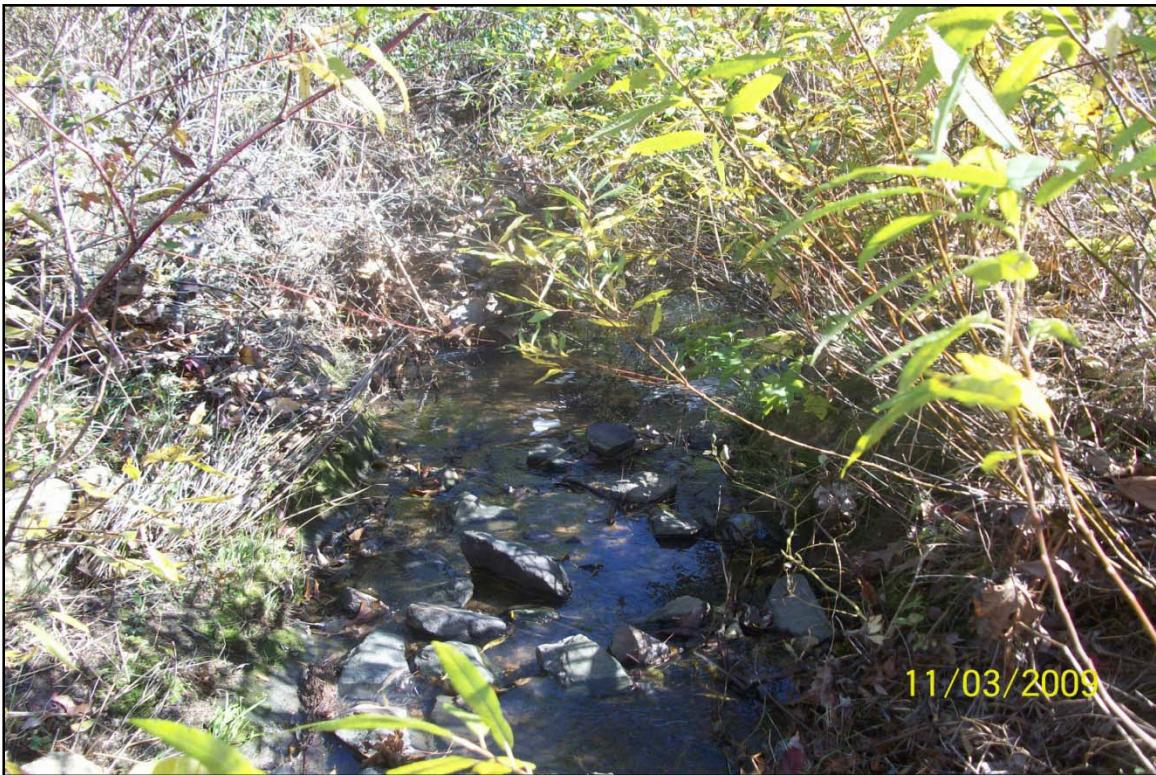
Plot 2 Photo – Taken from Photo Point #28 Buffer Plot #2 is on the left side of the stream. 11/3/09 - MY 05

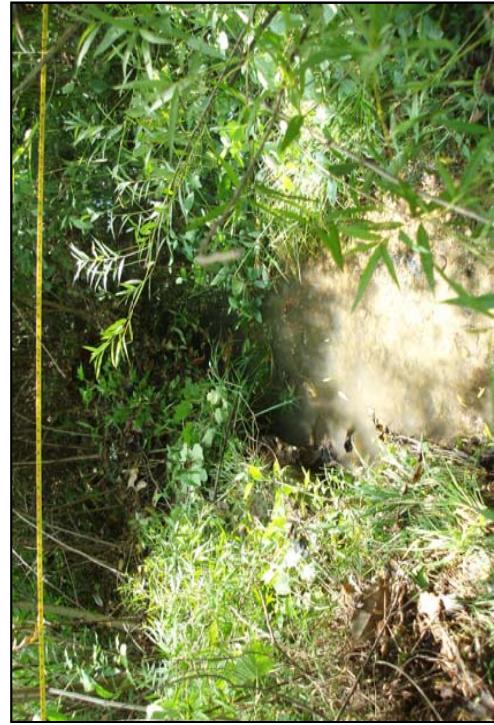
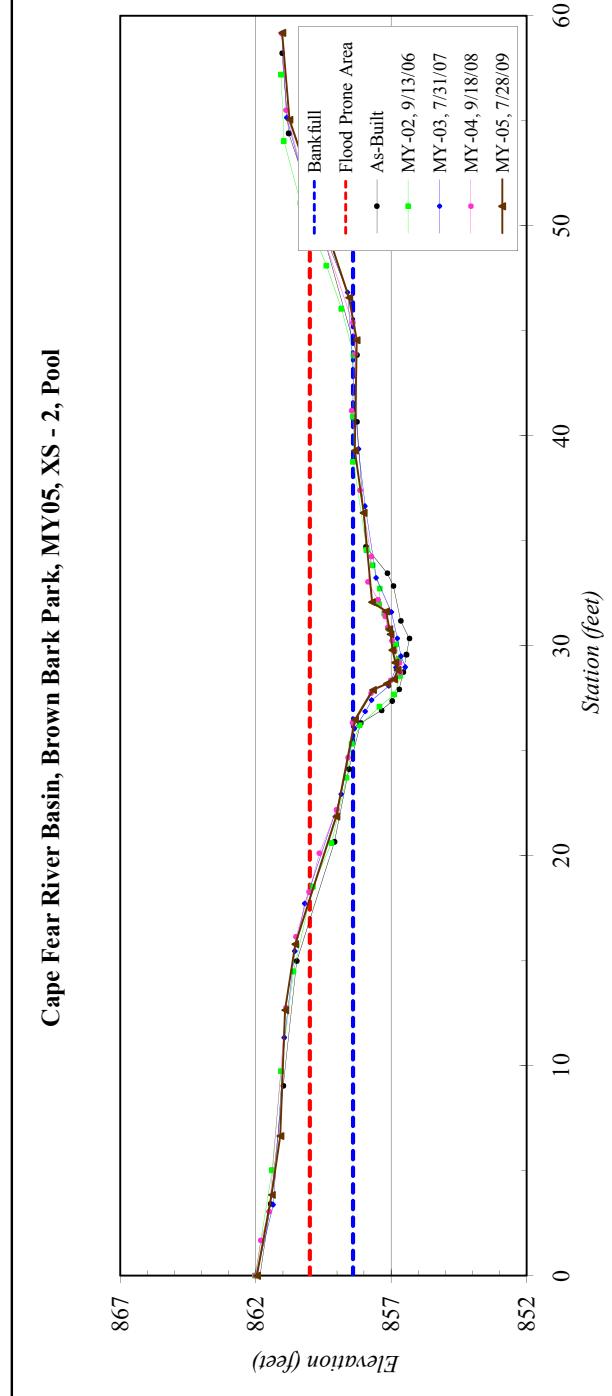
Cape Fear River Basin, Brown Bark Park, MY05, XS - 2, Pool

River Basin:	Cape Fear
Watershed:	Brown Bark Park, MY05
XS ID	XS - 2, Pool
Drainage Area (sq mi):	0.3
Date:	7/28/2009
Field Crew:	B. Roberts, C. Carter

Station	Elevation
0.0	861.95
3.9	861.41
6.6	861.09
12.6	860.91
15.8	860.54
21.9	859.03
26.5	858.34
27.9	857.67
28.2	857.15
28.4	856.90
28.8	856.76
29.2	856.85
29.8	856.95
30.5	857.02
30.8	857.07
31.6	857.19
32.1	857.71
36.3	858.02
39.3	858.34
44.6	858.28
46.6	858.55
50.5	859.56
55.0	860.75
59.2	861.03

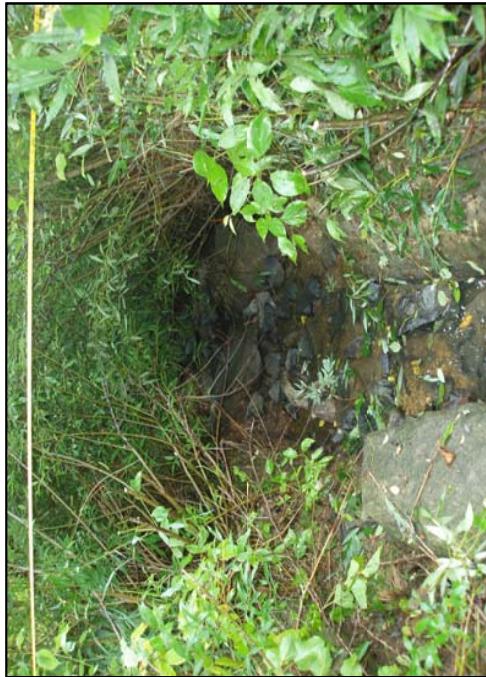
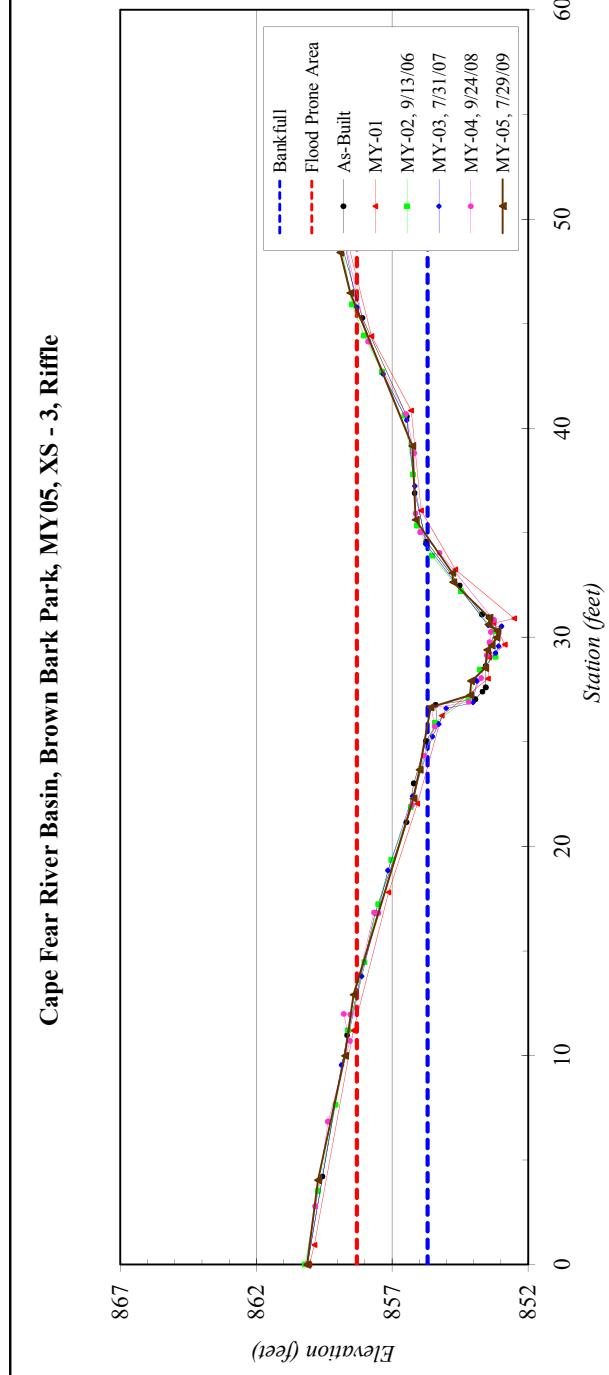
Cape Fear River Basin, Brown Bark Park, MY05, XS - 3, Riffle

River Basin:	Cape Fear
Watershed:	Brown Bark Park, MY05
XS ID	XS - 3, Riffle
Drainage Area (sq mi):	0.3
Date:	7/29/2009
Field Crew:	B. Roberts, C. Carter

Station	Elevation
0.0	860.12
4.0	859.72
10.0	858.74
12.9	858.42
22.3	856.22
23.7	855.99
26.6	855.59
27.2	854.13
27.9	854.09
28.5	853.58
29.4	853.50
29.6	853.34
30.0	853.16
30.3	853.13
30.6	853.46
30.9	853.42
32.6	854.76
33.1	854.78
35.6	856.13
39.1	856.25
46.5	858.54
48.4	858.90
50.8	859.03

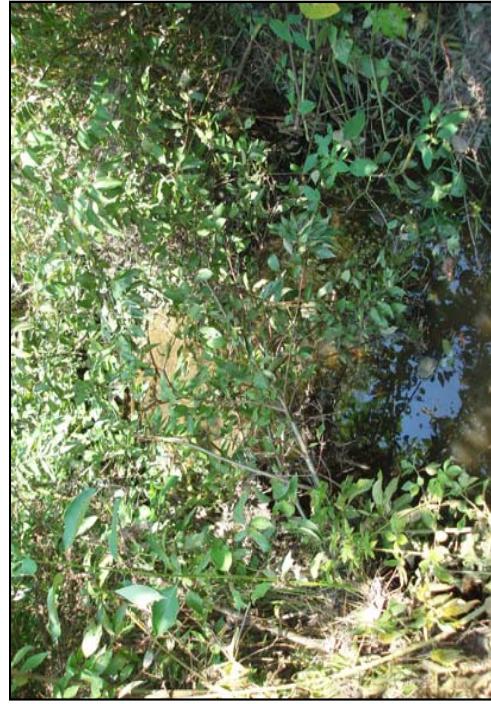
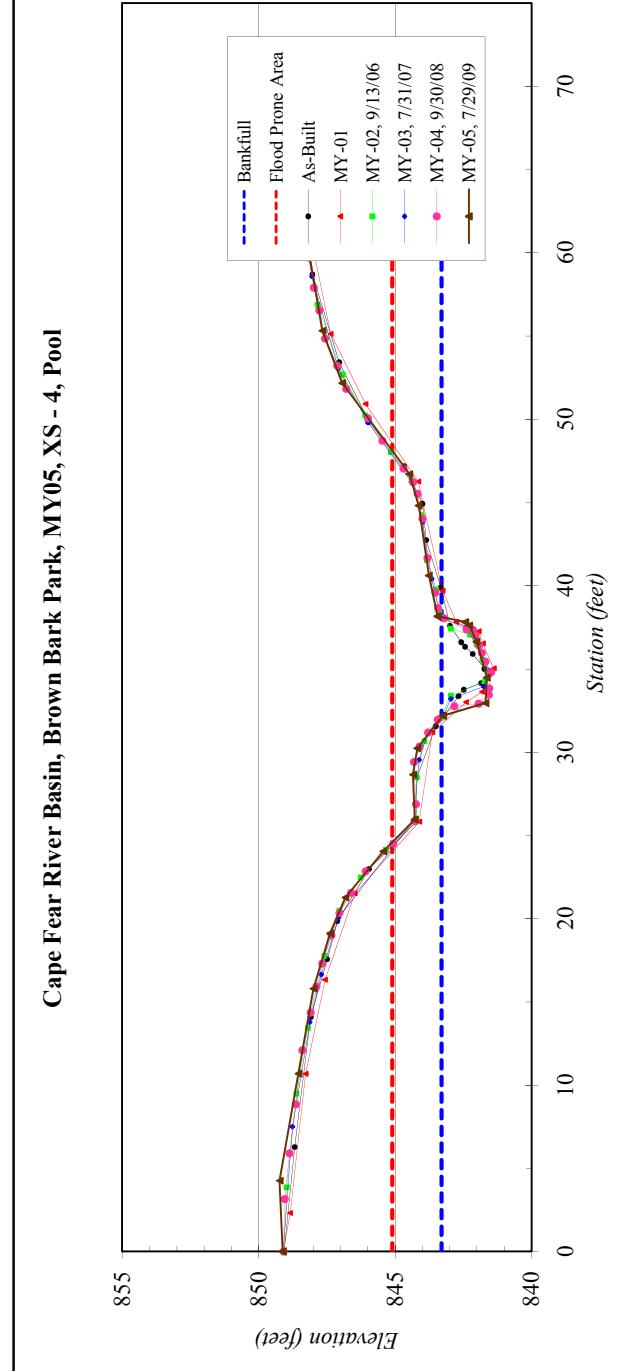
Cape Fear River Basin, Brown Bark Park, MY05, XS - 4, Pool

River Basin:	Cape Fear
Watershed:	Brown Bark Park, MY05
XS ID	XS - 4, Pool
Drainage Area (sq mi):	0.3
Date:	7/31/2009
Field Crew:	B. Roberts, K. Knight-Meng

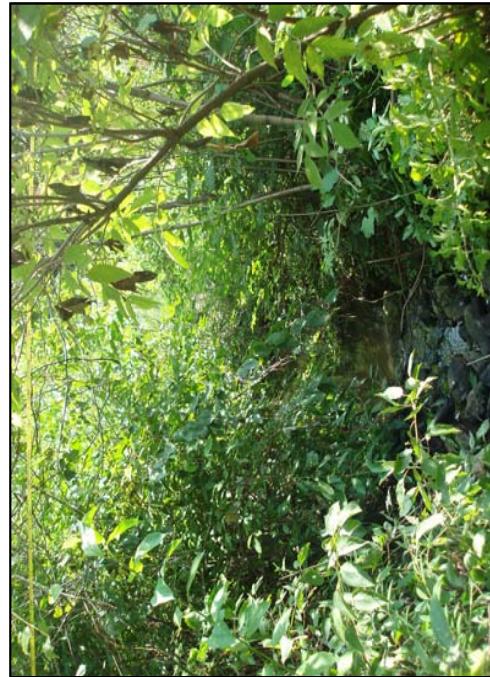
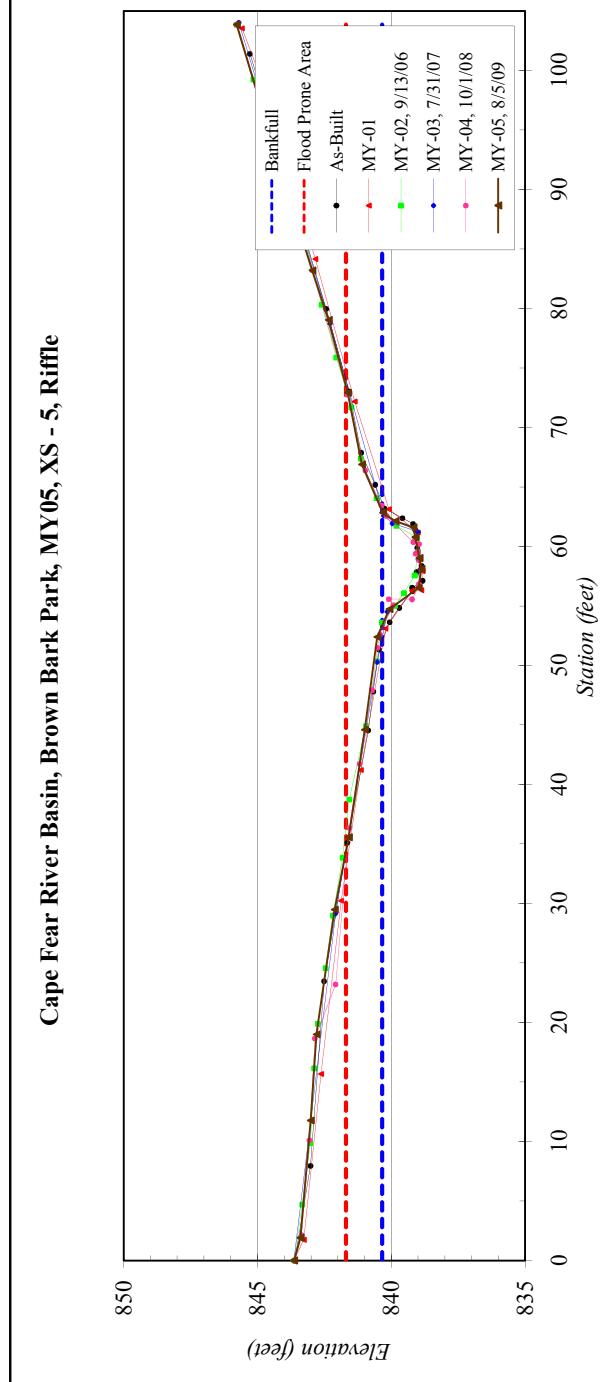
Cape Fear River Basin, Brown Bark Park, MY05, XS - 5, Riffle

River Basin:	Cape Fear
Watershed:	Brown Bark Park, MY05
XS ID	XS - 5, Riffle
Drainage Area (sq mi):	0.3
Date:	8/5/2009
Field Crew:	B. Roberts, A. Davis

Station	Elevation
0.0	843.63
1.9	843.39
11.8	843.01
19.0	842.79
29.5	842.12
35.6	841.59
44.6	840.99
52.4	840.53
54.7	840.07
56.5	838.99
58.1	838.87
59.0	838.95
60.8	839.10
61.6	839.17
62.1	839.84
62.8	840.31
66.9	841.10
72.9	841.62
79.0	842.34
83.2	842.95
94.3	844.50
103.8	845.77

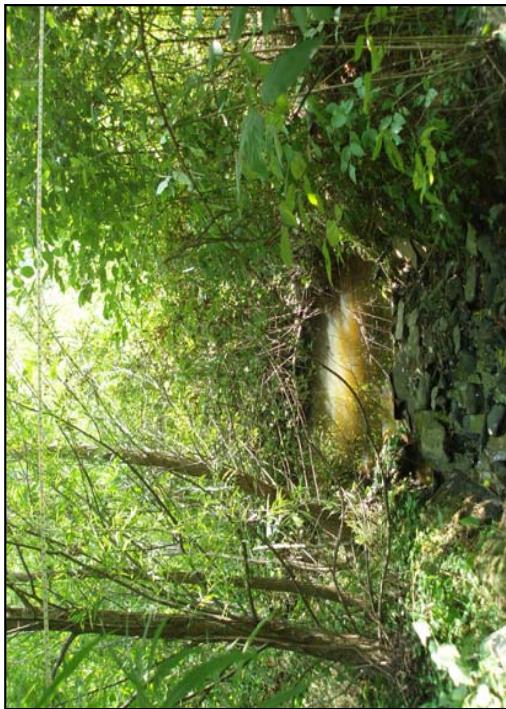
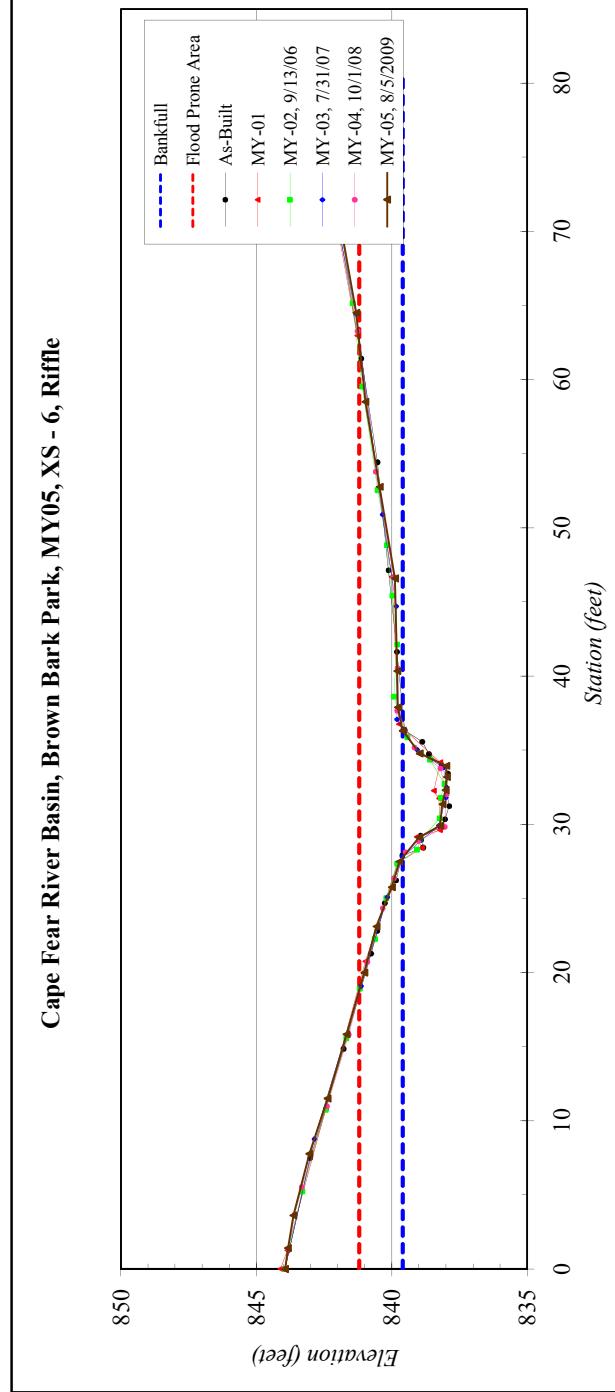
Cape Fear River Basin, Brown Bark Park, MY05, XS - 6, Riffle

River Basin:	Cape Fear
Watershed:	Brown Bark Park, MY05
XS ID	XS - 6, Riffle
Drainage Area (sq mi):	0.3
Date:	8/5/2009
Field Crew:	B. Roberts, A. Davis

Station	Elevation
0.0	843.94
1.4	843.84
3.6	843.64
7.8	843.04
11.5	842.37
15.8	841.67
20.0	841.02
23.1	840.56
25.8	840.00
27.5	839.72
29.1	838.99
29.9	838.22
31.4	838.13
32.3	838.02
33.2	837.97
33.9	837.99
34.8	838.97
36.3	839.60
37.9	839.78
40.3	839.80
46.6	839.88
52.8	840.45
58.5	840.97
64.5	841.31
74.7	842.31
77.8	842.73
80.6	843.05
